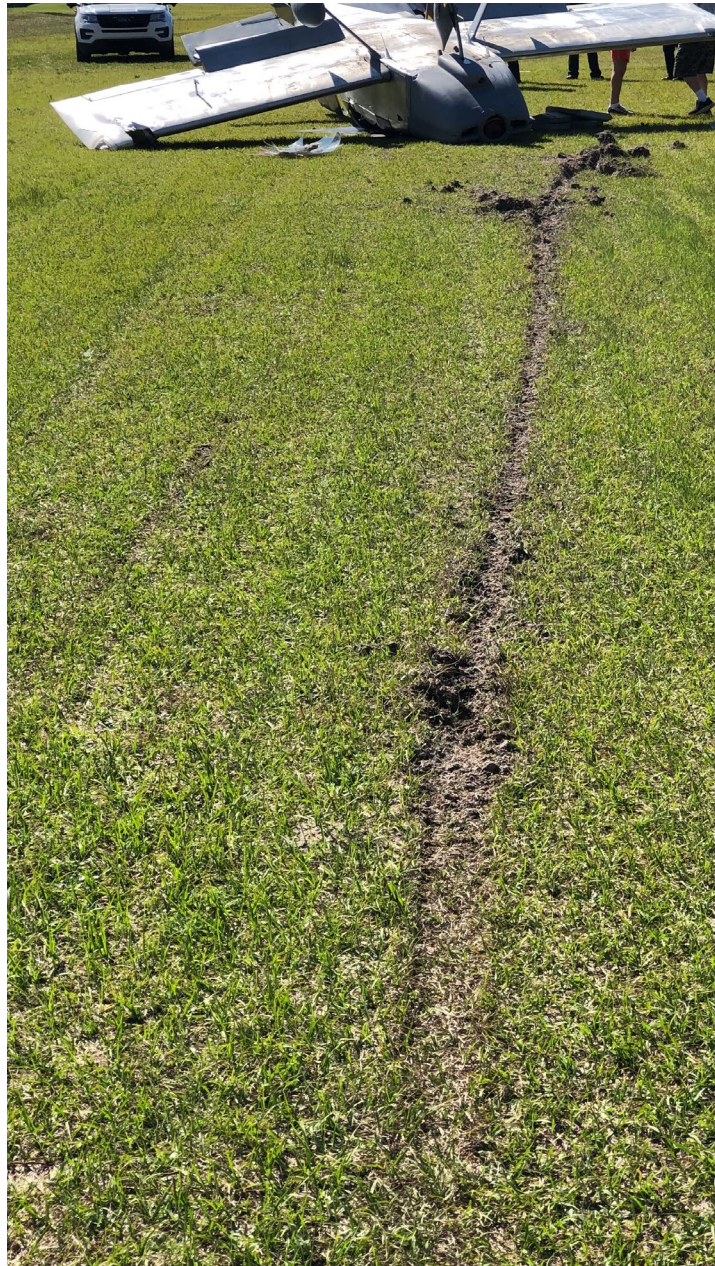
**Photo 1 – Digital Photograph Provided by FAA. View Depicting the Ground Scar on the Runway Made by the Nose Landing Gear and the Inverted Airplane.**

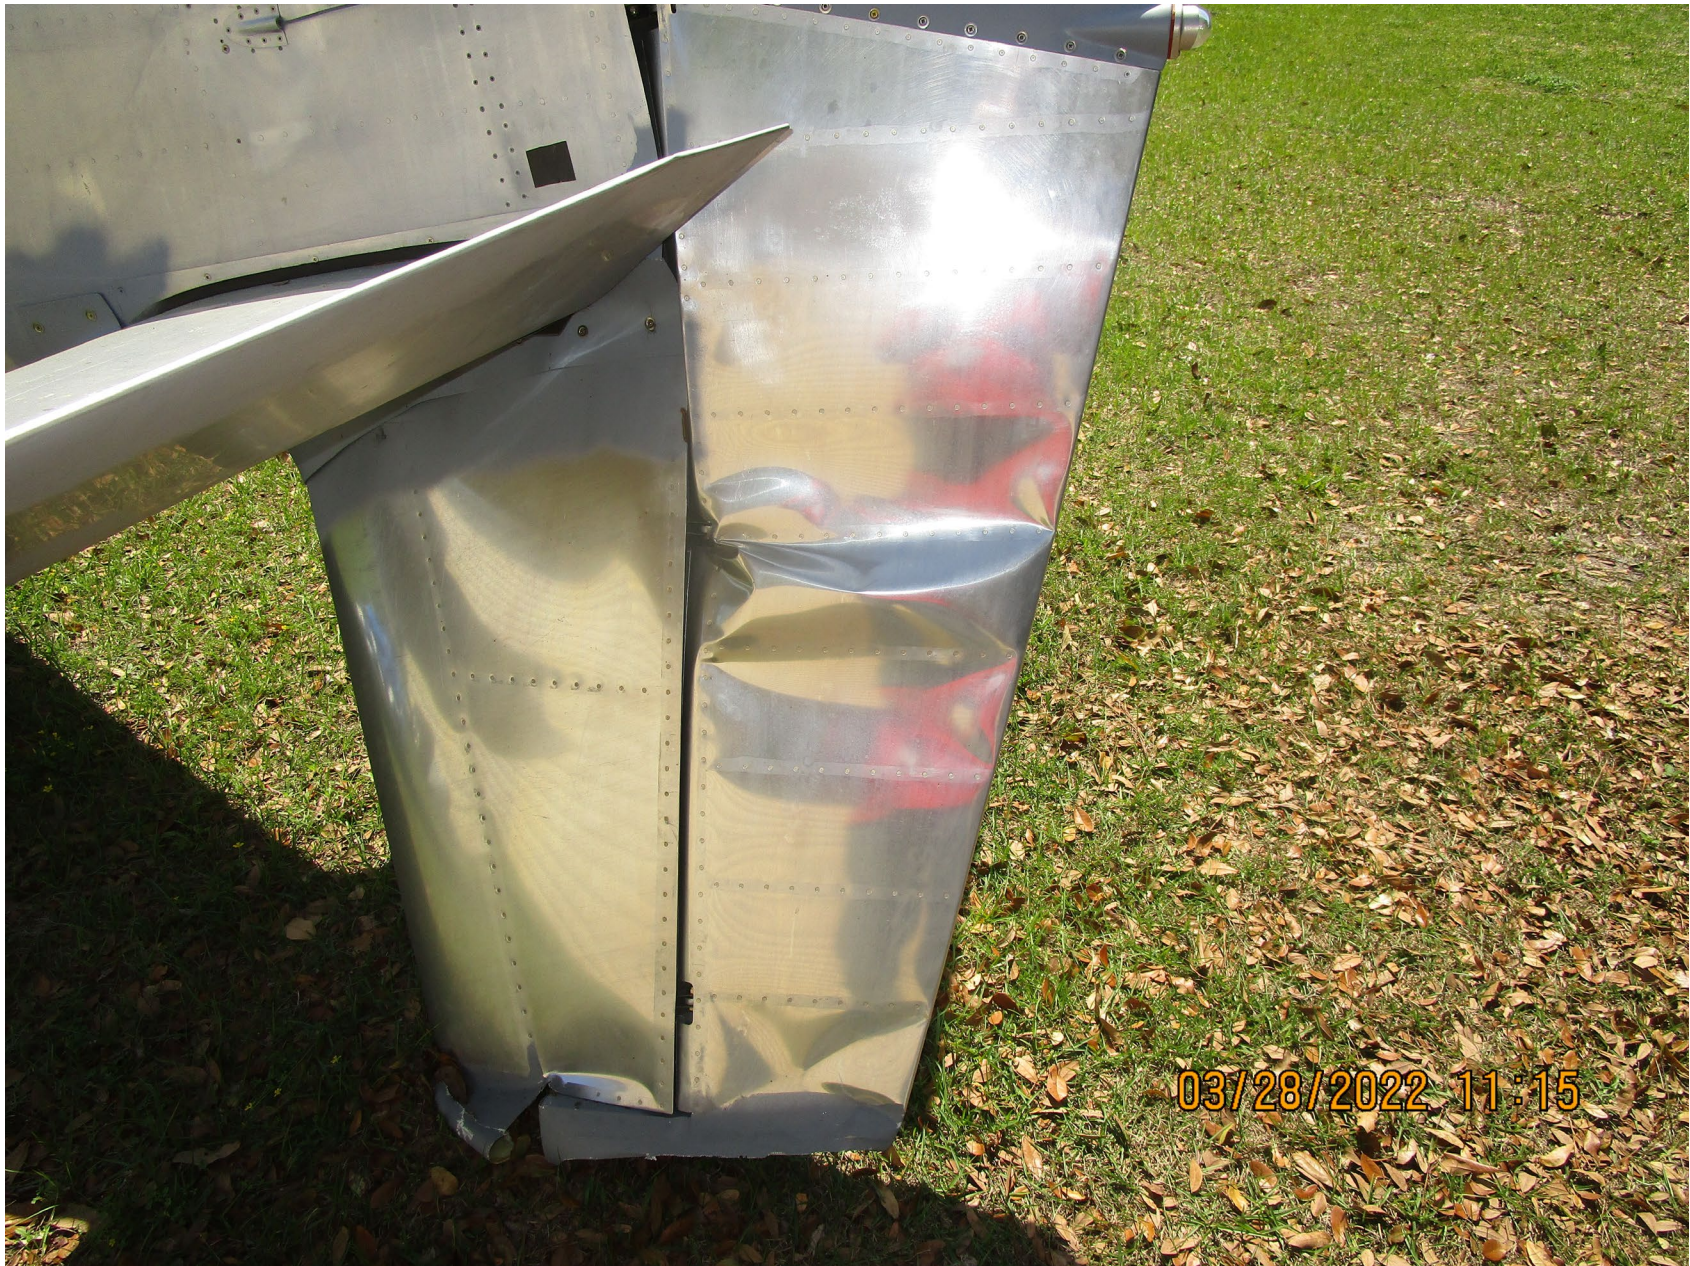
**Photo 2 - Digital Photograph Provided by FAA. View Depicting the Substantial Damage to the Rudder Flight Control Surface.**

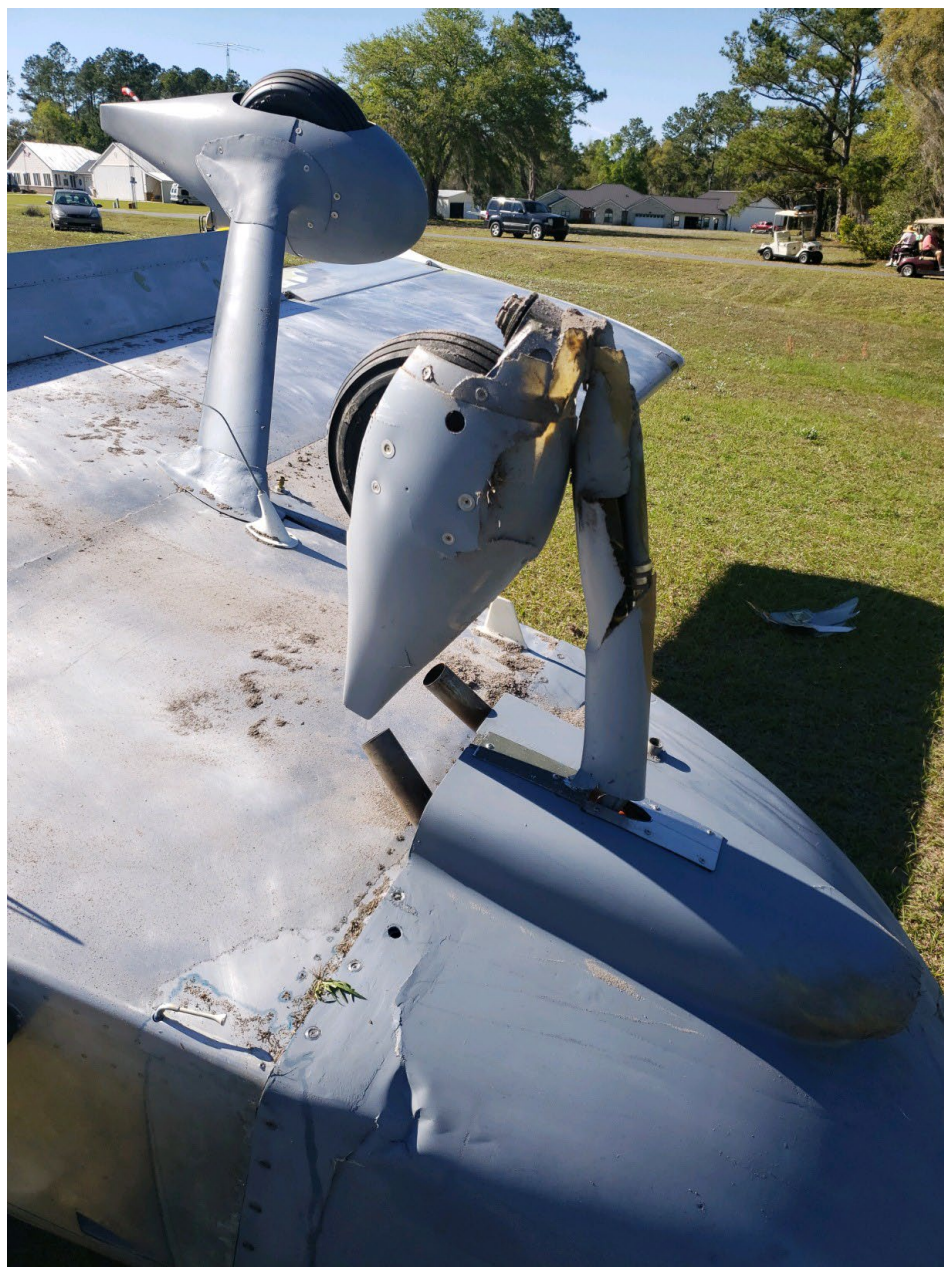
**Photo 3 - Digital Photograph Provided by FAA. Left Side View of the Inverted Airplane At the Accident Site, and the Nose and Right Main Landing Gears visible. Note the Aft Displaced Nose Landing Gear.**

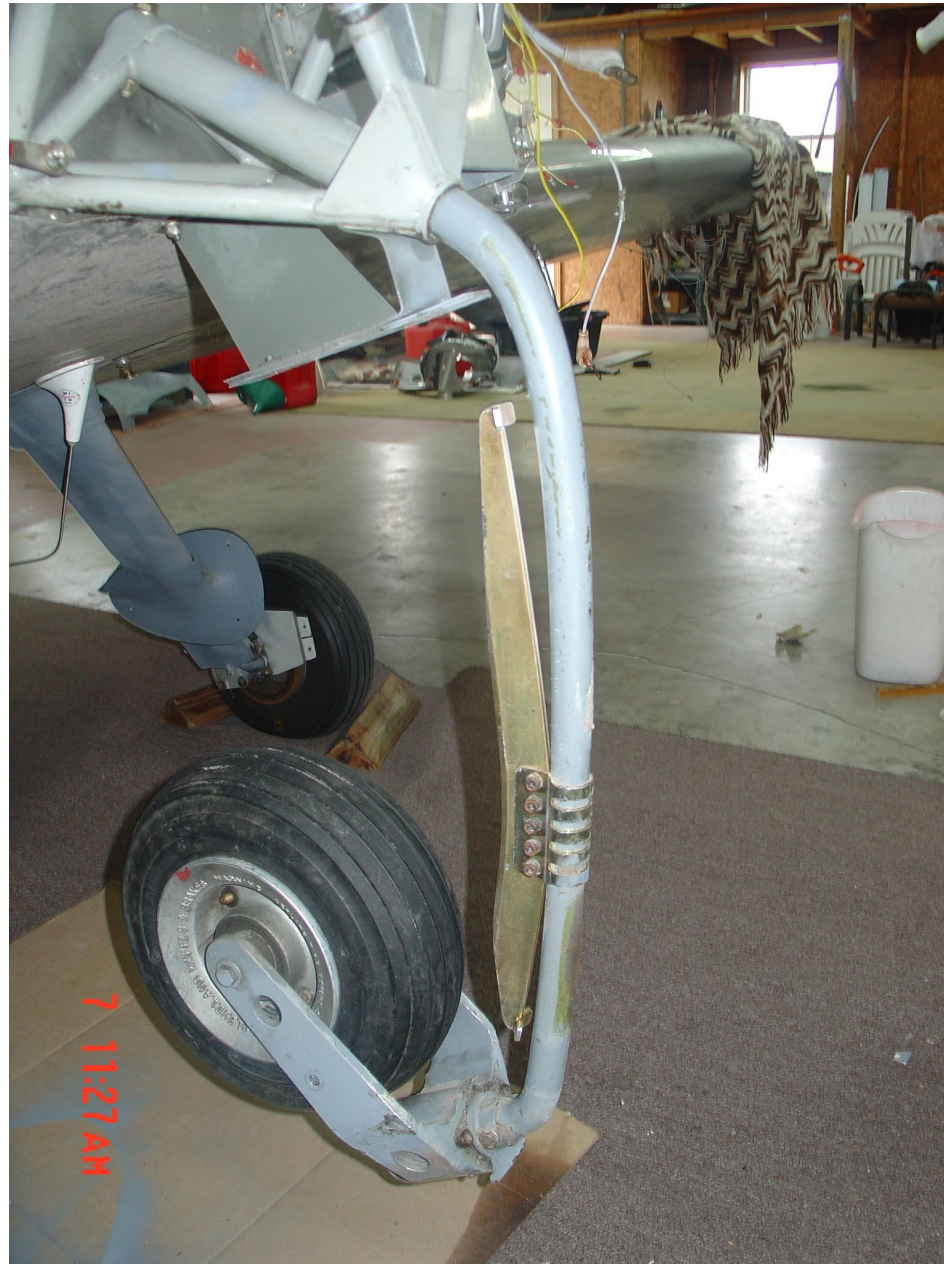
**Photo 4 - Digital Photograph Provided by Owner/Pilot. Right Side View of the Nose Landing Gear Following Recovery of the Airplane. Note the Aft Displacement of the Nose Gear Leg.**
