ERA23LA121

INVESTIGATION PHOTOGRAPHS

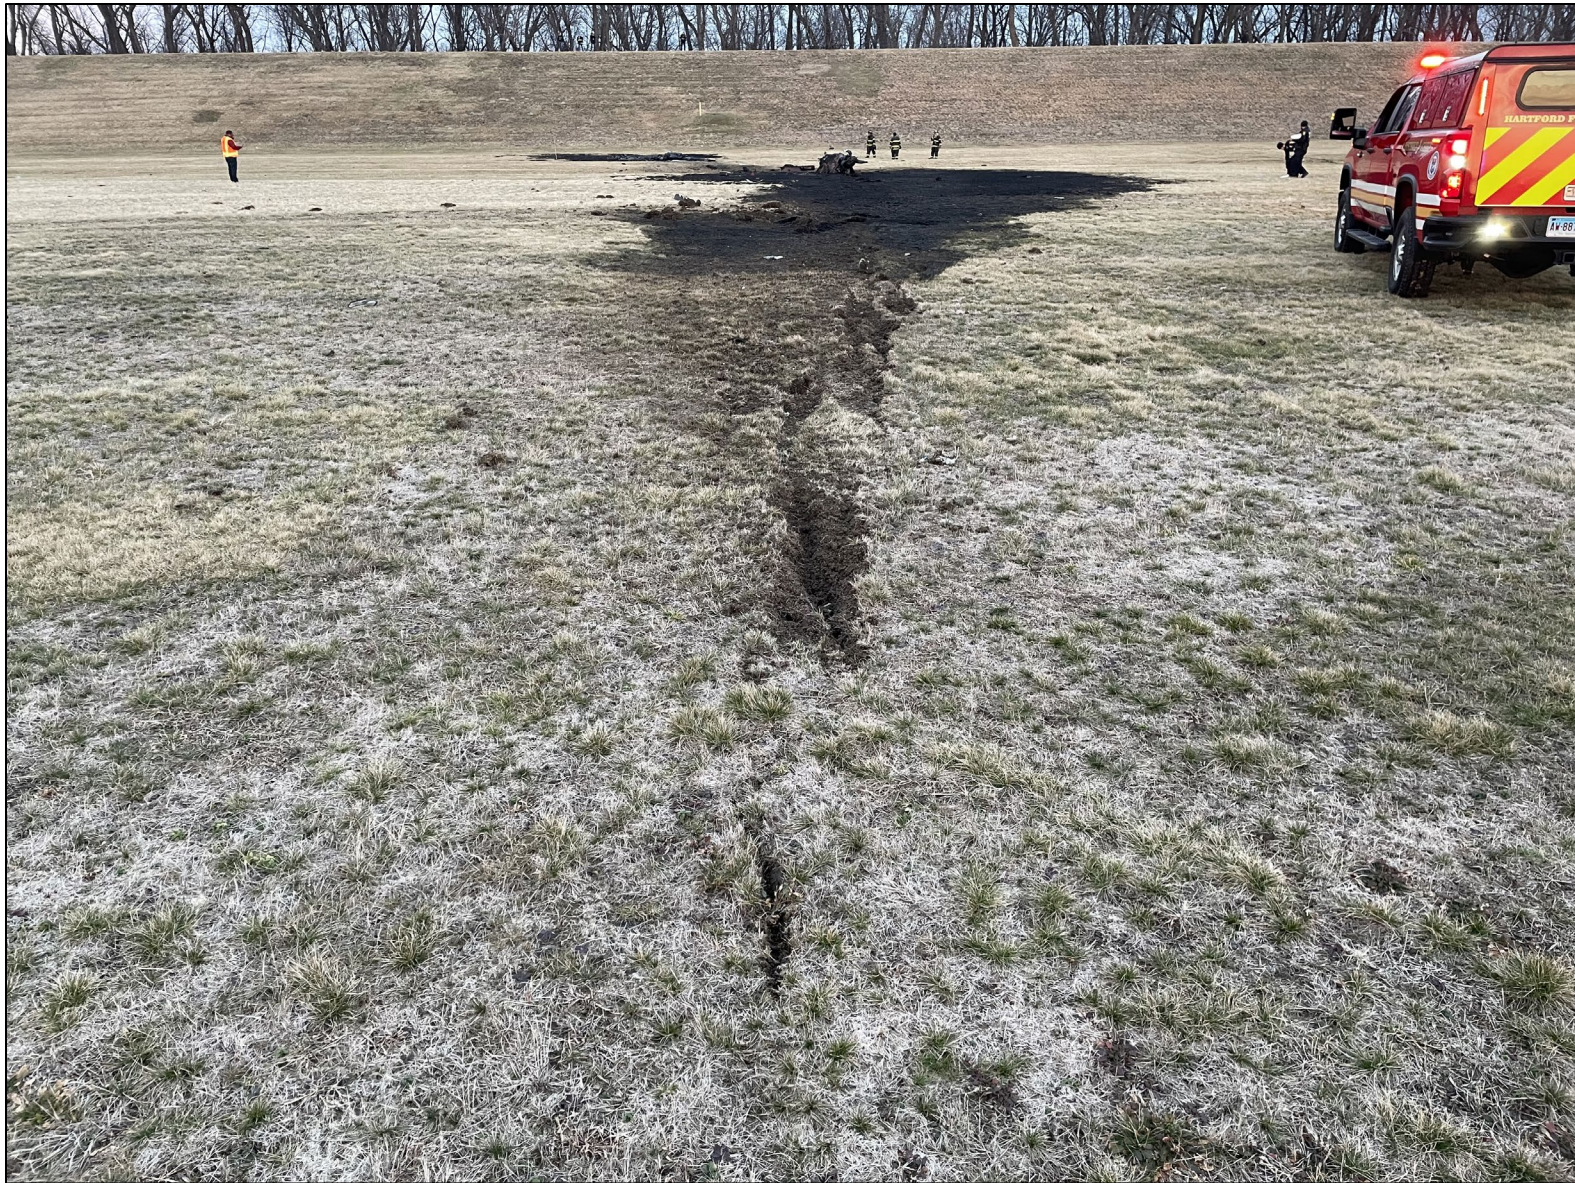
Photograph 1 - View of the accident site (Photo Courtesy of FAA)

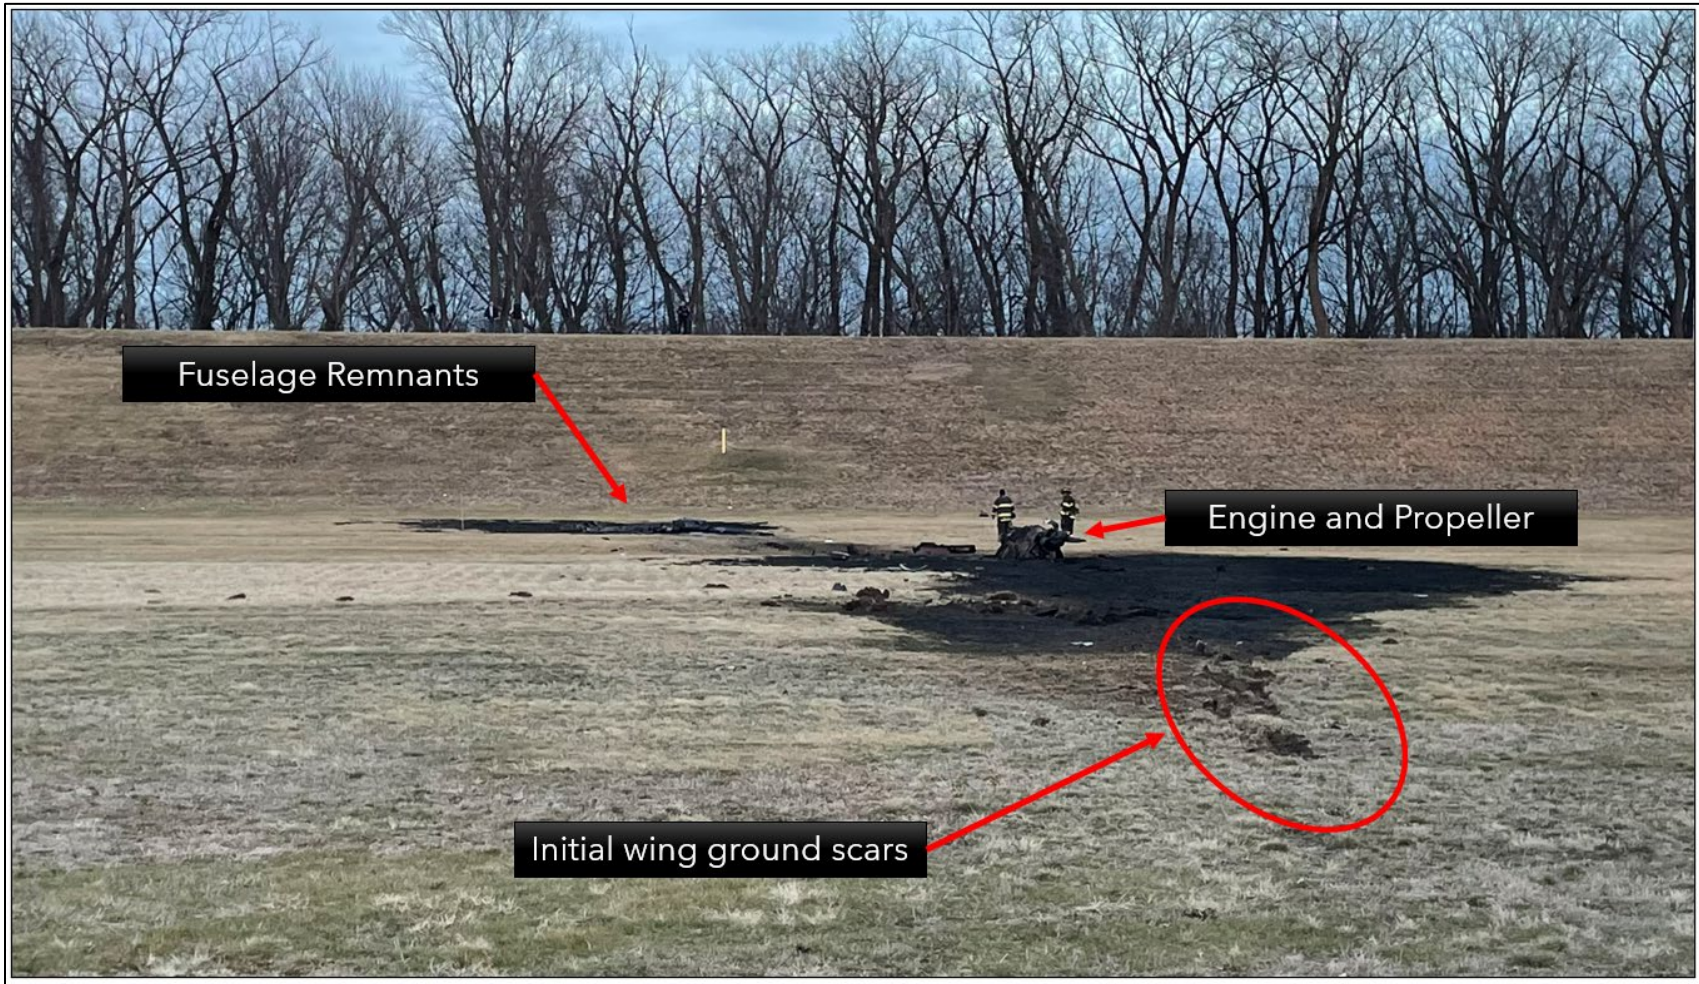
Photograph 2 - Annotated view of the accident site (Photo Courtesy of FAA)

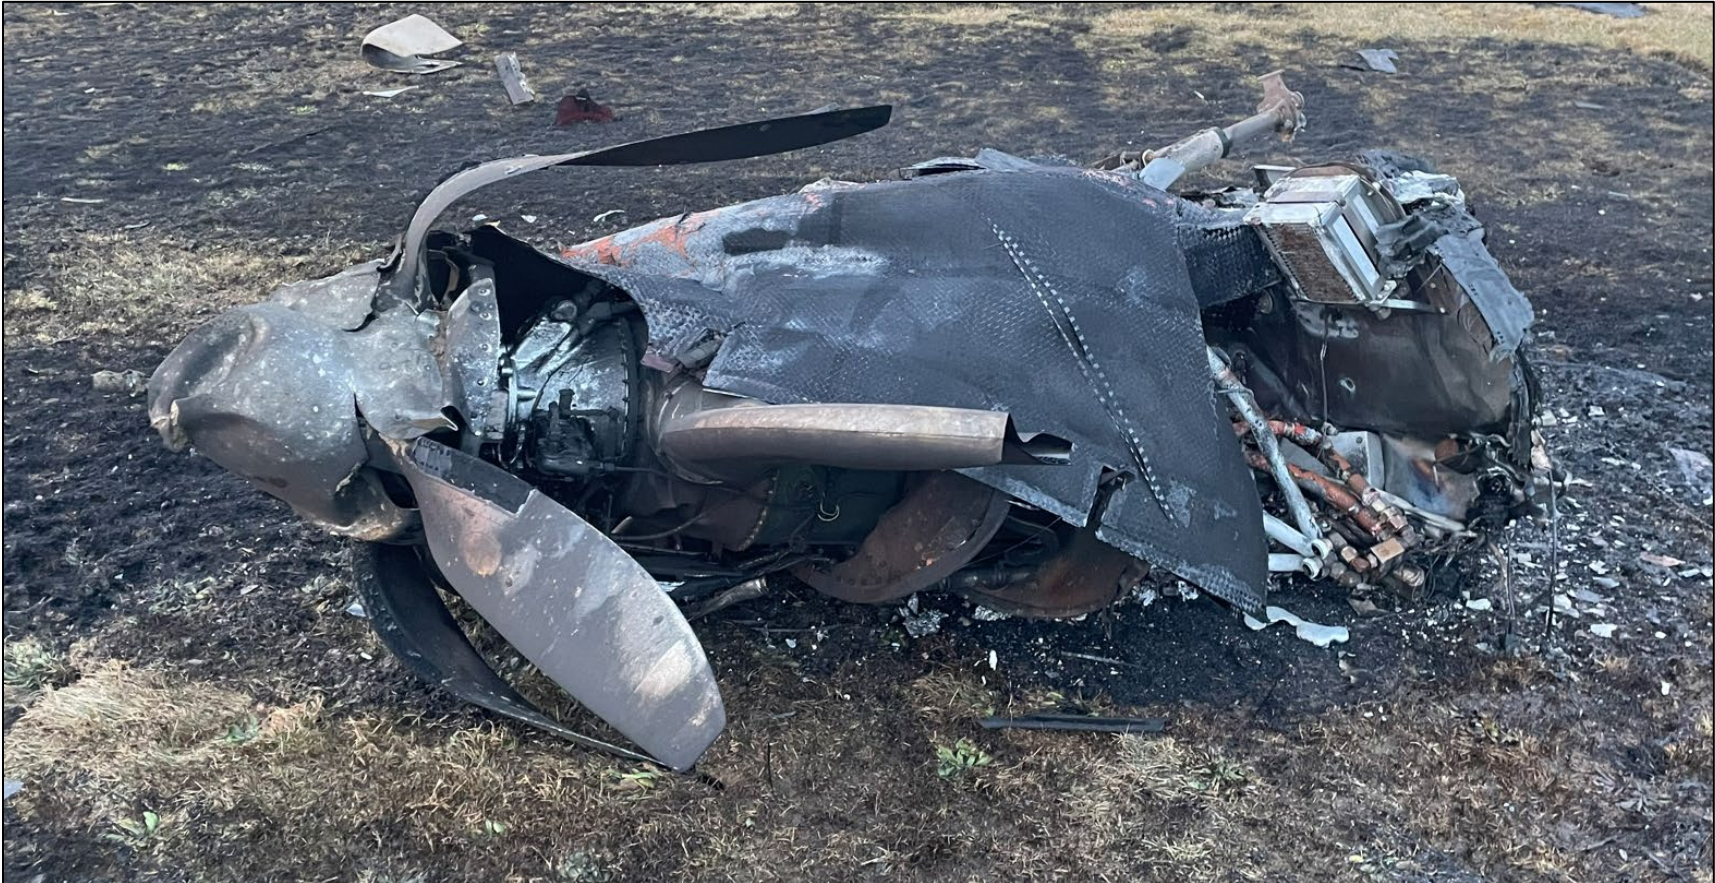
Photograph 3 - View of the engine and propeller (Photo Courtesy of FAA)

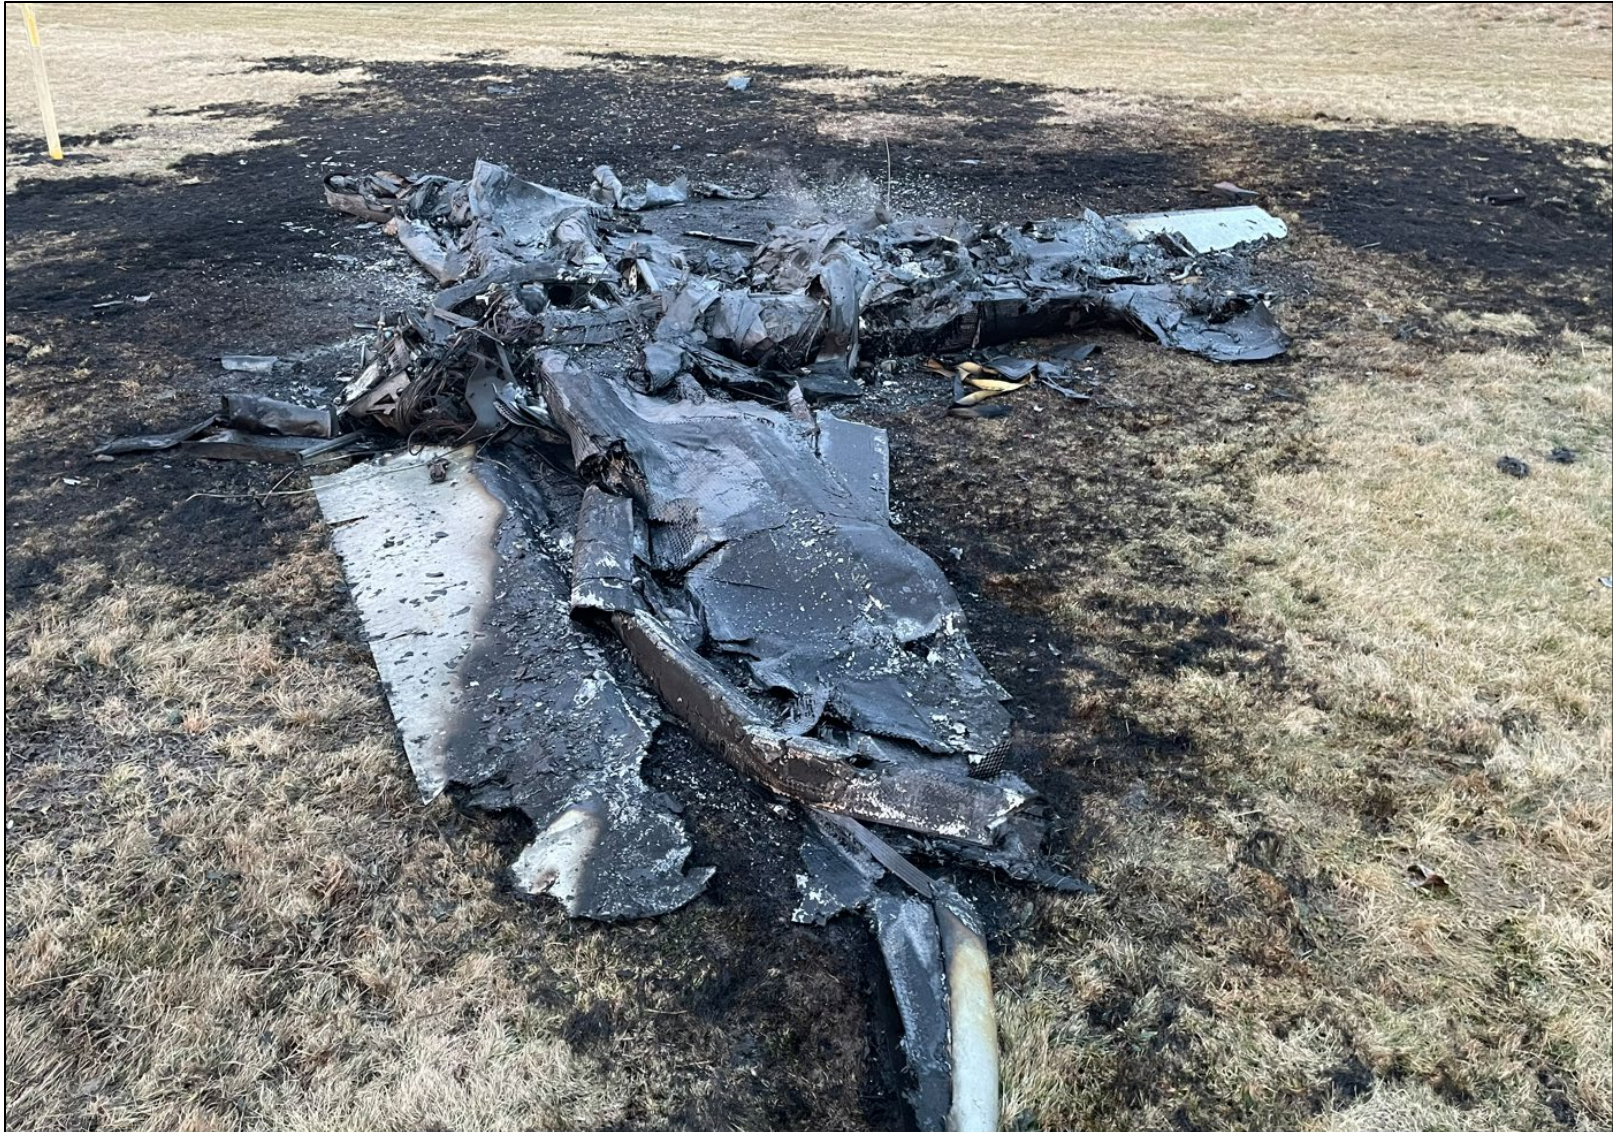
Photograph 4 - View of the thermally damaged fuselage and wings (Photo Courtesy of FAA)

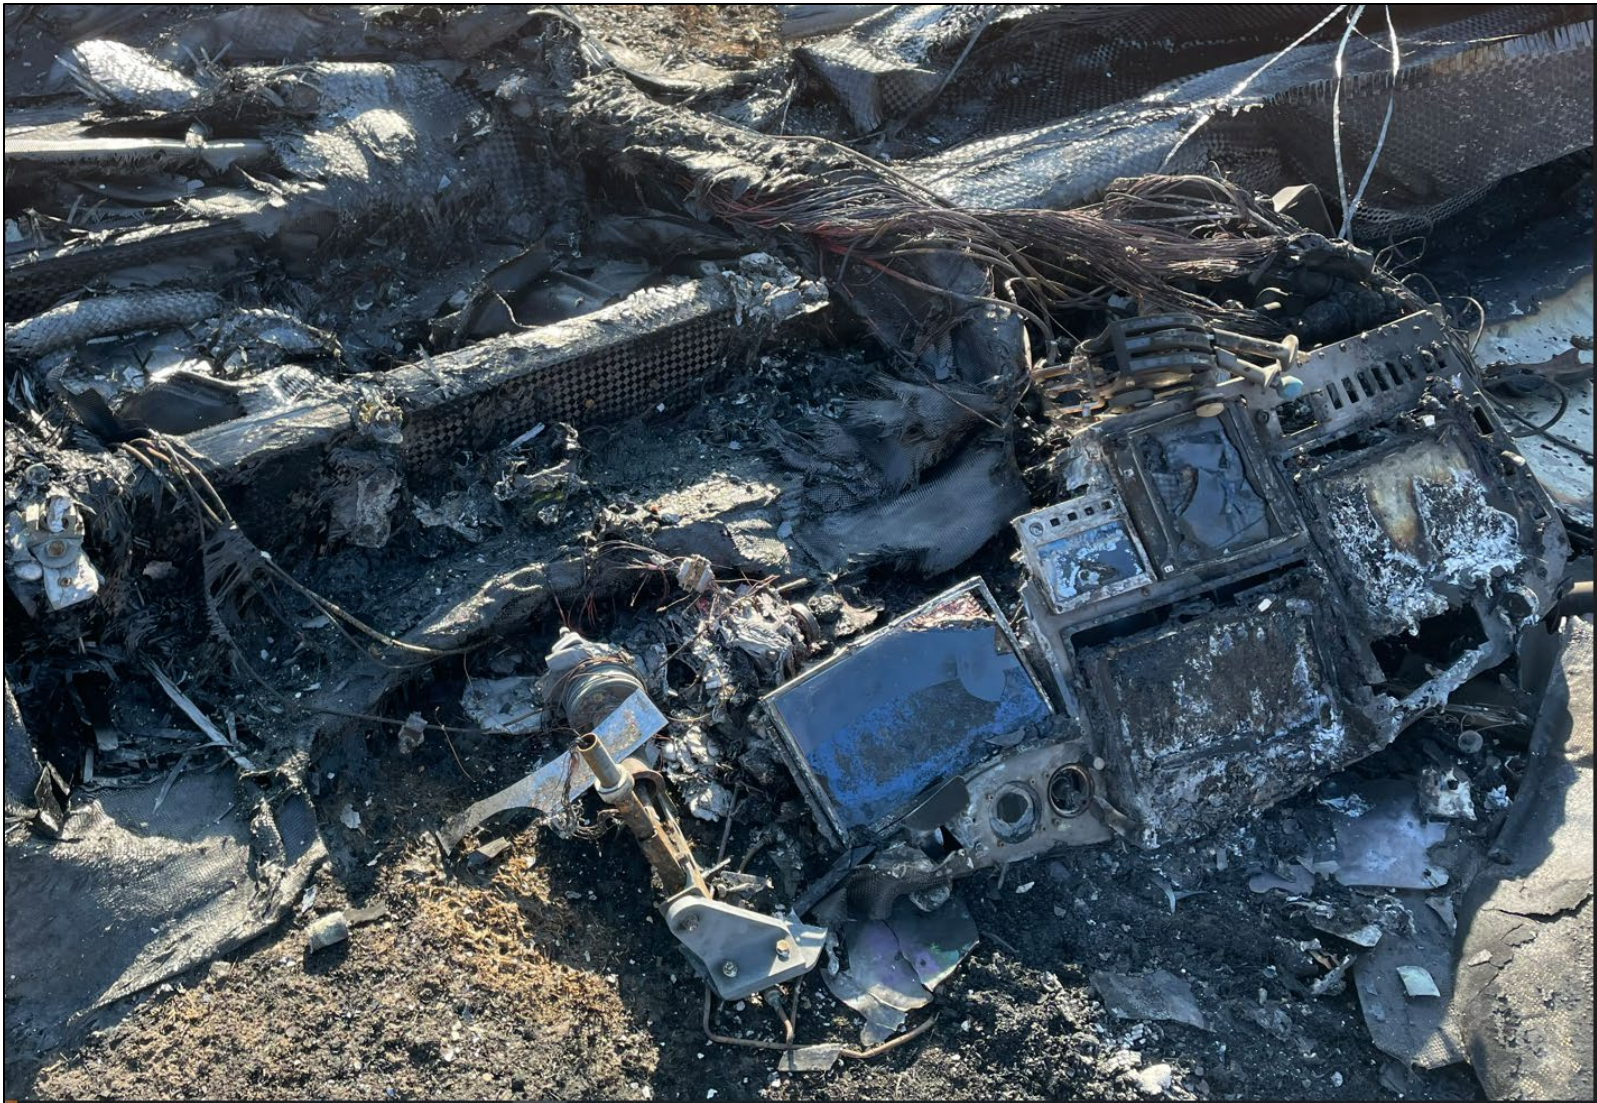
Photograph 5 - View of the thermally damaged cockpit panel (Photo Courtesy of FAA)

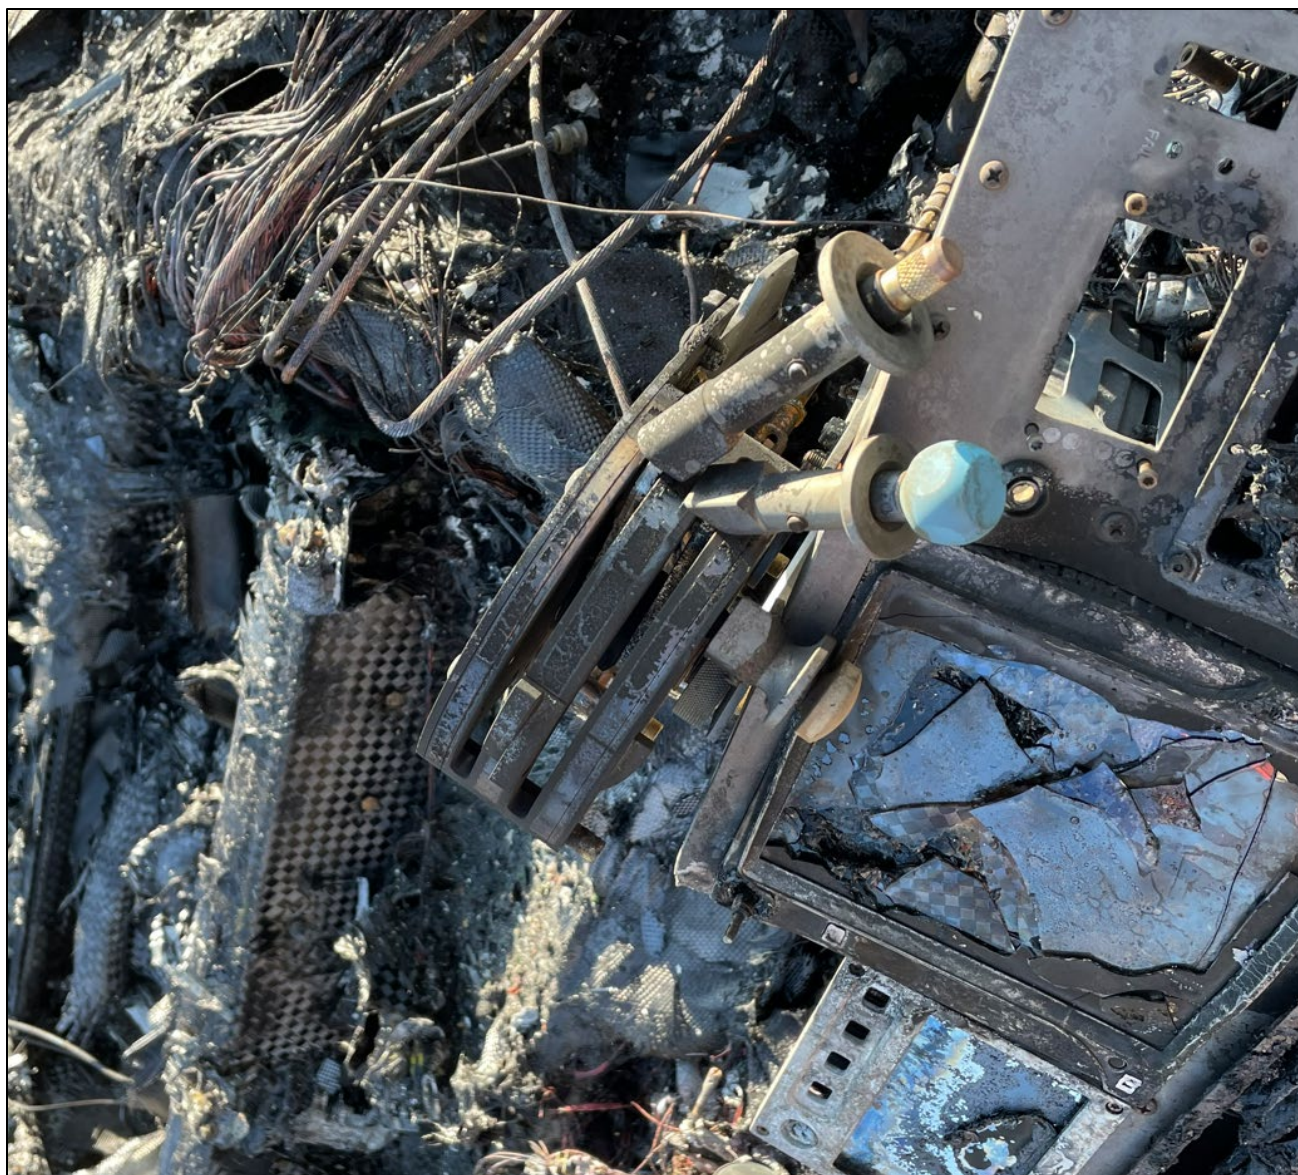
Photograph 6 - View of the throttle quadrant (Photo Courtesy of FAA)

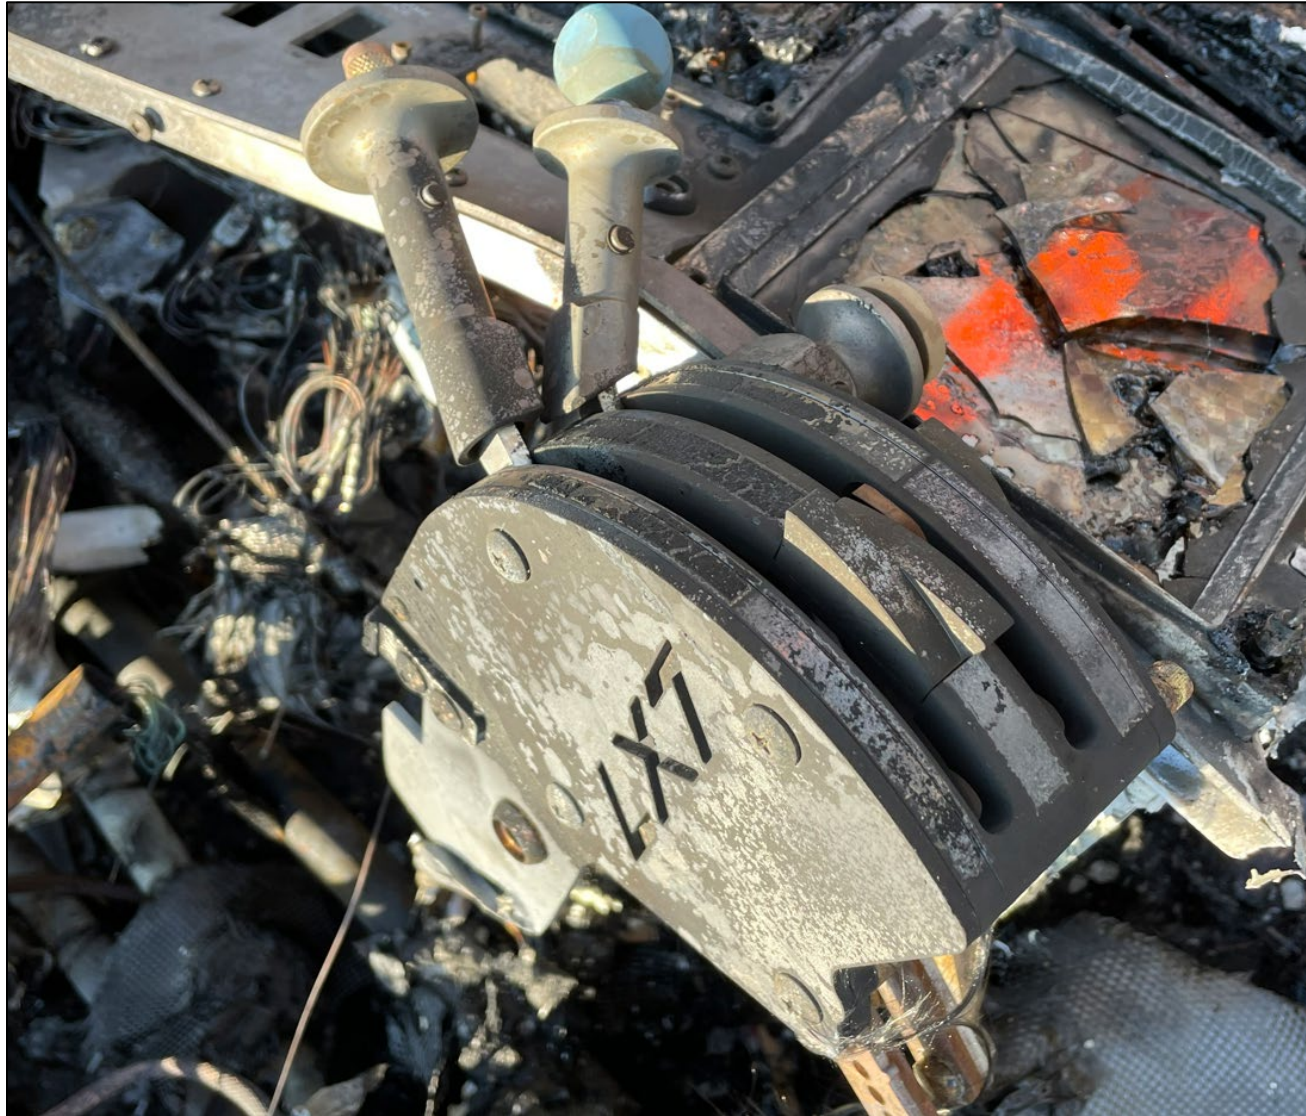
Photograph 7 - Additional view of the throttle quadrant (Photo Courtesy of FAA)

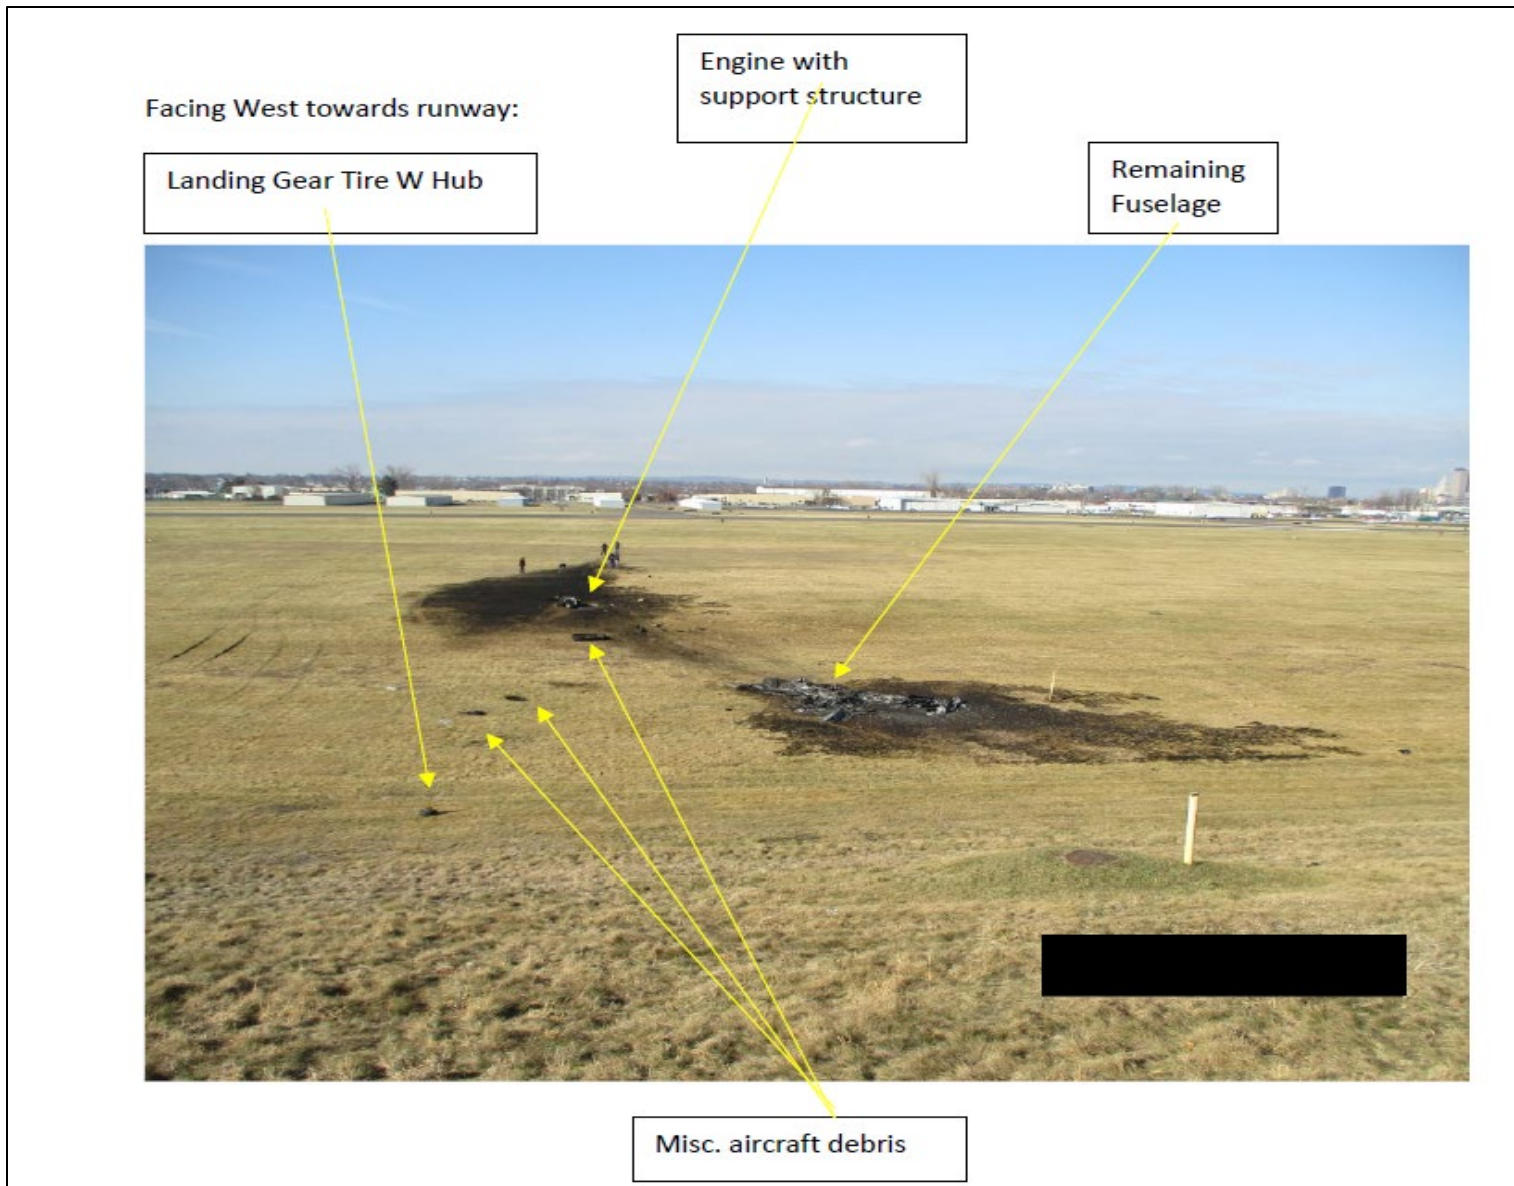
Photograph 8 - Additional view of accident site with FAA annotations (Photo Courtesy of FAA)
