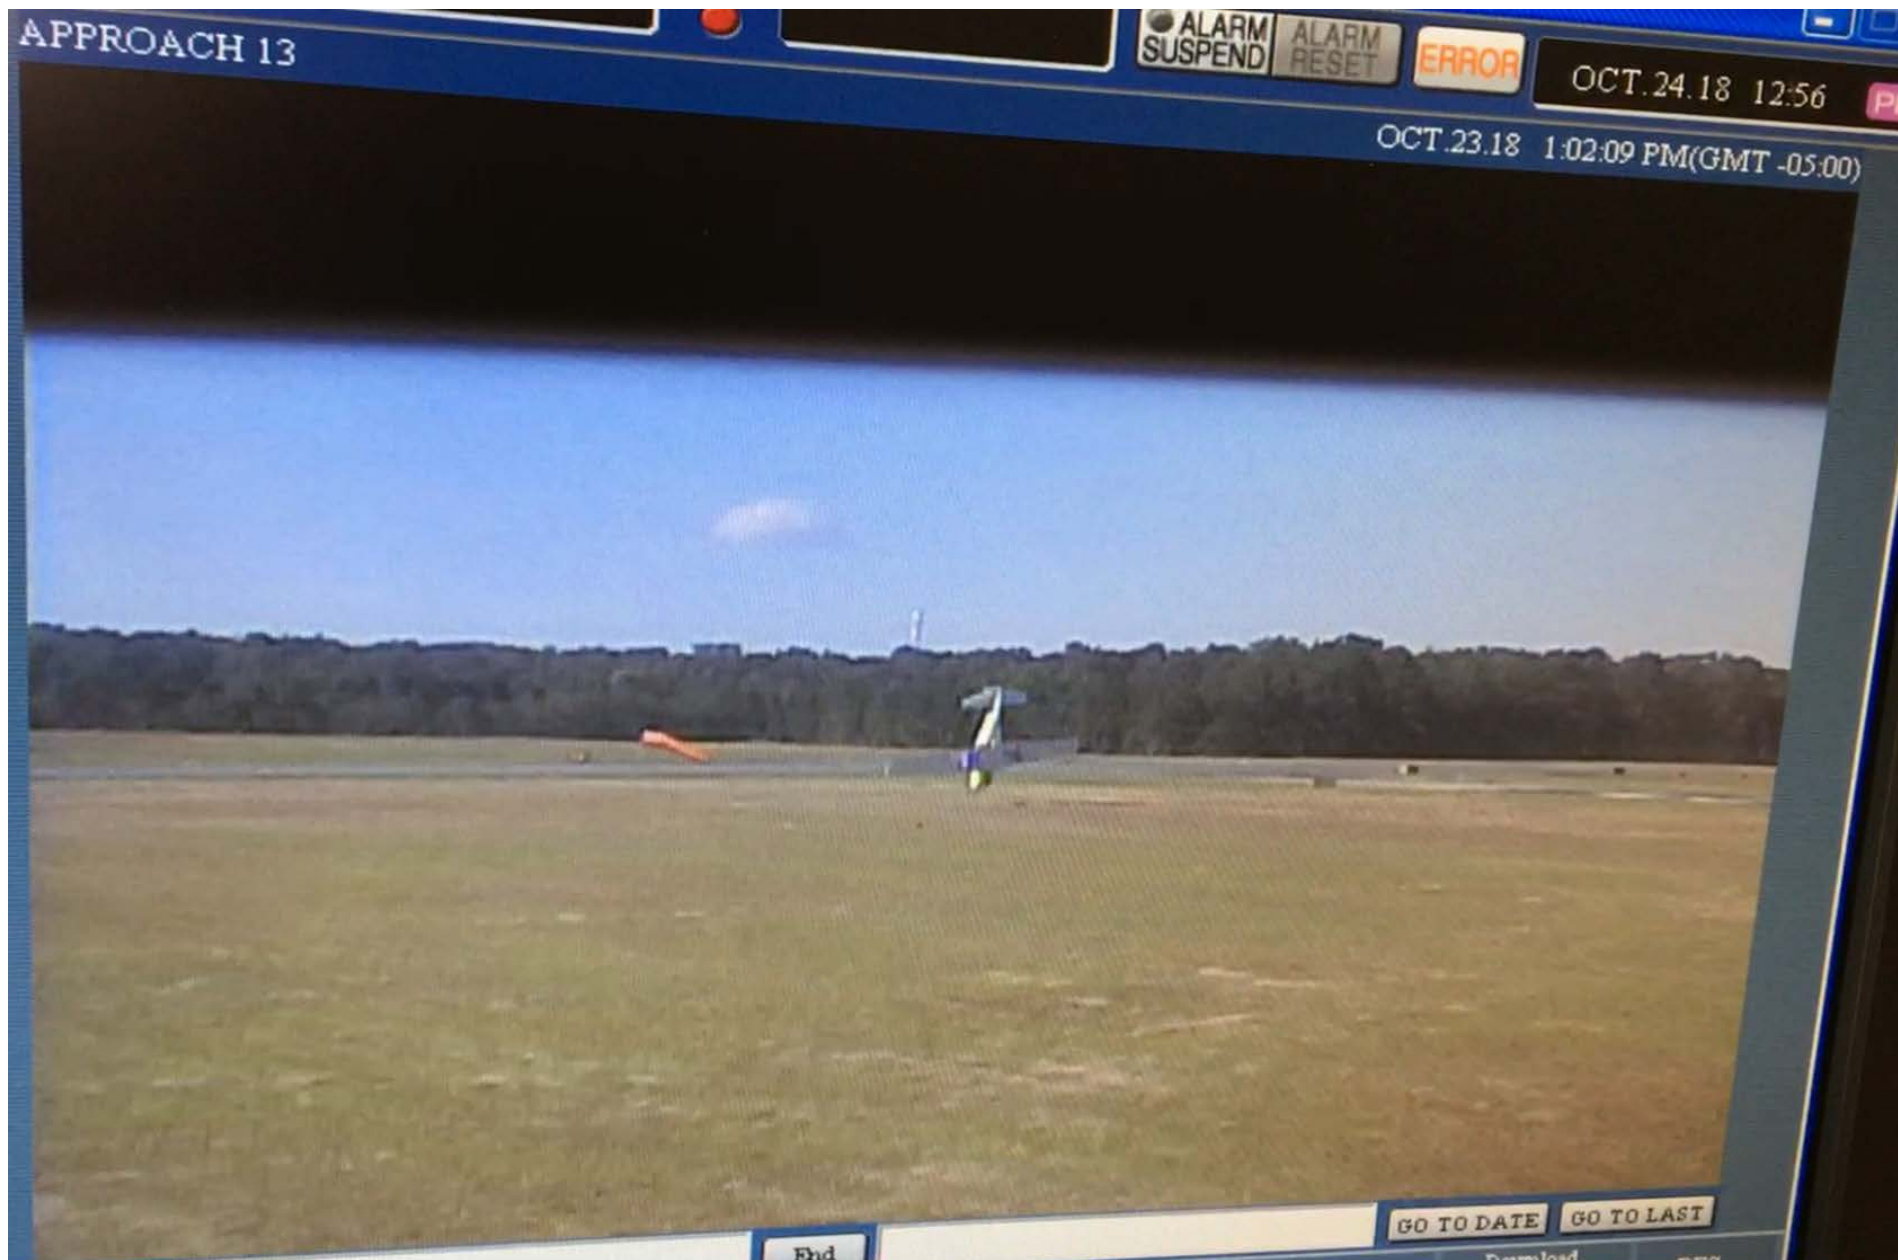
Photo 1 – Screenshot Capture from Airport Security Approach 13 Camera Depicting the Airplane immediately Before Ground Contact.

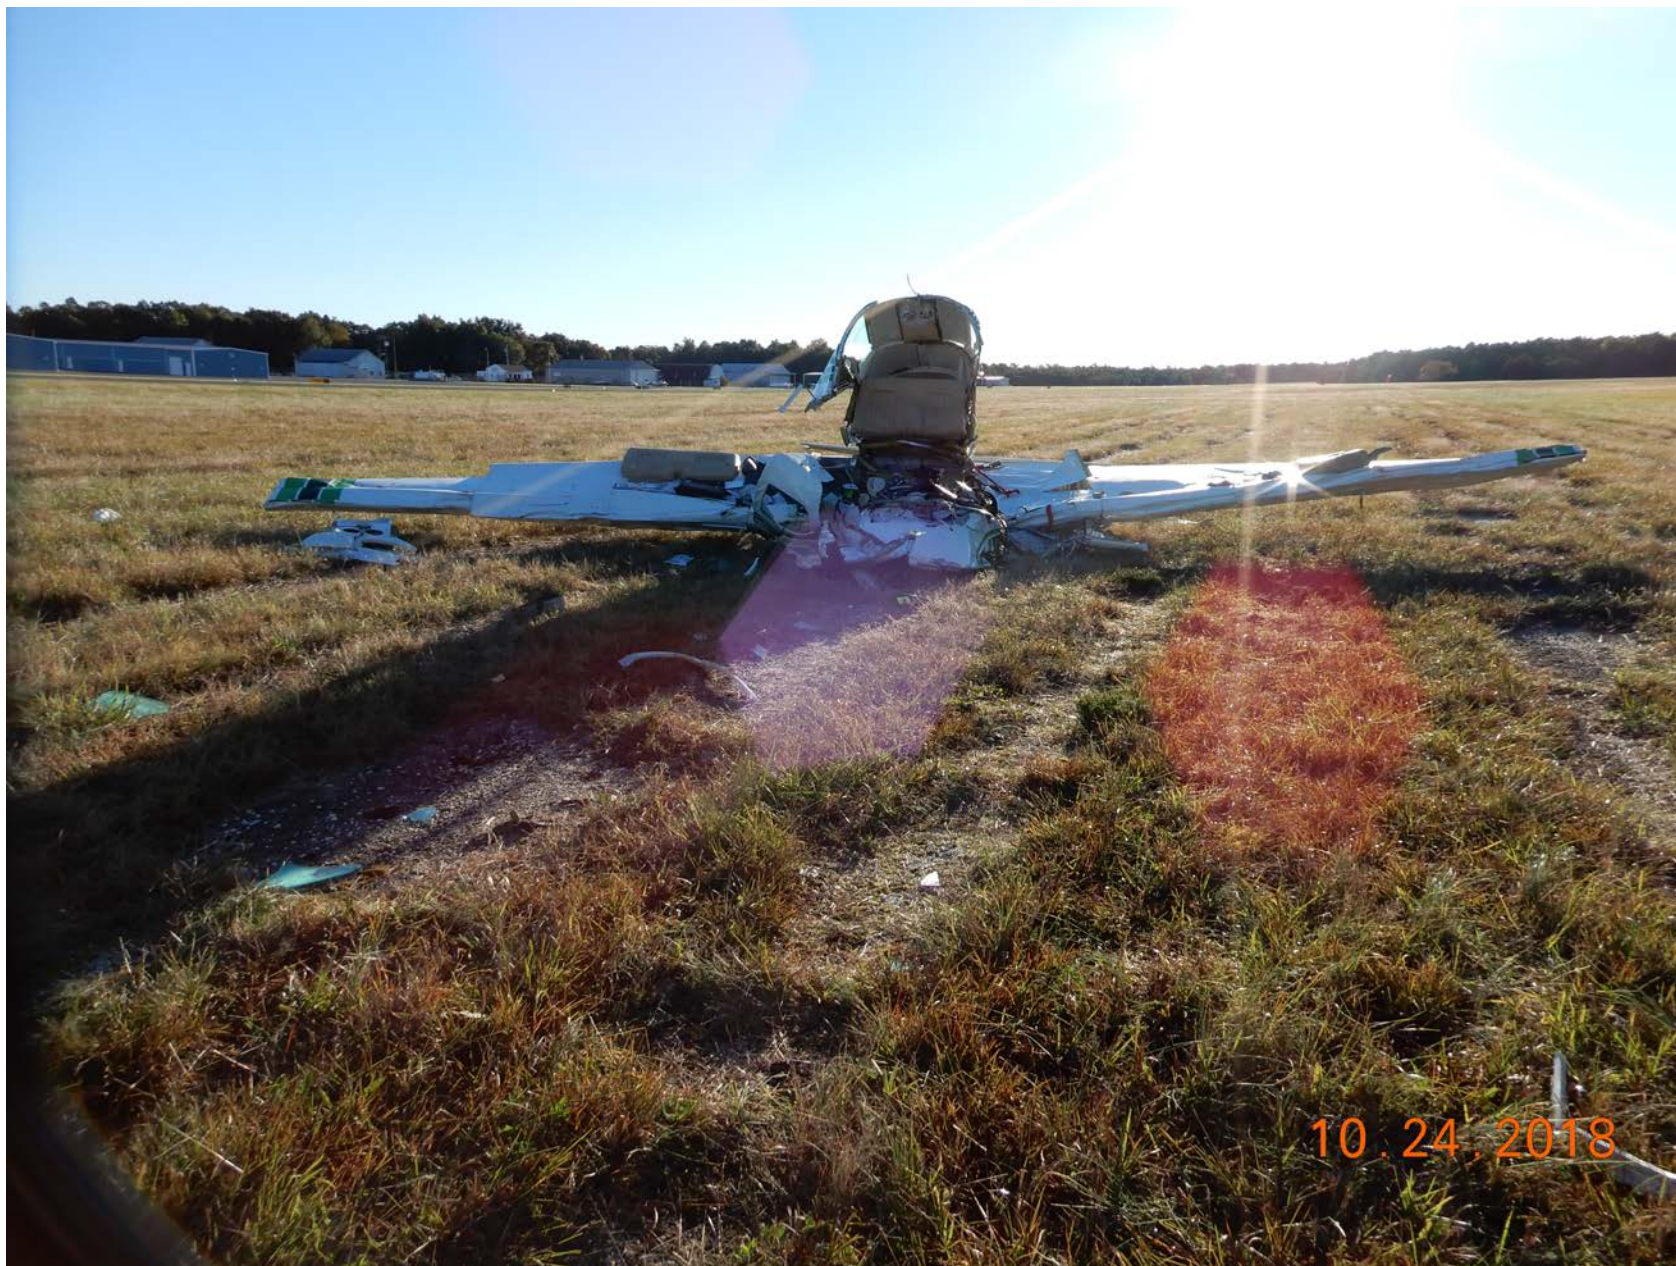
Photo 2 – NTSB Digital Photograph. Frontal View of the Airplane at the Accident Site. Note the Deformation to the Leading Edges of Both Wings.

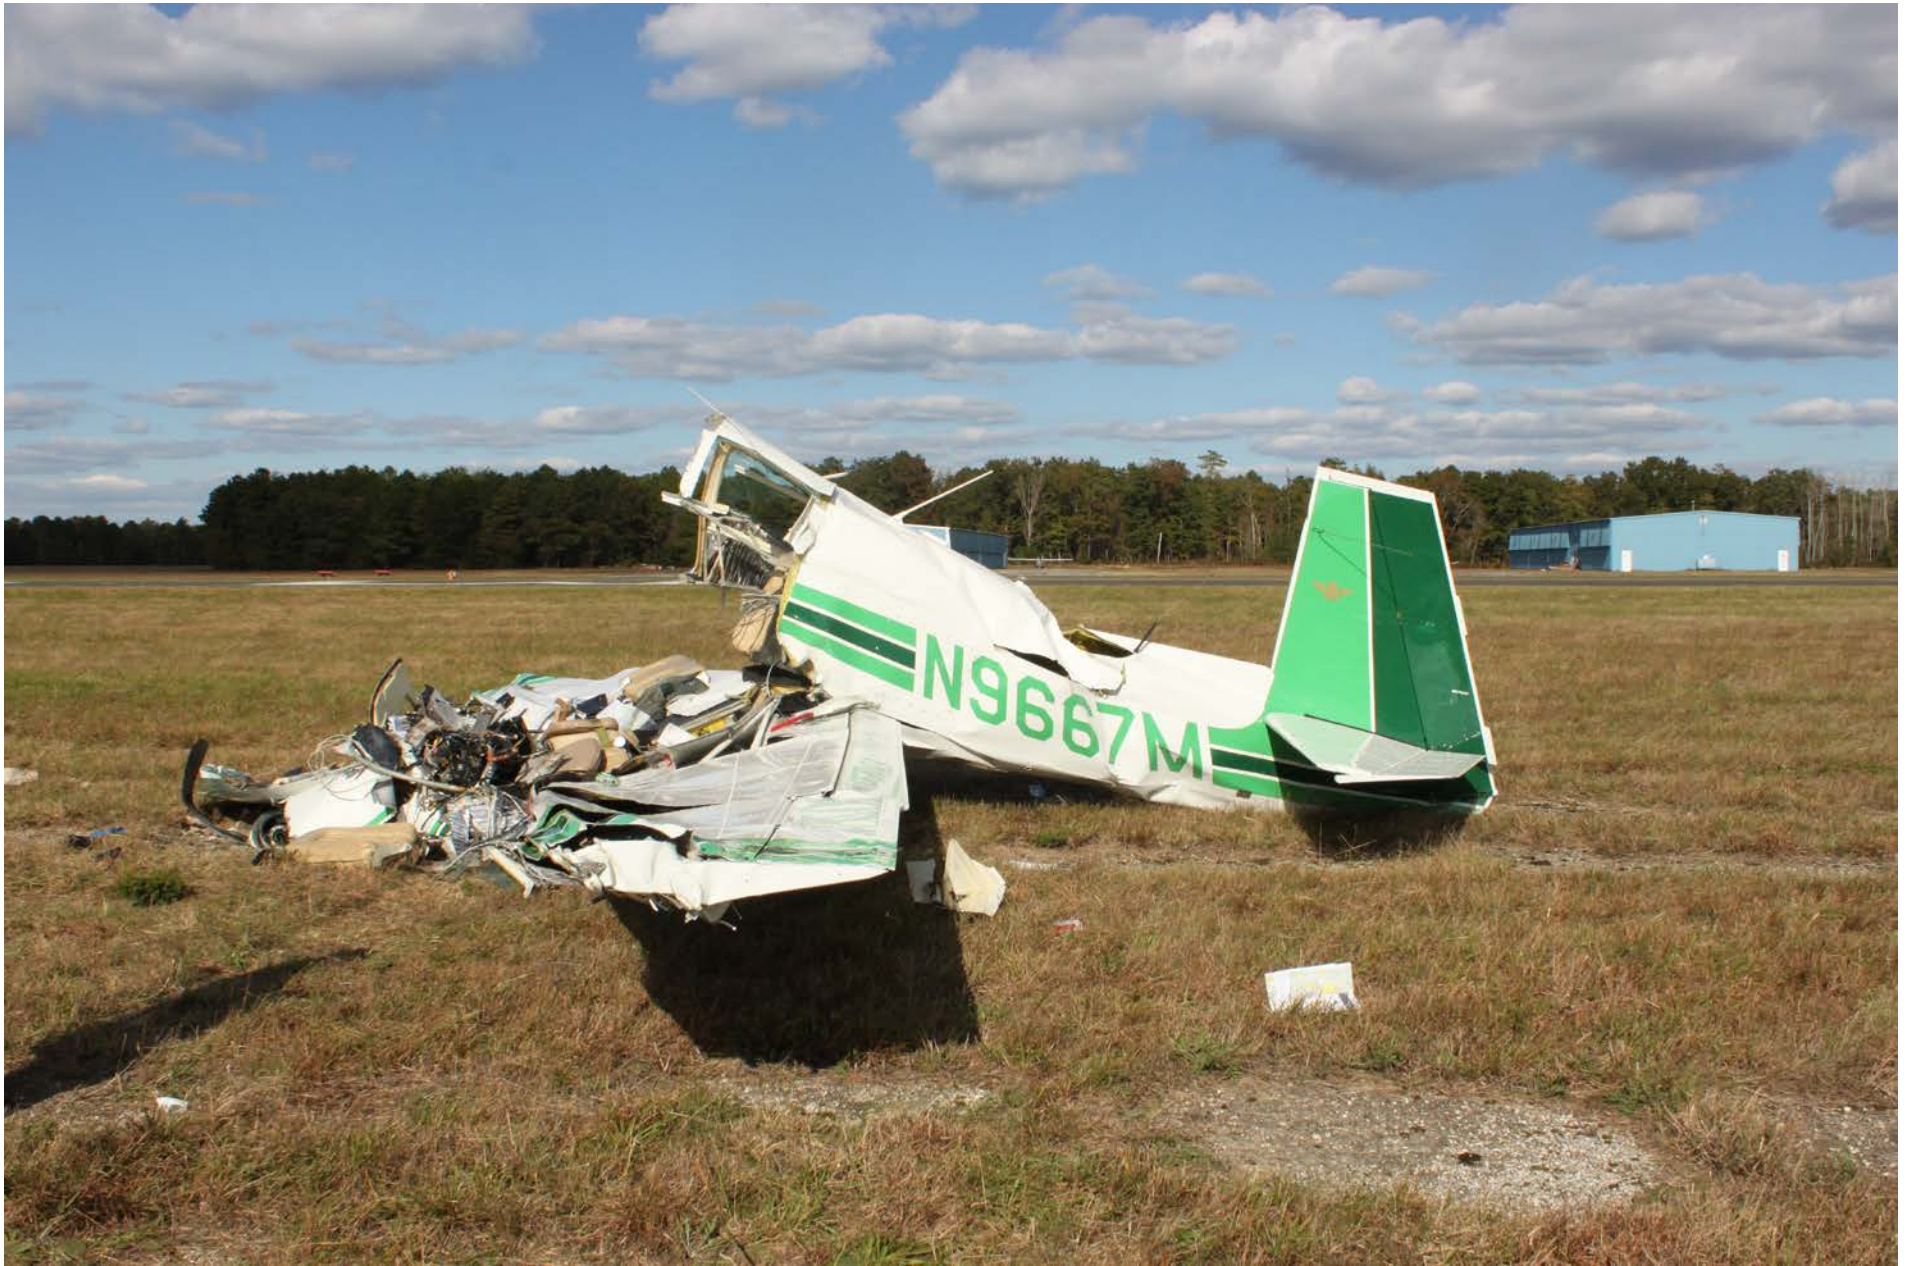
Photo 3 - NTSB Digital Photograph. Left Side View of the Airplane at the Accident Site. Note the destroyed Cockpit Area.

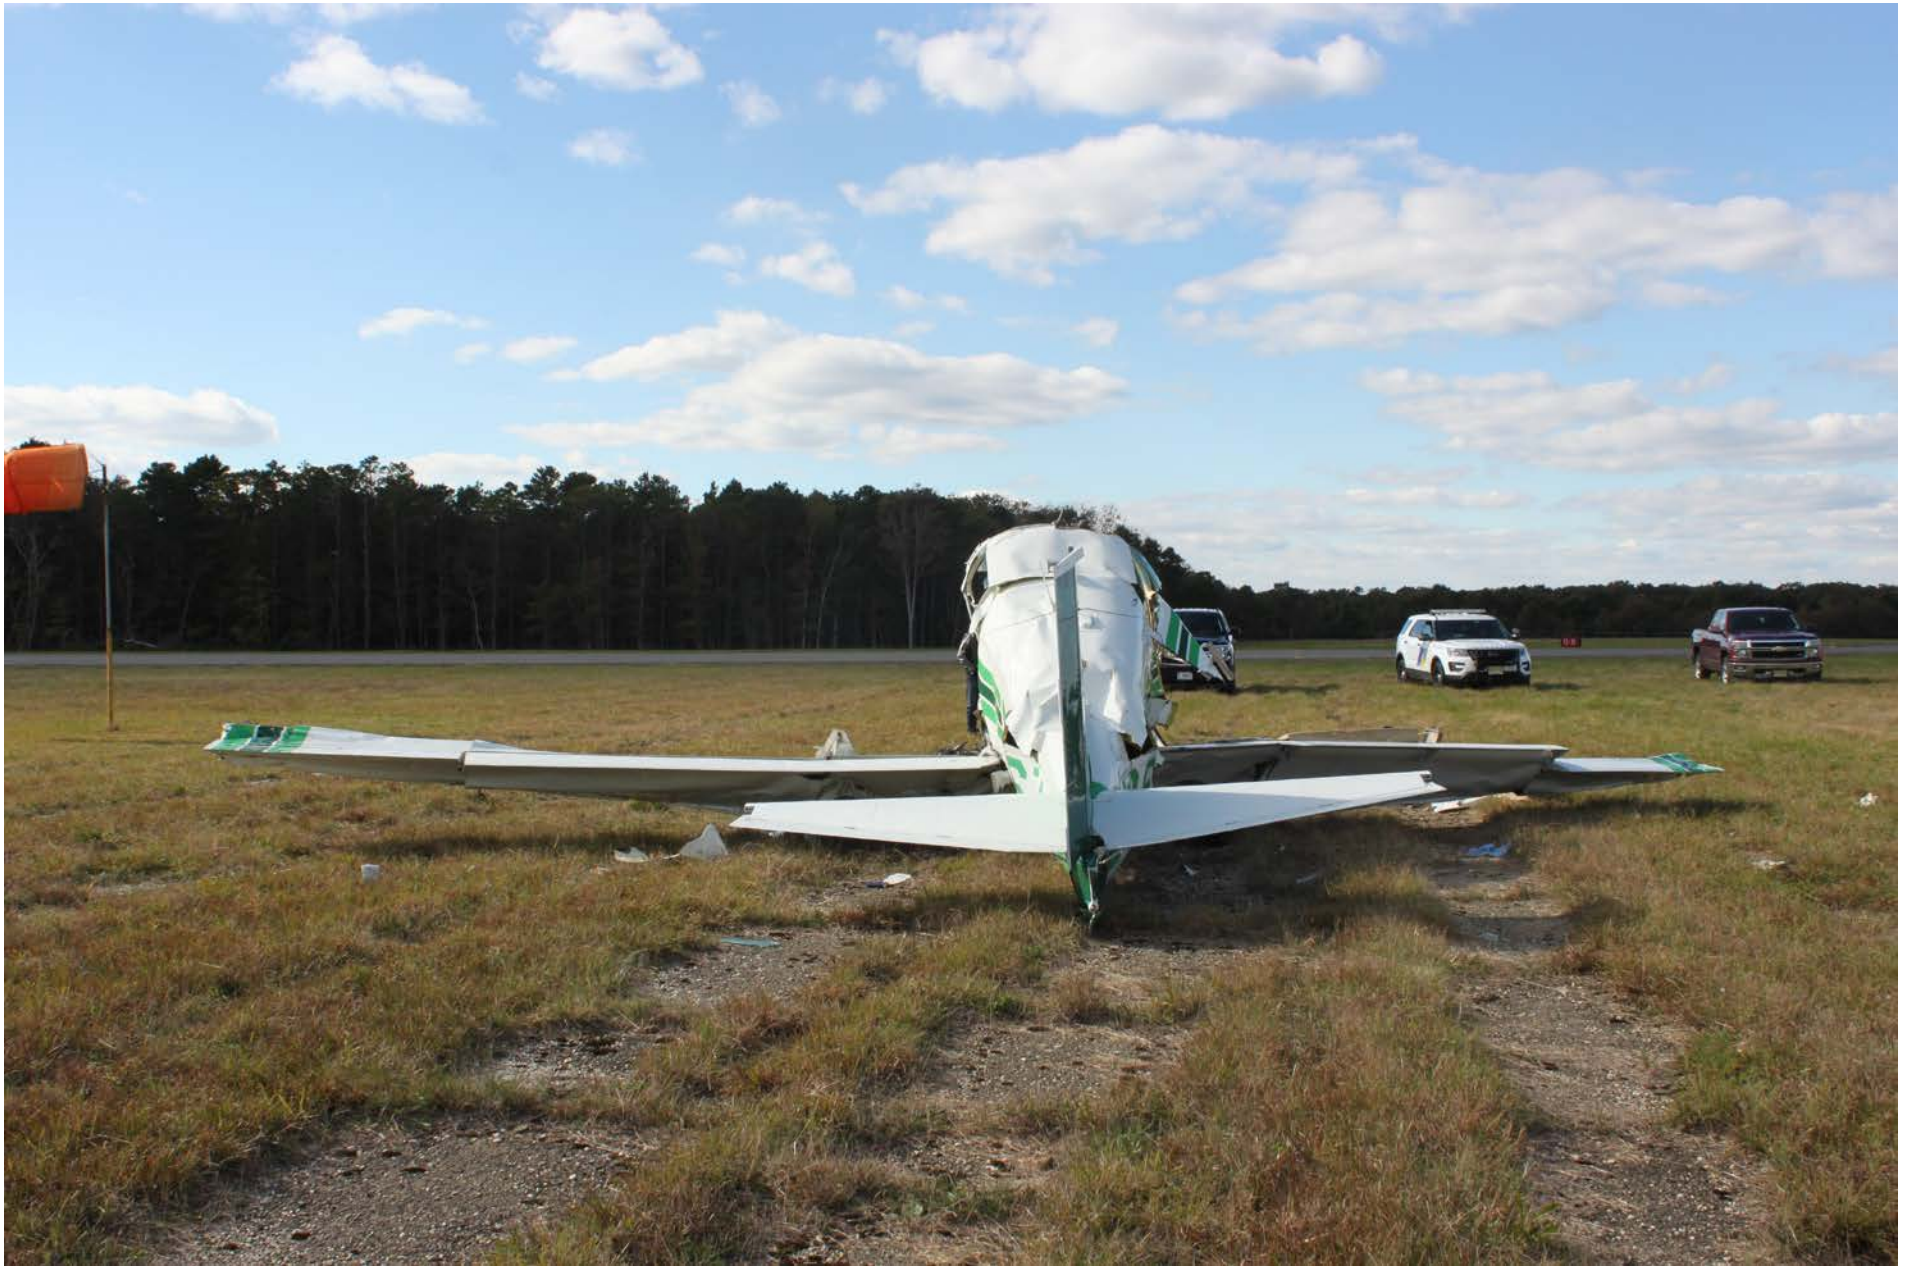
Photo 4 - NTSB Digital Photograph. Rear View of the Airplane at the Accident Site.

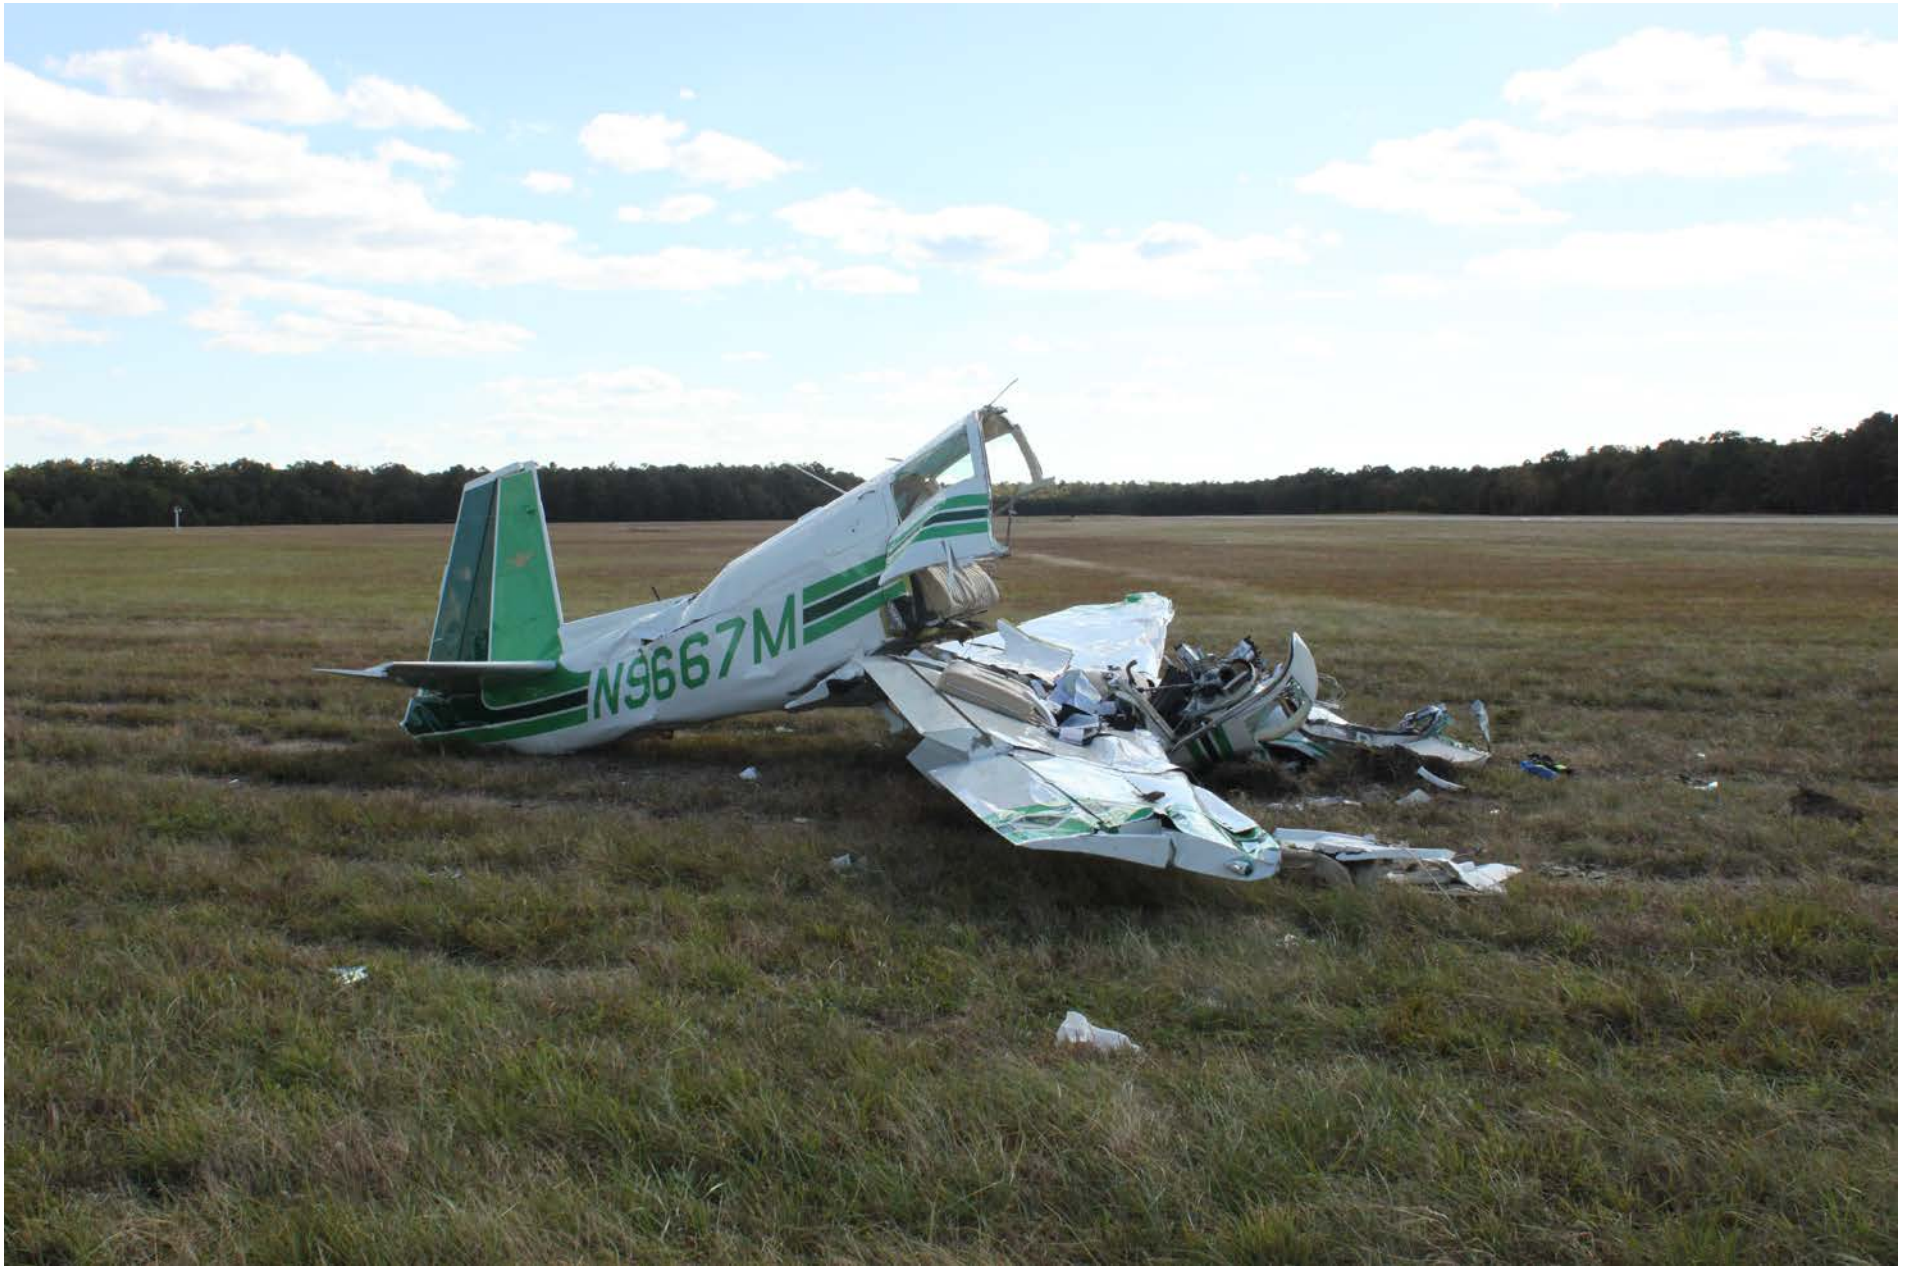
Photo 5 - NTSB Digital Photograph. Right Side View of the Airplane at the Accident Site.

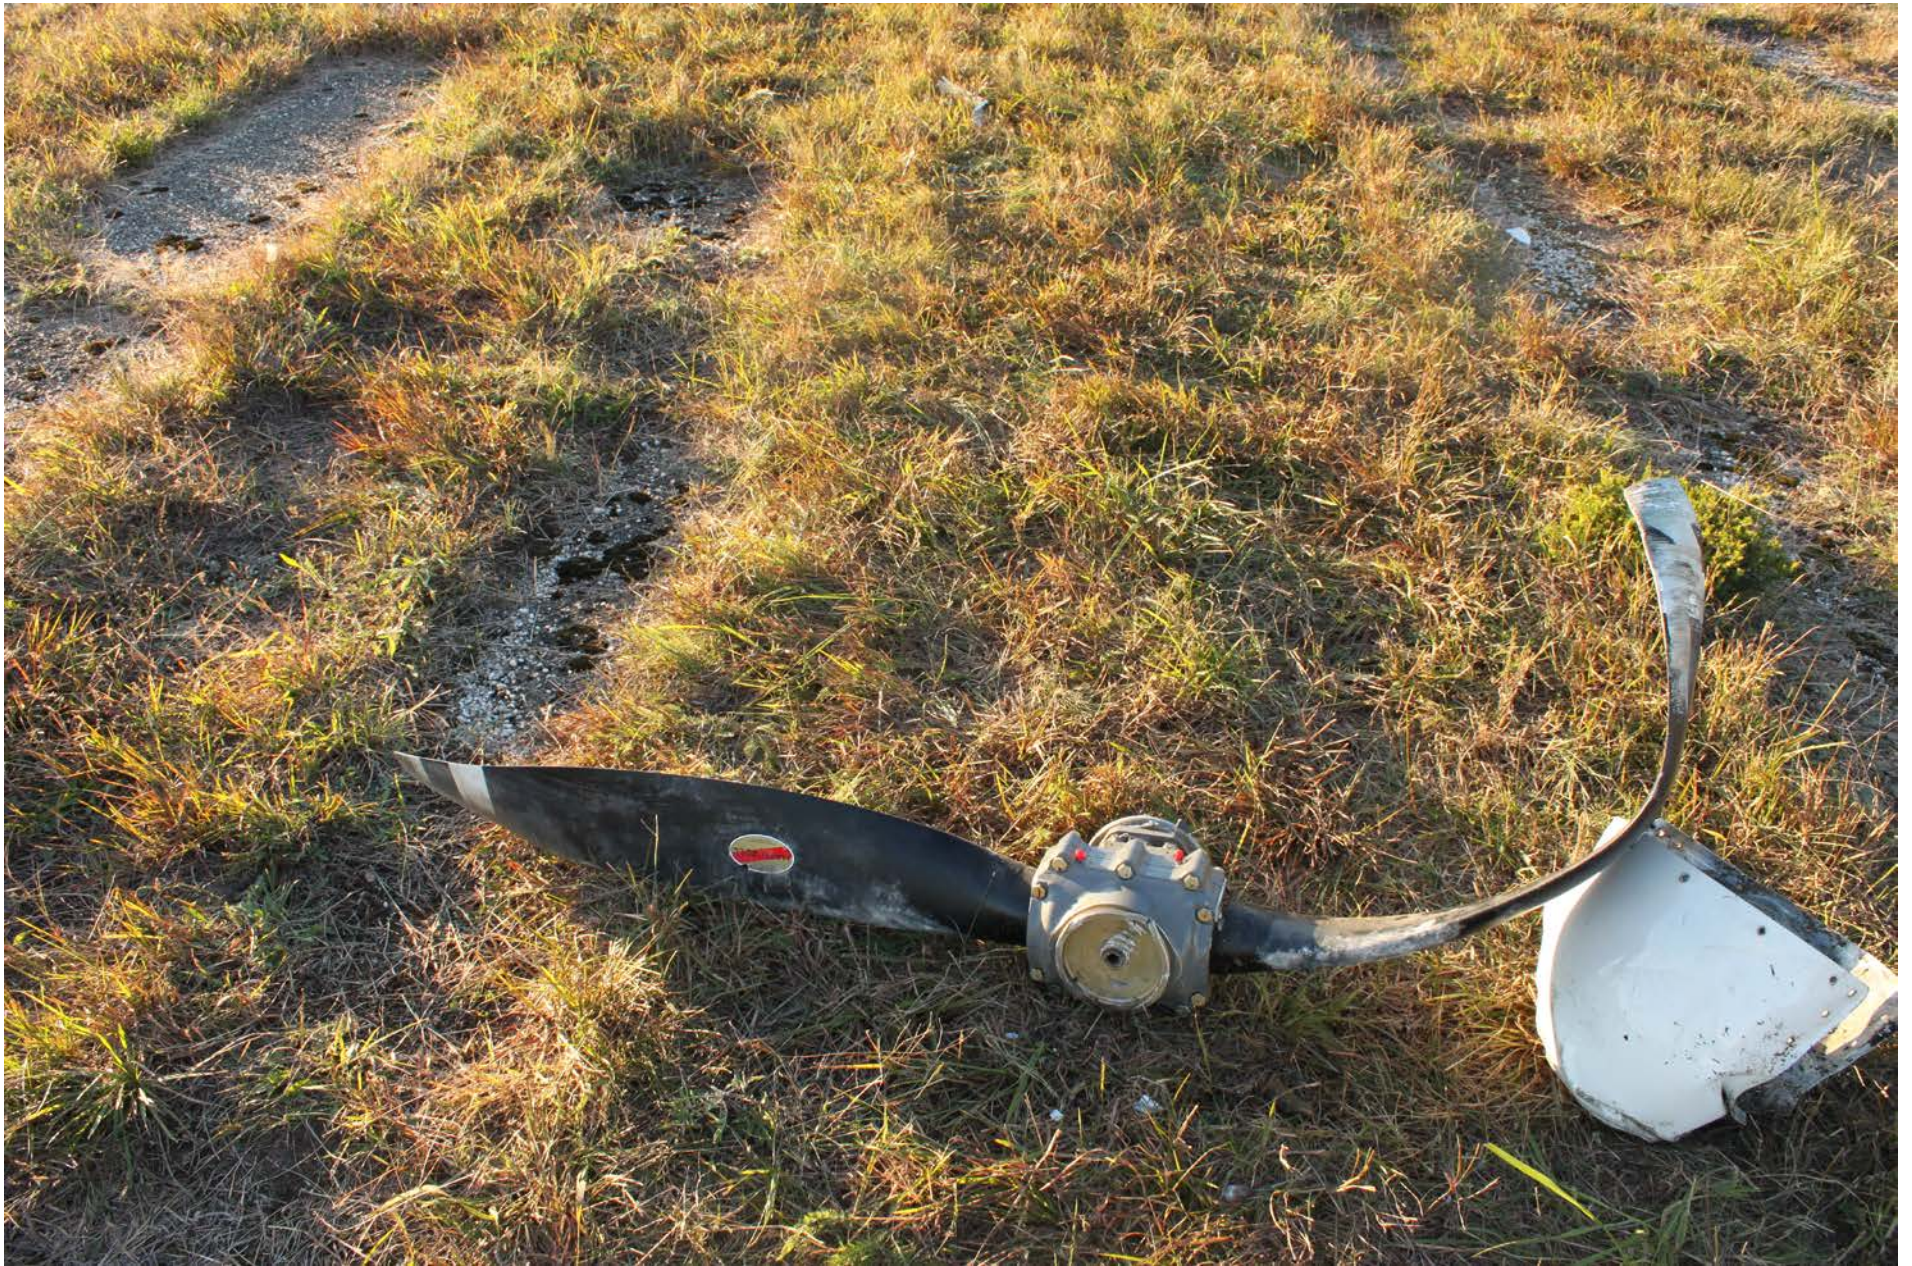
Photo 6 - NTSB Digital Photograph. View of the Separated Propeller at the Accident Site. Note the Blade Bending.

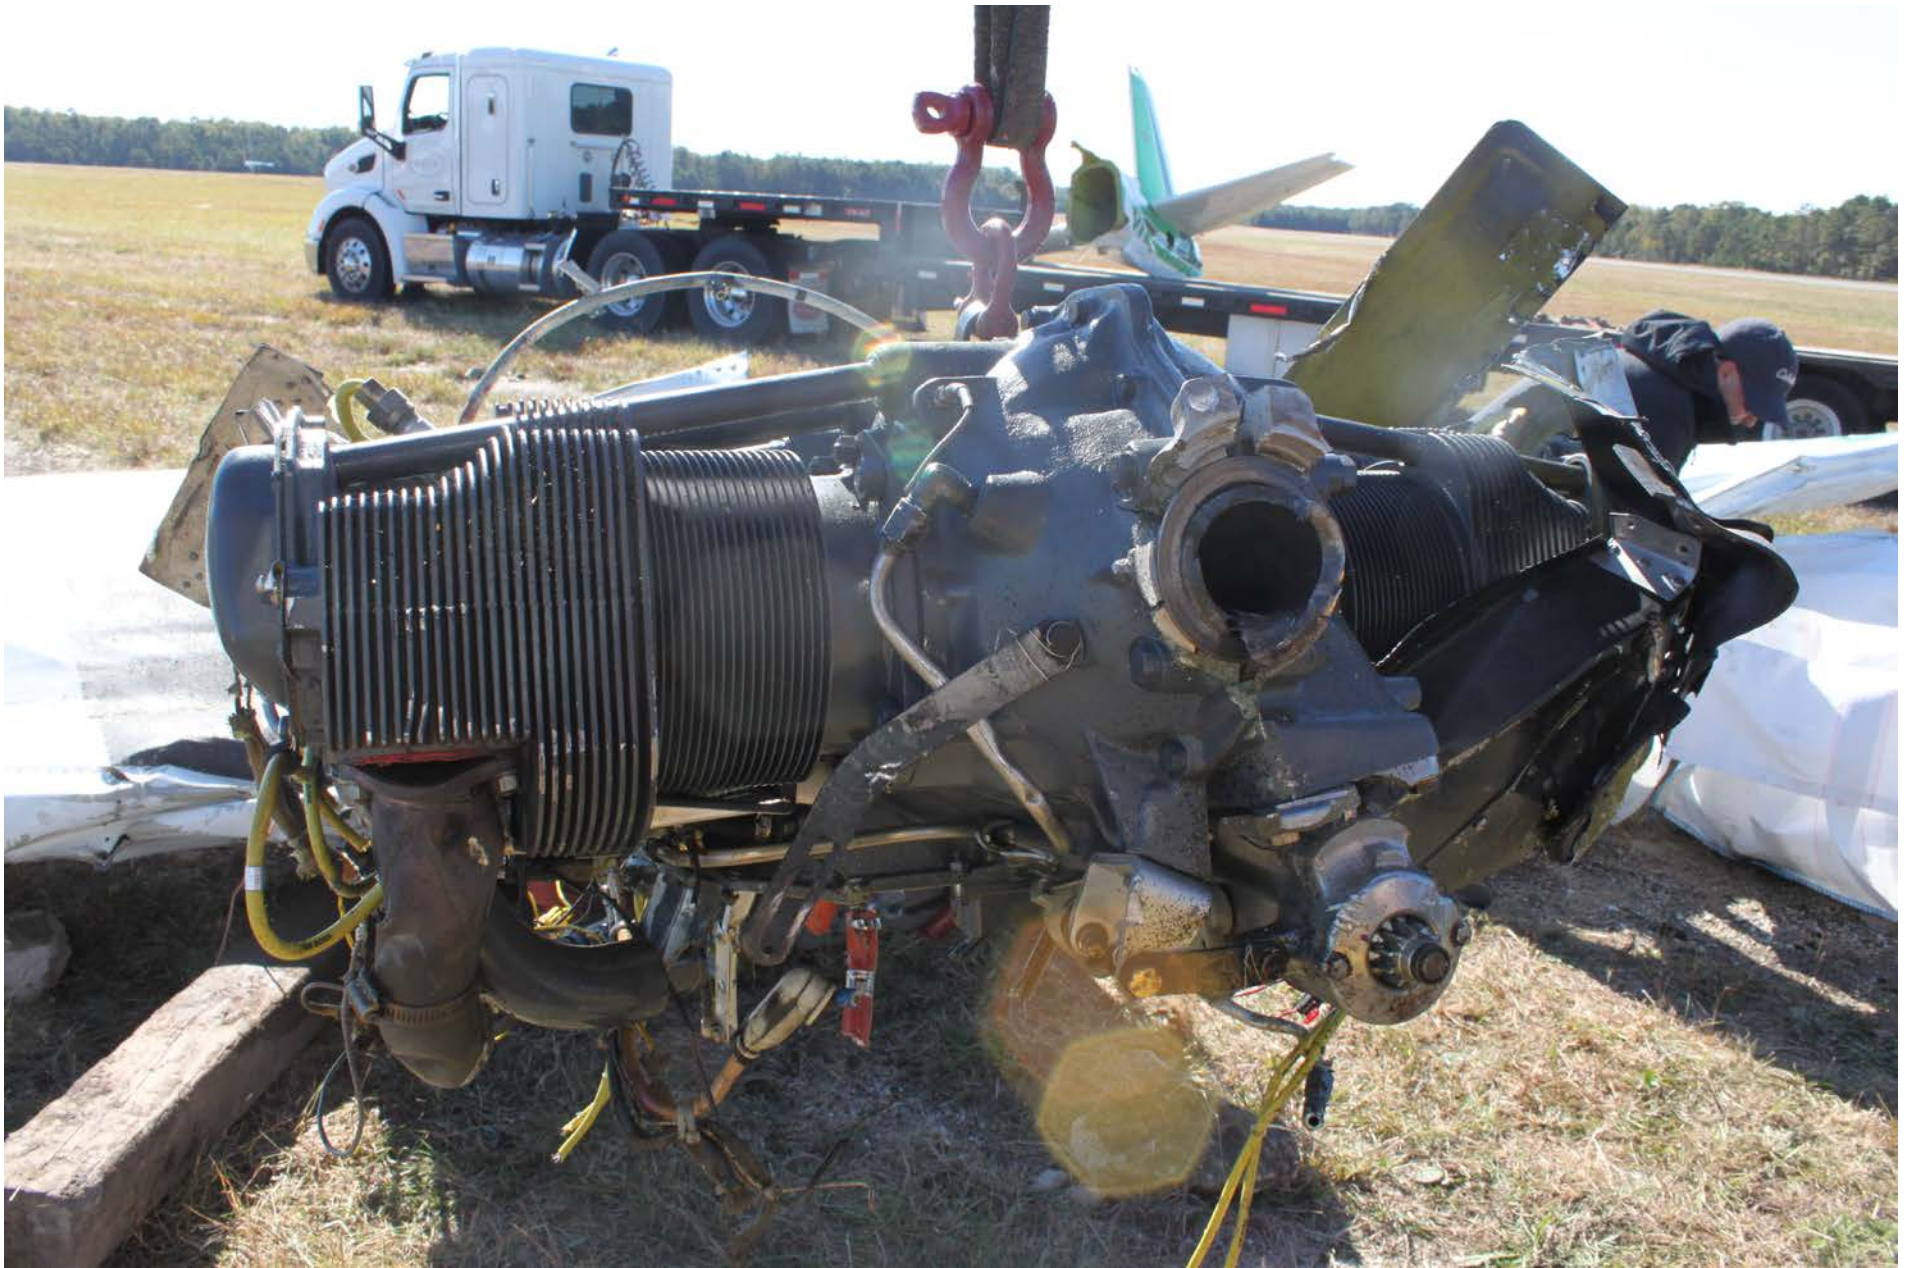
Photo 7 - NTSB Digital Photograph. Frontal View of the Engine at the Accident Site. Note the Fractured Crankshaft.
