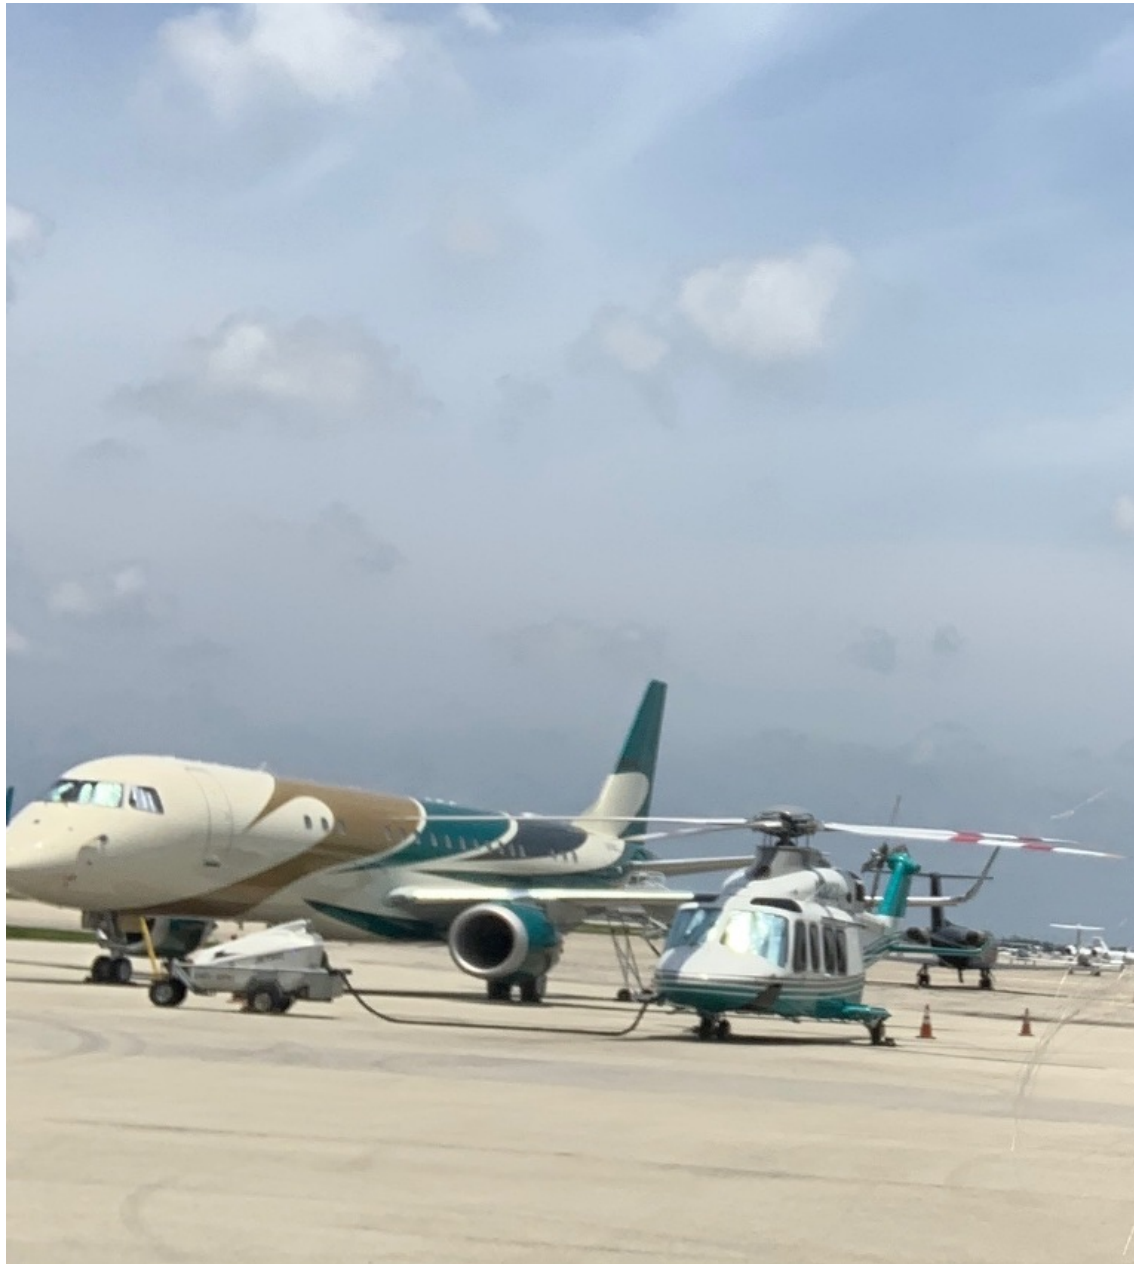
Photo 1 – Photograph Provided by Tiffany Melton. Left Forward View of the Accident Helicopter Taken July 3, 2019 at 1355 EDT.

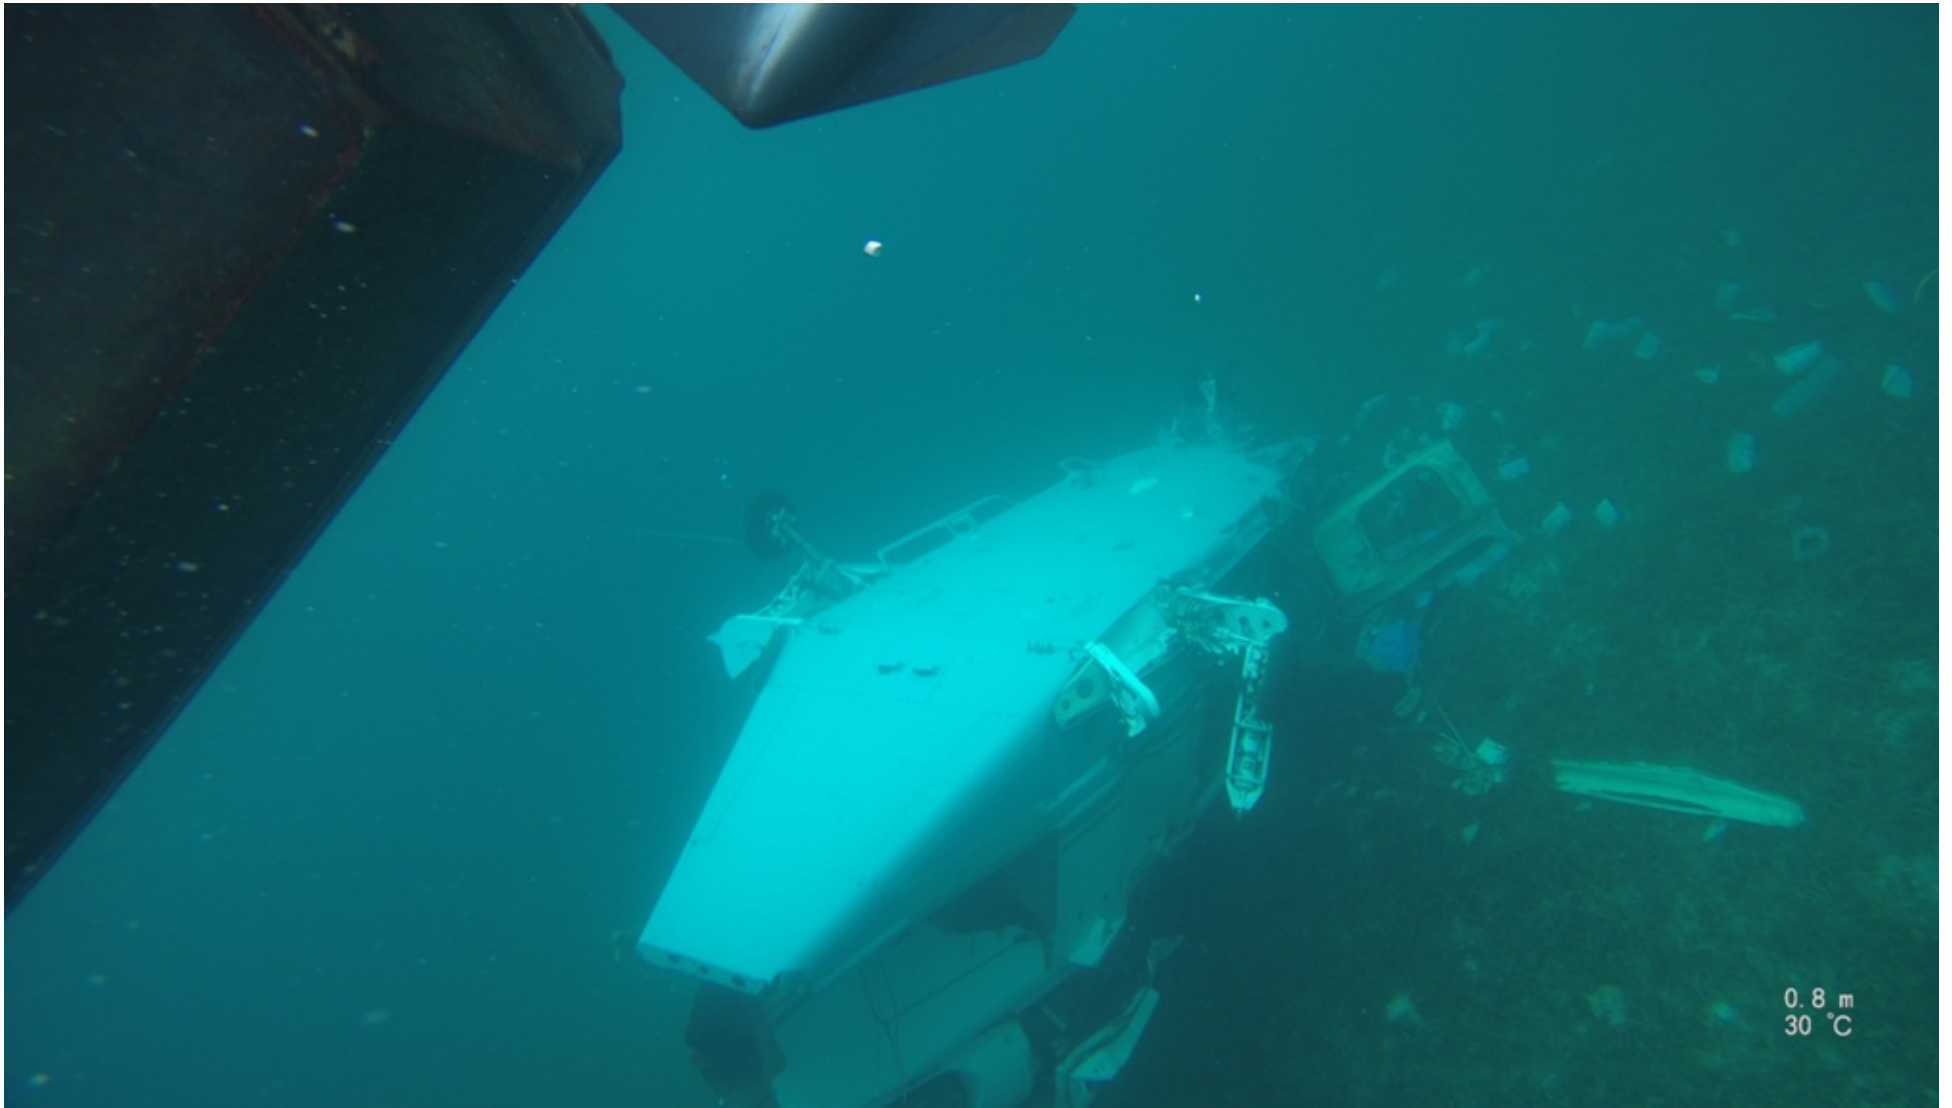
Photo 2 - Photograph Provided by Bahamian Accredited Representative. View of the Inverted Main Wreckage Under Water Before Recovery.

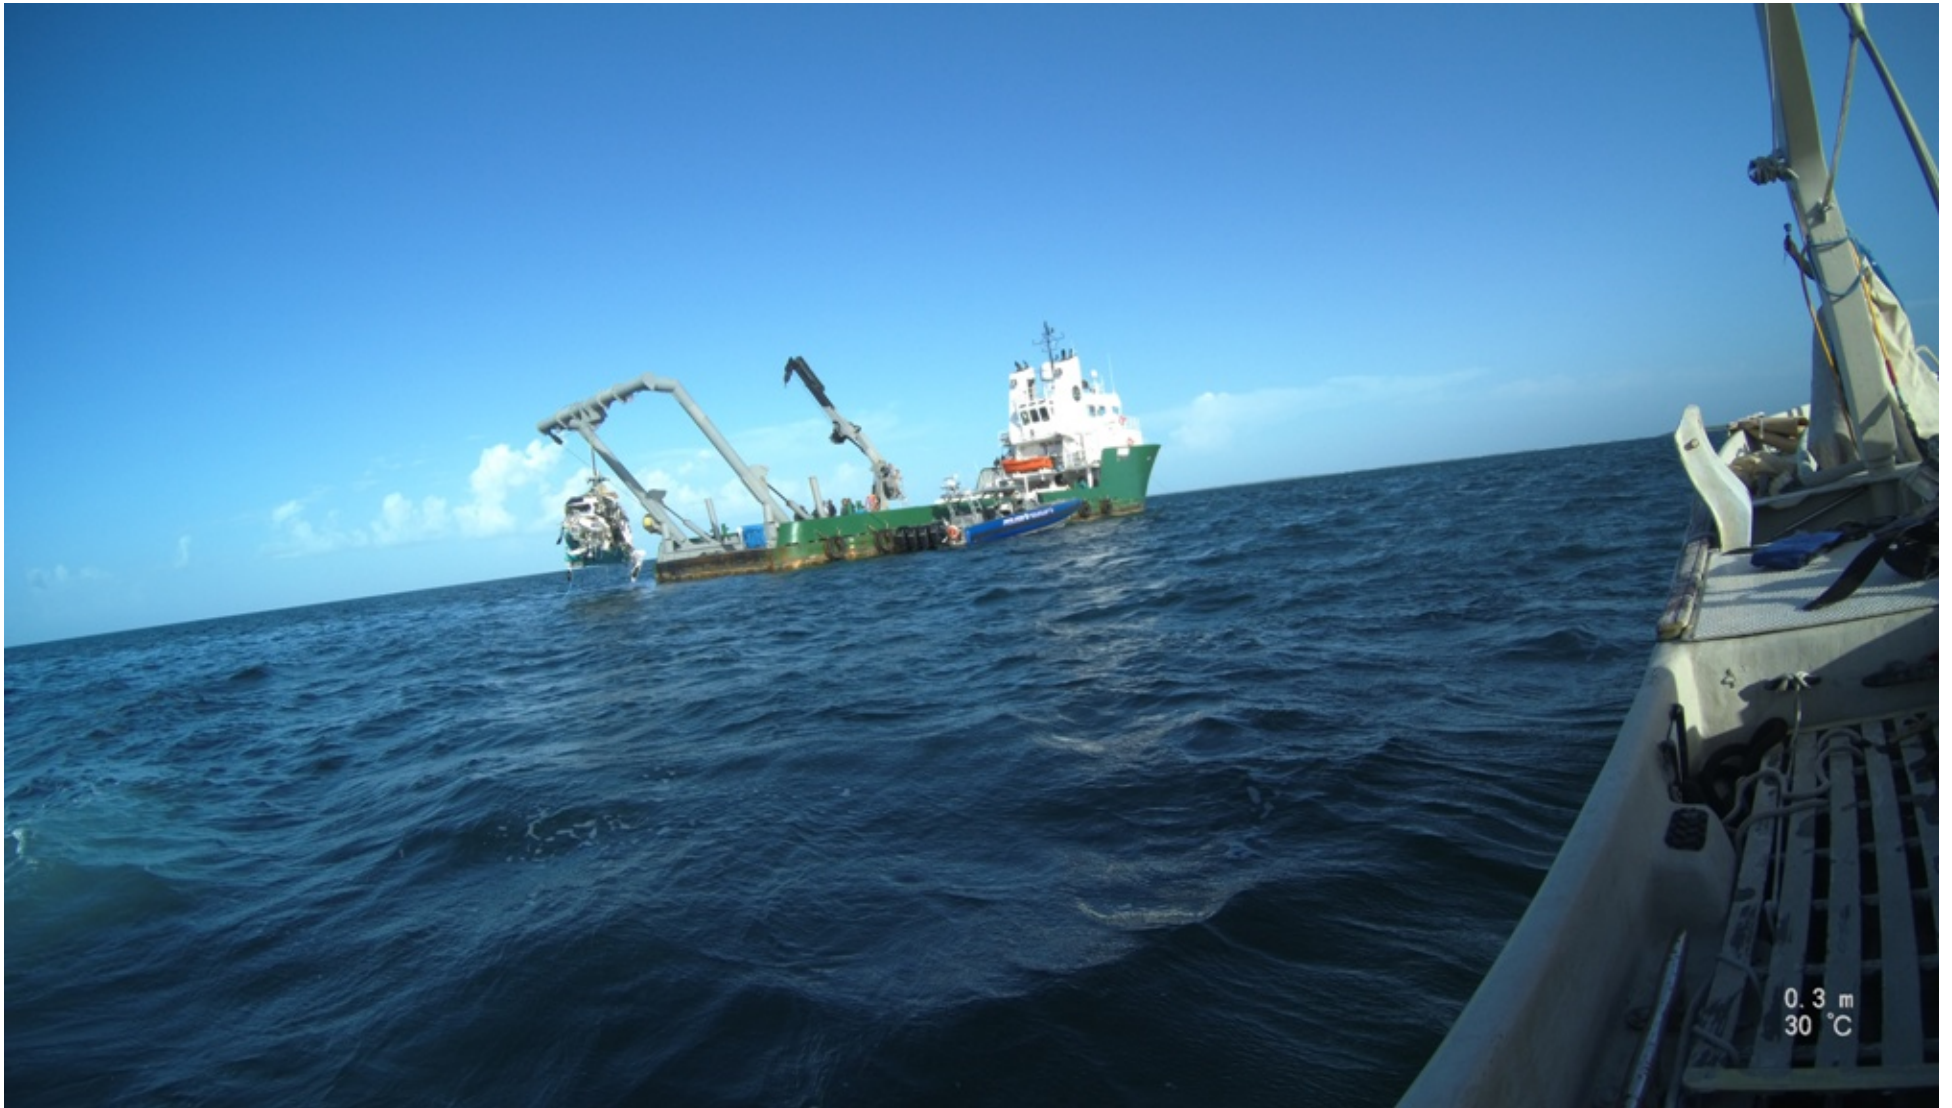
Photo 3 - Photograph Provided by Bahamian Accredited Representative. View Depicting the Fuselage During Recovery.

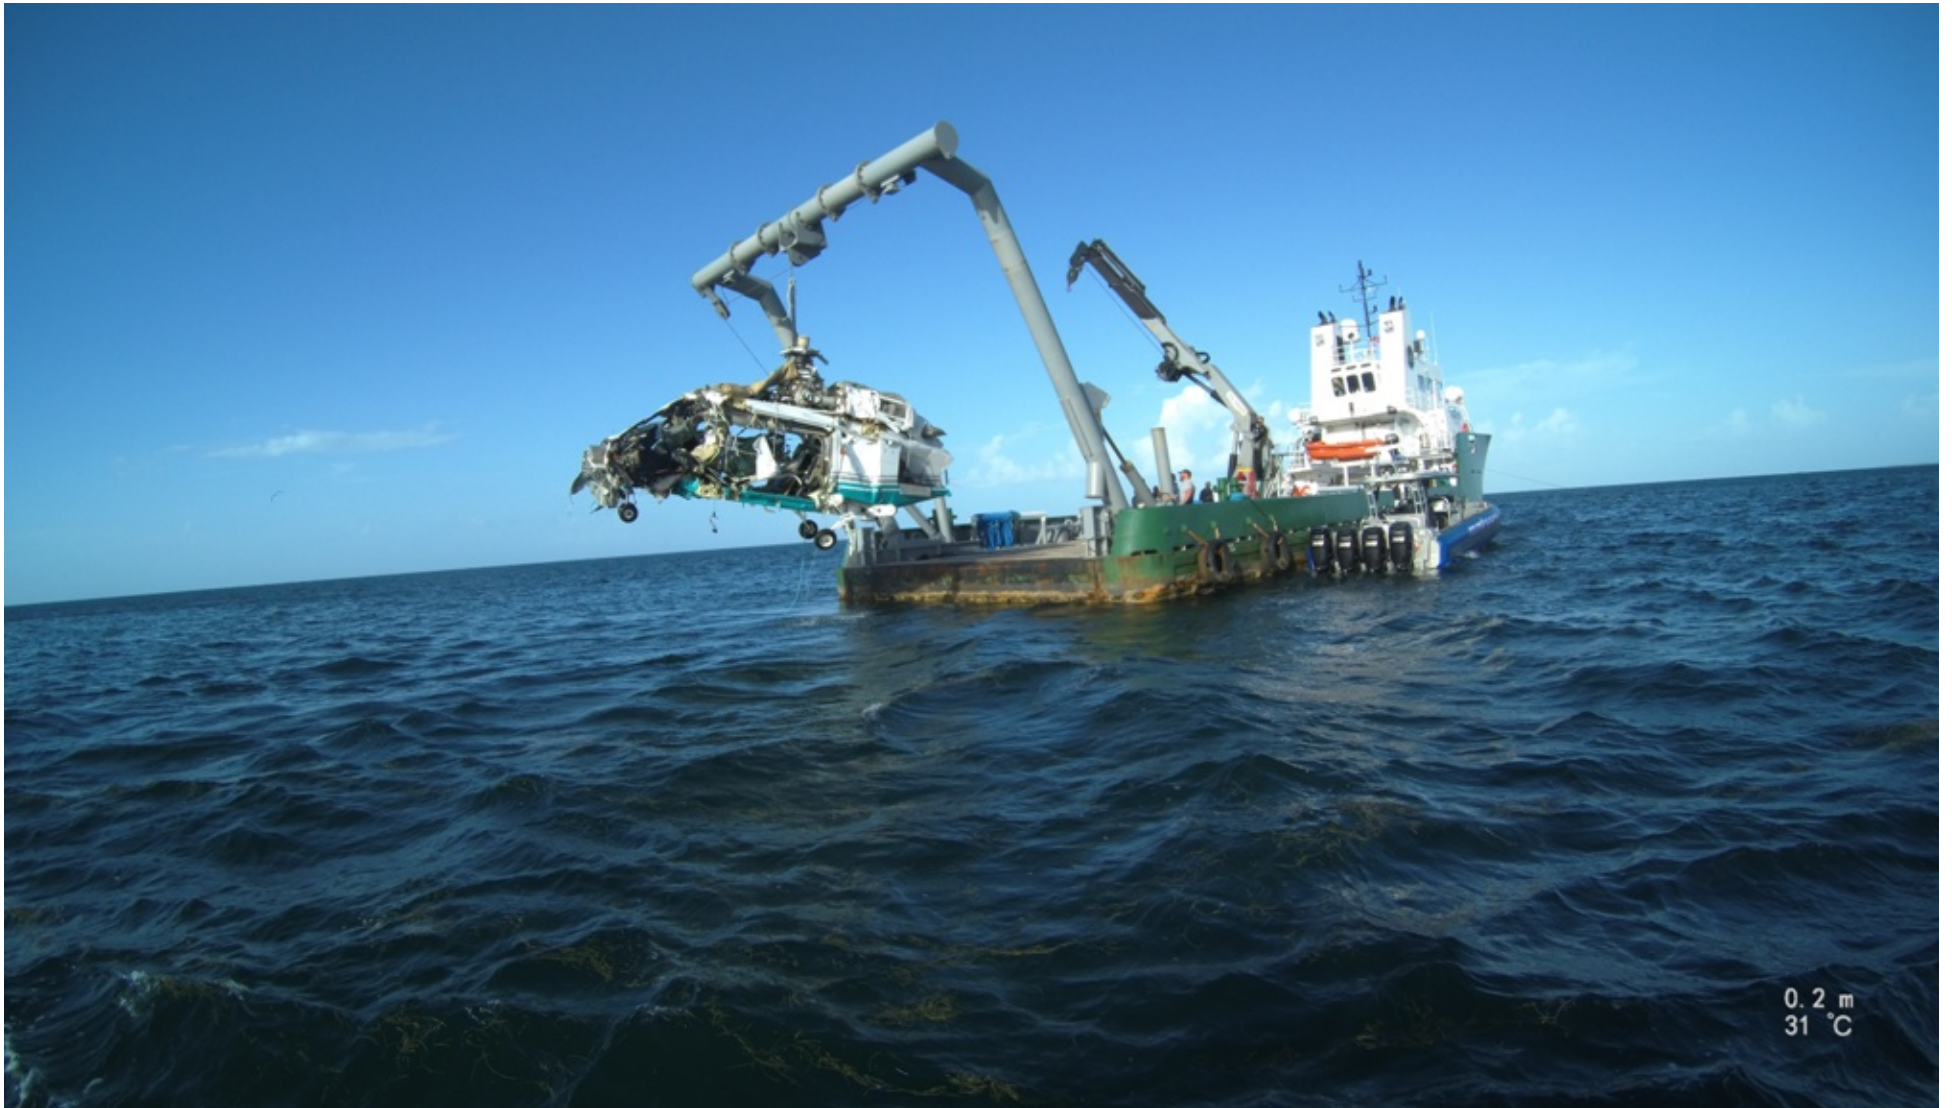
Photo 4 - Photograph Provided by Bahamian Accredited Representative. Left Side View of the Fuselage During Recovery.

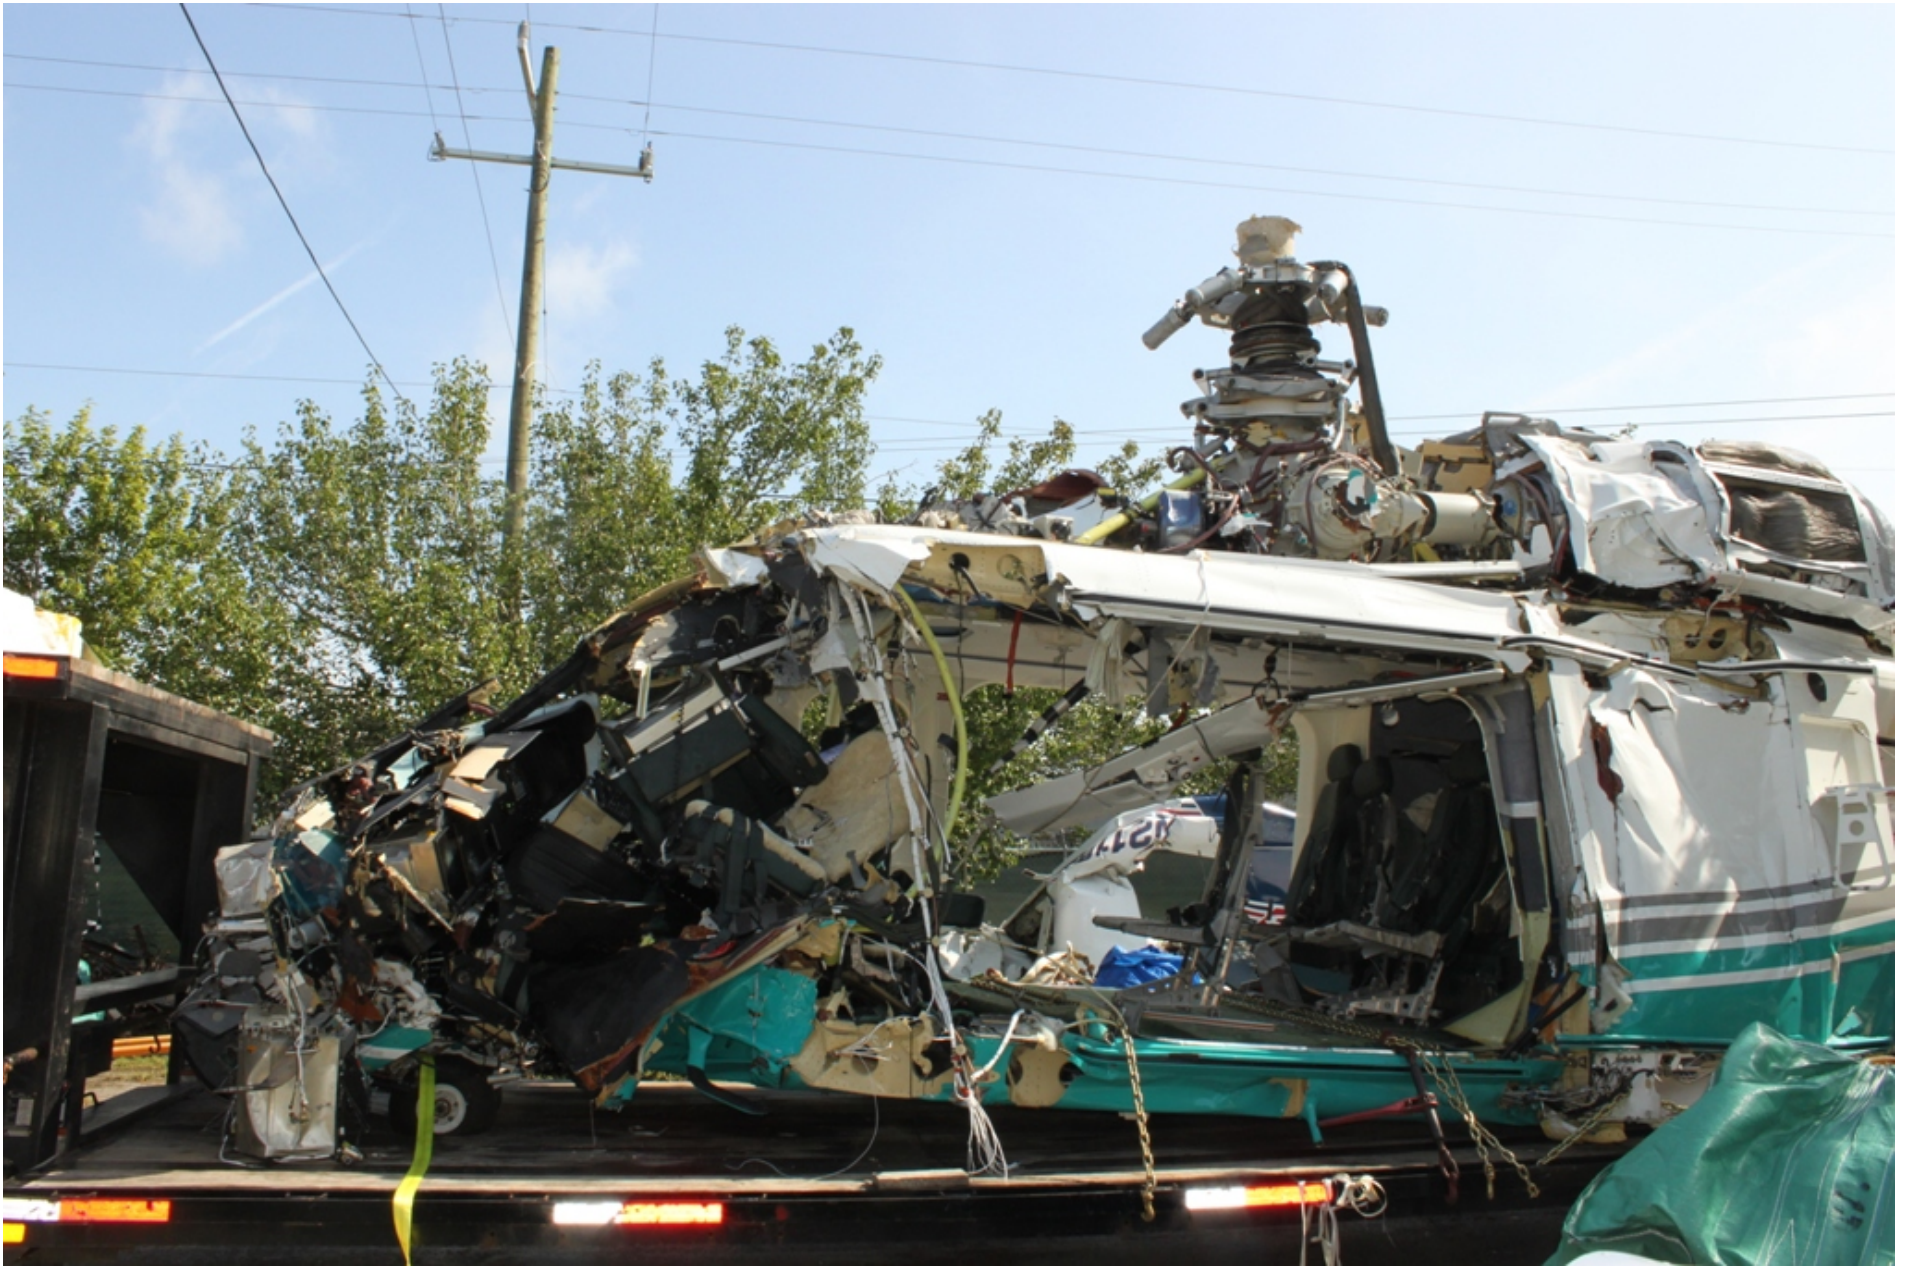
Photo 5 – NTSB Digital Photograph. Left Side View of the Fuselage Following Recovery.

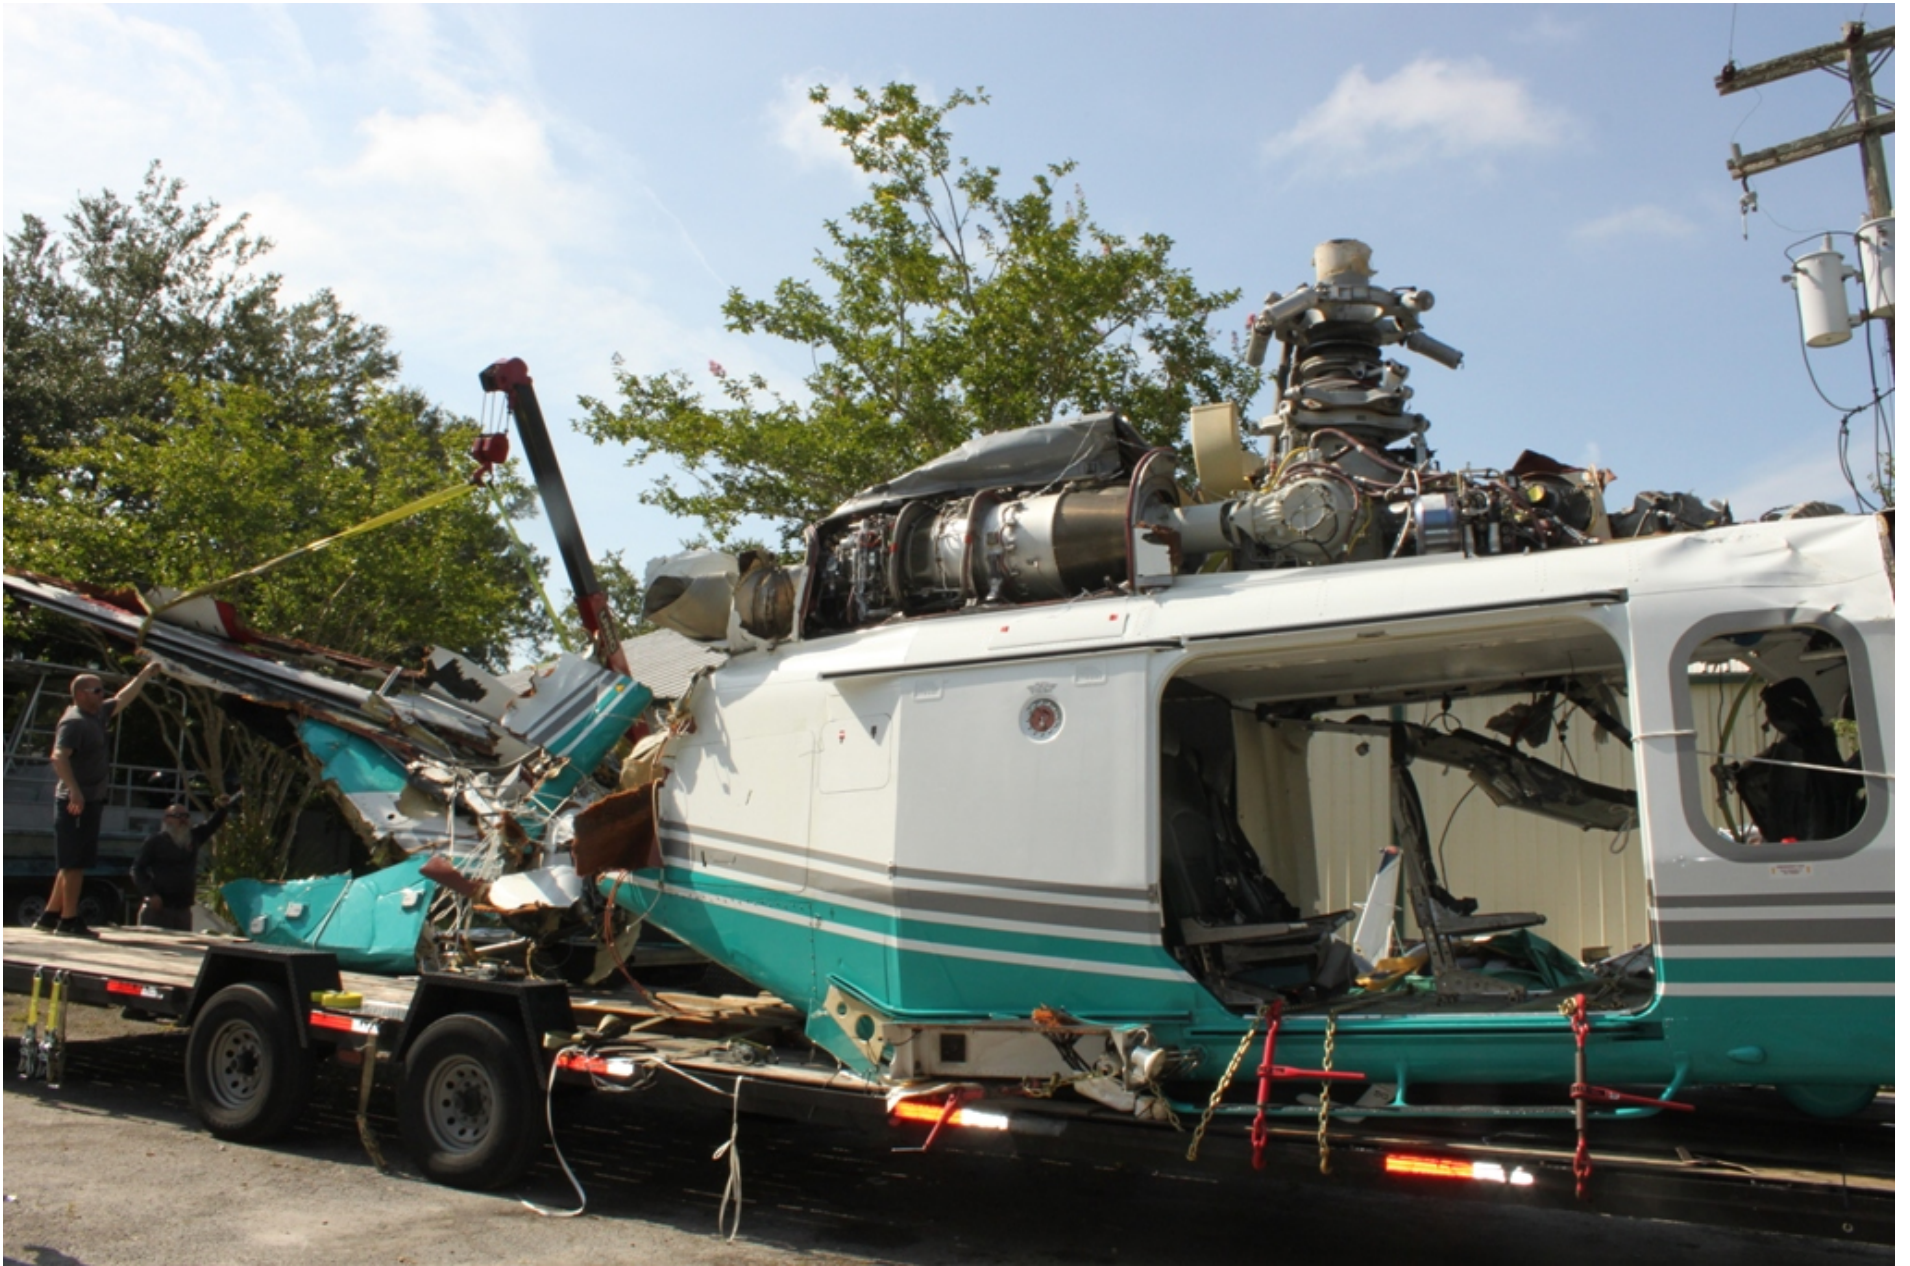
Photo 6 - NTSB Digital Photograph. Right Side View of the Fuselage Following Recovery.

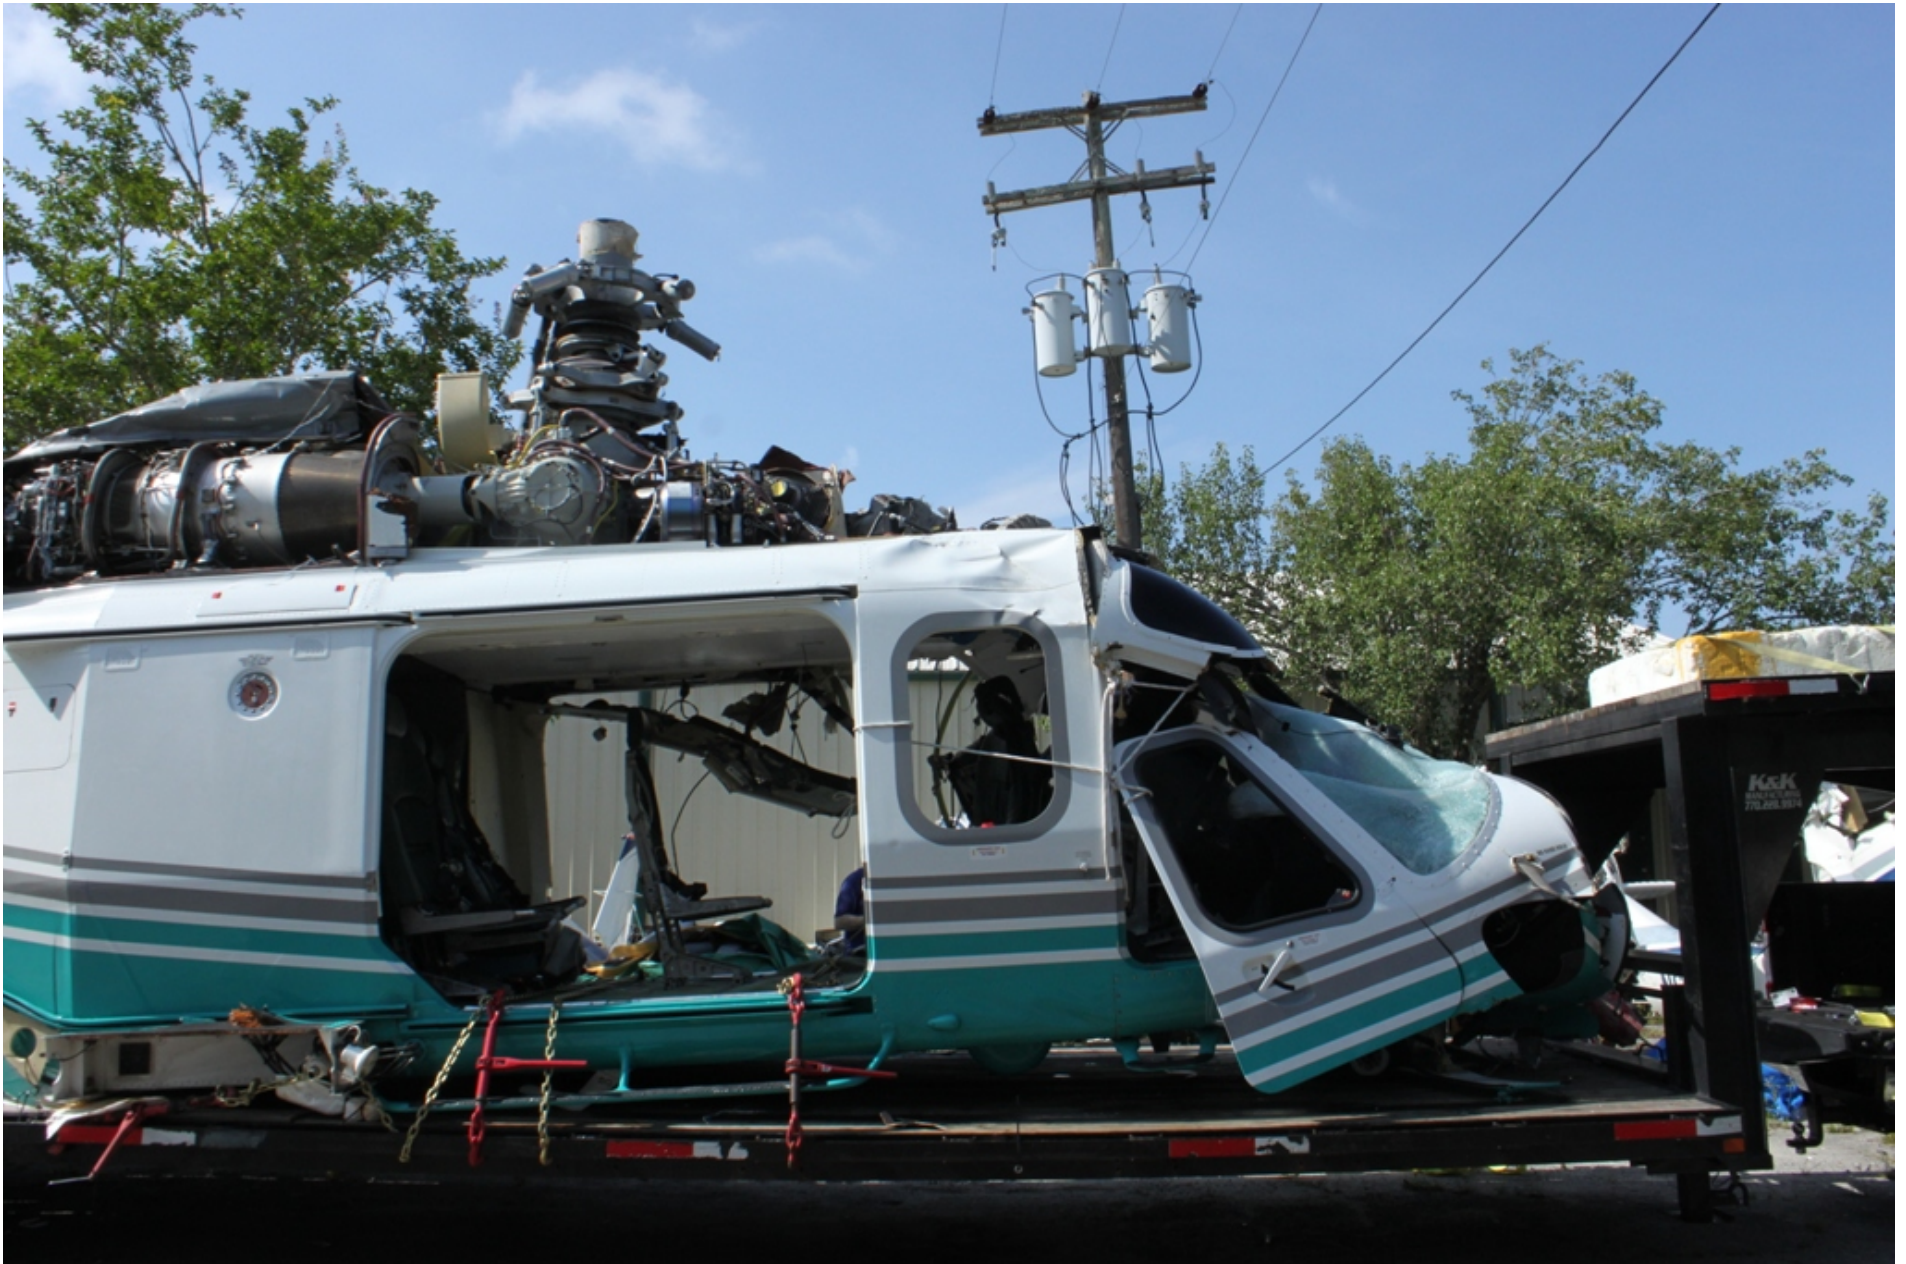
Photo 7 - NTSB Digital Photograph. Right Side View of the Fuselage Following Recovery.

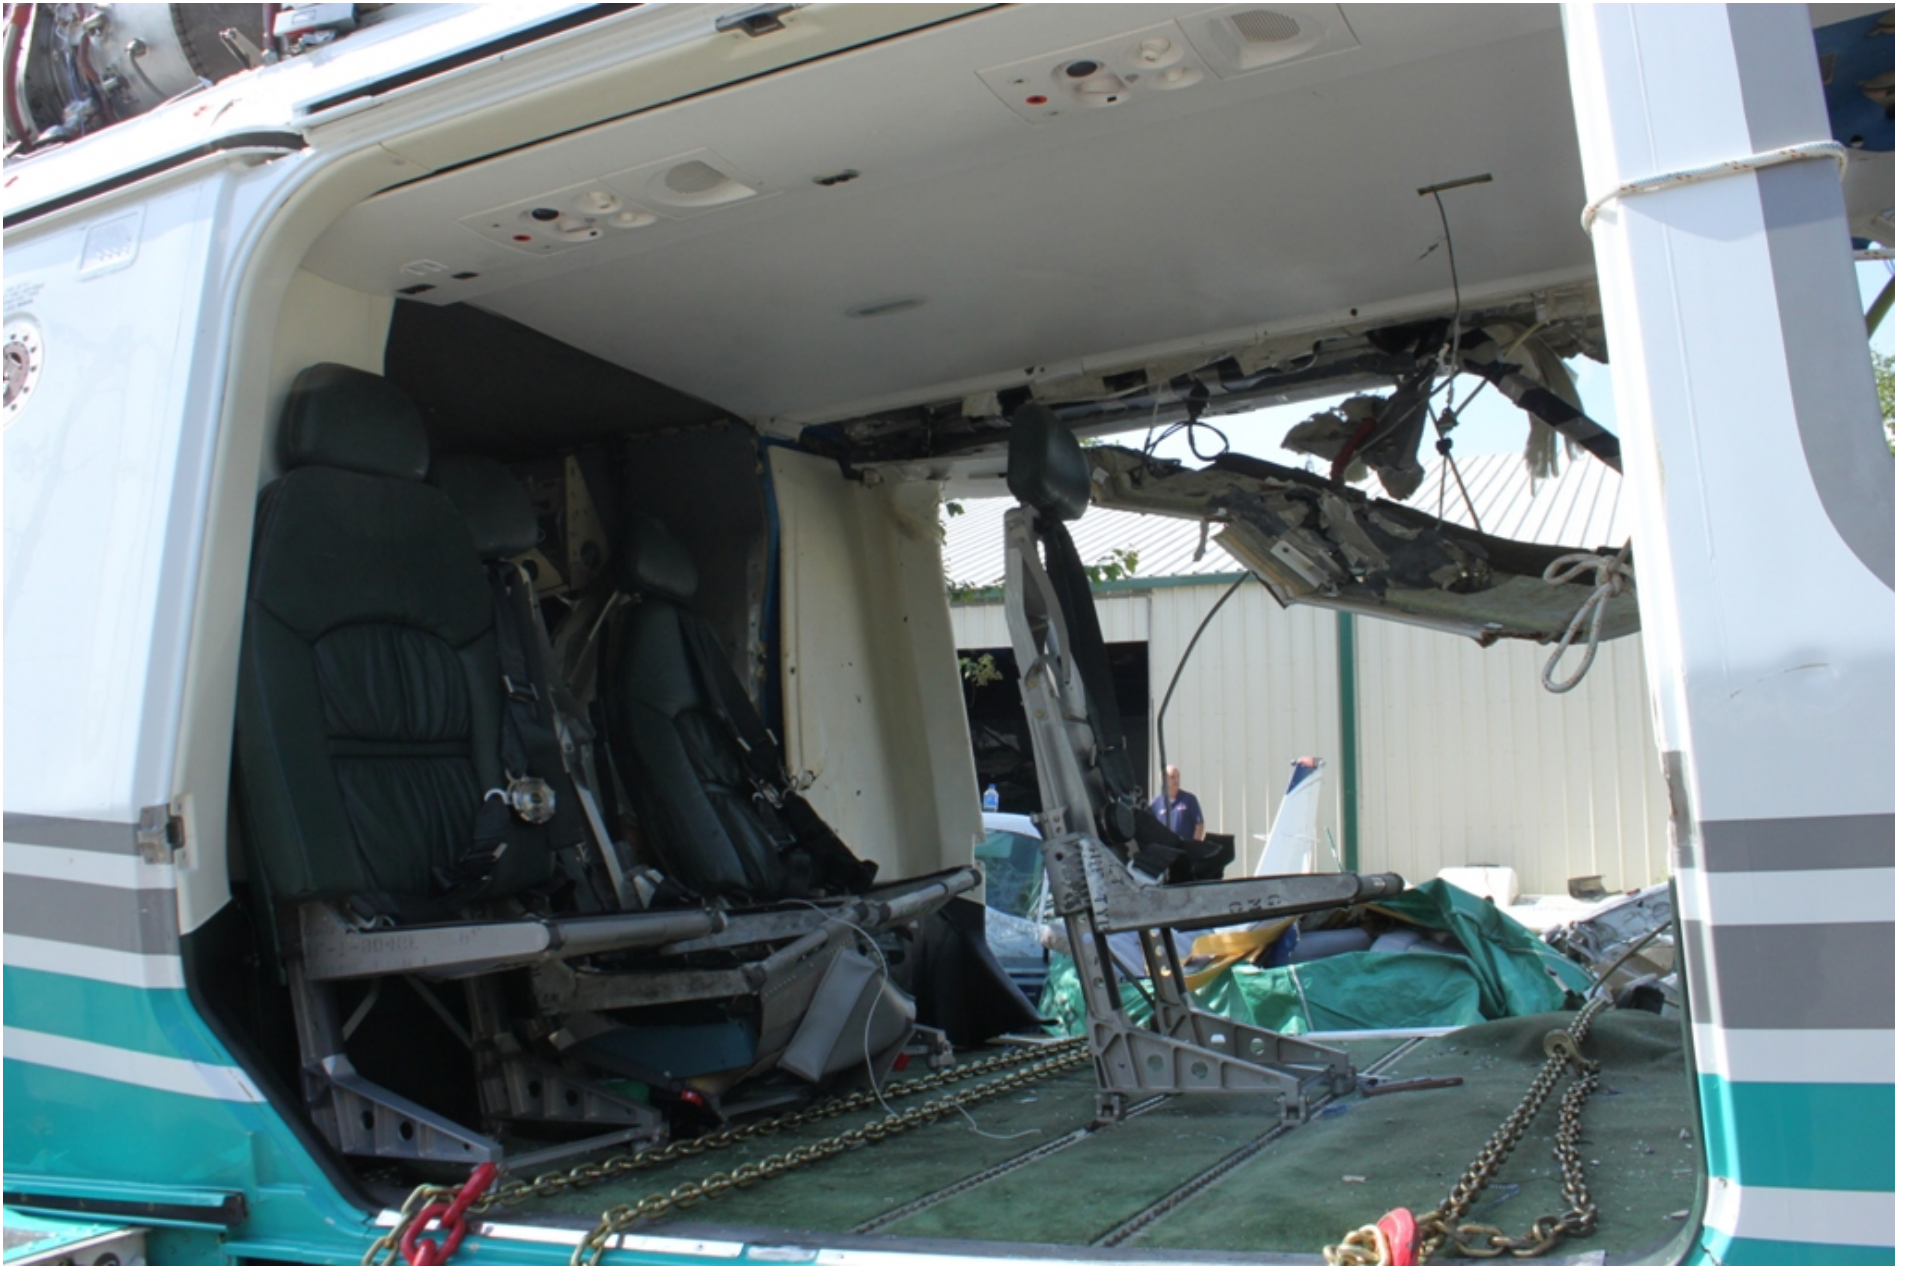
Photo 8 - NTSB Digital Photograph. Right Side View of the Aft Row Seats Remaining Installed Following Recovery.

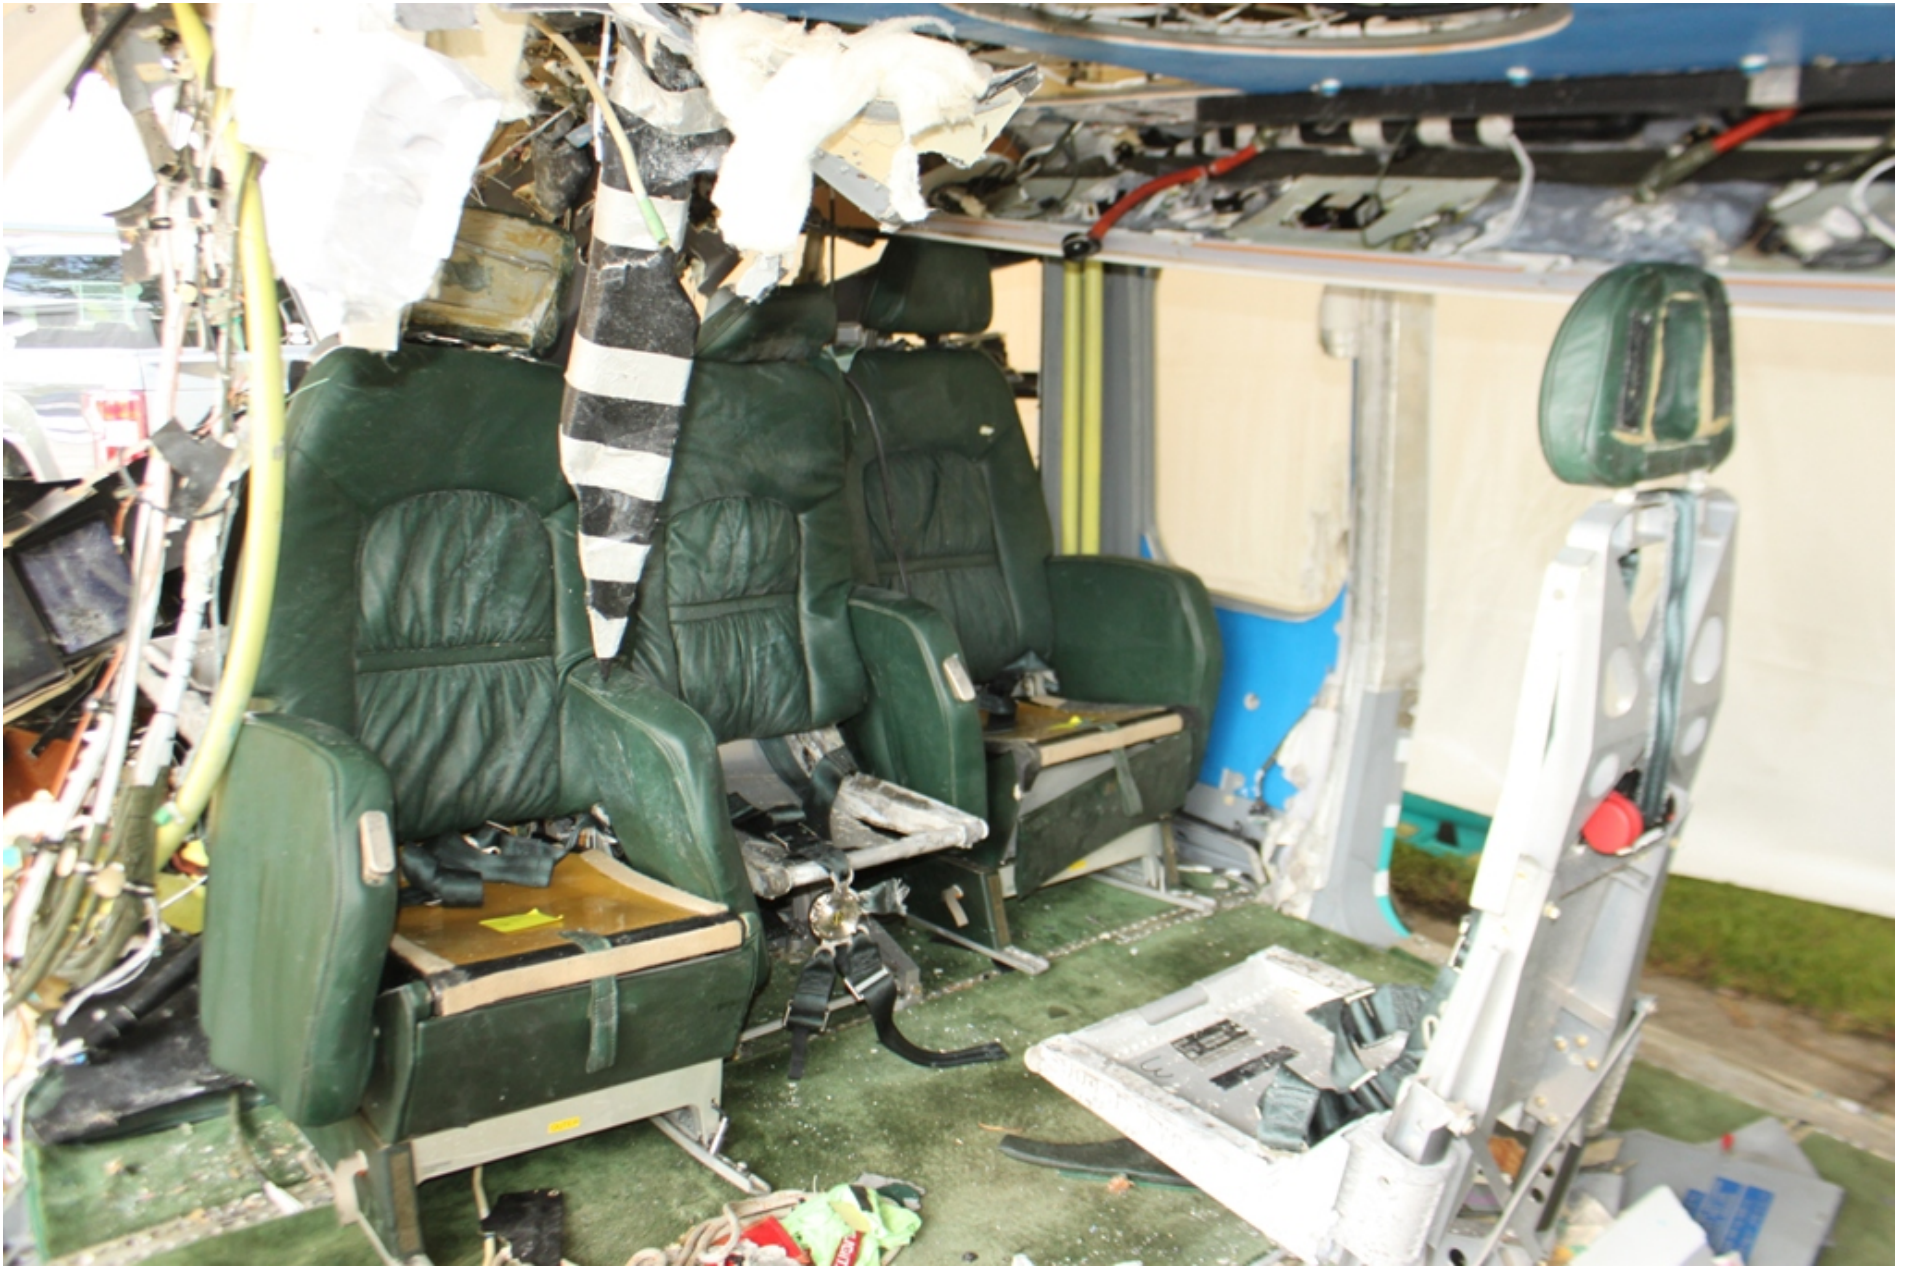
Photo 9 - NTSB Digital Photograph. Left Side View of the Middle Seat and Forward Row Seats Installed Following Recovery.

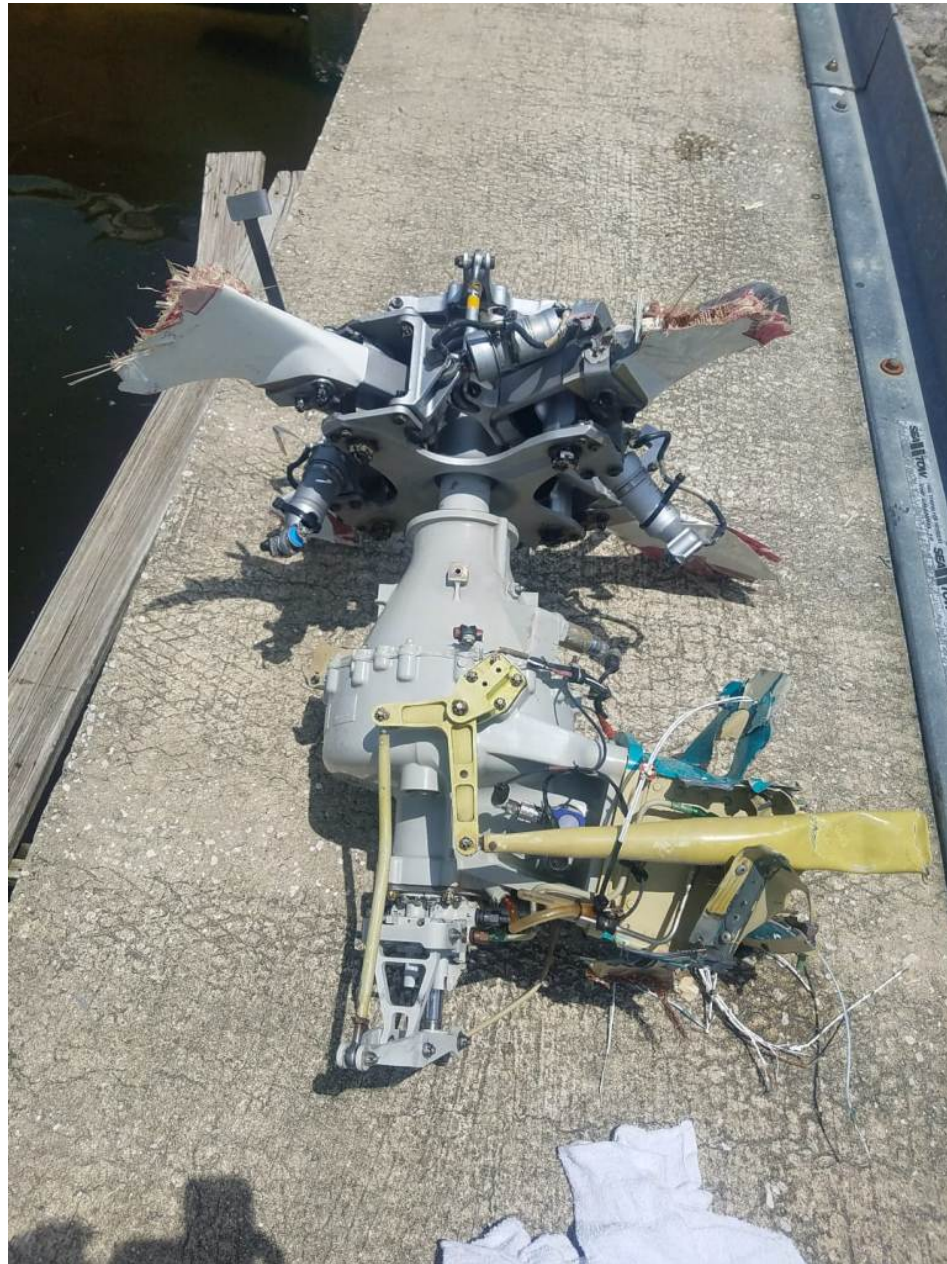
Photo 10 - Photograph Provided by Bahamian Accredited Representative. View of the Recovered Tail Rotor Assembly. Note the Fractured Tail Rotor Blades.
