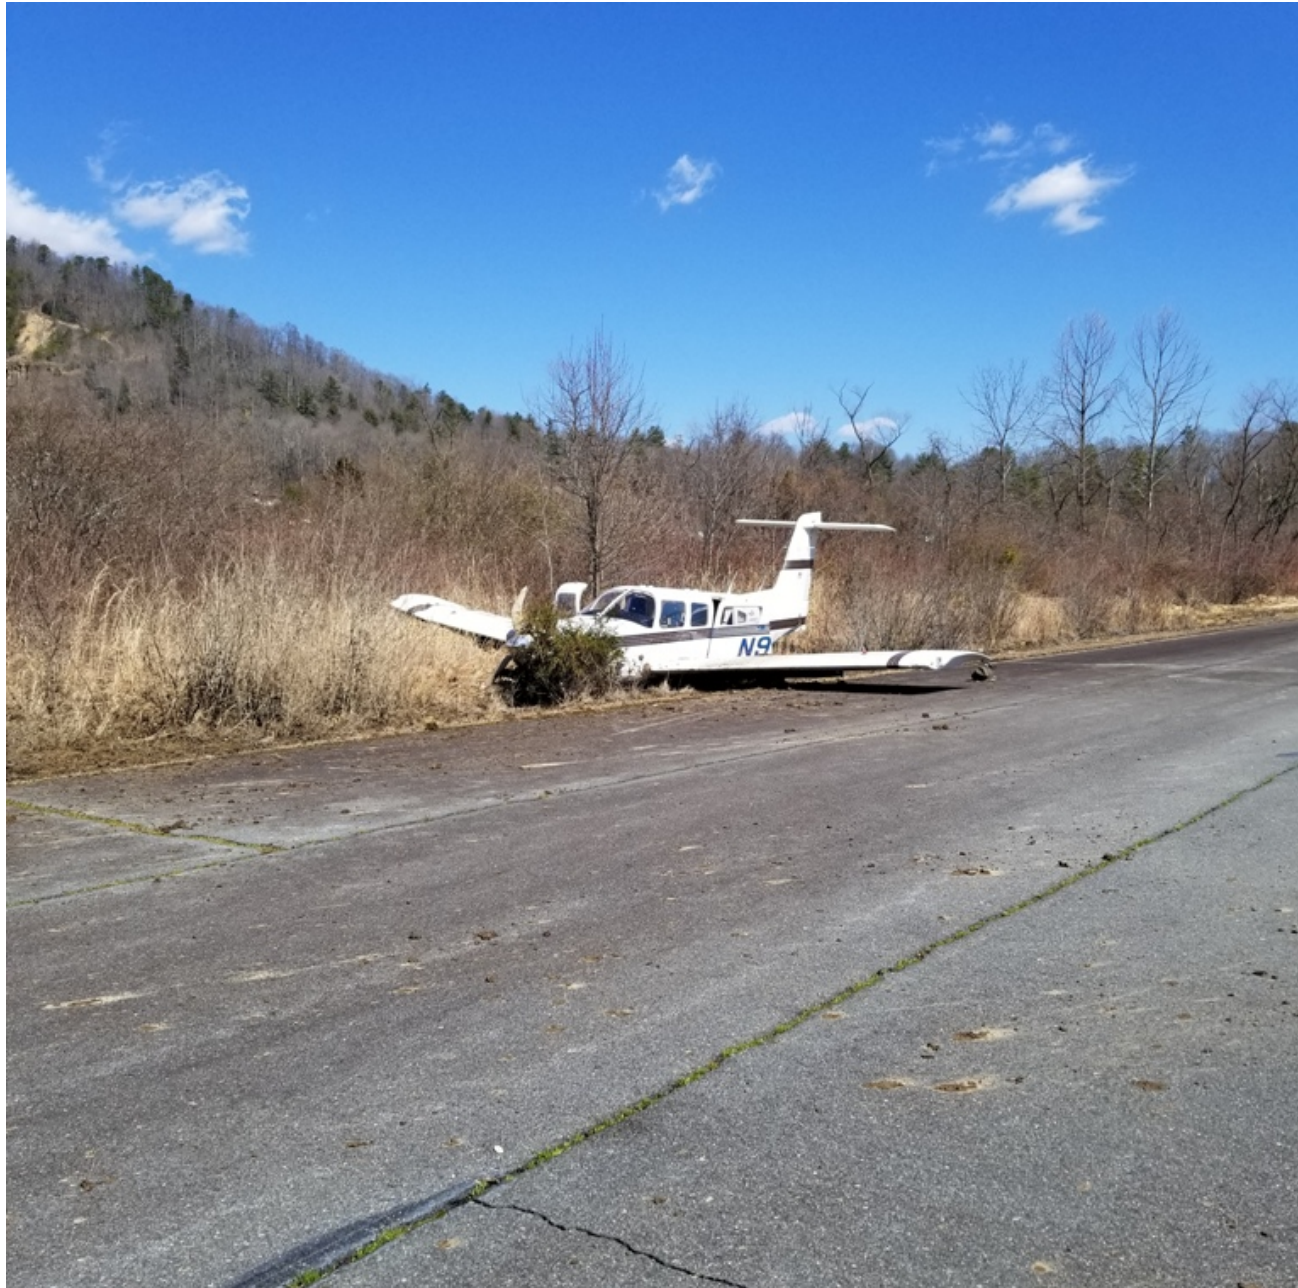
**Photo 1 – Digital Photograph From FAA. Left Forward Quartering View of the Airplane at the Accident Site.**

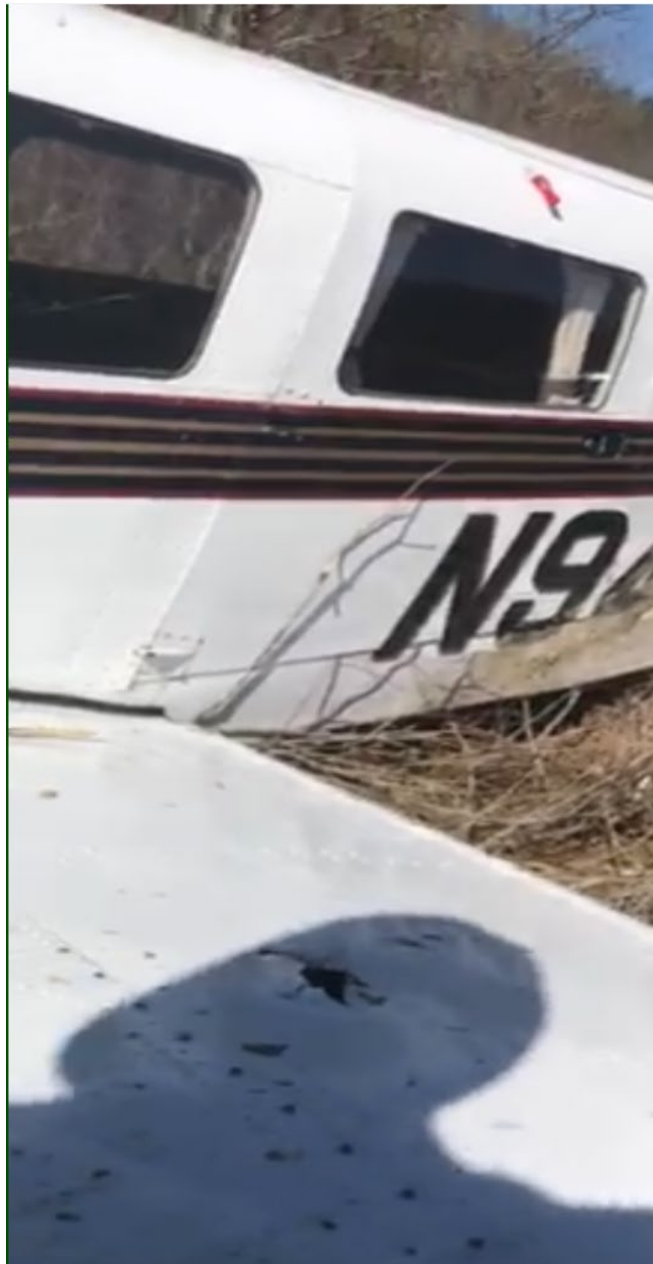
**Photo 2 – Screen Shot from Video Taken After the Accident. View of the Upper Wing Skin of the Left Wing With a Hole Above the Location of the Trunnion in a Normally Installed Position.**

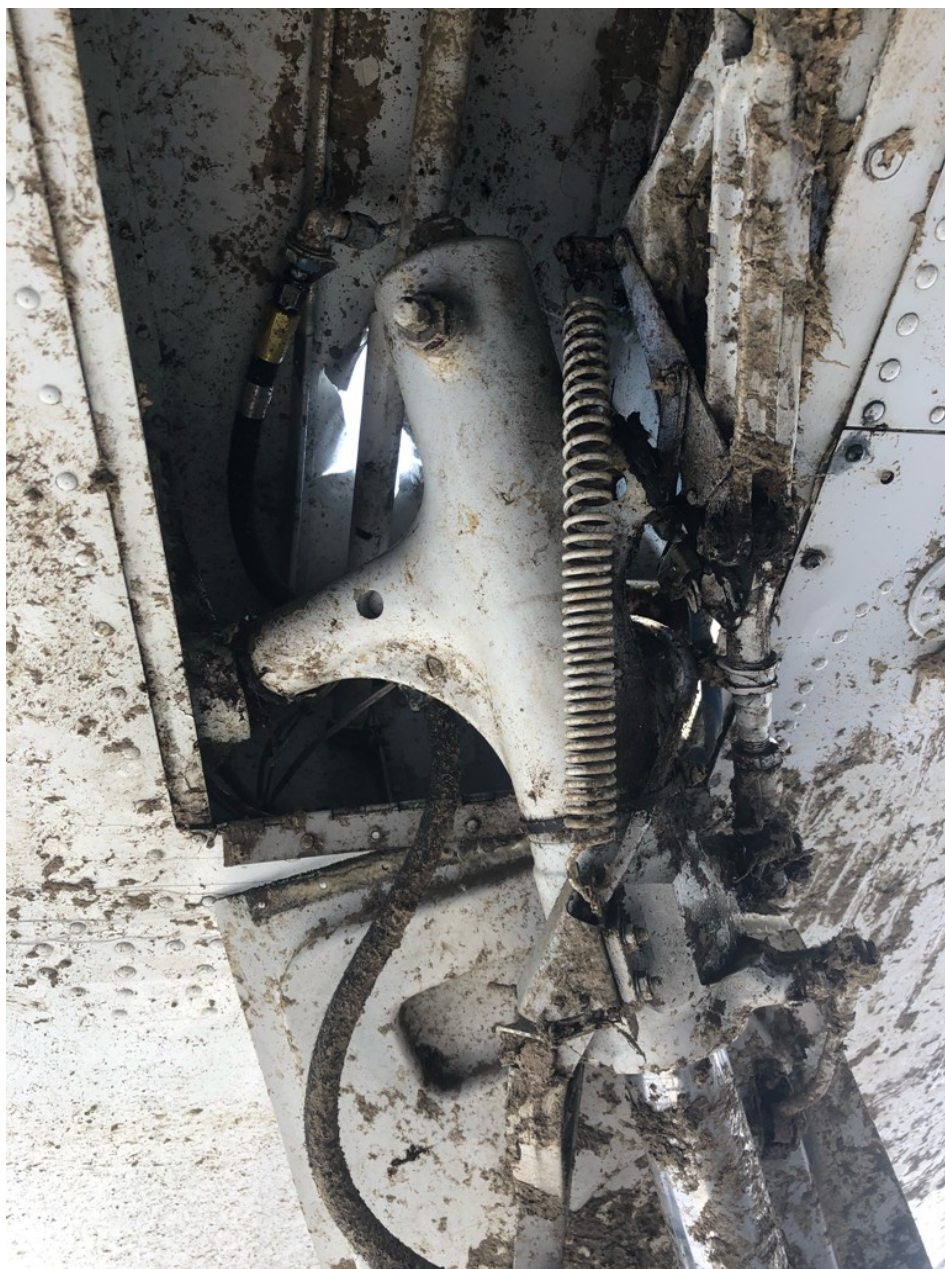
**Photo 3 - Digital Photograph From Airport Manager. View Depicting the Displaced Left Main Landing Gear. Note the Hole Punctured in the Upwards Direction of the Upper Wing Skin.**

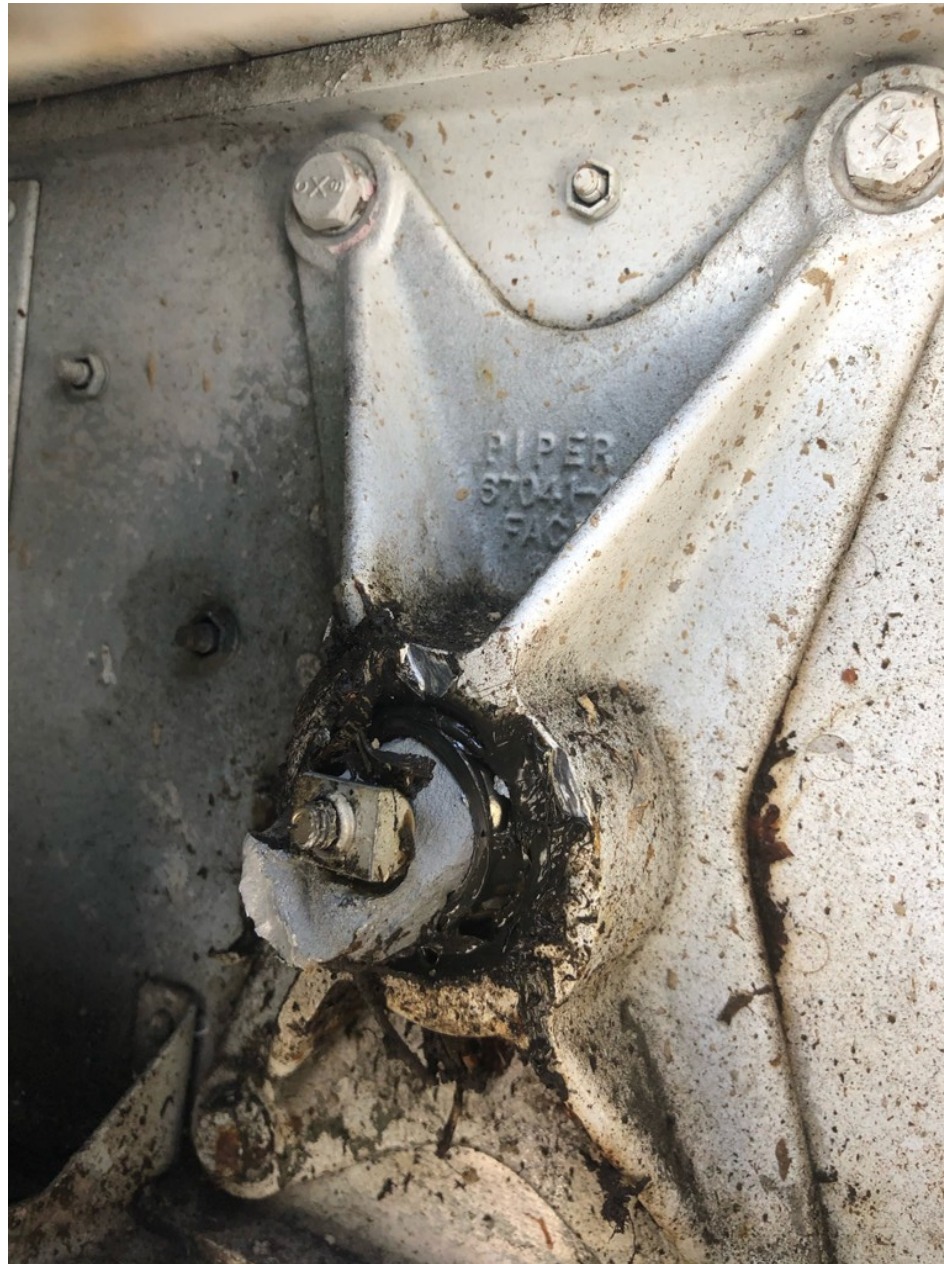
**Photo 4 - Digital Photograph From Airport Manager. View Depicting the Fractured Left Trunnion and the Forward Trunnion Fitting.**

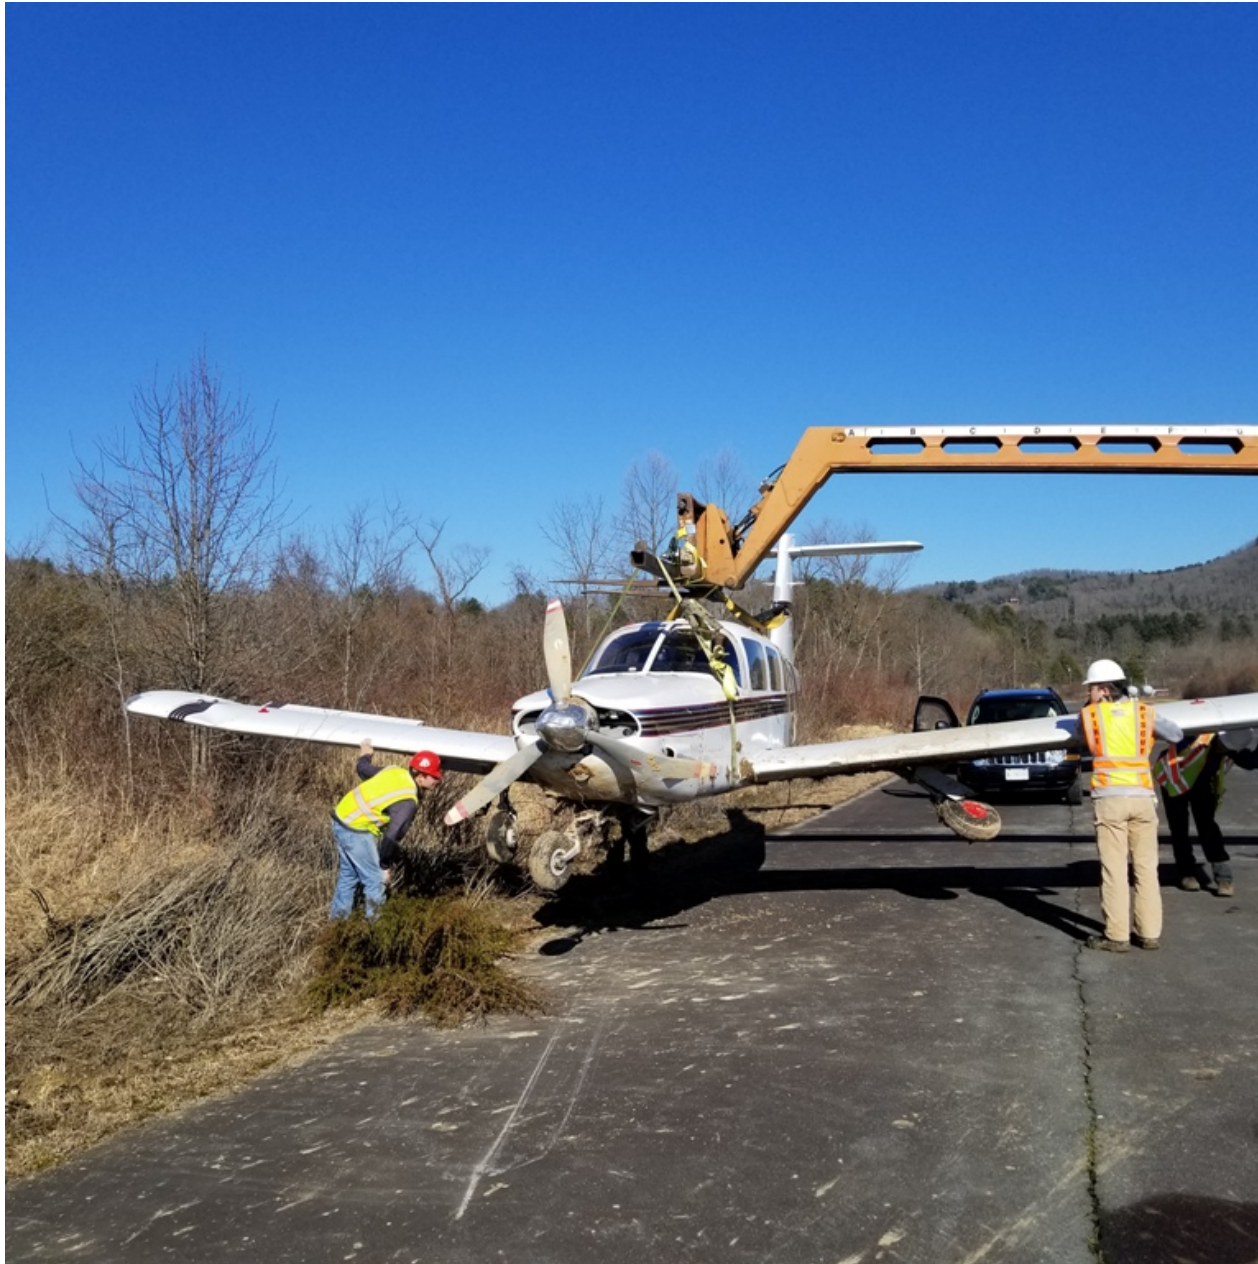
**Photo 5 – FAA Digital Photograph. Forward View of the Airplane During Recovery. Note the Compression Wrinkle on the Upper Wing Skin of the Right Wing Just Outboard of the Fuel Cap.**
