INVESTIGATIVE UPDATE

Electric Vehicle Run-off-Road Crash and Postcrash Fire Spring, Texas (HWY21FH007)

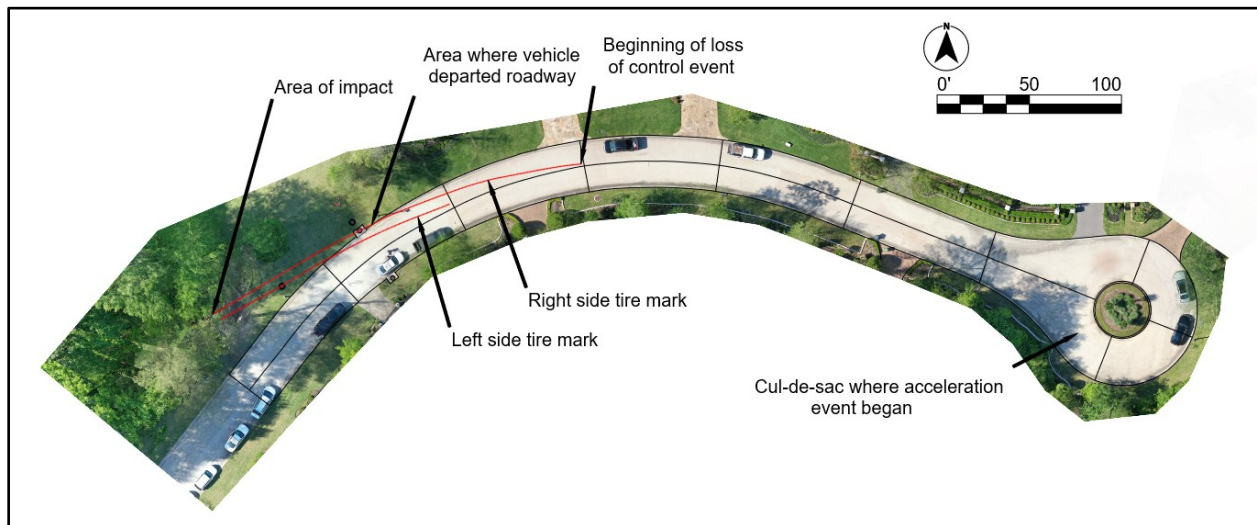
This report updates the preliminary report issued by the NTSB on May 10, 2021, concerning the crash of a Tesla Model S P100D car in Spring, Texas, on April 17, 2021. The car was westbound on Hammock Dunes Place when it left the road, drove over a curb, and hit a drainage culvert, a raised manhole, and a tree (see figure 1). A postcrash fire destroyed the car. The car was occupied by a driver and one passenger, both of whom died in the crash.

Figure 1. Overhead view of Hammock Dunes Place showing events in crash trip and tire evidence.

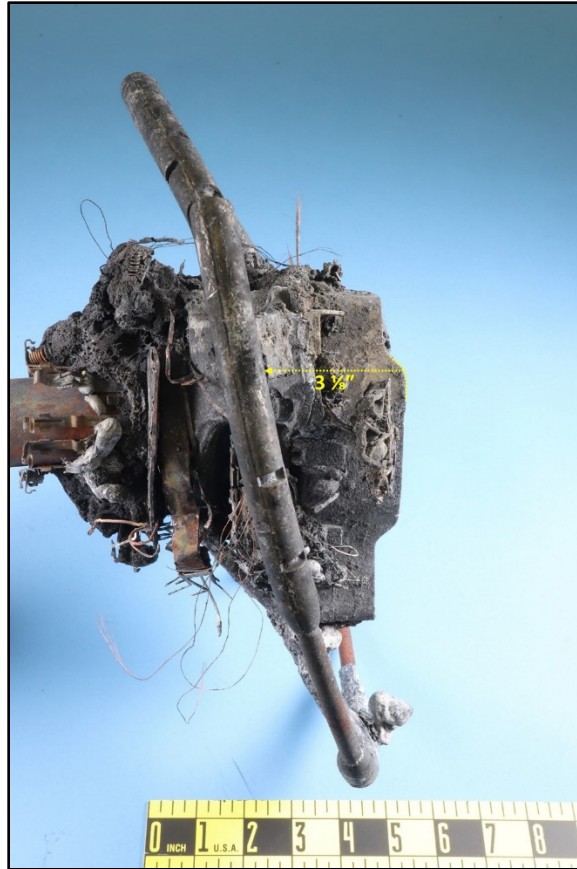
A postcrash inspection of the car showed that the steering wheel was damaged and deformed. The steering wheel was removed and transported to the NTSB Materials Laboratory for detailed examination. Initial results indicate that although some damage was caused by the intense heat of the postcrash fire, deformation along the top and left side of the steering wheel's outer rim, as shown in figure 2, was due to an impact.

Figure 2. Steering wheel viewed from left. Yellow dotted line shows measured displacement of outer rim from top right front corner of center hub cover.
