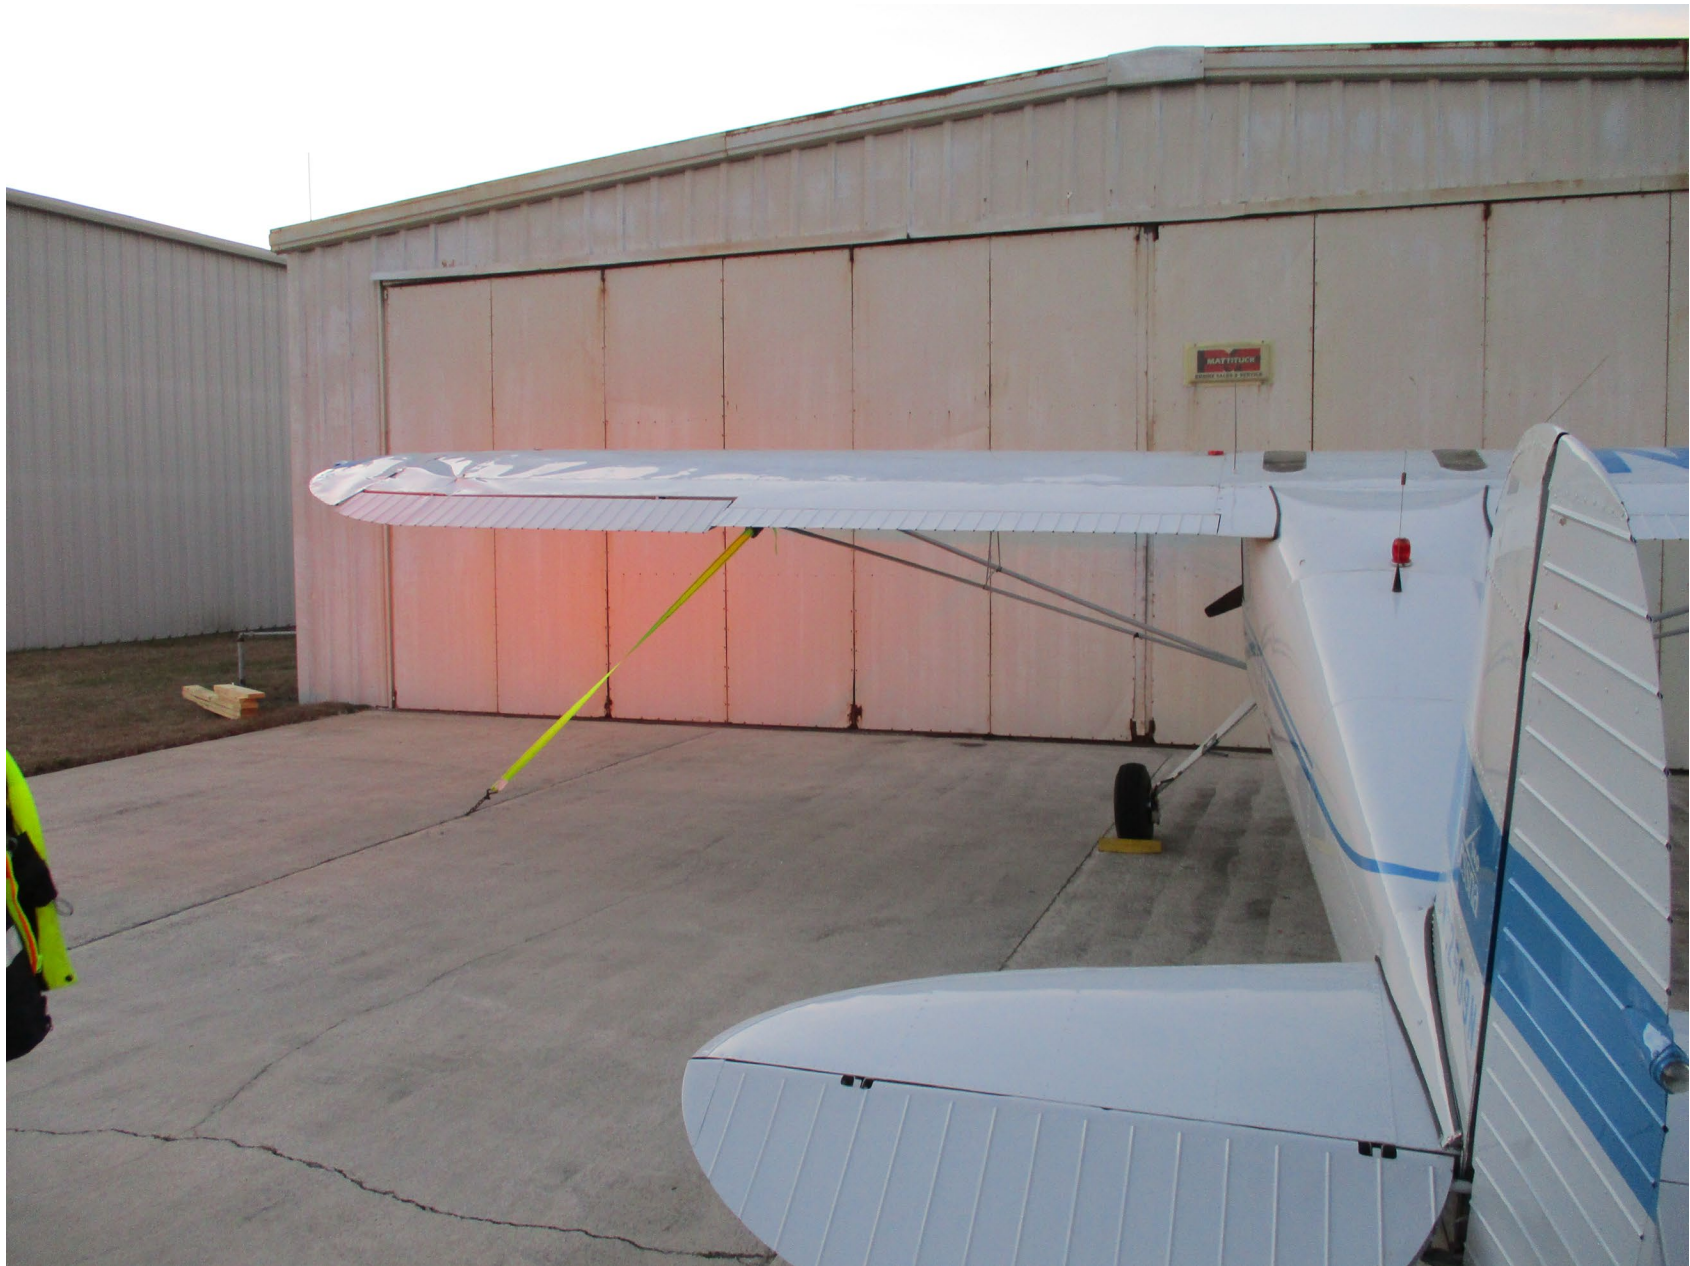
Photo 1 – View of left wing showing buckling damage on upper outboard section

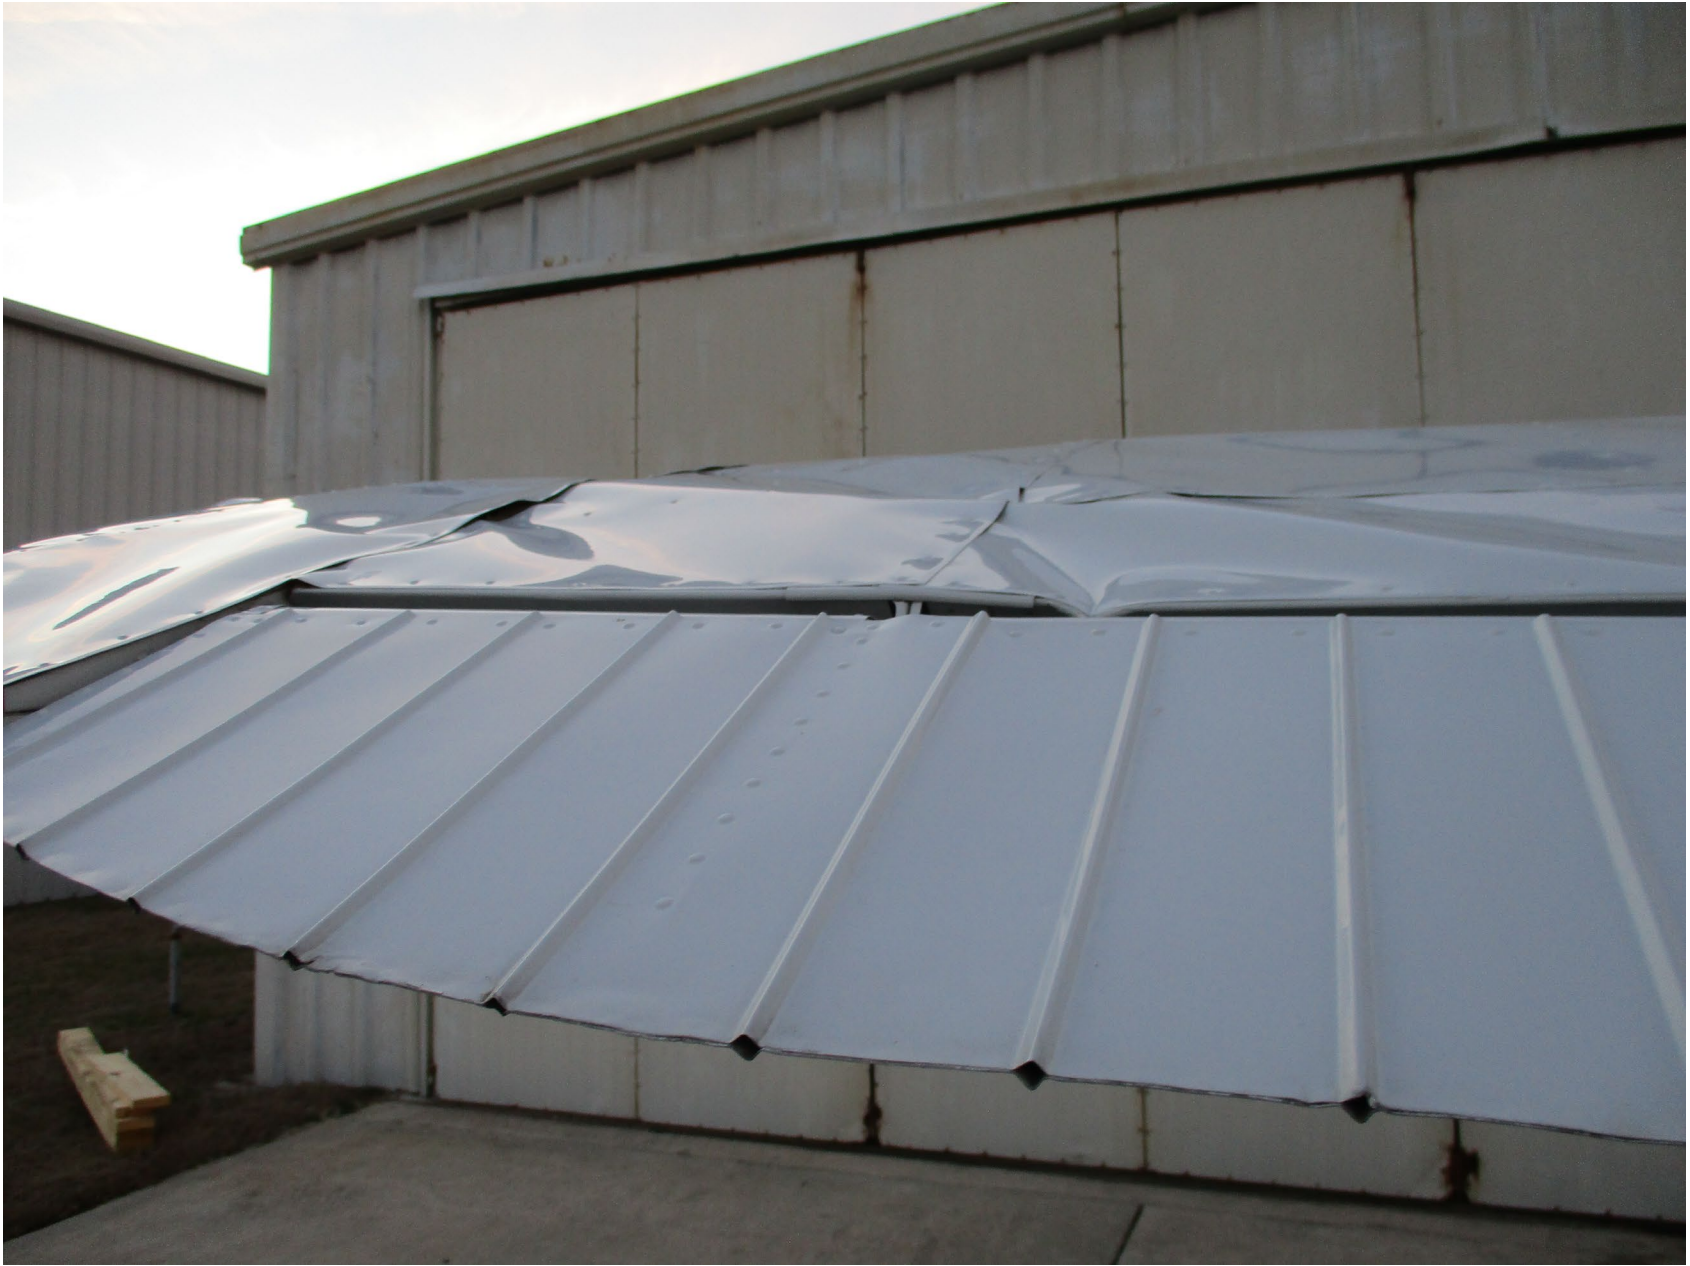
Photo 2 – Close-up view of left damaged wing

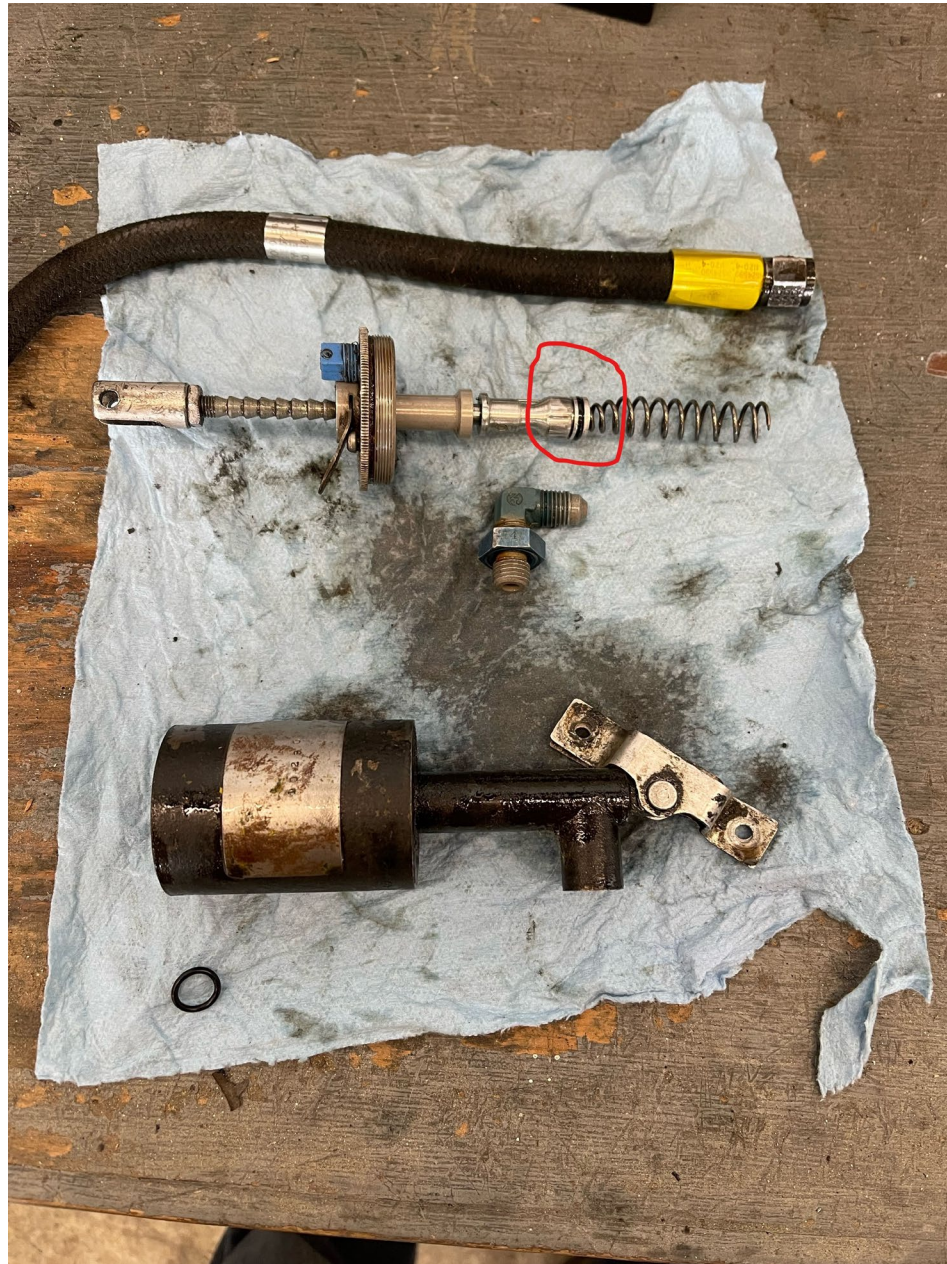
Photo 3 – Disassembled left brake master cylinder w/ damaged O-ring circled in red

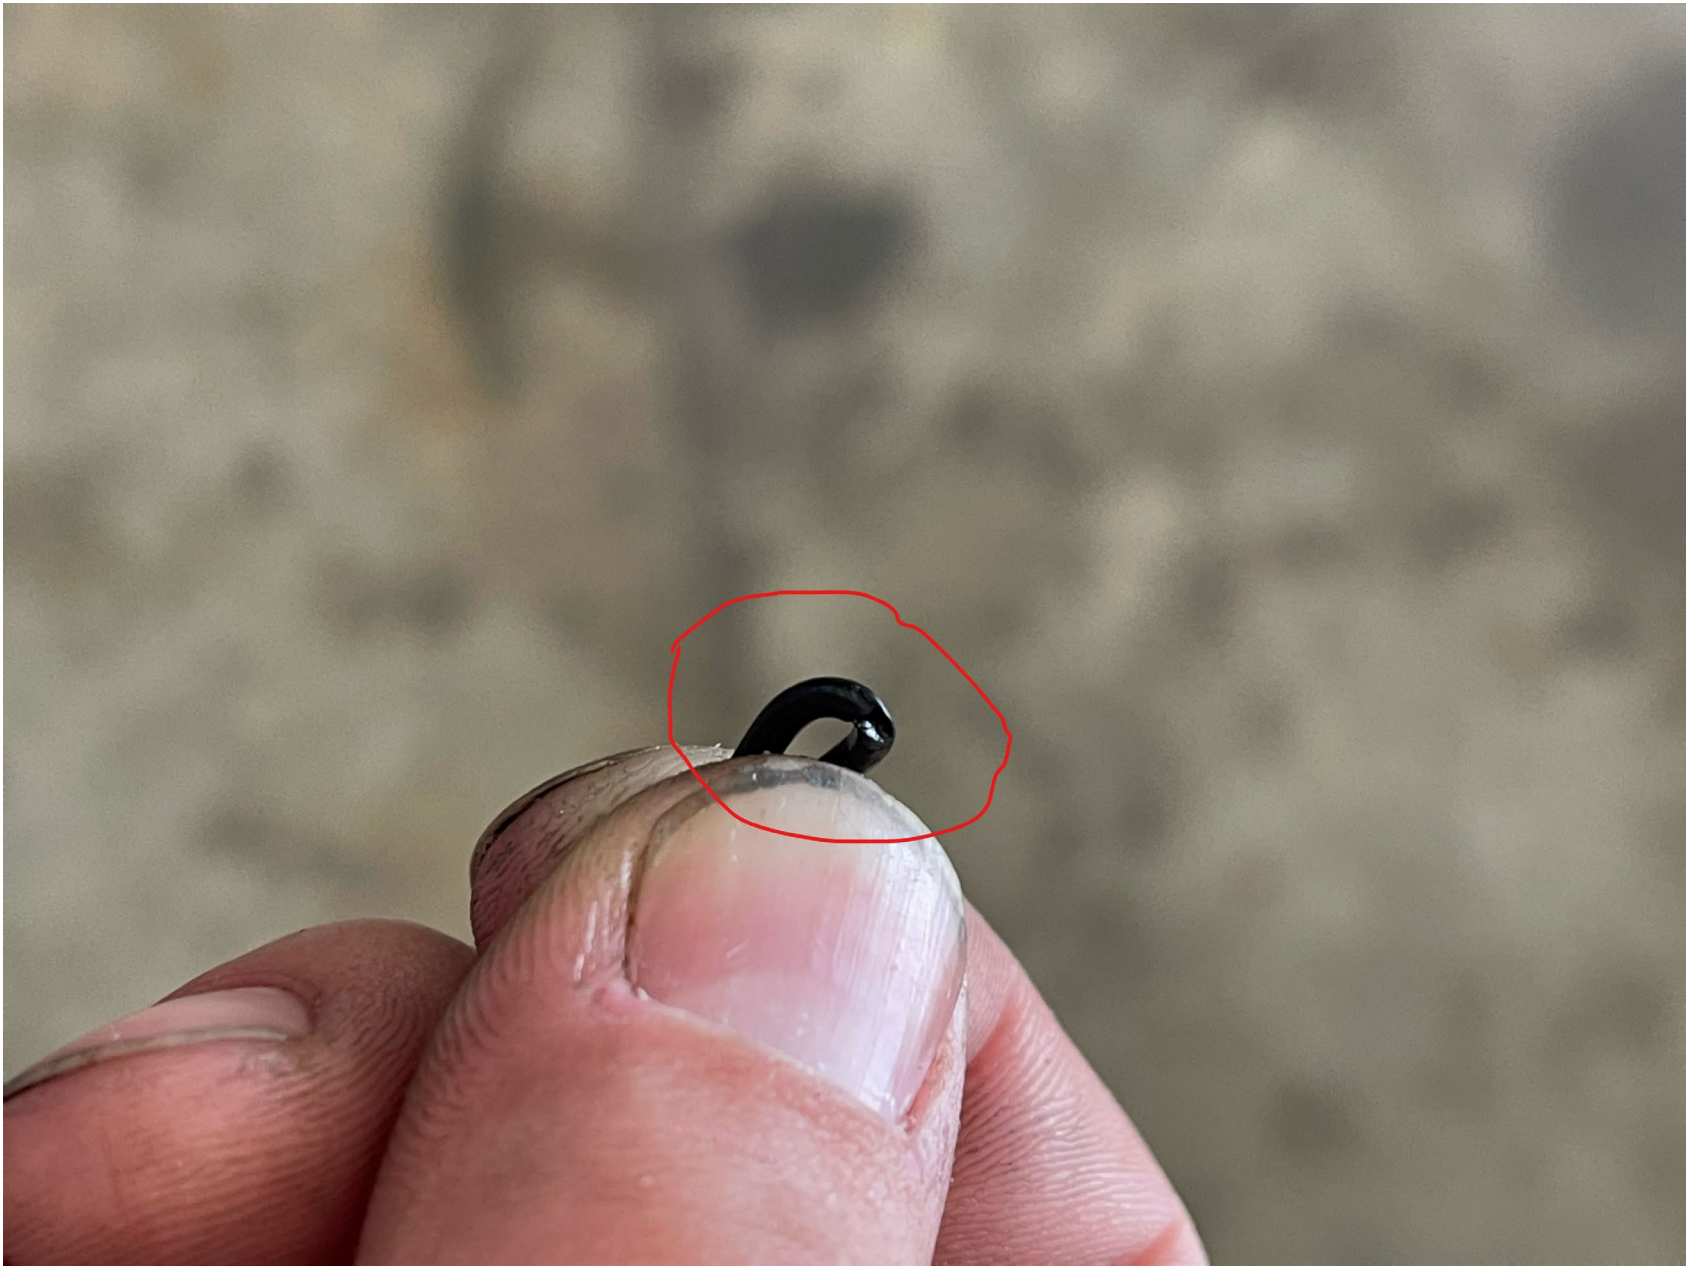
Photo 4 – Damaged O-ring showing pinch and cut
