## Project 07-4063

### Examination and Testing of a Tapping Tee

# ***JANA LABORATORIES INC.***

**Report No.:** Project 07-4063 – Report

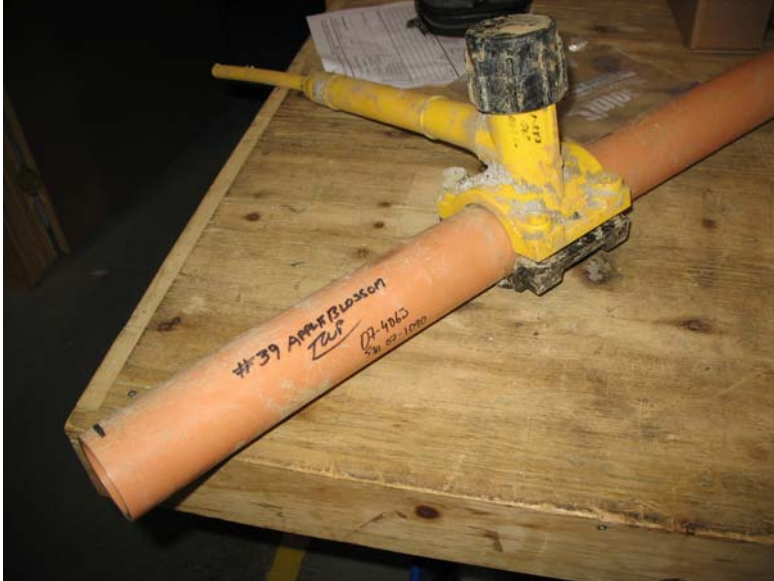
**Figure C1: Sample 07-1090, #39 Appleblossom**

Figure C1 is an overview of the sample as received, showing bottom and top saddle parts, tower, cap, branch with Excess Flow Valve (EFV) and ½" pigtail branch line.

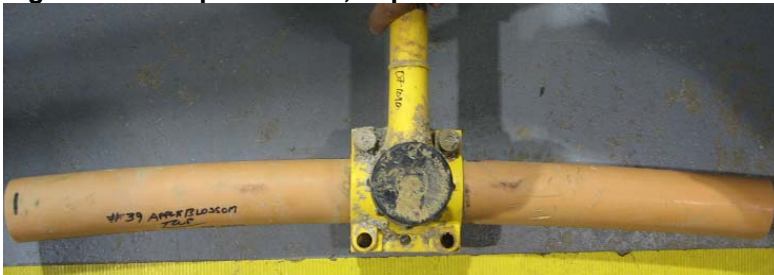
**Figure C2: Sample 07-1090, Top View**

Figure C2 shows the overall sample alignment from the top view. Part of the threaded portion of both of the lower two bolts in this view was retained in the threaded hole in the lower saddle. The head portions of the broken bolts were received in a separate bag.

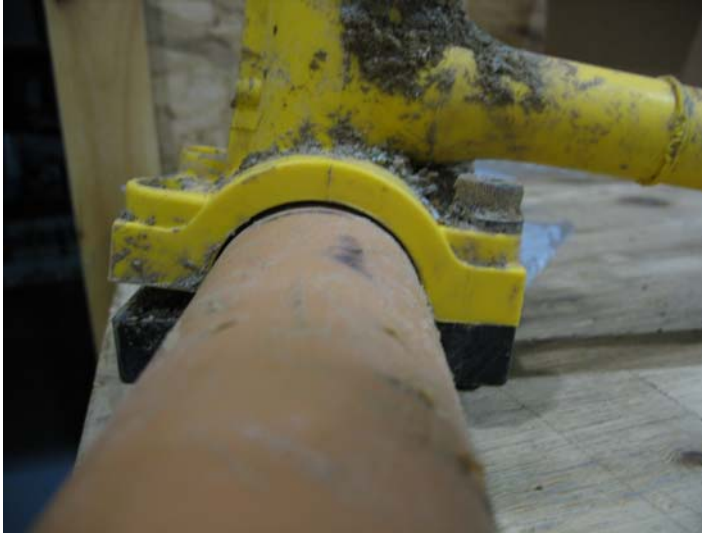
**Figure C3: Sample 07-1090 Side View**

Figure C3 shows a side view of the tapping tee saddles, with the intact bolts on the right and the broken bolts on the left.

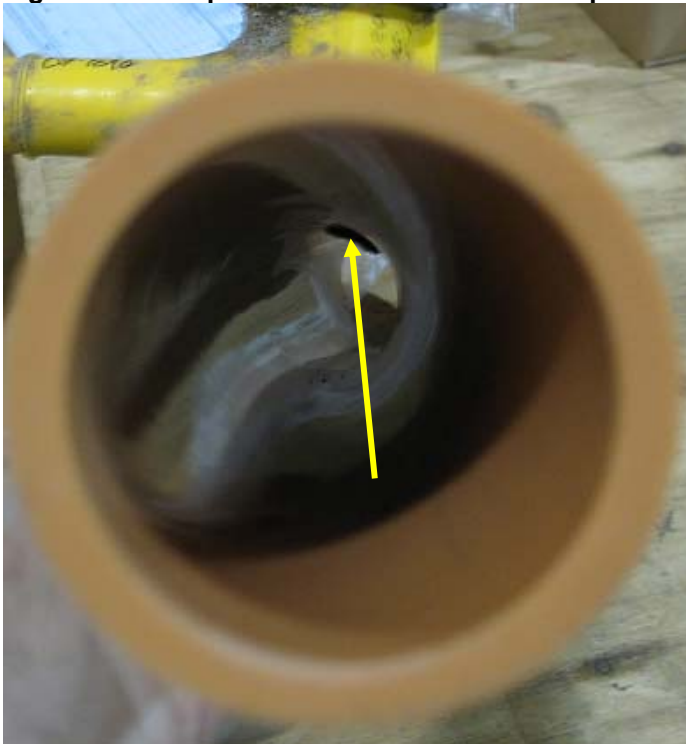
**Figure C4: Sample 07-1090 Interior View of Tap**

Figure C4 shows the tap viewed from the inside of the main pipe (arrow). No locking sleeve is visible.

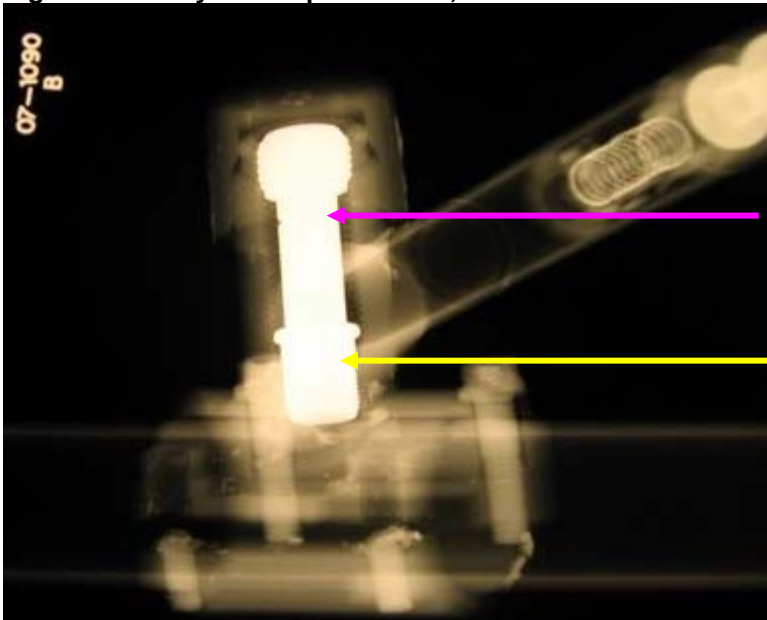
Figure C5: X-ray of Sample 07-1090, Side View

Figure C5 is an X-ray photograph of the tapping tee, showing the cutter (pink arrow) and the locking sleeve (yellow arrow). The locking sleeve does not appear to be engaged with the pipe wall.

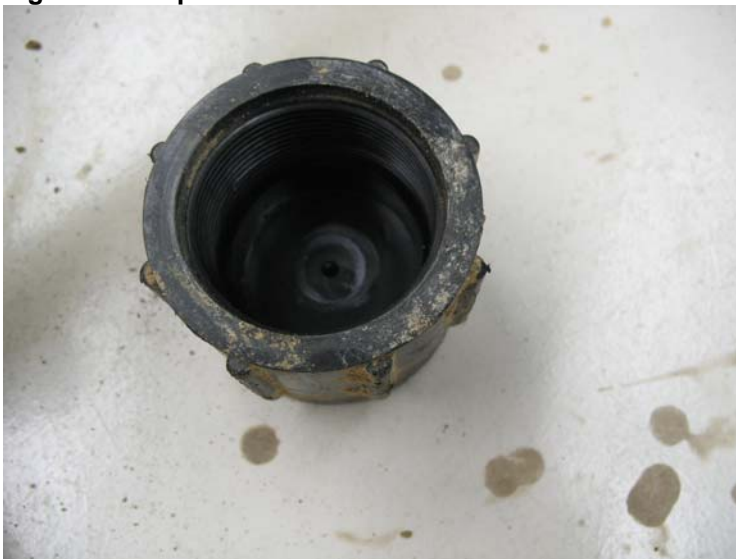
**Figure D1: Cap As-Removed**

*Cap removed. O-ring present and intact and lubricated. Cap clean.*

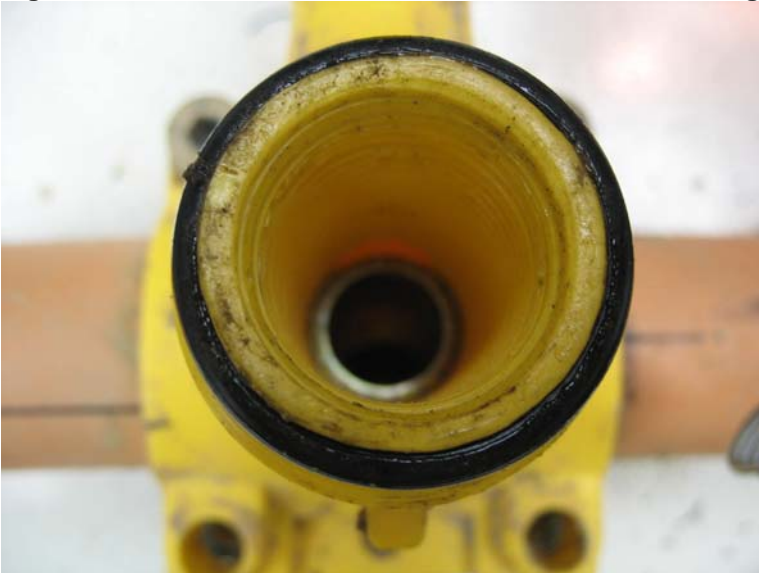
**Figure D6: View Down Tower with Cutter Removed; Locking Sleeve at Bottom**

*Observation: the locking sleeve was loose at the bottom of the tower.*

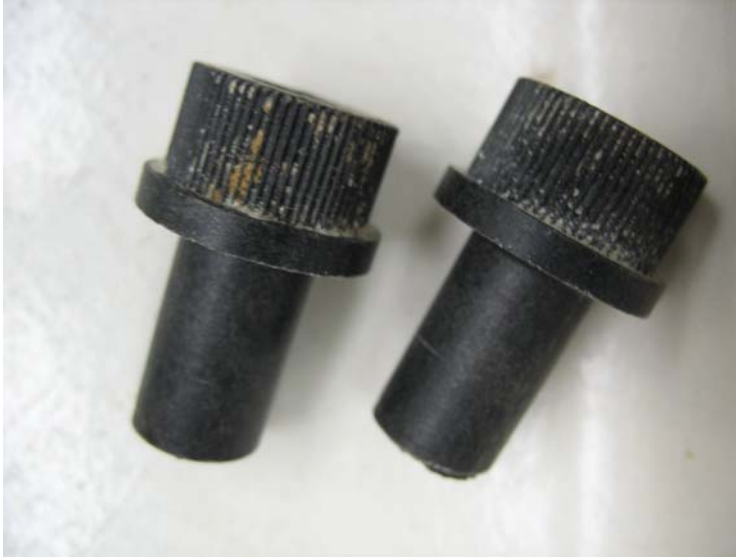
**Figure D7: Broken Bolts, Sample 07-1091**

- 3.10 Measure the length of threads on the broken bolt heads and the number of threads  
*No threads remaining on head end of broken bolts. Both bolts broke at the first thread.*

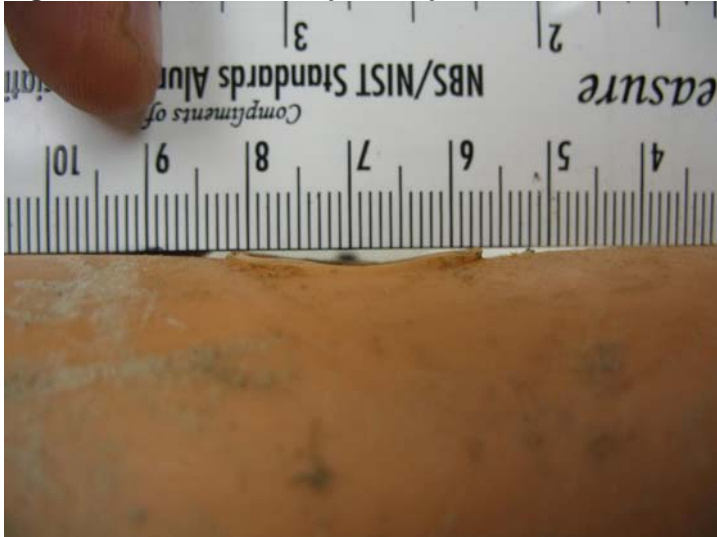
**Figure D12: Contour of Pipe at Tap**

- 5.3 Measure the protruding height of the sleeve at the valley  
*Not applicable; sleeve was not engaged with pipe*
- 5.4 Measure the protruding height of the sleeve at the shortest locations  
*Not applicable; sleeve was not engaged with pipe*
- 5.5 Measure the deflection of pipe wall near the opening  
*Complex with some deflection of wall and raising of a lip at the hole edge.  
See Figure D12.*

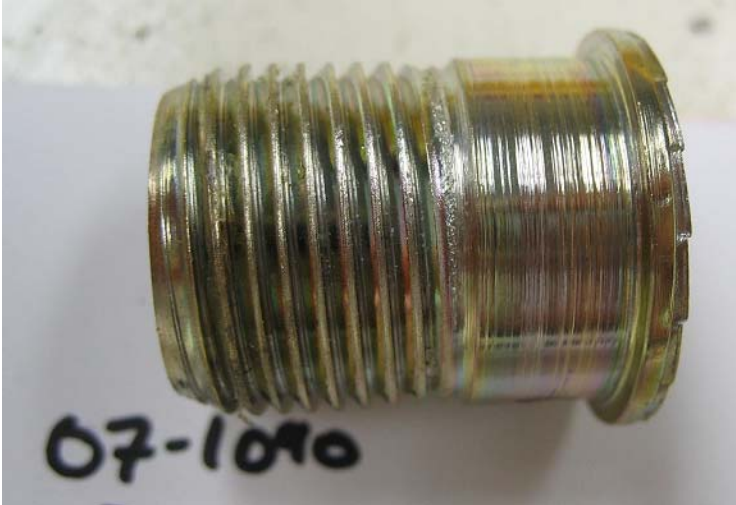
**Figure D13: Locking Sleeve**

*No marking were visible on the locking sleeve*

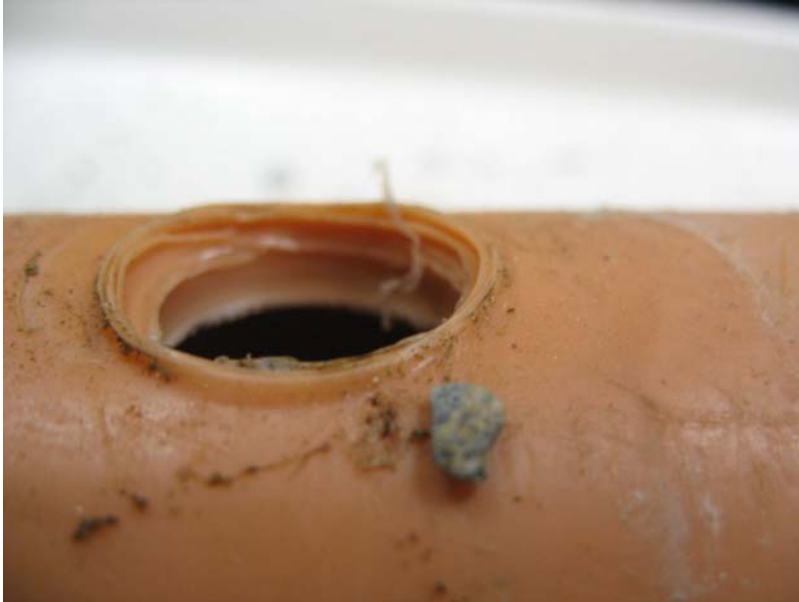
**Figure D18: Tap Hole Appearance**

- 5.11 Measure the diameter of the tap hole in the pipe  
*The tap hole was irregular with two general diameters as shown below, corresponding to a step at the approximate mid-wall of the pipe. A photograph is provided as Figure D18.*

- 5.12 Examine thread grooves in opening  
*Figure D18 is a photograph of the tap hole showing irregular dimensions and no well-formed thread grooves. The appearance suggests that the locking sleeve may have partially engaged the pipe wall by approximately 1½ threads.*

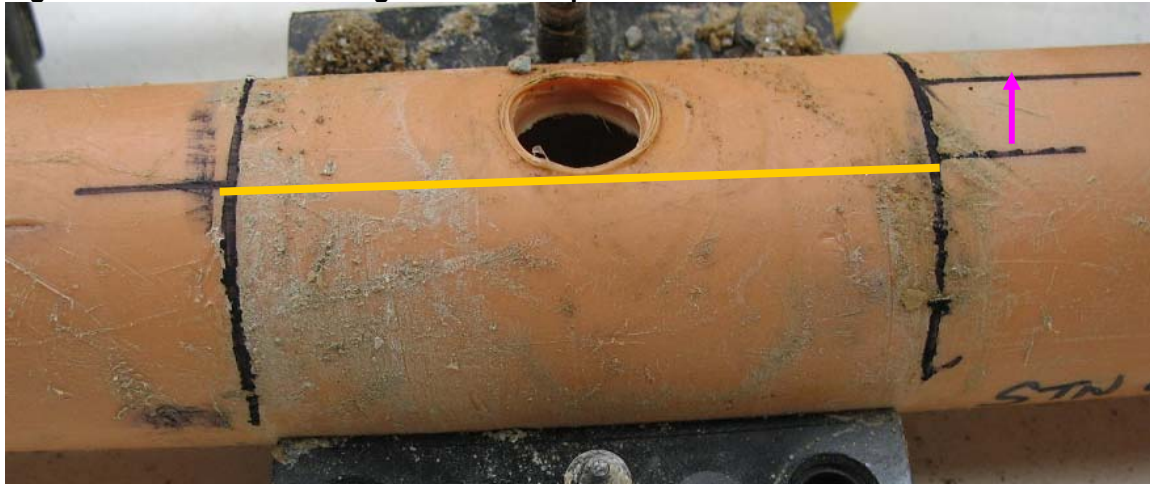
**Figure D19: Rotation of Fitting Relative to Tap Hole**

*The tap hole was out of alignment with the fitting by approximately 0.4 inches. That is, the fitting had apparently rotated on the pipe between the time the tap was made and the time the sample was examined.*

*Figure D19 shows the distance that the tapping tee apparently rotated relative to the pipe between the time the pipe was tapped and the time the sample was examined. The yellow line is the approximate centerline of the tapping tee saddle as-received. The distance between the tapping tee centerline and the hole centerline (pink line) is approximately 0.4 inches.*

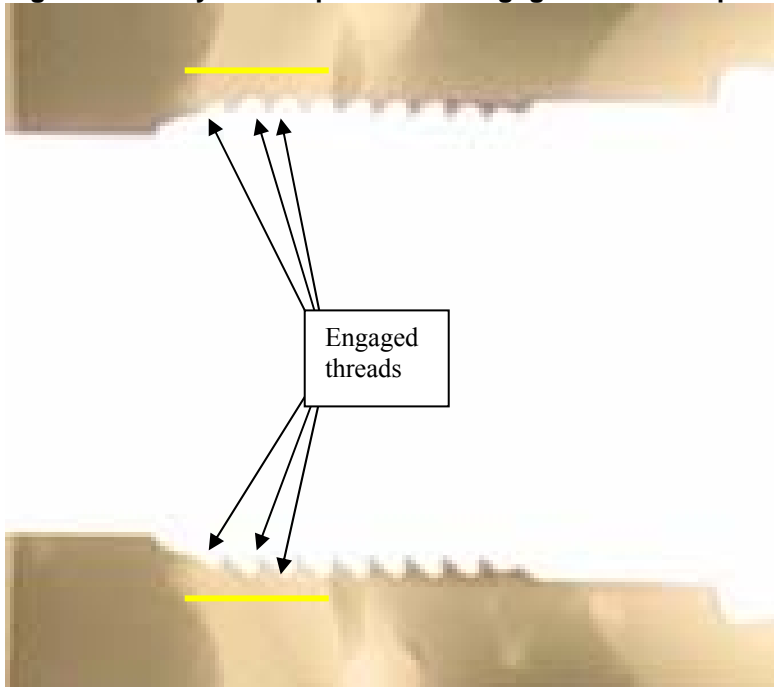
Figure E7: X-ray Close-up of Sleeve Engagement with Pipe Wall

Figure E7 shows the X-ray cross section of the engagement of the sleeve threads with the pipe wall. Although four threads contact the pipe wall, only three threads are actually engaged.
