NATIONAL TRANSPORTATION SAFETY BOARD

Engine Data Monitor

Factual Report
By Joshua Lindberg

Location: Ranger, Texas
Date: October 6, 2019
Aircraft: Beech B36TC
Registration: N36LS
Operator: Private
NTSB Number: CEN20LA004

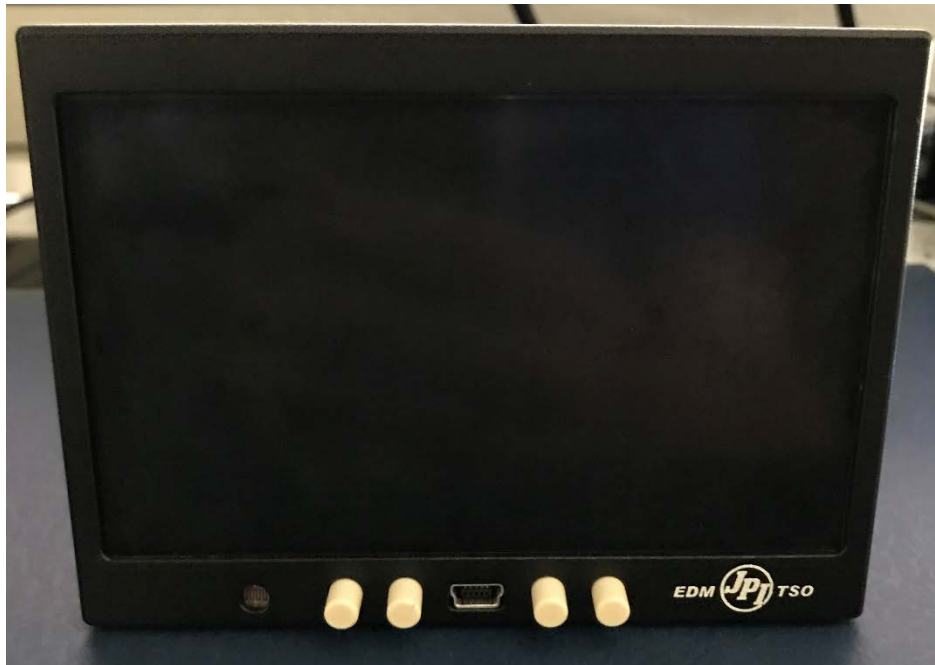
The device was undamaged and sent to the specialist for download. The device was downloaded normally using the manufacturer's software. Figure 1 shows the front of the device as received.

Figure 1 – Photo of undamaged EDM unit.
