DAILY PROGRESS REPORT

DATE/ REPORT NUMBER	Monday, April 10, 2023 / 003
PROJECT:	Kodiak Enterprise
JOB ID #:	23-EN02
CLIENT:	Trident Seafood
LOCATION:	Tacoma WA
DAYS ON SITE:	003
WEATHER (DELAY):

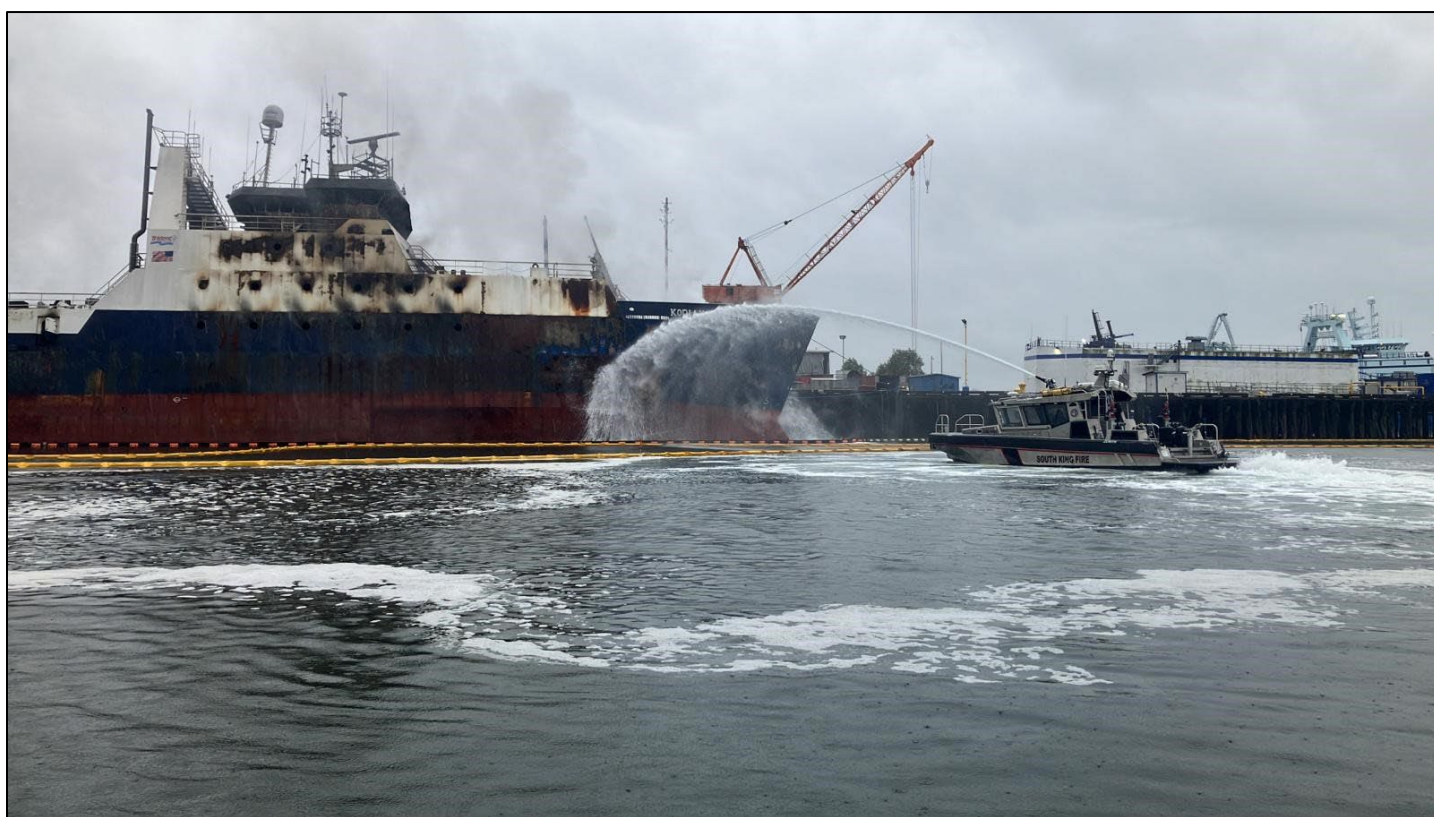
Figure 1 - South King County Fire Boat on site

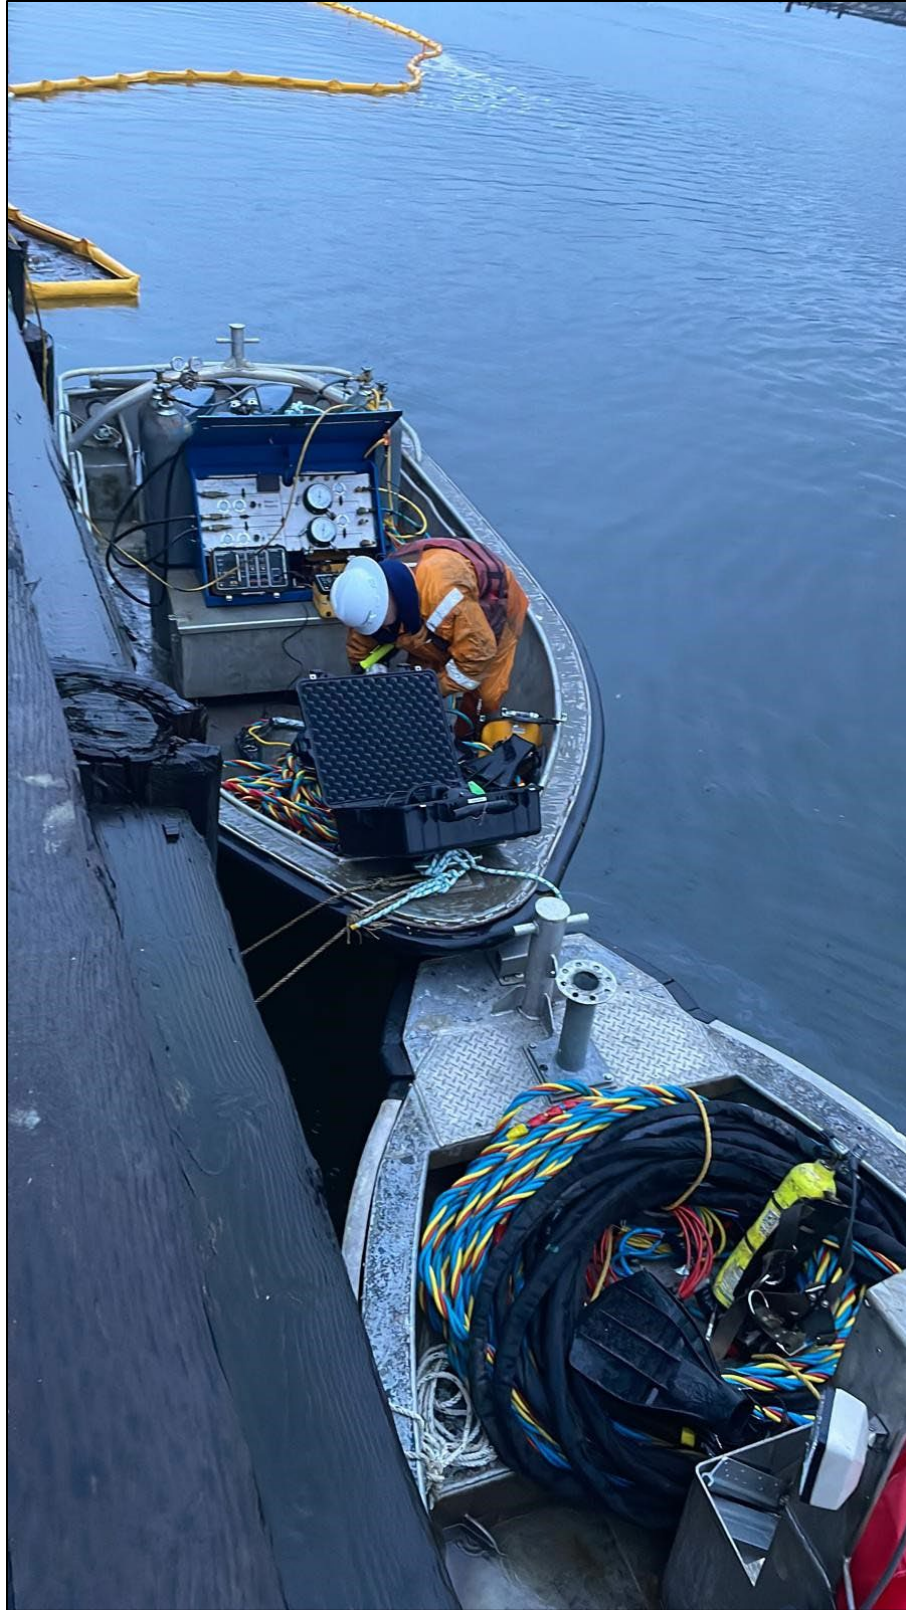
Figure 2 - Dive team setting up Trident's work boats for diving ops

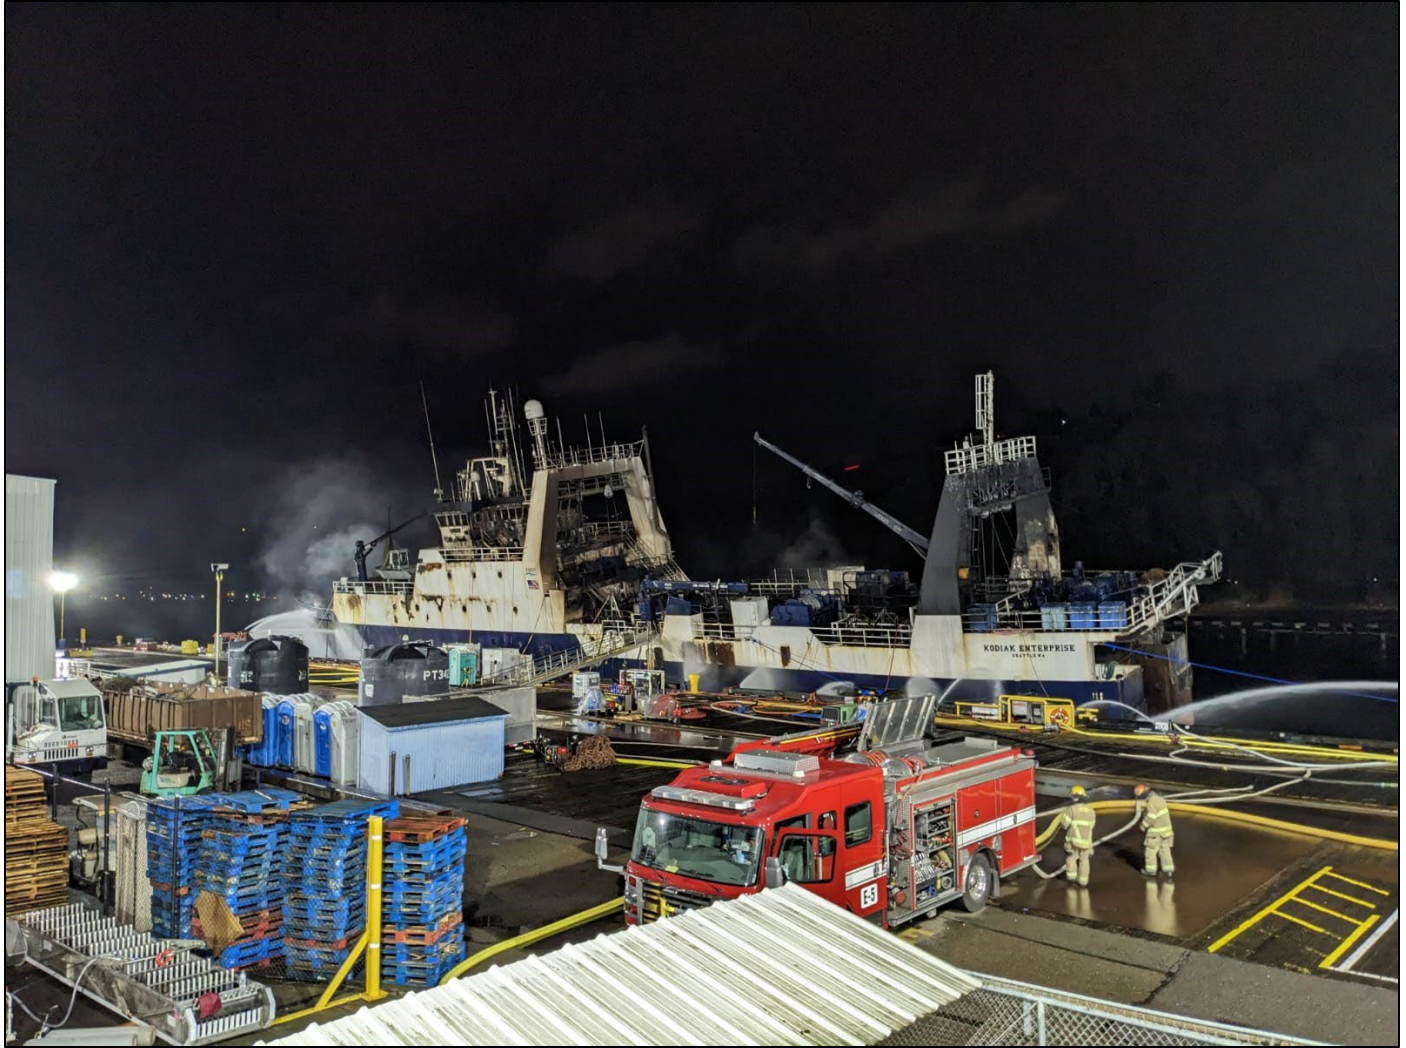
Figure 3 - Night Time Operations on the Pier

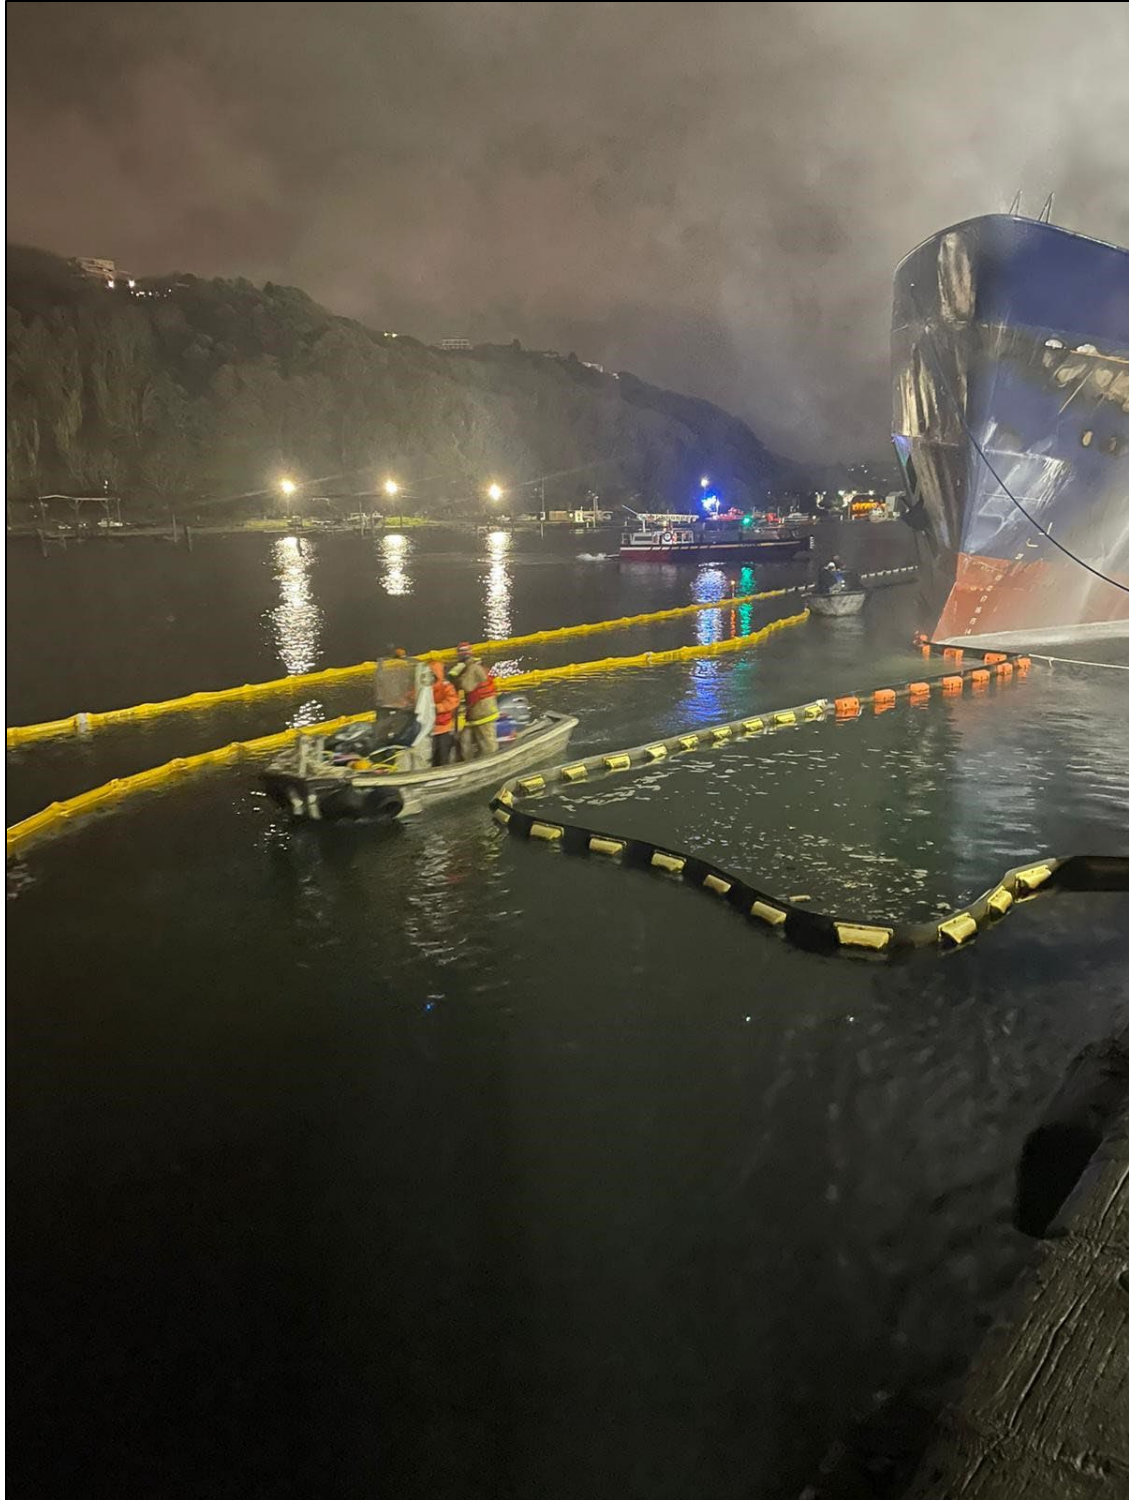
Figure 4 - Night Time Ops on the water

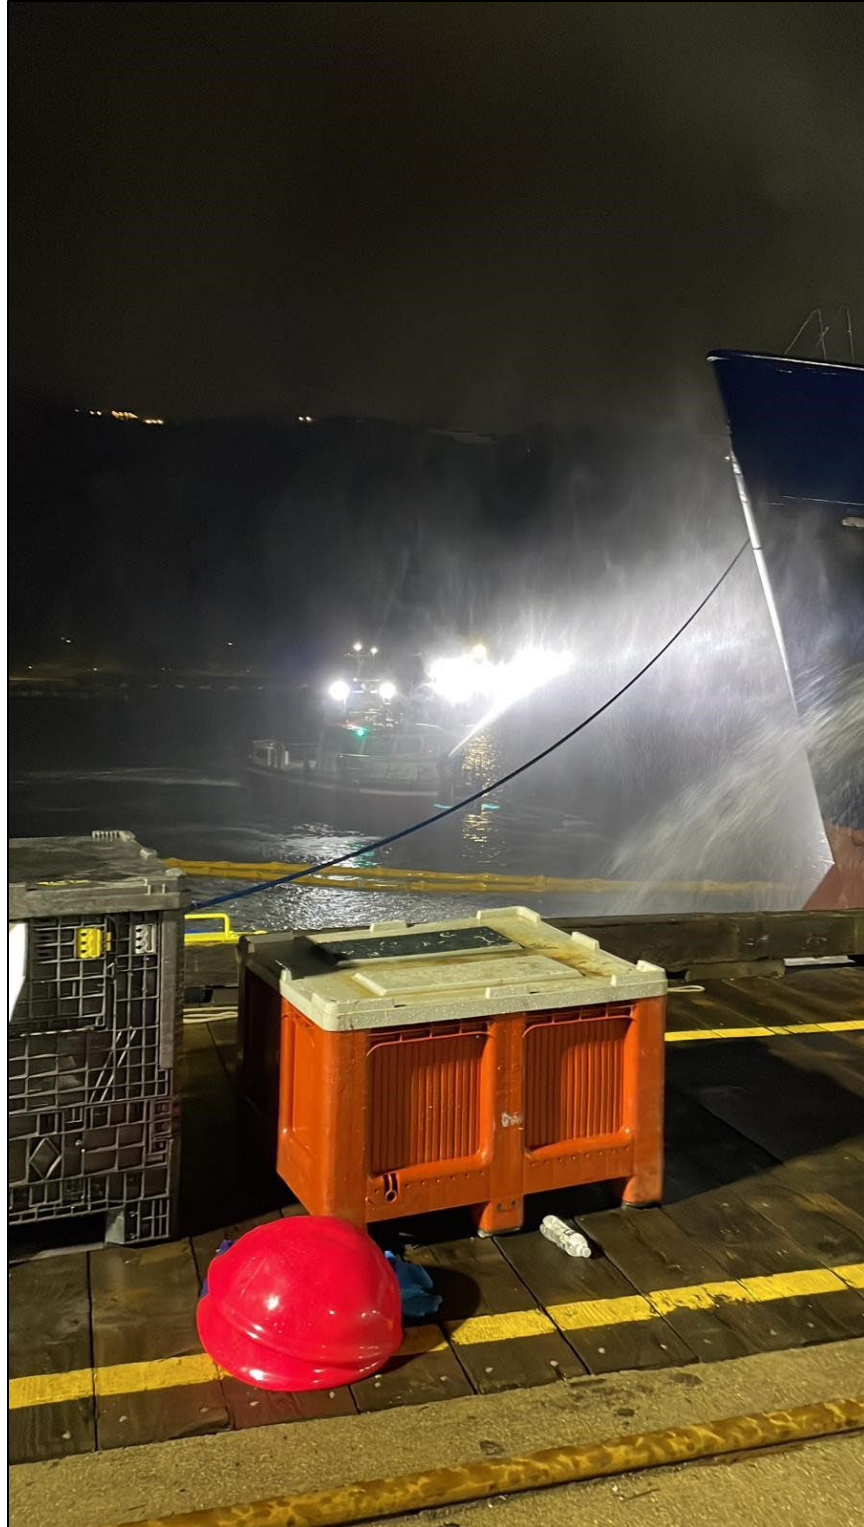
Figure 5 - Fire Boat hitting a hot spot in the starboard bow

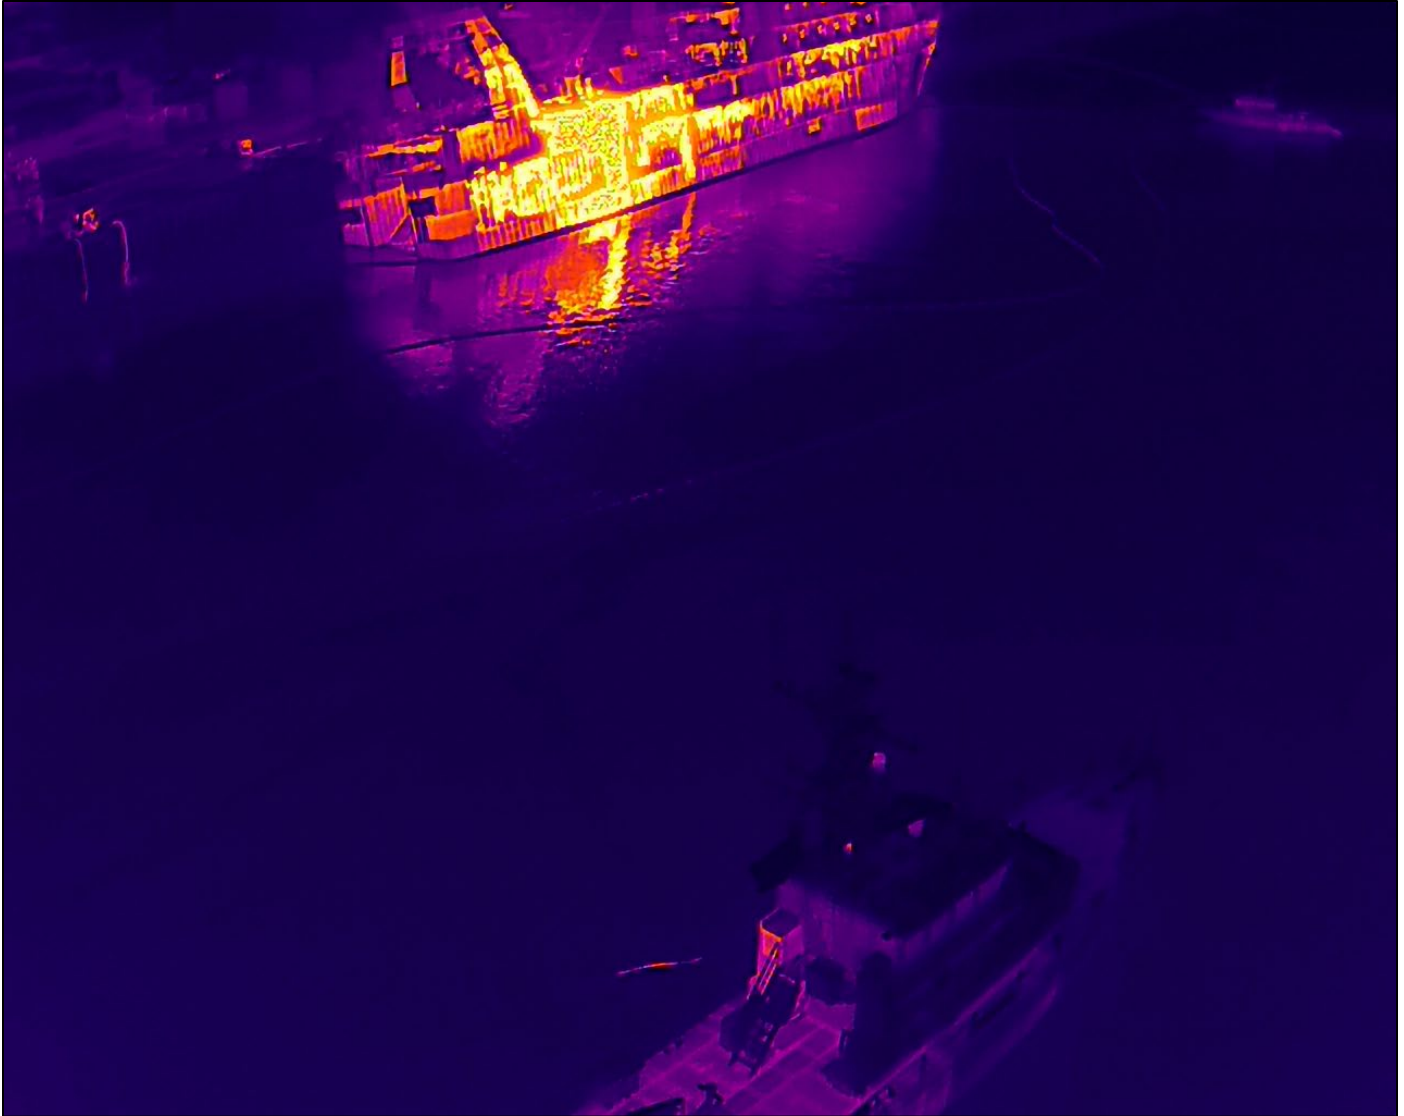
Figure 6 - Thermal imaging from April 10

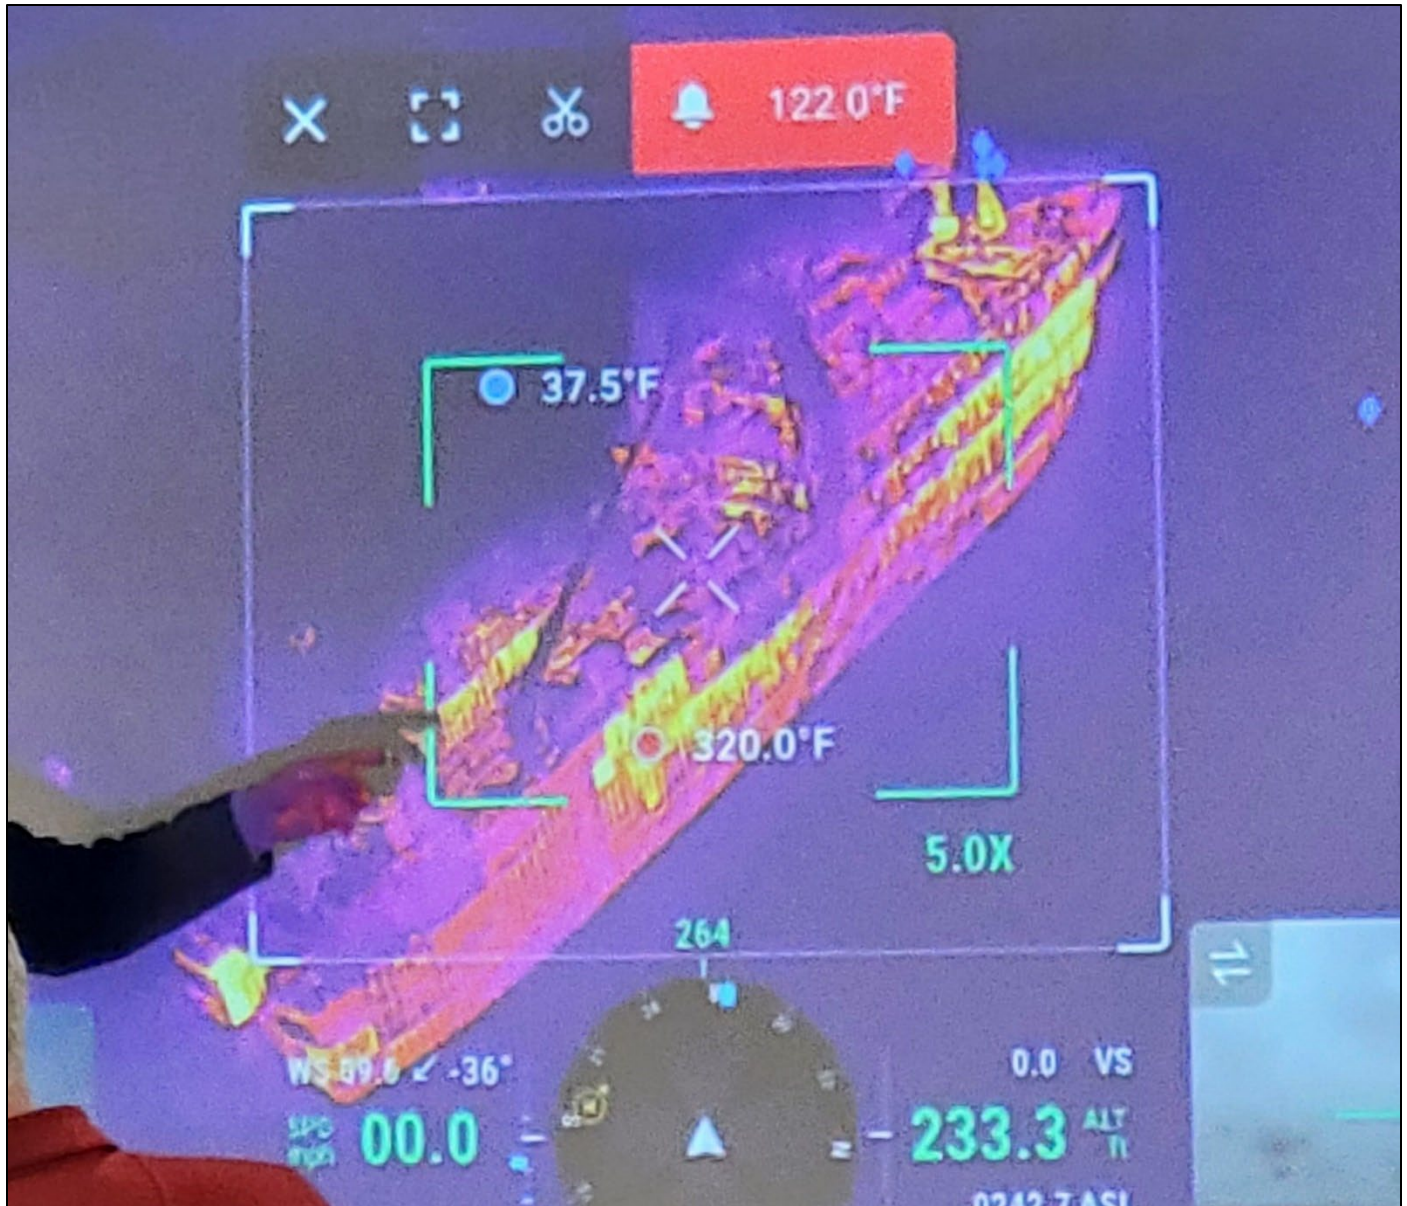
Figure 7 - Command post viewing drone footage
