RRD21FR008
BNSF Railway
March 3, 2021
La Mirada,
California

National Transportation Safety Board

Factual Report

Accident

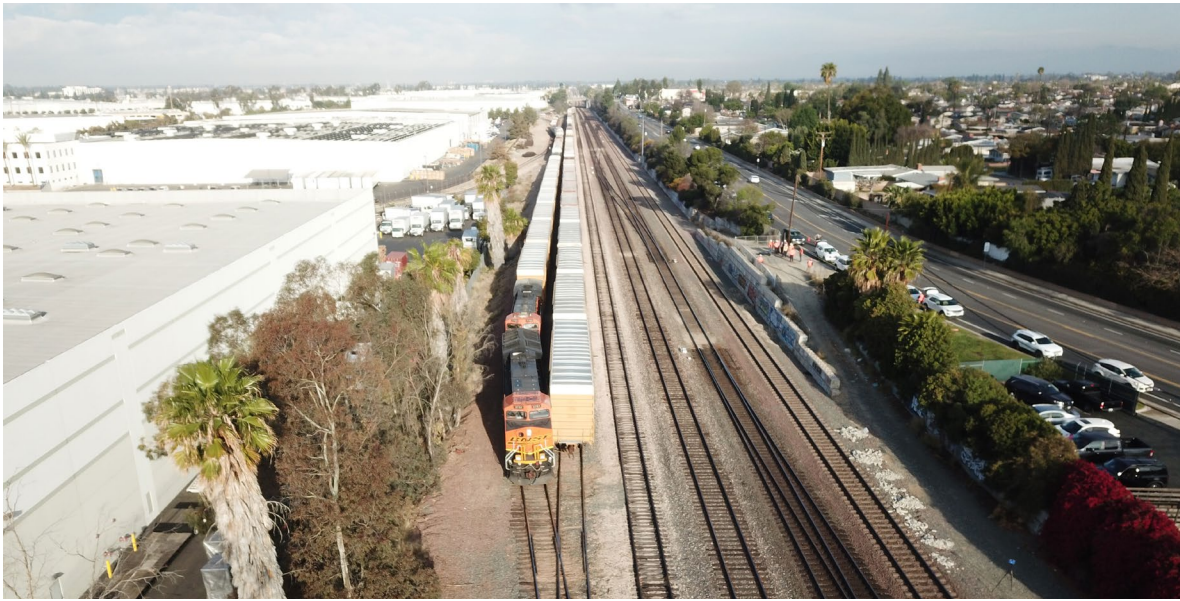
Figure 1: Overhead view of the accident looking west towards Long Beach. The San Bernadino Subdivision main line are the right 3 tracks in the photo.

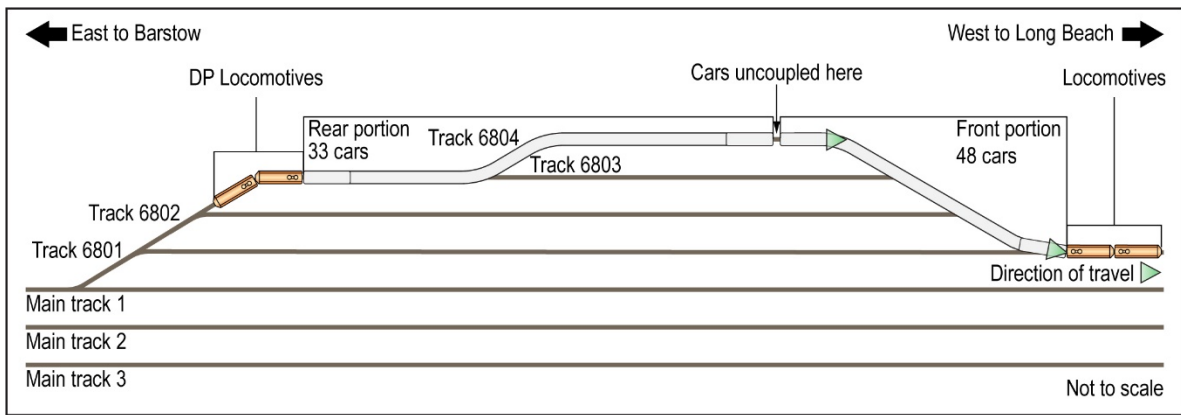
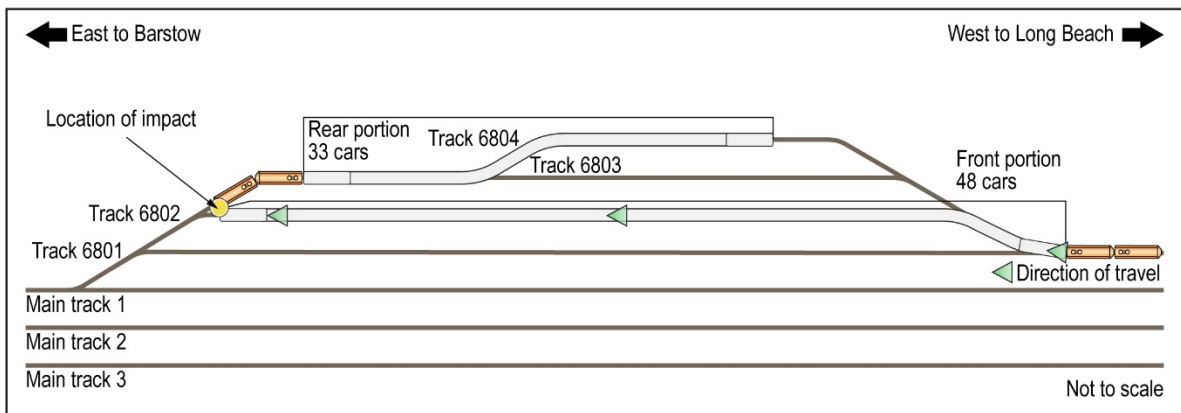
The front portion of the train approached the train's rear DP locomotives, which were attached to the rear portion of the train and were occupying the lead track on the west side of the railyard. The boxcar on which the conductors were riding impinged the side of the rear-most locomotive, pinning and killing the conductor who was on the south-side ladder. Schematic drawings showing what happened in the accident are found in figure 2.

Figure 2: Schematic drawing showing movement sequence of the H-BARLAC1-02 crew.

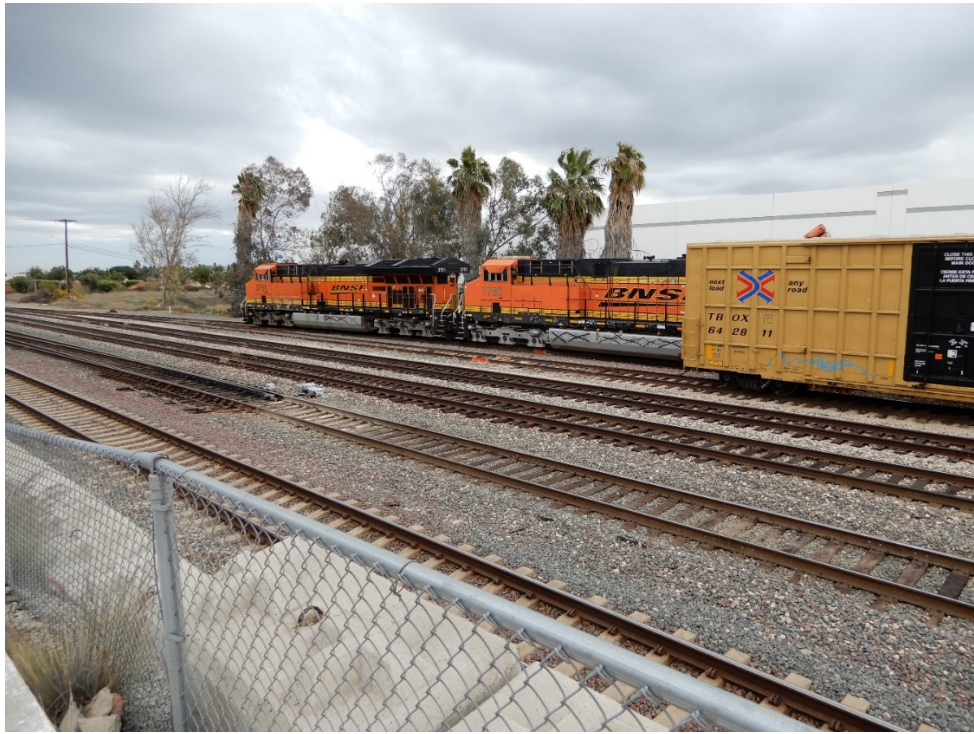
In the La Mirada railyard clearance points are marked by orange paint on the base and web of the rail. These markings are placed in accordance with BNSF Track Engineering Standard 2508. BNSF engineering specification require that orange paint be applied to the base area of the rail in close clearance locations in yards, sidings, and secondary tracks. Distances of where the paint should be applied vary and is based upon track geometry and configuration.

Figure 3: Photograph taken post-accident. Car No. TBOX 642811 has been moved to the west to facilitate emergency response. Orange paint is present on the yard tracks indicating a clearance point.

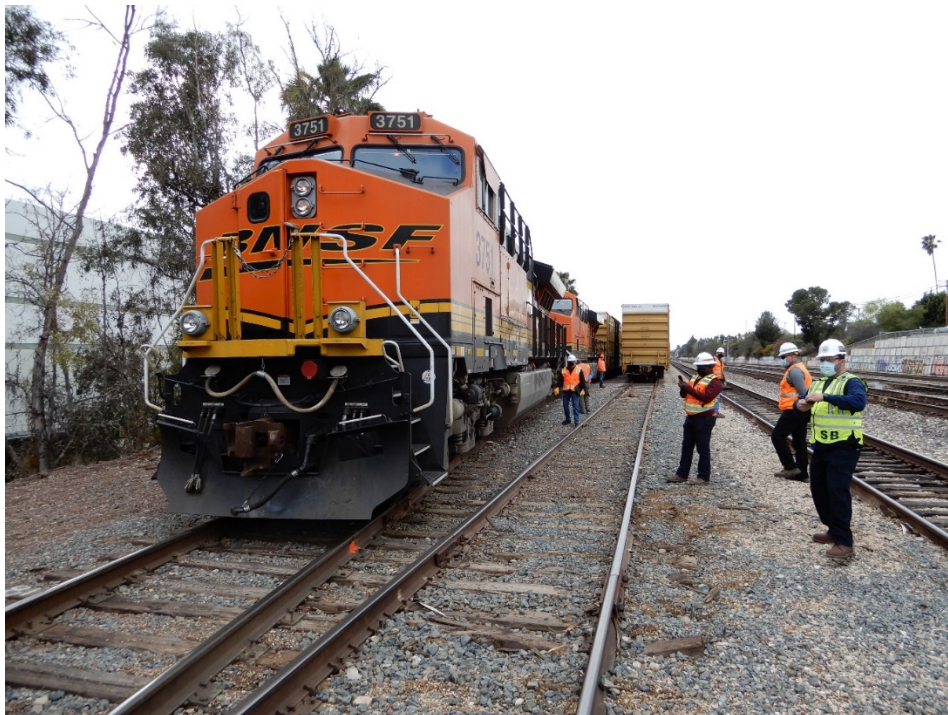
Investigators inspected the rear DPU locomotive positioned out to foul on the lead (BNSF 3751) and Car No TBOX 642811 after the equipment had been separated. Locomotive BNSF 3751 had damage to an area on the left side above the third axle and below the walkway. In this area, there was evidence of raking and scraping damage with paint loss and paint transfer beginning at the left stairway and stopping just above the second axle. There was also paint missing on the front corner of the fuel tank. Car No. TBOX 642811 had damage to the A-end right side-ladder. The vertical stanchions of the ladder were bent, torn and showed signs of paint transfer. The witness marks on the locomotive and boxcar were consistent with a raking/scraping collision. BNSF reported damage to equipment of approximately \$1300.

Figure 4: Photograph of investigators examining the rear most DPU locomotive

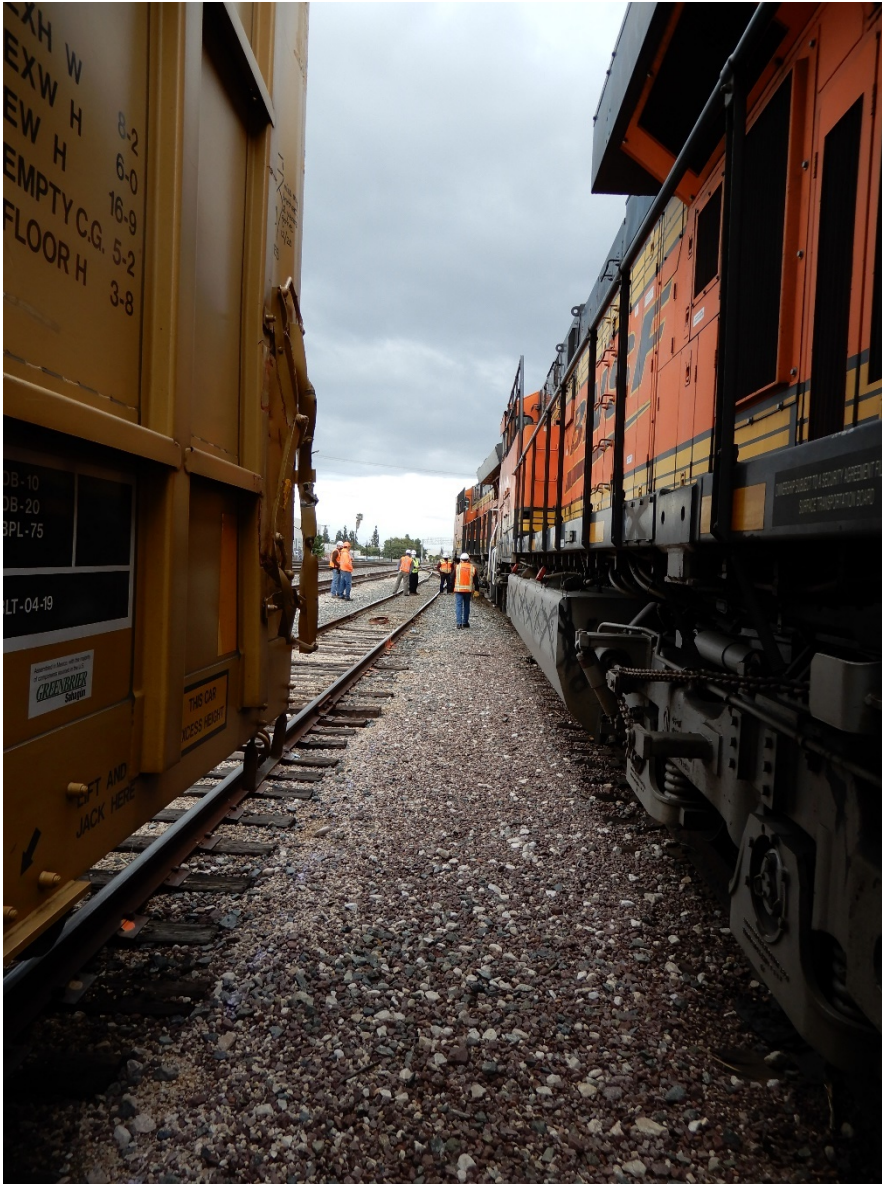
Figure 5: Photograph looking east alongside the boxcar that was involved in the accident. Orange paint marking the clearance point can be seen on the base of the rail approximately 30 feet in front of the boxcar.

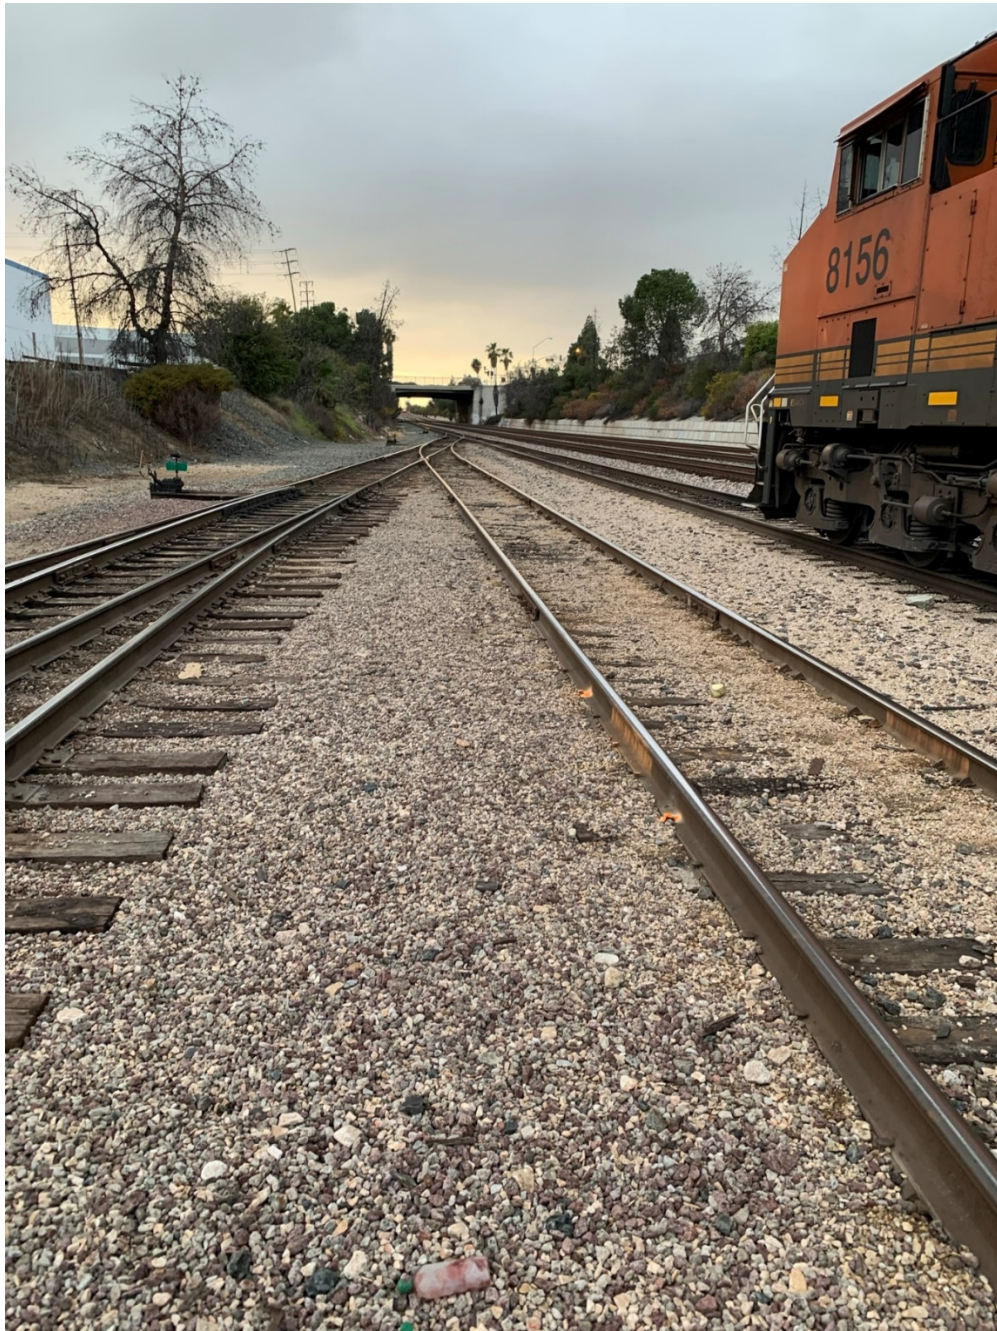
Figure 6: Photograph taken looking west at the west end of the railyard. Faded paint indicating a clearance point is located on the base and web of the rail.

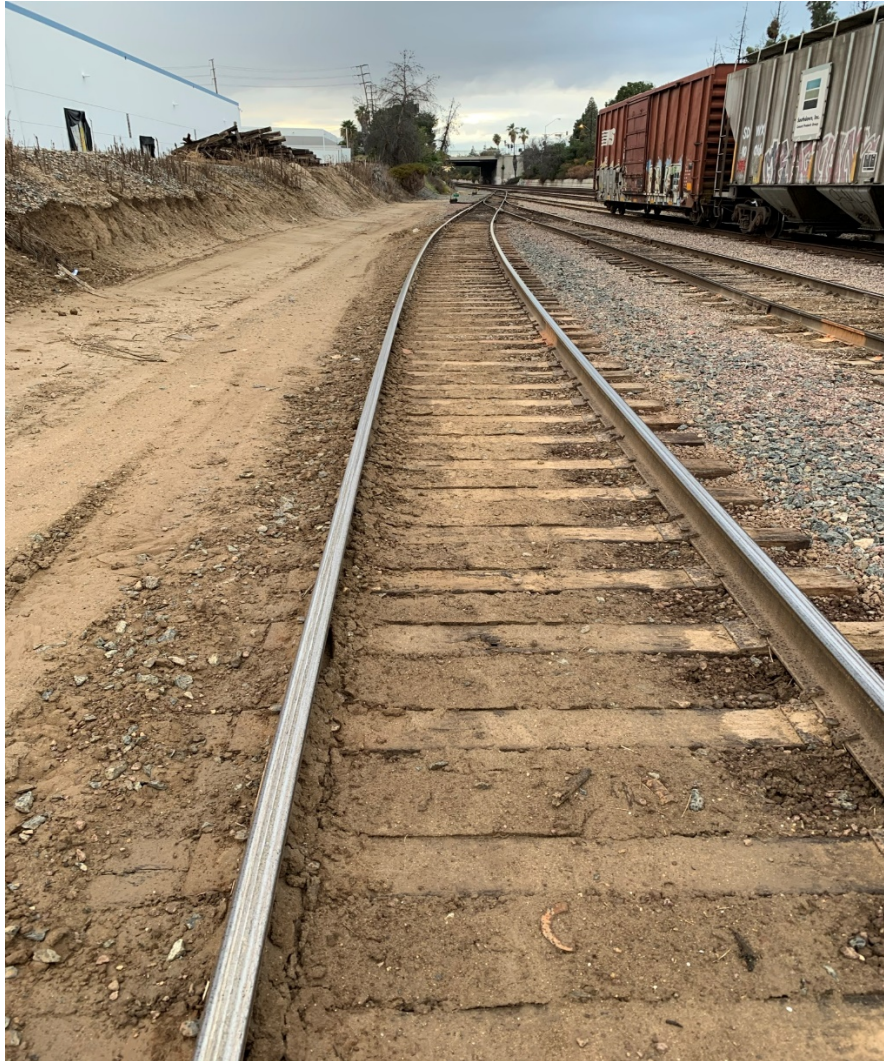
Figure 7: Photograph taken looking west at the west end of the railyard. Faded paint indicating a clearance point is located on the base and web of the rail of several yard tracks.

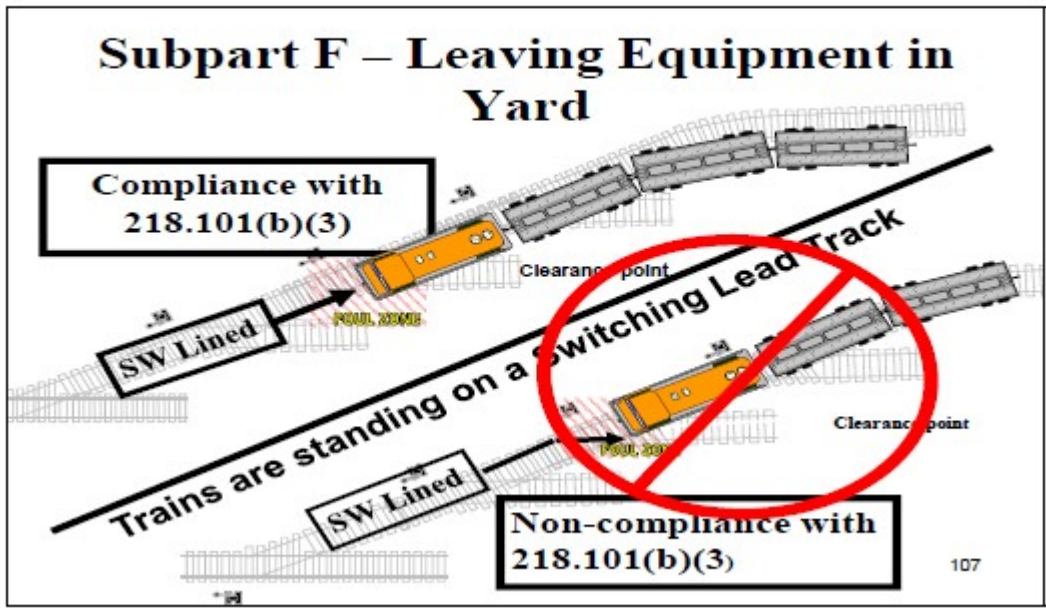
The (DPU) rear end of the train, located on the lead track, was in the foul of track 6802. However, it was not in violation of 218.101 due to the position of the track 6802 switch. The 6802-track switch was lined for the lead in compliance with the following 218.101(b)(3) rule:

The following Operating Practices Compliance Manual diagram depicts 218.101(b)(3):

The above diagram closely reflects the La Mirada accident scenario.
