MV MARY DUPRE

Vessel Fire

LESSONS LEARNED

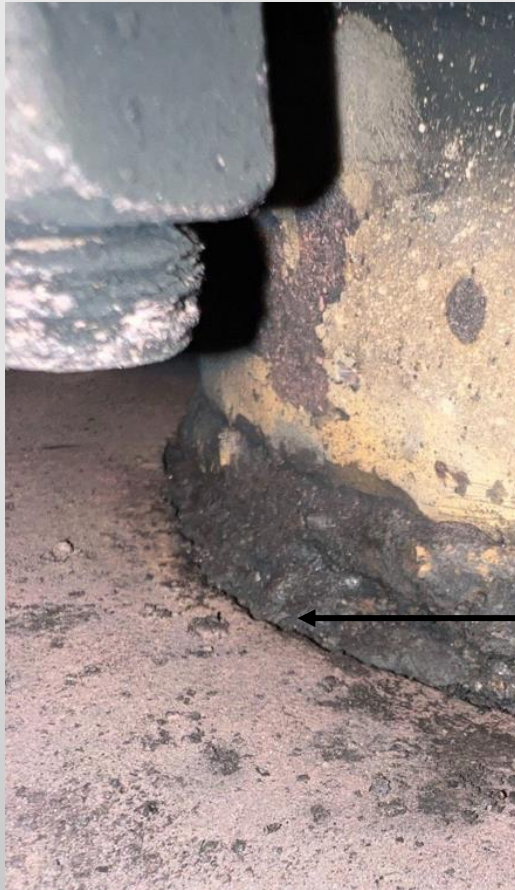
- While investigating the source of the fire, a Marine Surveyor, Dupre Marine Transportations Port Engineer and Operations Manager, and marine investigators from the USCG identified a cracked muffler in the starboard exhaust stack that was allowing excessive heat to contact the metal walls of the stack. (See Photo #5)

- While investigating the source of the fire aboard the *MV Mary Dupre*, the exhaust stacks were cut to gain a better perspective as to why the heat increased inside of the starboard stack to a degree that would ignite a fire within the wall of the bunkroom, and it was discovered that the muffler located within the starboard exhaust stack was cracked. This crack allowed excessive heat to escape the muffler and increase the heat of the stack walls to the point where the paint started to bubble (See Photo #6). Because of the design and layout of the vessel, the excessive heat was allowed to penetrate the wall of the Pilot bunkroom and eventually cause the wood within this wall to ignite. If the muffler in the starboard exhaust stack would have not failed, the walls of the stack would have not heated to a degree that would have posed a risk.

Crack in Muffler

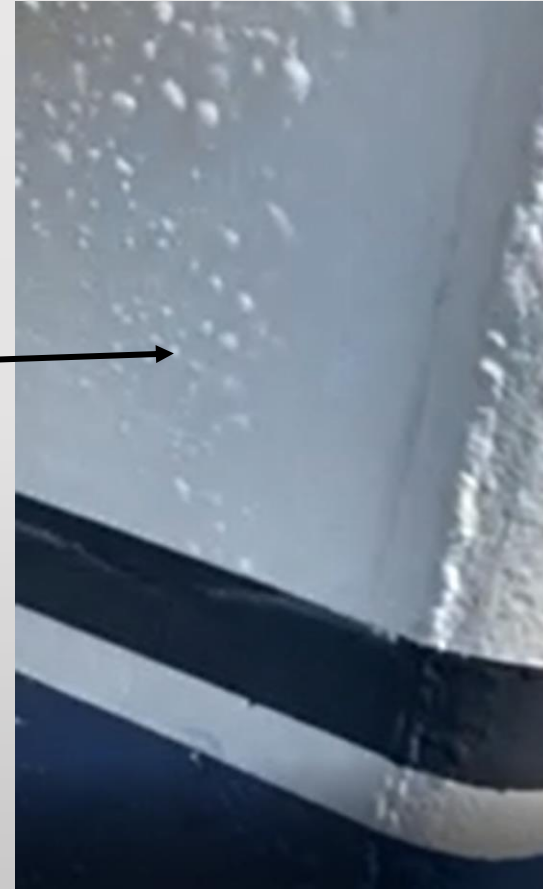
Bubbling Paint
