**NATIONAL TRANSPORTATION SAFETY BOARD**  
Office of Research and Engineering  
Washington, D.C. 20594

## **Airport Cameras – Factual Report**

**NTSB Case Number:  
WPR21FA283**

Location: Lewiston, Idaho  
Date: July 24, 2021  
Time: 1152 PDT  
Aircraft: SIAI-Marchetti, SM1019B

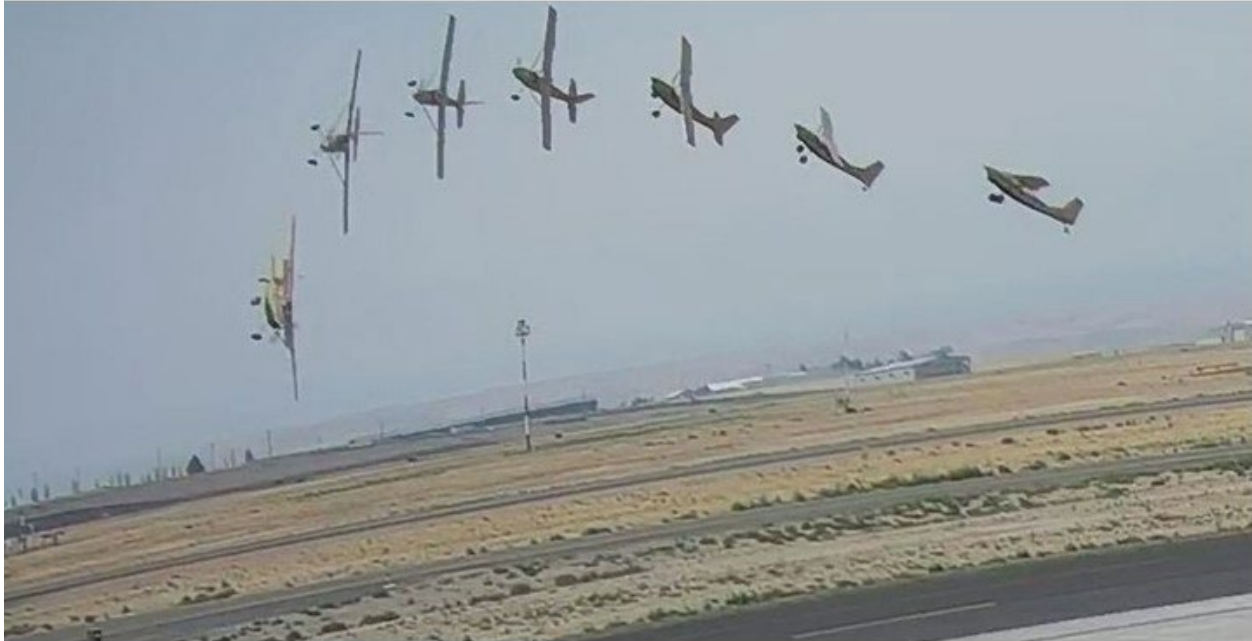
Figure 1 is a composite image that shows the airplane during the left roll. The first airplane image in the figure was recorded 3.7 seconds after takeoff, before the left roll started. The last image was taken 7.3 seconds after takeoff. The airplane impacted the

ground 0.7 seconds later, about 8 seconds after takeoff. The impact location was about 600 feet from the cameras.

**Figure 1. Composite Image Showing the Airplane between 3.7 seconds and 7.3 seconds after Takeoff**

The high resolution of the videos and the airplane closeness to the cameras allowed for relatively accurate estimation of the deflections of the control surfaces. The deflections of the elevators and ailerons were either zero or so small that they could not be seen by zooming into frames of the three videos. The airplane flaps were deflected.
