National Transportation Safety Board

HWY23FH005

HIGHWAY FACTORS GROUP

Group Chair's Factual Report

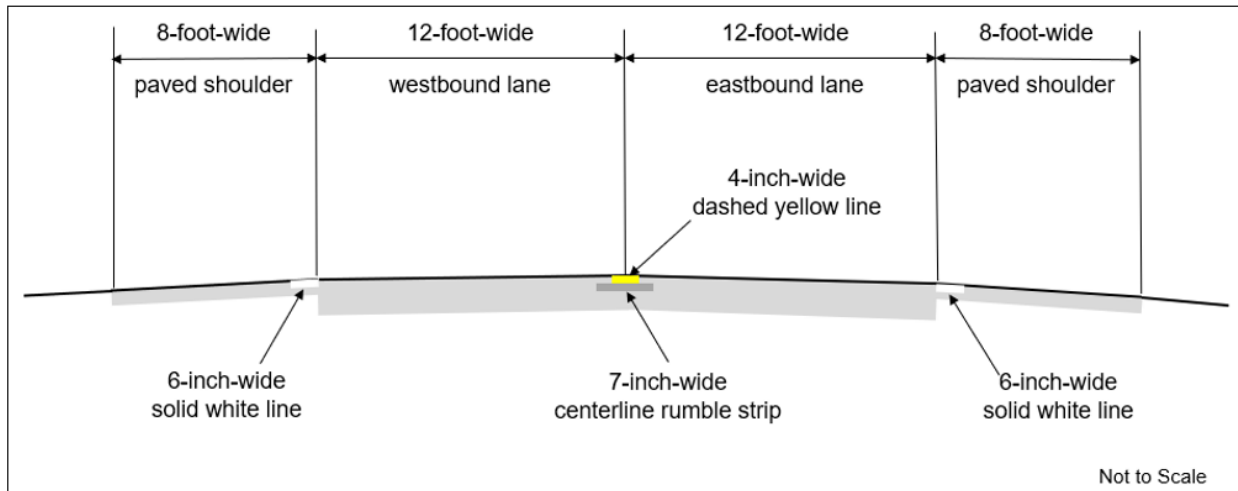
Figure 2 - Typical section for State Route 37

State Route 37 was a two-lane road, one lane in each direction.² Each of the travel lanes, eastbound and westbound, measured 12-foot-wide. A paved shoulder existed adjacent to each of the travel lanes that was approximately 8-foot-wide. A 4-inch-wide dashed yellow line separated the eastbound lane from the westbound lane,

and 6-inch-wide solid white lines separated the travel lanes from the paved shoulders.³ A 7-inch-wide centerline rumble strip existed along State Route 37. **Figure 2** illustrates the typical section for State Route 37.

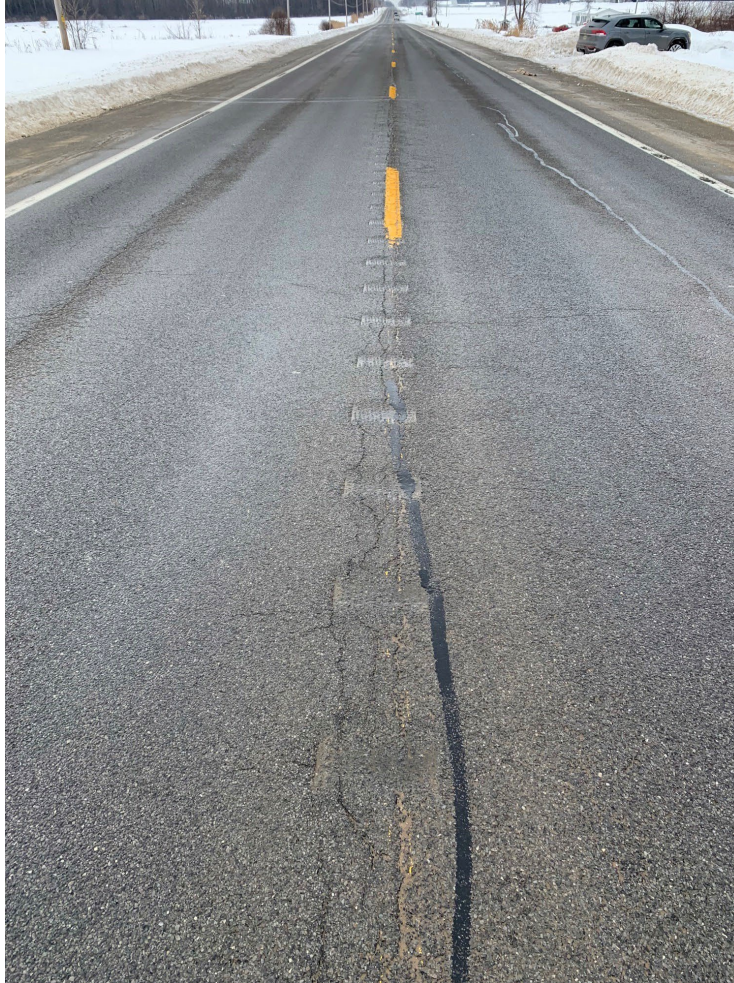
Figure 3 - View of centerline rumble strips along State Route 37 in the vicinity of the crash

Centerline rumble strips existed along State Route 37 in the vicinity of the crash.⁶ **Figure 3** illustrates the centerline rumble strips were 7 inches wide by 12 inches long with a depth of one-half inch and spaced approximately 24 inches apart.⁷

⁷ FHWA's Technical Advisory Center Line Rumble Strips dated November 7, 2011, indicated most crash studies referenced evaluated center line rumble strips of 7 inches wide by 16 inches long with a depth of one-half inch.

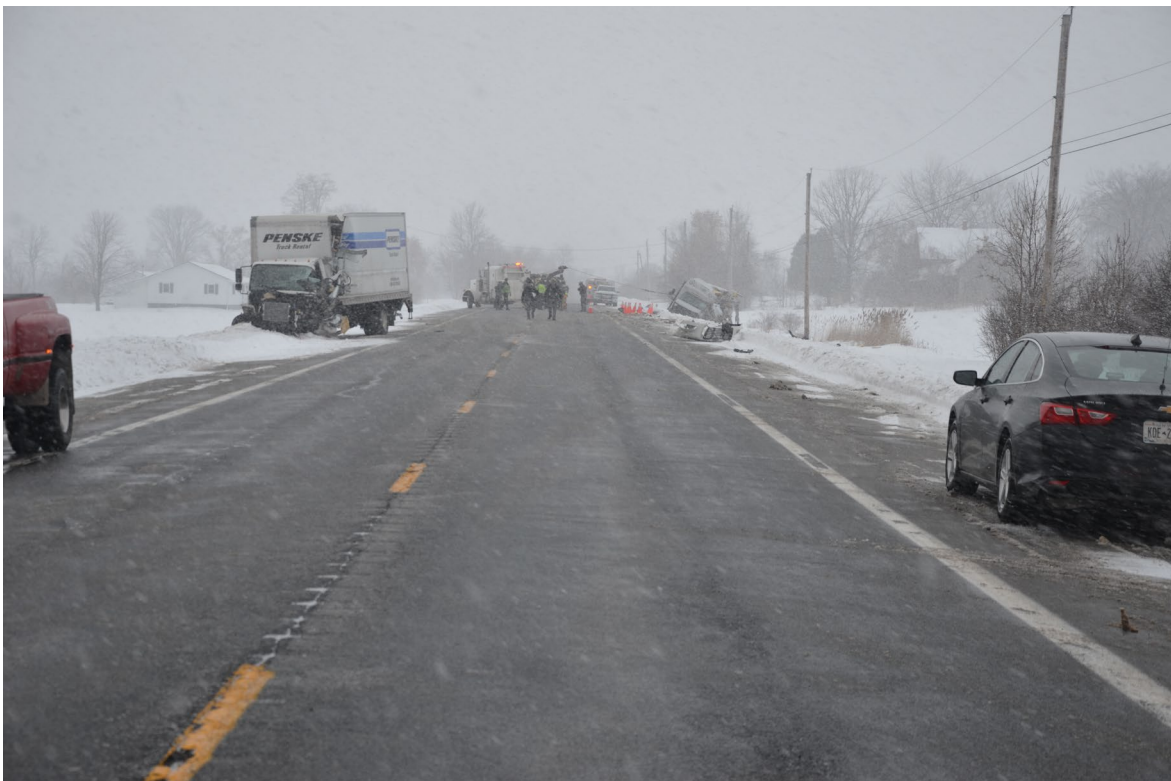
Figure 4 taken on January 28, 2023, at 8:26 a.m., approximately 2 hours and 24 minutes after the crash looking to the west, illustrates bare pavement conditions on State Route 37 in the vicinity of the crash.¹²

Figure 4 - Taken on January 28, 2023, at 8:26 a.m., approximately 2 hours and 24 minutes after the crash looking to the west, illustrates bare pavement conditions on State Route 37 in the vicinity of the crash (Source: New York State Police)

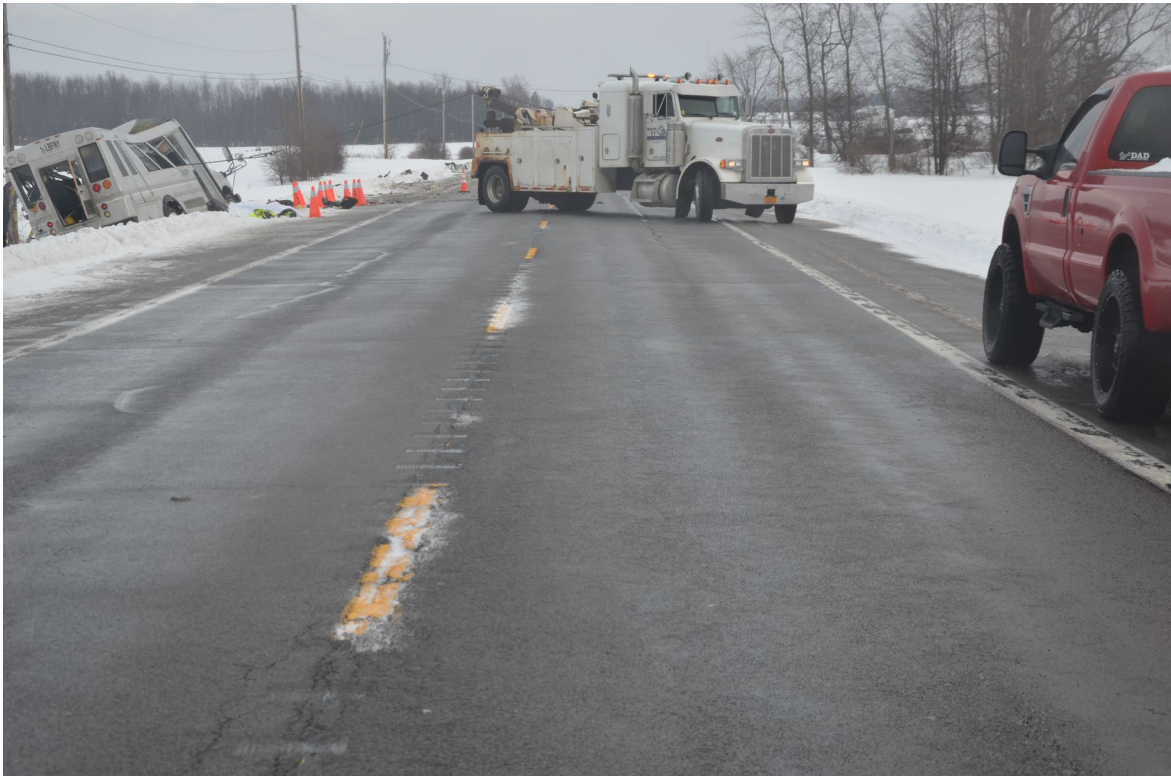
Figure 5 taken on January 28, 2023, at 8:32 a.m., approximately 2 hours and 30 minutes after the crash looking to the east, illustrates bare pavement conditions on State Route 37 in the vicinity of the crash.

Figure 5 - Taken on January 28, 2023, at 8:32 a.m., approximately 2 hours and 30 minutes after the crash looking to the east, illustrates bare pavement conditions on State Route 37 in the vicinity of the crash (Source: New York State Police)
