National Transportation Safety Board

Marine Accident Brief

Capsizing and Sinking of Fishing Vessel *Misty Blue*

Accident type	Capsizing/Listing	No. DCA18FM005
Vessel name	<i>Misty Blue</i>	
Location	Atlantic Ocean, 9 miles southeast of Nantucket, Massachusetts 41°11.35' N, 69°46.03' W	
Date	December 4, 2017	
Time	1806 eastern standard time (coordinated universal time – 5 hours)	
Injuries	2 fatalities	
Property damage	\$1.25 million est.	
Environmental damage	Oil sheen observed; about 1,635 gallons diesel fuel and 225 gallons of hydraulic fluid and lube oil were on board	
Weather	Visibility 10 miles, seas at 3–4 feet, winds north-northeast at 6 mph with gusts to 9 mph, air temperature 42°F, water temperature 46°F	
Waterway information	East side of Old South Shoal, Atlantic Ocean; water depth about 80 feet

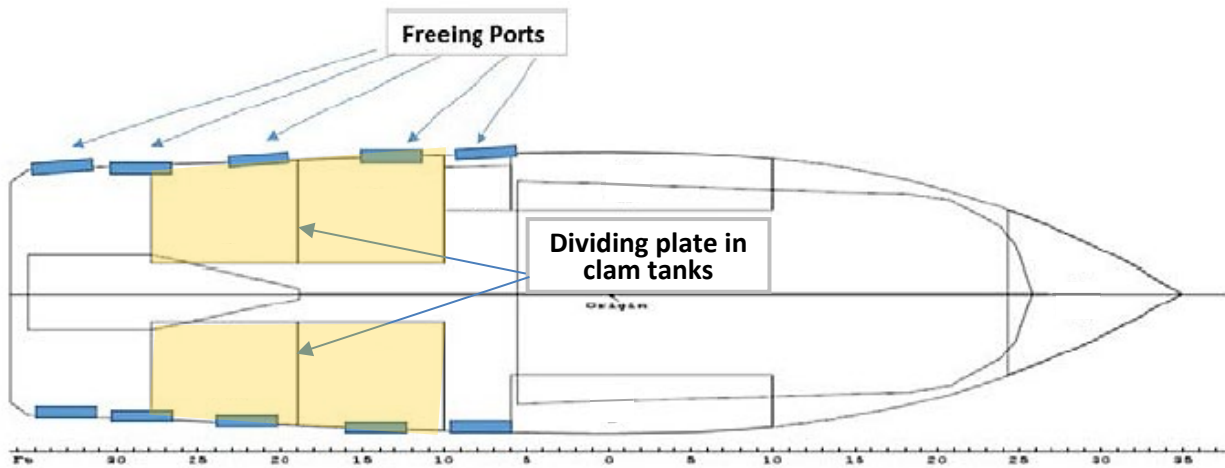
pumped some water in the tanks, and the water could communicate freely from each side over the top of the plate. A total of 16 cages were stowed below deck in the tanks and an additional 2 cages could be stowed above on deck.

Plan view of *Misty Blue*'s tank layout and freeing port locations. The clam tanks are highlighted in yellow. (Modified image from US Coast Guard model)

In our review of the vessel's loading and witness reports provided for the day of the sinking, the off-center flooding of the port clam tanks could have created the port list noted by survivors. We estimate that this list would have brought the bottom of the freeing ports to about the water line in a static condition. While our

analysis provides insight into the vessel's stability in static conditions, we are not able to quantify the effects of the many external and dynamic forces that likely acted on MISTY BLUE at the time of the casualty. We did estimate the impact of water trapped on deck and found that even small amounts of water on deck would significantly reduce stability of the vessel. Wind and wave action would have further negatively impacted stability. We found that the freeing port area on this vessel was relatively small compared to a vessel which must comply with the regulatory requirements of 46 *Code of Federal Regulations* §28.555 which likely resulted in compounding water accumulation on the main deck.

The National Transportation Safety Board determines that the probable cause of the capsizing and sinking of fishing vessel *Misty Blue* was flooding of the port clam tank from an undetermined point of ingress, which led to a decreased freeboard and a list allowing boarding seas to be trapped on deck, thereby decreasing the vessel's stability. Contributing to the sinking was the relatively small freeing port area of the vessel, which likely increased water accumulation on deck.
