National Transportation Safety Board

Marine Accident Brief

Capsizing of Fish Tender *Pacific Knight*

Accident type	Capsizing/Listing	No. DCA18FM029
Vessel name	<i>Pacific Knight</i>	
Location	Nushagak Bay, Queens Slough area, about 11 miles south of Dillingham, Alaska, 58°51.5' N, 158°32.1' W ¹	
Date	July 25, 2018	
Time	0630 Alaska daylight time (coordinated universal time – 8 hours)	
Injuries	One fatality	
Property damage	\$1.55 million est.	
Environmental damage	Oil sheen on water; undeterminable amount of diesel oil released	
Weather	Visibility 10 miles, winds northeast at 8 knots, calm waters, air temperature 54°F, water temperature 55°F	
Waterway information	Nushagak Bay, on the north side of Bristol Bay, has extensive salmon fishing and several canneries that operate during the summer. Strong currents are always prevalent and can be extreme due to the combination of both river and tidal constituents. The tide range is 13–20 feet daily.

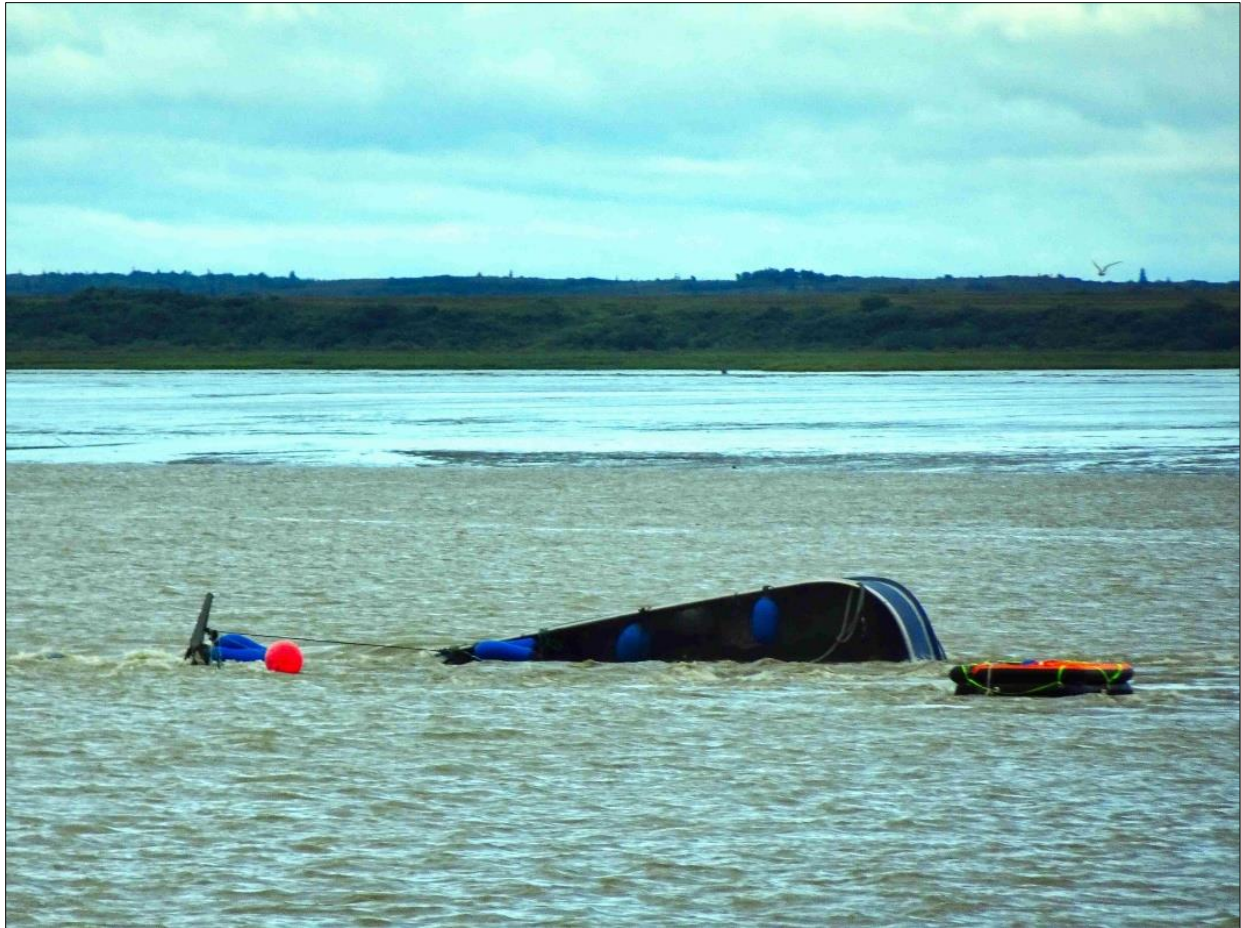
Starboard quarter of the *Pacific Knight*. (Photo by Mike Jones)

Witnesses to the sinking of the *Pacific Knight* recalled the vessel capsized to port and sank rapidly, leaving only the starboard quarter out of the water. The vessel had no reported problems, and the hull showed no post-salvage signs of leaks or damage. Thus, there is no evidence that any hull damage, machinery defects, or structural failures led to the capsizing and sinking of the *Pacific Knight*.

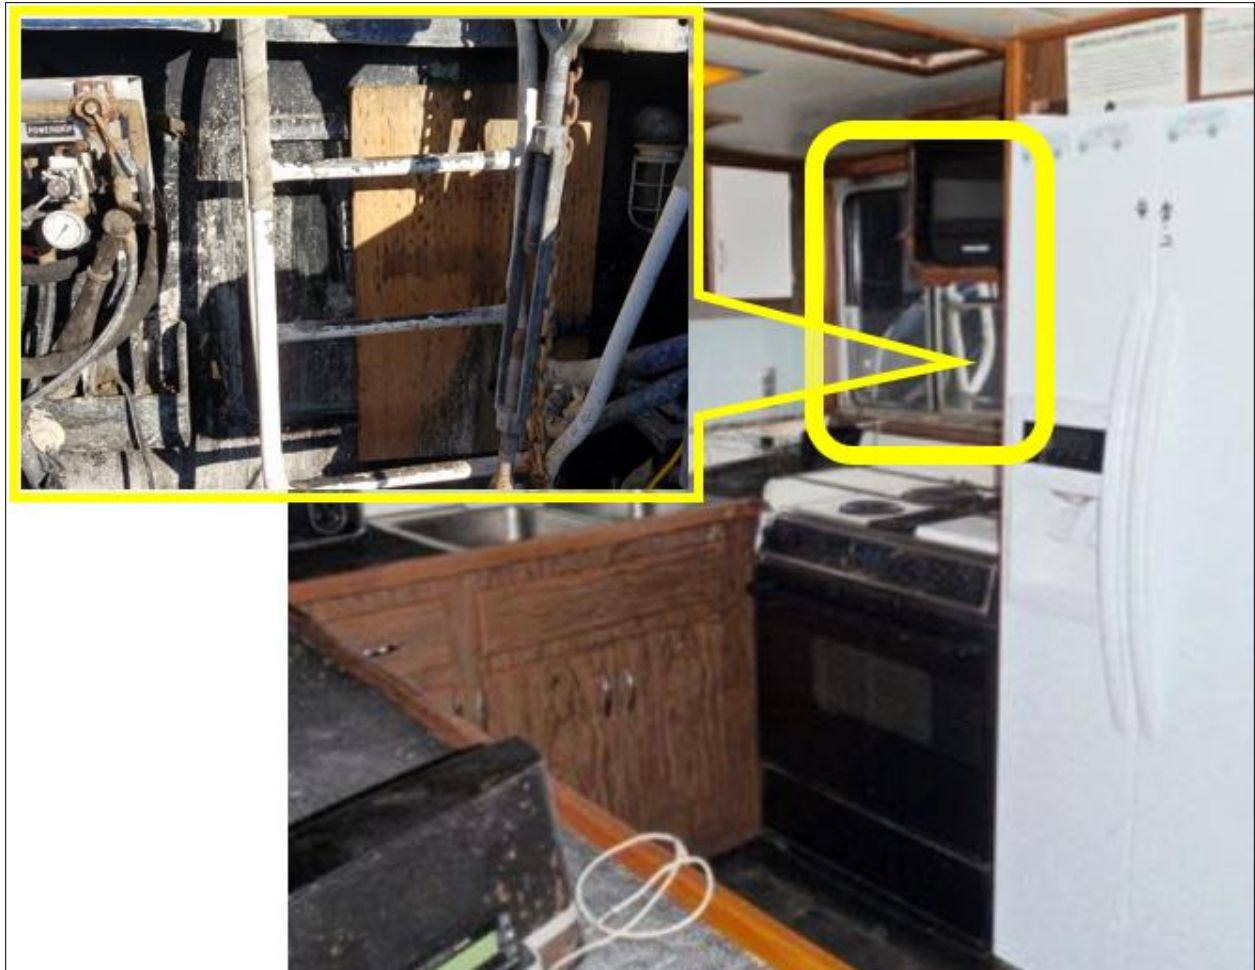
According to the surviving deckhand, he was in his bunk when he woke up to a crushing sound and water flooding his berth. He stated he took a big breath before the room filled up, kicked the stateroom door open, and swam into the galley where he was able to “pop up and get more air” from an air pocket. The surviving deckhand last saw the senior deckhand inside the accommodation space attempting to climb the stairs to the wheelhouse. He then came up in the galley where he broke open a window. He tried to swim out but ran into a ladder on the other side of the glass. He then tried to return to where the air pocket was, but found it had already filled with water. He went back to the window he broke, pulled himself through, and came to the surface of the water outside of the vessel. He saw the *Amanda C* and swam toward it, where he was then pulled on board.

Galley area and window, marked by a yellow rectangle, from where the deckhand escaped. Inset: post-casualty picture of the ladder on the main deck that was in front of the window. The window was later boarded up by the salvors. (Main photo courtesy of Jeff Steffen; inset photo courtesy of Coast Guard)

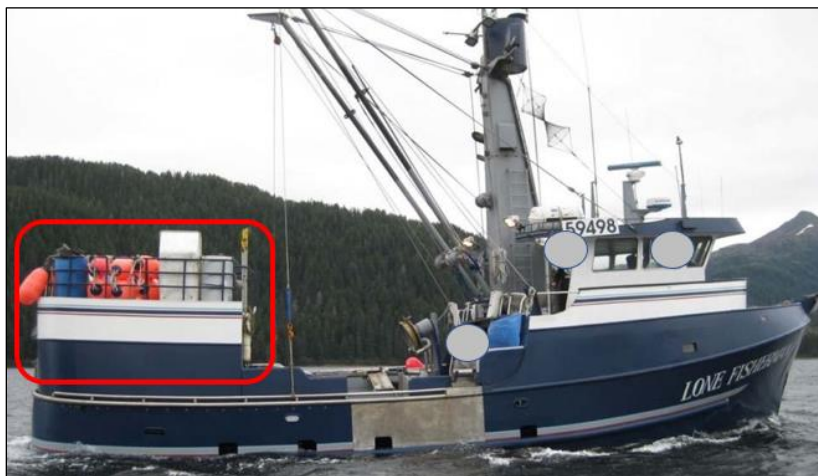
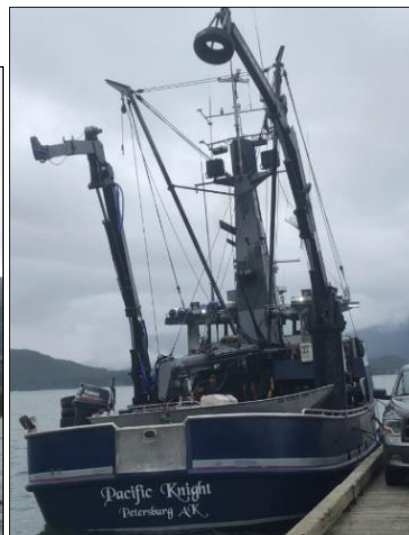
According to an insurance survey report conducted in April 2015, the *Pacific Knight* had a stability booklet that was dated April 23, 1996. This booklet was not found in the wreckage, and the captain was not able to find a copy. The captain declined to disclose the history of the vessel for the time he had owned and operated it (since 2013). Few records were found related to the maintenance history or to any conversions and modifications. Based on past photographs and the April 2015 insurance survey report, two modifications were made to the vessel that could have affected the load line and stability. First, the aft deck enclosure and equipment, which also included long lining equipment, was removed at an undetermined time. Then in June 2018, before the start of the vessel's tender contract, two pedestal cranes were added to the main deck. On the starboard side was a knuckle-type boom crane and on the port side, a larger and heavier telescopic crane. Investigators found no weights or installation specifications for the cranes, nor was a stability assessment made after their installation.

Left; undated photo of the *Pacific Knight* (then named the *Lone Fisherman*) with the aft deckhouse that was removed (highlighted in red). Right: the *Pacific Knight* while moored alongside a dock on June 10, 2018, with the two added cranes. (Photos courtesy of Lone Fisherman, LLC)

The last stability assessment of the *Pacific Knight* was conducted in 1996, about 22 years before the accident, and would not have included any modification done to the vessel since then. The weight and placement of the two cranes that the captain added to contract for tendering a month before the sinking likely increased the vessel's vertical center of gravity (based on the position in which the cranes were found when salvaged). Though not required for uninspected fishing vessels like the *Pacific Knight*, once the vessel was substantially modified by removing and adding equipment, a revised stability assessment should have been conducted to reflect the changes. Had it been, the captain would have had the necessary information to safely load the vessel for specific operations.

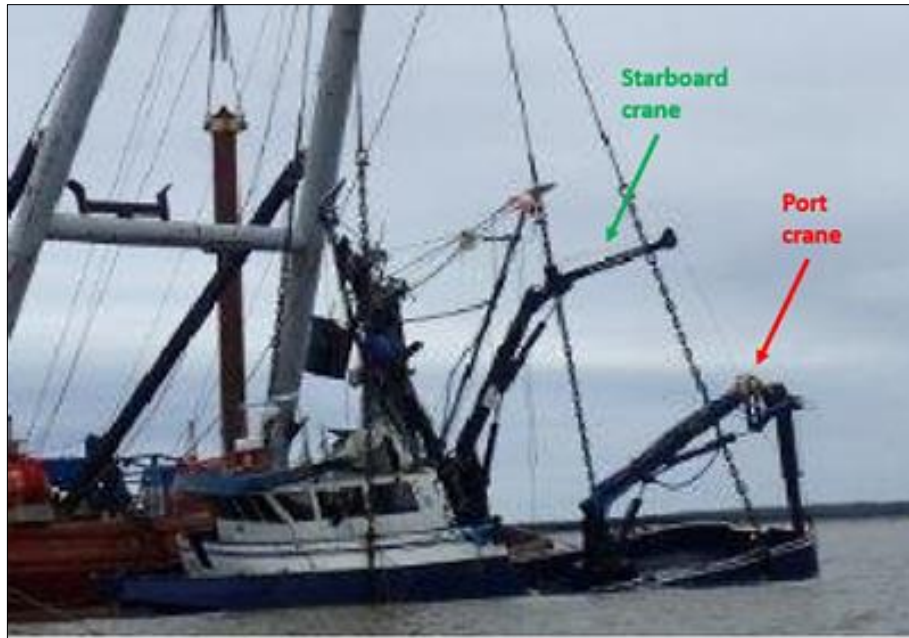
According to a report filed by the state and wildlife troopers, a crewmember on the *Amanda C* informed them that the two large cranes on the deck of the *Pacific Knight* required frequent positioning to maintain proper balance of the boat. When the *Pacific Knight* was refloated, the starboard crane was found in the extended position above the deckhouse and the port crane was found with its boom extended to the top of the deckhouse and knuckled down to the port corner of the main deck.

Pacific Knight while it was salvaged, with the crane positions visible. (Source: Resolve Magone)
