# National Transportation Safety Board

## Marine Accident Brief

### Container Damage and Loss aboard Deck Cargo Barge *Ho'omaka Hou*, Towed by *Hoku Loa*

<b>Accident type</b>	Hull/Machinery/Equipment Damage	<b>No.</b> DCA20FM022
<b>Vessel names</b>	<i>Hoku Loa</i> and <i>Ho'omaka Hou</i>	
<b>Location</b>	Pacific Ocean, 6.9 miles north-northwest of Hilo, Hawaii <sup>1</sup> 19°50.1' N, 155°02.69 W	
<b>Date</b>	June 22, 2020	
<b>Time</b>	0230 Hawaii-Aleutian time (coordinated universal time – 10 hours)	
<b>Injuries</b>	None	
<b>Property damage</b>	\$1.6 million est.	
<b>Environmental damage</b>	None reported	
<b>Weather</b>	Visibility 7 miles, overcast, winds southwest at 5 knots; seas northeast 6 feet, swell 1 foot, air temperature 72°F, water temperature 79°F, sunrise 0543.	
<b>Waterway information</b>	Open ocean off the northeast coast of the island of Hawaii, near Pepeekeo Point, at a depth of about 750 feet.	
<b>Persons on board</b>	6

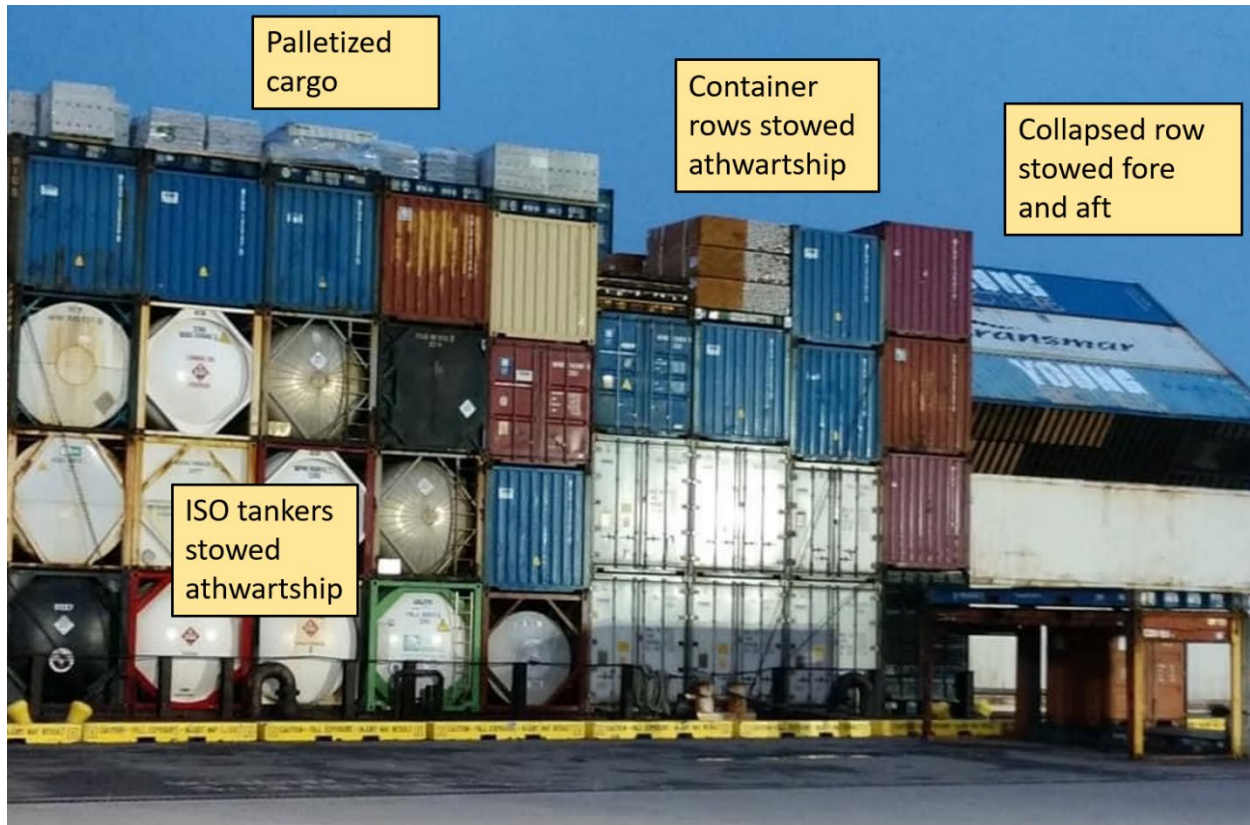
**Cargo on the *Ho'omaka Hou* upon arrival to Hilo at the end of the accident voyage.**

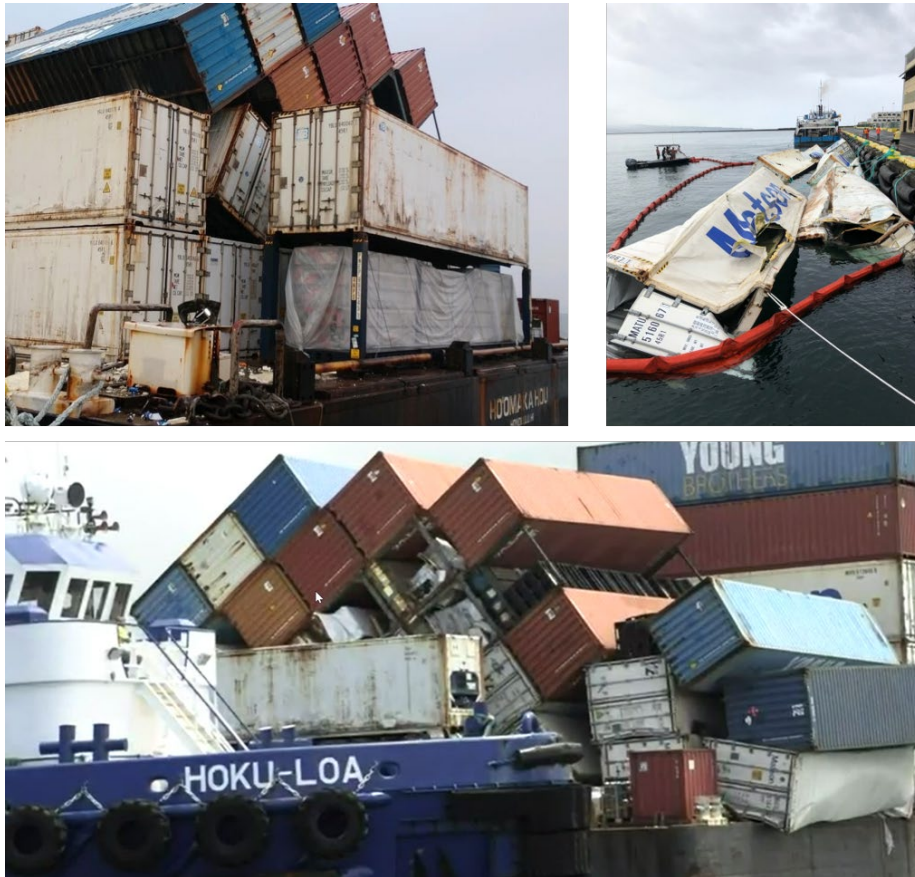
**Clockwise, from top left: The collapsed row of containers on the barge in Hilo; salvaged containers, pier side in Hilo; and the collapsed row of containers, from the starboard quarter of the *Ho'omaka Hou*. (Source: Coast Guard)**

Once moored, shoreside personnel carried out a damage assessment and found that the aftermost row of containers stowed in a fore and aft direction had collapsed and that 21 40-foot

containers had fallen overboard. At 0445, notifications were sent to the Coast Guard and other entities. Later that afternoon, a salvage company was hired to search for and recover the lost containers. Eight containers were found adrift about 3 miles off Pepeekeo Point and were recovered by salvors. Thirteen containers were not found. The cost to repair the recovered containers and to replace those missing was \$104,885; the cost to repair the barge was estimated at \$25,000; and the cost of lost or damaged cargo was estimated to exceed \$1.5 million. Following the accident, a thorough inspection of the concrete deck and fixed securing points on the *Ho'omaka Hou* was completed. Damage to the concrete deck was deemed to be pre-existing, except for “small pockets of damage” that corresponded to where the ends of the containers rested on the deck.

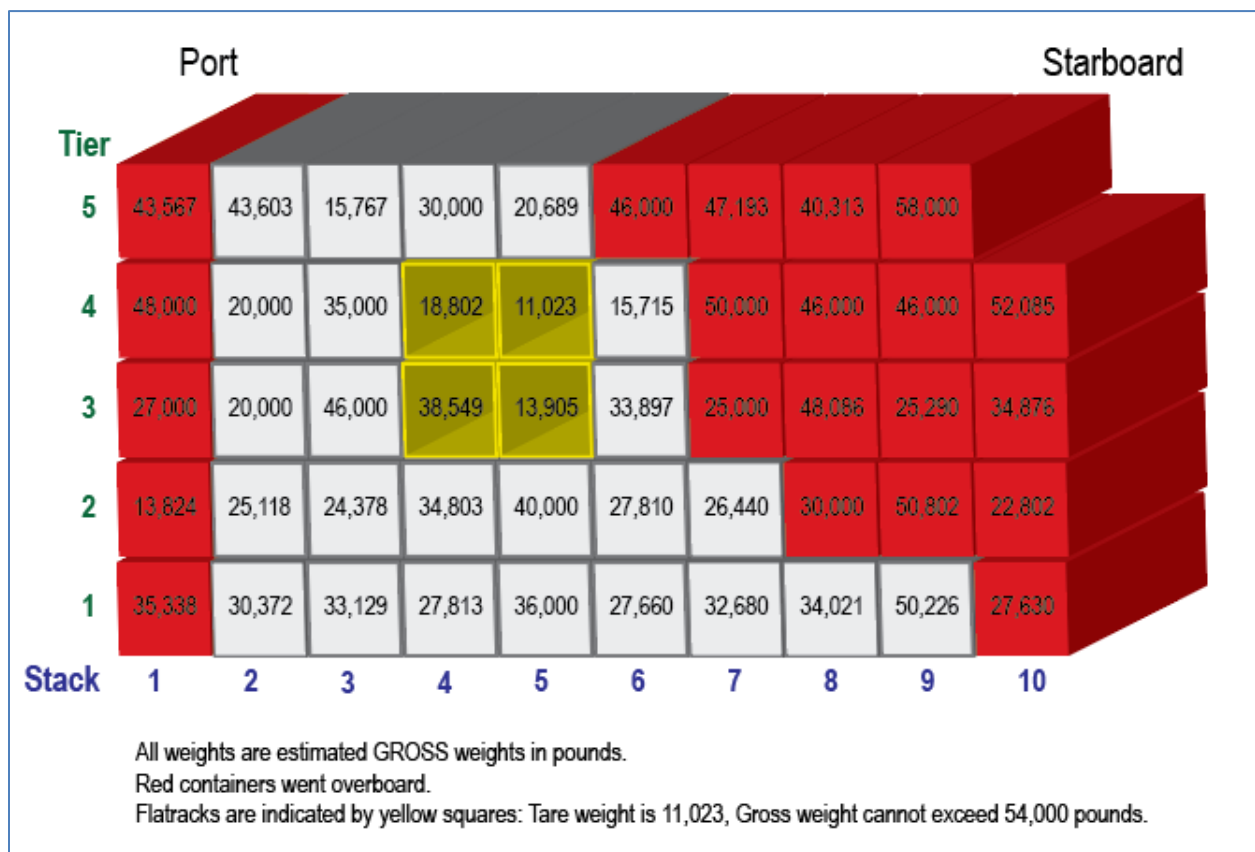
**Portion of stow plan showing container weights of the toppled container row.**

The containers in the toppled row were loaded in a fore and aft orientation and stacked on top of each other in five-high tiers except for the outboard stack on the starboard side, which was stacked four high. All the containers were 40 feet long, and there was a total of 10 stacks across the barge, port to starboard.

The NTSB study of the centers of gravity of the containers in the toppled stacks on the accident voyage showed that most were loaded in a manner that produced reverse stratification—meaning that heavier containers were loaded above lighter containers. Reverse stratification results in stacks having a higher center of gravity than stacks created by placing the heaviest containers on the deck, with progressively lighter containers above—referred to as normal stratification. Normal stratification is preferred, because it creates a stack having the lowest possible center of gravity.

An initial barge load plan showing stratified container weights would have been a useful tool to assist the barge team machine operators in stacking containers on the barge to reduce or eliminate reverse stratification. Even though machine operators stated they tried to stack containers with heavy containers on the bottom and light ones on top, neither the barge team member job descriptions or the company-provided Container Lashing Tips included instructions pertaining to the order in which to stack containers. Instead, on the accident voyage, heavy containers in the collapsed row were consistently loaded over lighter containers, and stacks 1, 7, 8, and 10—which accounted for 20 of the 21 lost containers—were loaded almost exactly in reverse stratification. In addition, the company did not provide the barge team procedures or calculations to determine if the lashing arrangements were sufficient for the reverse-stratified container stacks.

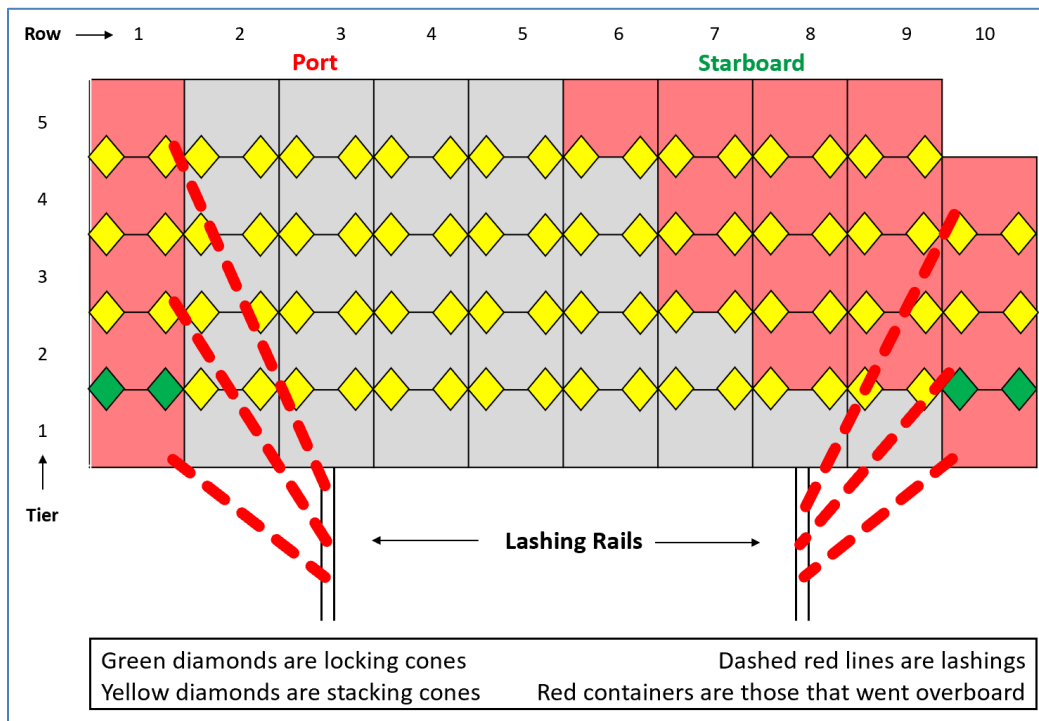
Container rows were generally secured in a similar fashion. The collapsed row of containers was secured to the deck of the barge using a lashing arrangement (loose fitting) consisting of 0.5-inch chain, ratchet binders, slip hooks, and grab hooks. The chains were secured to the deck with a hook on the steel lashing rails. The steel lashing rails ran fore and aft along the deck of the barge, were recessed in the concrete facing covering the deck, and were welded to the steel deck under the facing. The ratchet binders were used to tighten (tension) the complete chain lashing assembly.

A separate chain was hooked to the forward and after corner castings to the bottom of the first-, third-, and fifth-tier containers on the port outboard five-high stack of containers and to the forward and after corner castings of the first-, second-, and fourth-tier containers to the starboard outboard four-high stack of containers. The chains were also secured to the steel lashing rails by a hook.

**Lashing diagram of collapsed row of containers on *Ho'omaka Hou*, as viewed from aft.**

Compared to normal stratification, the reverse-stratified toppled stack's securing arrangements (lashings and locking cones) would have been subject to increased forces while moving in a seaway. The containers were secured primarily with stacking cones, which provided little protection against the containers leaning or tipping. It is likely that when the barge turned about 30 degrees to a new south-southeasterly course about 0200, the dynamic rolling from the seas on the vessel's beam resulted in forces on the container stacks with the greatest reverse stratification so that, unchecked by the lashings used solely on outboard stacks of containers and the stacking cones used as the primary securing point between containers, the containers tipped over and caused the row to collapse.

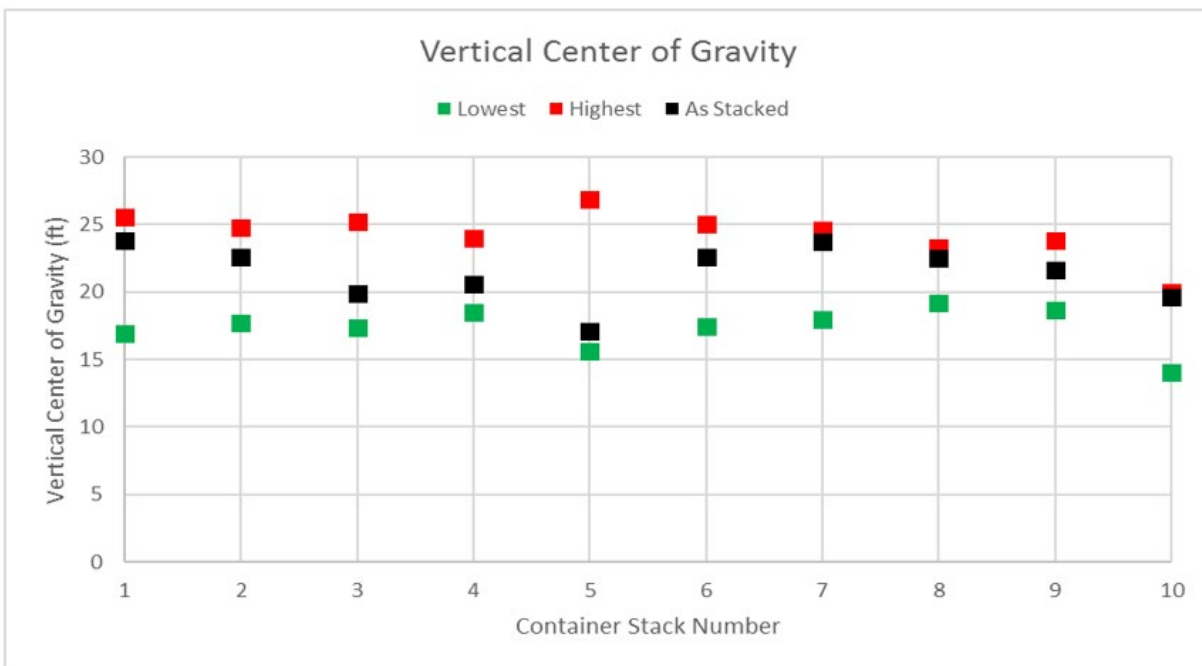
**Toppled Stack Weight Study.** The NTSB conducted a study to determine the locations of the centers of gravity for each stack in the collapsed row of containers on the *Ho'omaka Hou*, based on the weights of each container, as provided by the company. The study also calculated the centers of gravity for each stack as if they had been stacked according to normal stratification and as if they had been stacked according to reverse stratification. The complete study is included in the accompanying docket to this brief.

The height of the center of gravity for each stack: As stacked on the *Ho'omaka Hou* in black; the lowest possible centers of gravity of the stacks if containers were loaded per normal stratification, in green; and the highest possible centers of gravity for each stack if containers had been loaded per reverse stratification, with containers getting progressively heavier going up the stack, in red.

The National Transportation Safety Board determines that the probable cause of the collapse of container stacks onboard the barge *Ho'omaka Hou* towed by the *Hoku Loa* was the company not providing the barge team with an initial barge load plan, as well as inadequate procedures for monitoring stack weights, which led to undetected reverse stratification of container stacks that subjected the stacks' securing arrangements to increased forces while in transit at sea.

It is important for cargo planners to have tools, such as stow plans and calculations, to assist with determining proper stowage and the sufficiency of securing arrangements for containers stacked on barges. These tools should address the potential that container stacks may be stacked in a reverse stratified manner.
