# National Transportation Safety Board

## Marine Accident Brief

### Collision of Cargo Vessel *Nomadic Milde* and Bulk Carrier *Atlantic Venus*

<b>Accident type</b>	Collision	<b>No.</b> DCA20FM017
<b>Vessel name</b>	<i>Nomadic Milde</i> and <i>Atlantic Venus</i>	
<b>Location</b>	Lower Mississippi River, mile 114.5, South Kenner, Louisiana <sup>1</sup> 029°58.03' N, 090°16.60' W	
<b>Date</b>	May 8, 2020	
<b>Time</b>	1655 central daylight time (coordinated universal time – 5 hours)	
<b>Injuries</b>	None	
<b>Property damage</b>	\$16,854,348 million est.	
<b>Environmental damage</b>	13 gallons of lube oil est.	
<b>Weather</b>	Visibility 10 miles, overcast skies, winds northeast at 8 knots; thunderstorms in area, river surface conditions rippled, air temperature 73°F, water temperature 68°F, sunset 1943	
<b>Waterway information</b>	The Mississippi River at the Kenner Bend anchorage was about 54 feet deep and 0.6 miles wide. The current was estimated between 4 and 5 knots.

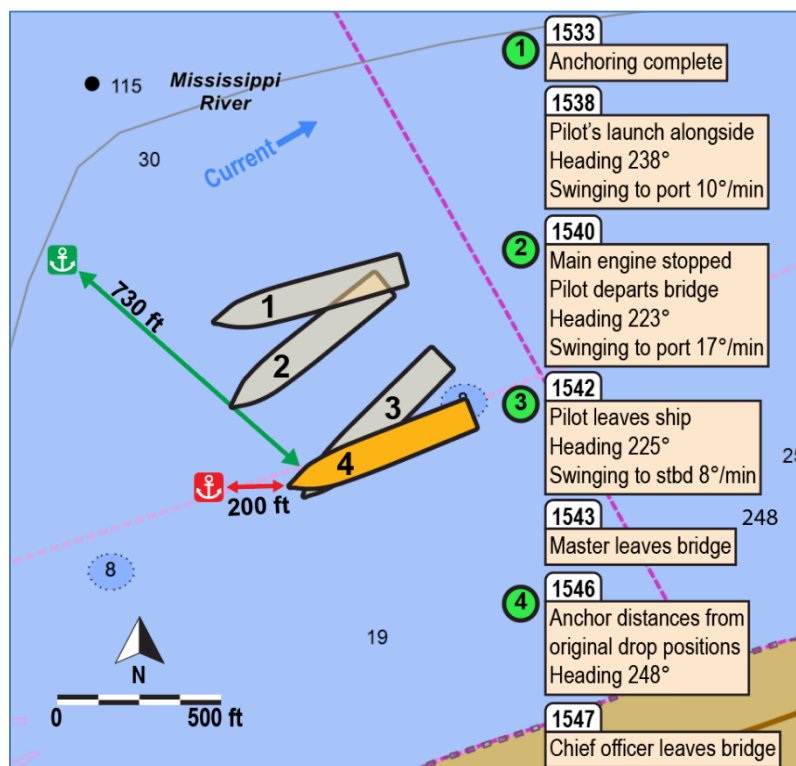
From 1533, when the pilot informed the master that the anchoring was complete, the *Nomadic Milde* continued to shift position and heading. The pilot departed the bridge at 1540 and left the ship on a launch at 1542.

*Nomadic Milde*’s initial movements from 1533 to 1547 from the vessel’s VDR, scale approximate. The green anchor icon indicates the starboard anchor drop position, and the red anchor icon indicates the port anchor drop position. (Background source: NOAA ENC 6LA54M)

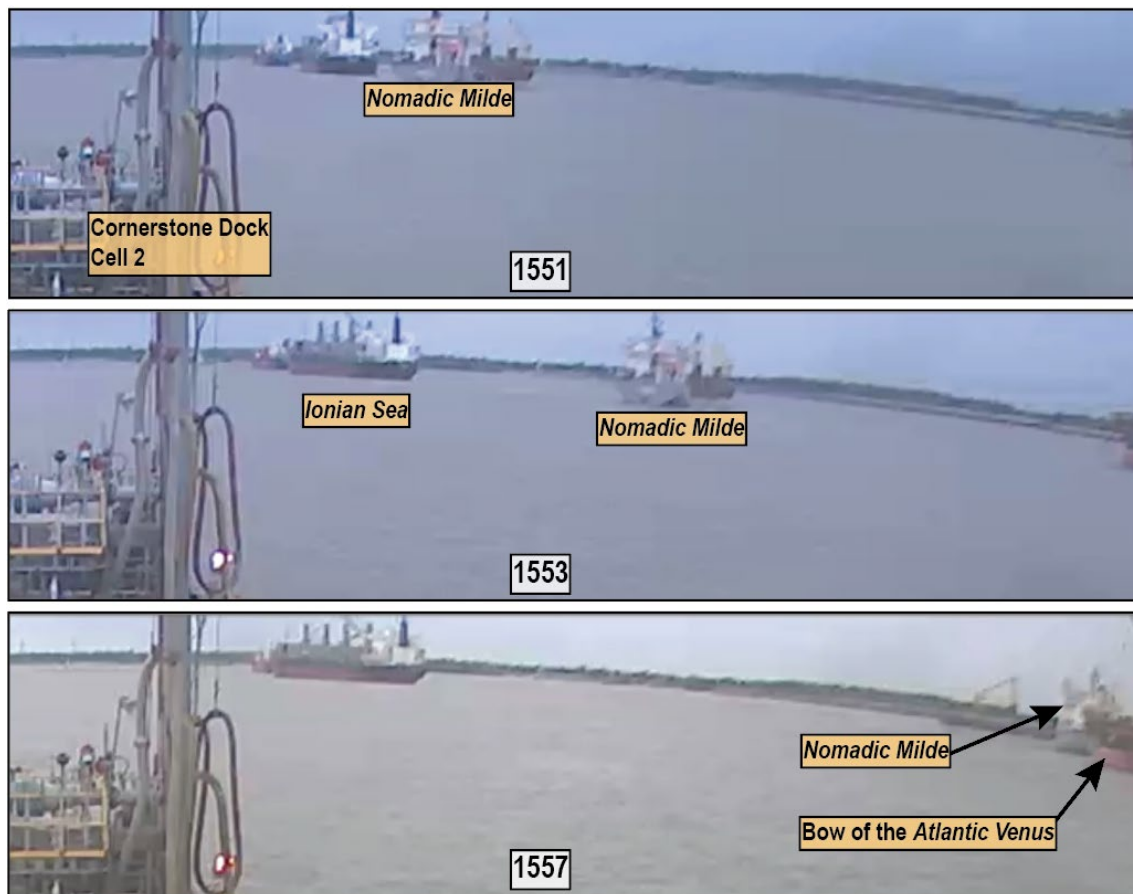
About 1550, from a heading of 264°, the *Nomadic Milde*’s rate of turn began to increase to starboard. Closed-circuit television (CCTV) at the nearby Cornerstone Chemical Dock at mile 114.5 recorded the *Nomadic Milde*’s bow falling off to starboard and moving away from the right descending bank. At 1554, the *Nomadic Milde*’s ECDIS recorded its speed to be about 1.8 knots over ground. At 1557, the *Nomadic Milde* appeared to stop moving and hang in position about 350 feet off the starboard bow of the *Atlantic Venus*.

Footage from 1551, 1553, and 1557 (top to bottom) from the Cornerstone Chemical Dock showing the *Nomadic Milde* dragging anchor downriver towards the *Atlantic Venus*.

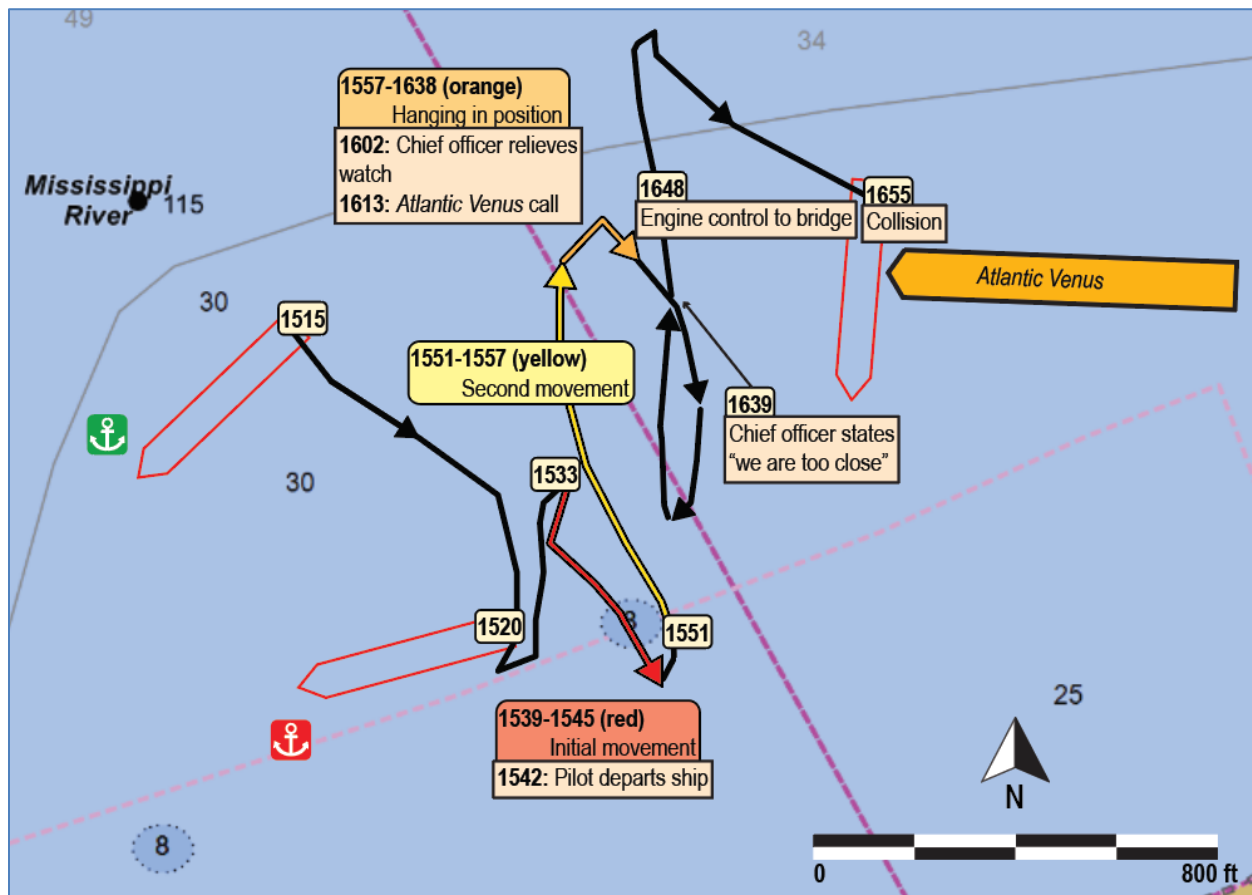
GPS positions of the *Nomadic Milde* from the vessel's ECDIS, from the time the *Nomadic Milde*'s starboard anchor was let go at 1515 to the collision with the *Atlantic Venus* at 1655. The green anchor icon indicates the starboard anchor drop position, and the red anchor icon indicates the port anchor drop position. Note: the GPS receiver is located on the main mast above the bridge of the *Nomadic Milde*. Scale approximate. (Background source: NOAA ENC 6LA54M)

The *Nomadic Milde*'s positions and headings suggested that the *Nomadic Milde* did not initially settle at its original anchor position. After the starboard anchor was let go, the ship moved about 730 feet away from the original starboard anchor drop position towards the right descending bank, a distance double the amount of chain that was set on the anchor, indicating that the starboard anchor likely dragged. The initial 6-minute anchor drag began within 10 minutes of when the pilot had informed the master that the anchoring was finished. The pilot departed the bridge while the vessel was still moving, although he said he had no concerns about the *Nomadic Milde* holding anchor. Had he noticed the initial drag of the *Nomadic Milde*, he may have remained with the vessel. Additionally, had the bridge team detected the initial drag before the pilot departed the vessel, or if the master had voiced any concern, they may have been able to request that the pilot remain with the ship to attend to the issue.

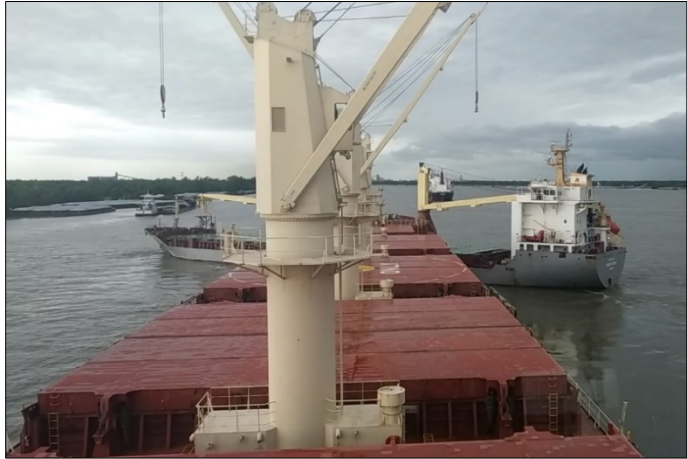
At 1655, the port side of the *Nomadic Milde* collided with the bulbous bow and anchor chains of the *Atlantic Venus*. Both vessels remained in contact: the *Atlantic Venus* was facing up river, and the port side of the *Nomadic Milde* was laying up against the bulbous bow of the *Atlantic Venus* with its bow facing the right descending bank. At 1659, the second officer of the *Nomadic Milde* informed VTS that they had collided with the *Atlantic Venus*. Neither vessel reported any flooding. With the *Nomadic Milde* broadside to the current and pushing on the bow of the *Atlantic Venus*, both vessels moved towards the right descending bank and closed on the Cornerstone

Image from video taken at 1701 from the bridge of the *Atlantic Venus* with the *Nomadic Milde* lying against its bow. (Source: *Atlantic Venus* crewmember)

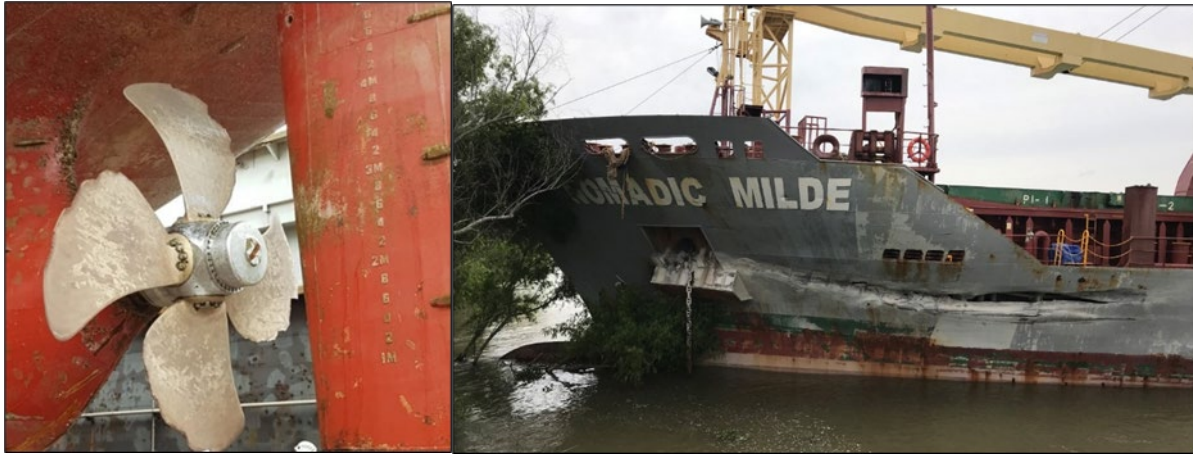
**Damages.** The *Nomadic Milde* lost its starboard anchor with 4 shots of anchor chain just before it hit the dock, and its starboard anchor windlass was damaged. The anchor was later recovered. The contact with the Cornerstone dock left an approximate 25-foot gash aft of its port anchor pocket, as well as an indentation and a fracture to the portside shell plating in the vicinity of the no. 5 port wing ballast tank from the contact with the bulbous bow of the *Atlantic Venus*. The propeller had numerous indentations and fragments missing from each blade. There was damage to the portside bilge keel, and there were multiple anchor chain abrasion markings at the bulbous bow on the portside hull area, and in the vicinity of the propeller. An estimated 13 gallons of stern tube lube oil were released into the river from a broken propeller hub seal. Damage and repair costs were estimated at between \$5.5 and \$6 million.

**Left:** Postaccident damage to the *Nomadic Milde*'s propeller. (Source: Intership Navigation Co. Ltd)  
**Right:** *Nomadic Milde* on the right descending bank at the Cornerstone Dock showing a gash in the hull aft of the port anchor pocket. (Source: US Coast Guard)
