National Transportation Safety Board

Marine Accident Brief

Collision between *Cooperative Spirit* Tow and *RC Creppel* Tow

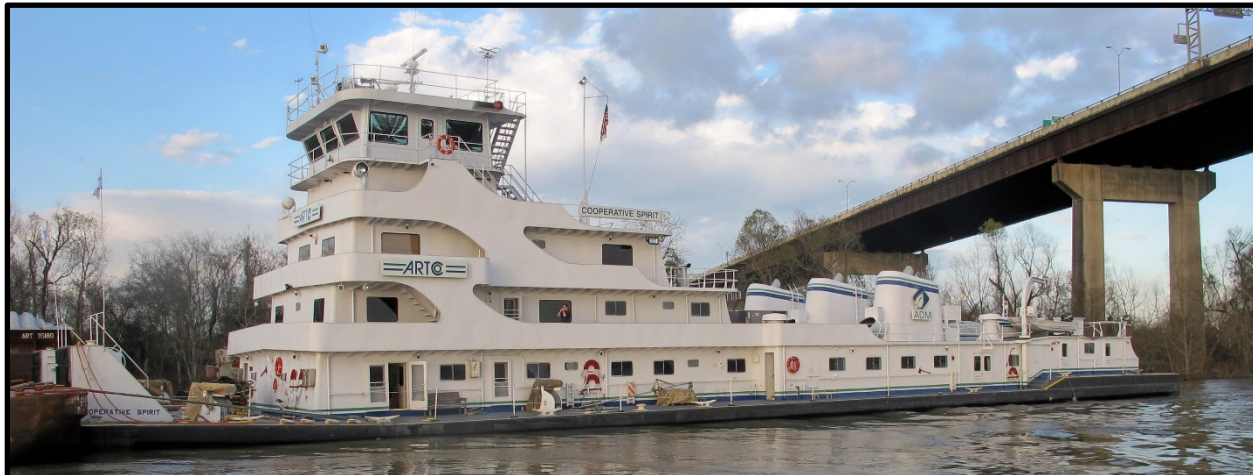
Cooperative Spirit moored after the accident.

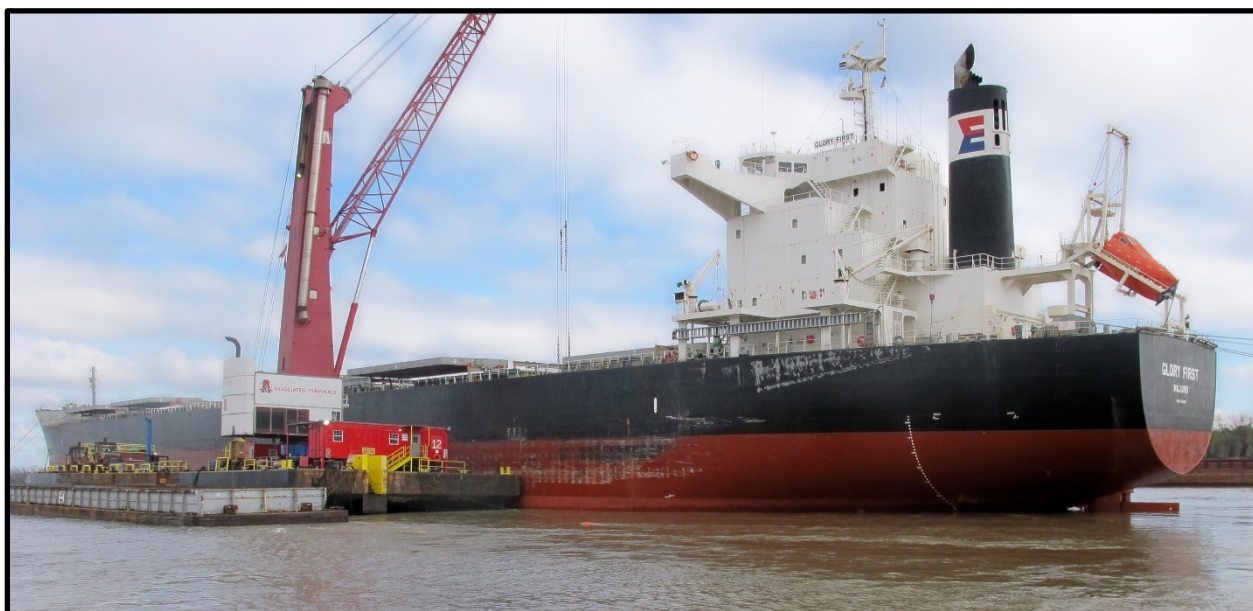
Glory First anchored after the accident.

The *Glory First* sustained external hull damages on its portside outer shell plating with indentations and a set-in (a deformation of steel plate[s]) located near the bow (cargo hold no. 1) and farther aft around cargo hold no. 7.

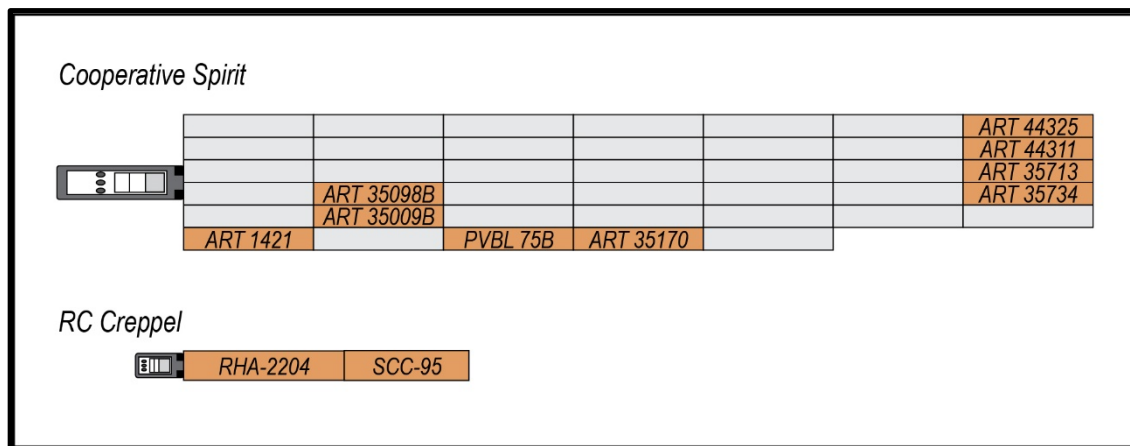
Approximate arrangement of the *Cooperative Spirit* and *RC Creppel* tows. (Note: The barges in orange were damaged in the accident.)

Damage. Both of the *RC Creppel*’s barges, the *SCC-95* and the *RHA-2204* (both tank barges), sustained damage in the accident. Nine of the *Cooperative Spirit*’s 40 barges were damaged, including the *ART 44325*, *ART 35713*, *PVBL 75B*, and *ART 1421* (all hopper barges), as well as the *ART 44311* (a freight barge). The barges sustained varying levels of damage consisting of insets, cracks, and penetrations. Additionally, sulfuric acid (99.4% concentration) vapors escaped into the atmosphere from the *RC Creppel*’s loaded barge (*RHA-2204*), which was later capped to contain the acid vapors.

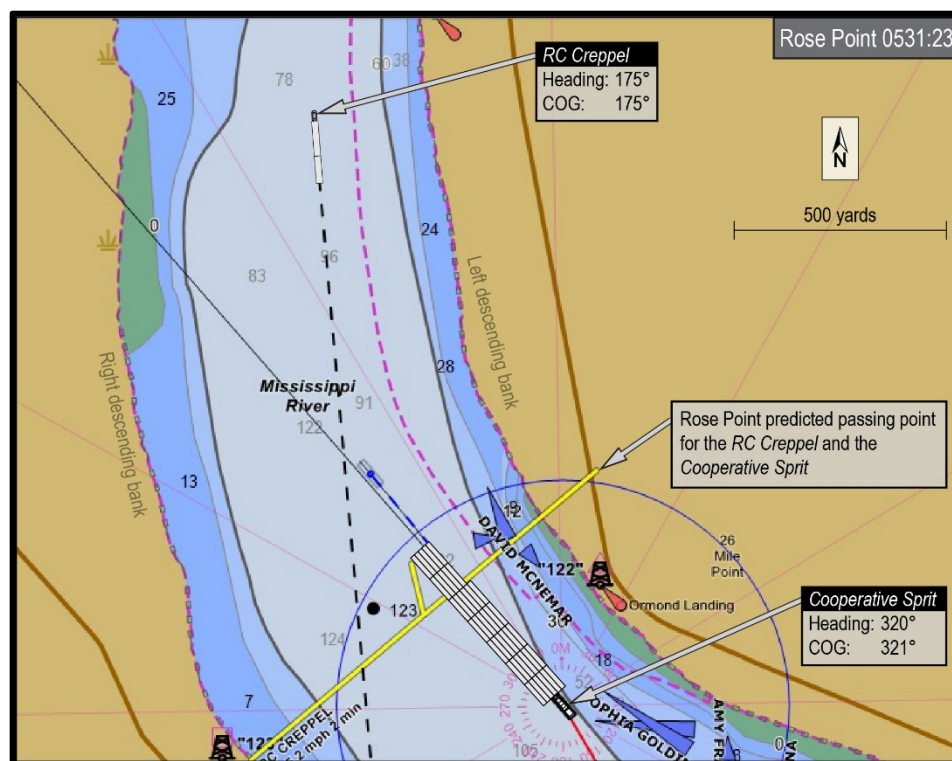
At 0531:23, even as the pilot used right rudder angles of 15-20° to round the point, the *Cooperative Spirit*'s course over ground began to move to port toward the right descending bank at a speed of 4.6 mph, away from its course of 320°. At that time, the *Cooperative Spirit*'s lead barges were about 810 yards (about 0.5 miles) from the *RC Creppel*'s lead barge. The rate-of-turn indicator continued to show a rate of turn to port.

Screenshot of *Cooperative Spirit* Rose Point at 0531:23 when the vessel's course and heading began to swing toward the right descending bank (with *Cooperative Spirit* tow and *RC Creppel* tow icons added to show overall tow dimensions to approximate scale). (Source: ARTCO, annotated by NTSB)

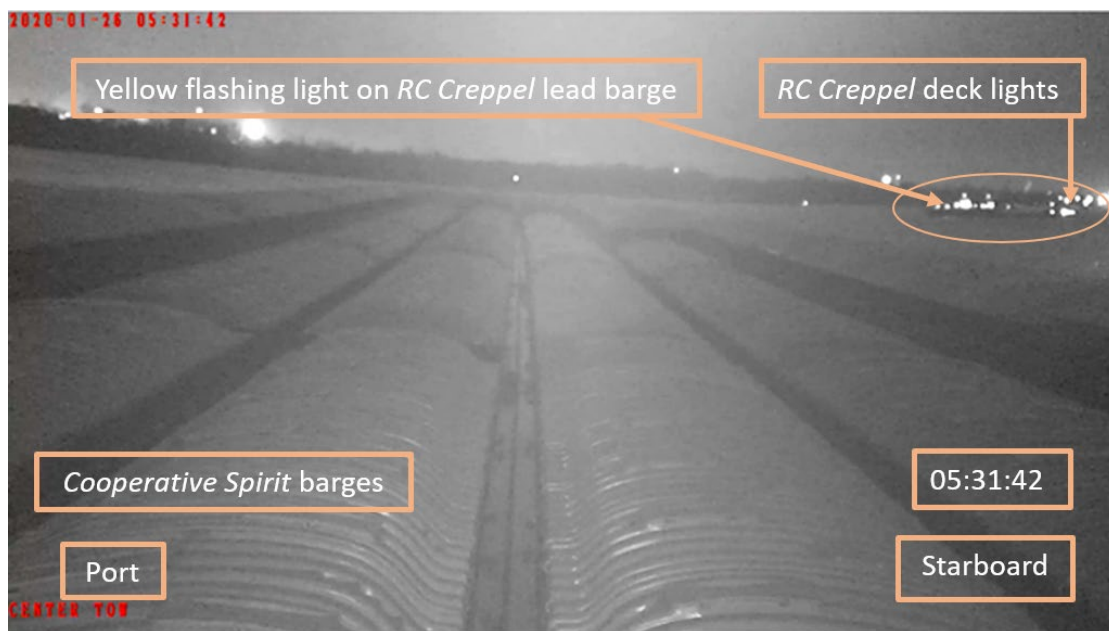
Screenshot from *Cooperative Spirit* center camera looking northwest at 0531:42. Image shows the *RC Creppel* navigation and deck lights against lighting in the background from vessels in the vicinity of Hahnville Landing. (Source: ARTCO annotated by NTSB)

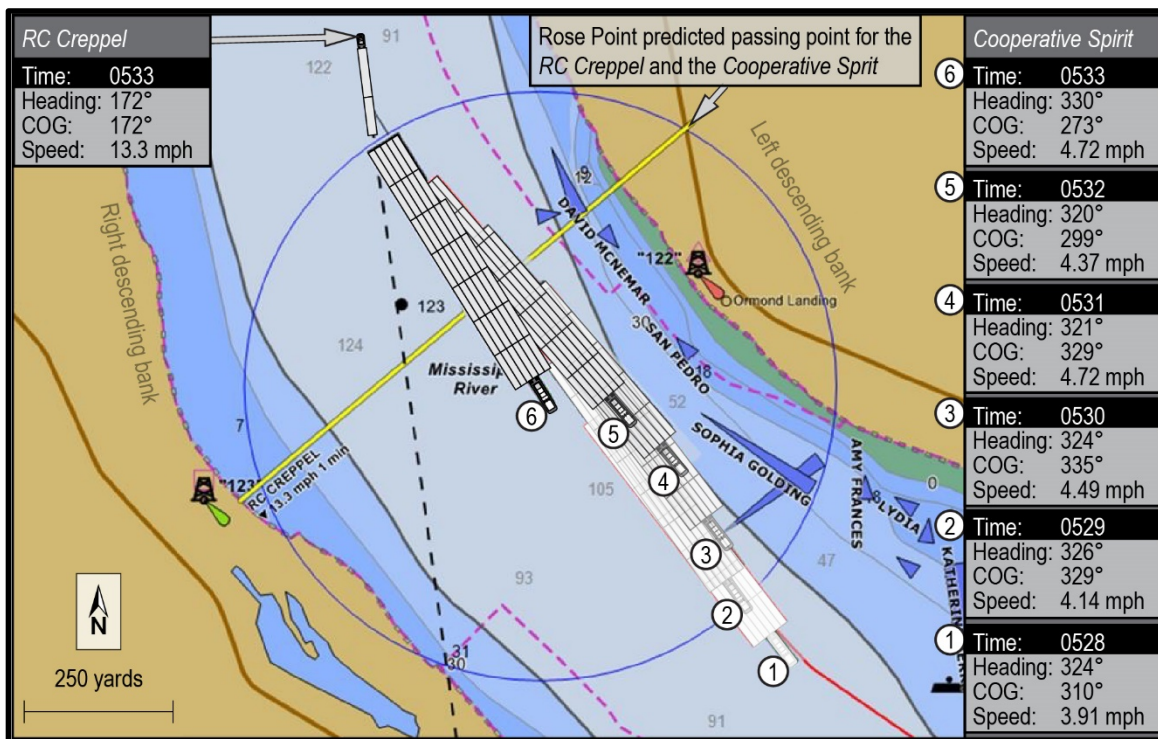
Rose Point ECS display at 0533 screenshot from the *Cooperative Spirit*, with previous positions of the *Cooperative Spirit* starting at 0528 (with *Cooperative Spirit* tow and *RC Creppel* tow icons added to show overall tow dimensions to approximate scale). (Source: ARTCO, annotated by NTSB)

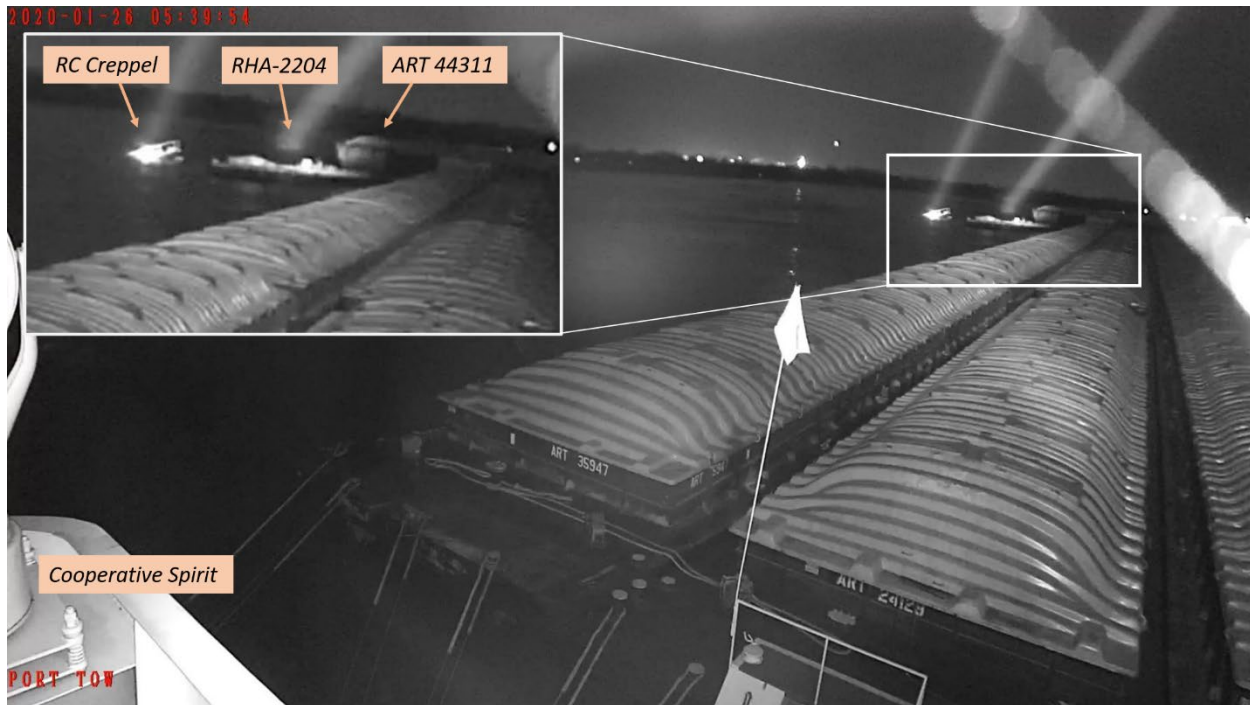
Cooperative Spirit port camera screenshot of the mostly submerged *RC Creppel* and barge *ART 44311* on top of barge *RHA-2204* at 0539:54. (Source: ARTCO, annotated by NTSB)

After the collision, according to the surviving deckhand, water rapidly entered through the open starboard main deck weathertight door to the galley on the *RC Creppel*. While the vessel was not salvaged and could not be examined under water, it is likely that the ingress of water into the vessel through the main deck weathertight door may have been prevented or slowed had the door been closed and properly dogged, thus allowing the three other crewmembers more time to escape before the vessel sank.

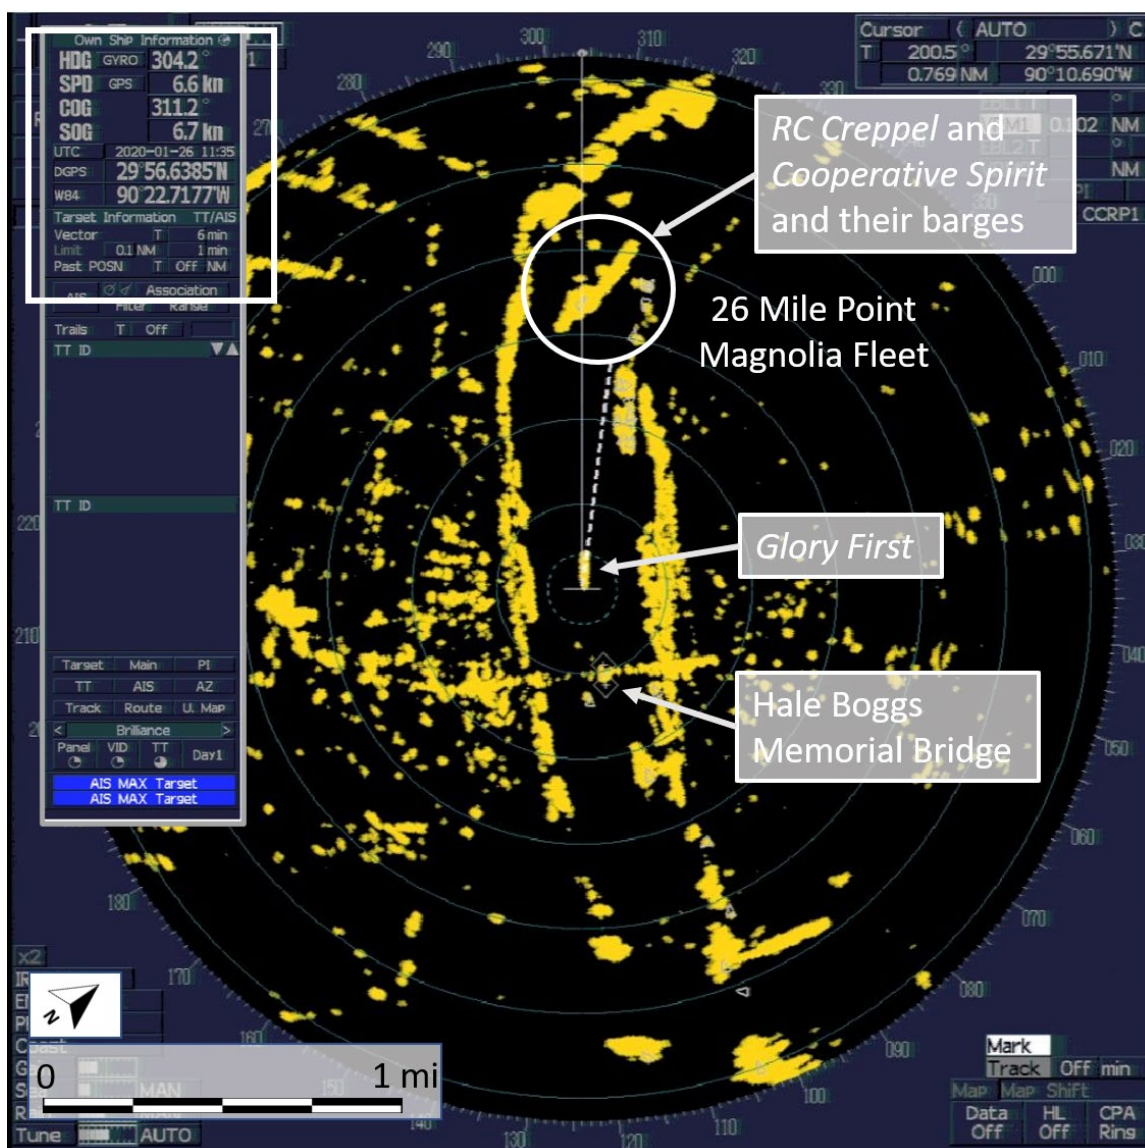
The *Glory First*'s radar showed the *RC Creppel*, *Cooperative Spirit*, and their barges as one entity about a 45° angle within the bend, blocking the river with the ends equidistant from the riverbanks. The NOBRA pilot stated that his first thought was to stop the *Glory First*, but he decided not to because the vessel would lose steerage as it slowed, and there was a potential for collision with the many boats and hazardous cargo barges in the Magnolia fleeting area below and along the left bank at 26 Mile Point. He stated that he considered maneuvering the *Glory First* into the mud along the left descending bank but did not because he assessed that there was not enough room. He reported back to the *Cooperative Spirit* pilot that he was going to slow down as much as he could. At 0537, the *Glory First* was 1,000 yards (about 0.6 miles) from the breakaway barges and traveling at 6.3 knots (7.2 mph). The radar showed that the distance from the *RC Creppel* and *Cooperative Spirit* tows to the right descending bank was decreasing, and by 0538:31, there was no space between the tows and the right descending bank.

Glory First radar at 0537:07, when the pilot called the *Cooperative Spirit*. (Source: *Glory First*, annotated by NTSB)
