National Transportation Safety Board

Marine Accident Brief

Breakaway of Containership *CMA CGM Bianca*

NTSB/MAB-21/18

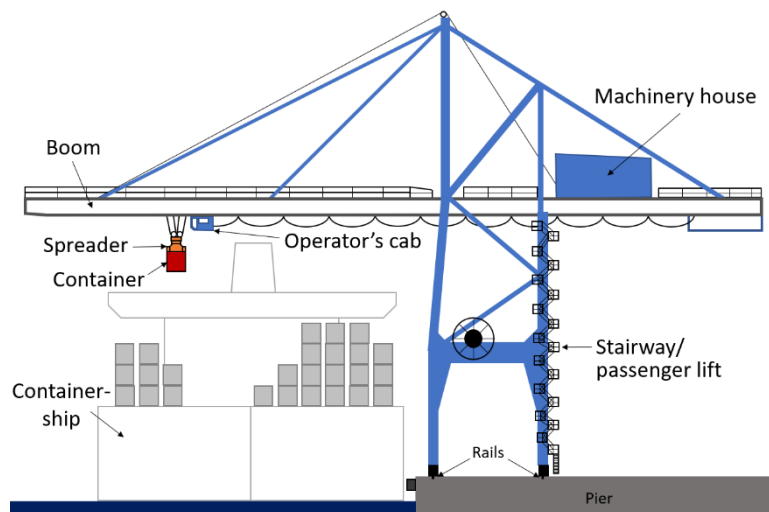
Simplified diagram of Port of New Orleans marine terminal gantry crane no. 6.

The container suspended from crane no. 6 struck a hatch cover guide in the *CMA CGM Bianca*'s cargo bay 38, puncturing the container. The forward spreader bars then detached from the spreader, dropping the container and the forward spreader bars into the ship's hold. The remainder of the spreader, still attached to the crane, then impaled and lodged in another container.

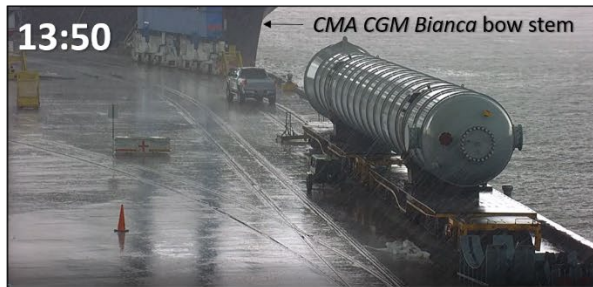
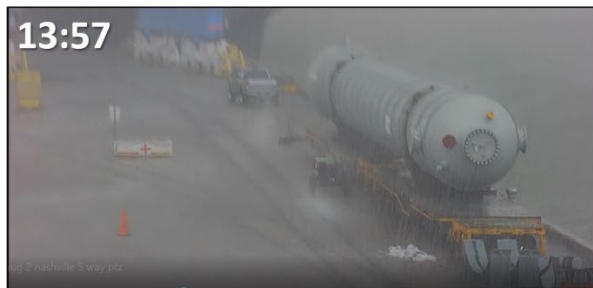
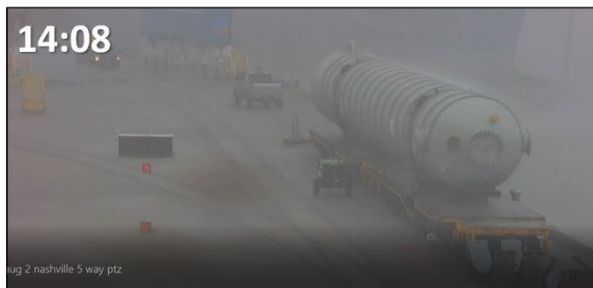
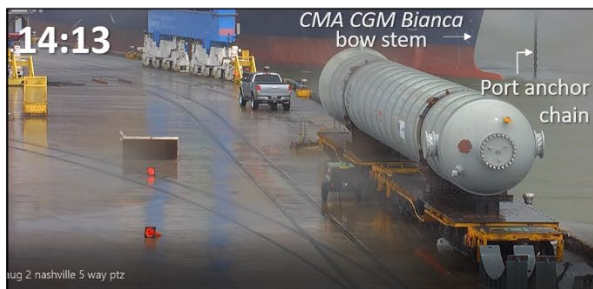
At 1350, security cameras at the terminal recorded rain beginning to fall. The rain increased steadily while visibility decreased, completely obscuring the camera view. Ten minutes later, “gale force winds, and strong rain” hit the *CMA CGM Bianca*, according to the vessel’s deck log. The master described the conditions as “in the form of a tornado,” and both crane operators stated that the winds developed “in seconds.” At 1402, seven forward mooring lines and three aft mooring lines on the *CMA CGM Bianca* parted, and the ship moved away from the pier.

About the same time, crane nos. 5 and 6, both with containers suspended from their spreaders, began moving along their rails (forward to aft, in relation to the *CMA CGM Bianca*) as they were buffeted by the wind. The container suspended from crane no. 5 hit other containers stowed on the ship and then fell from the ship, still connected to the spreader, hitting the pier and breaking open before falling in the water. Part of the container’s cargo of very small (less than 5 millimeters) plastic pellets, known as “nurdles” and used for producing plastic products, was discharged into the river. Millions of the pellets floated downriver, washing up on the river banks or out into the Gulf of Mexico. According to port officials, the nurdles were “irretrievable.”²

Security camera footage of Napoleon Avenue Container Terminal pier during accident. (Source: Ports America)

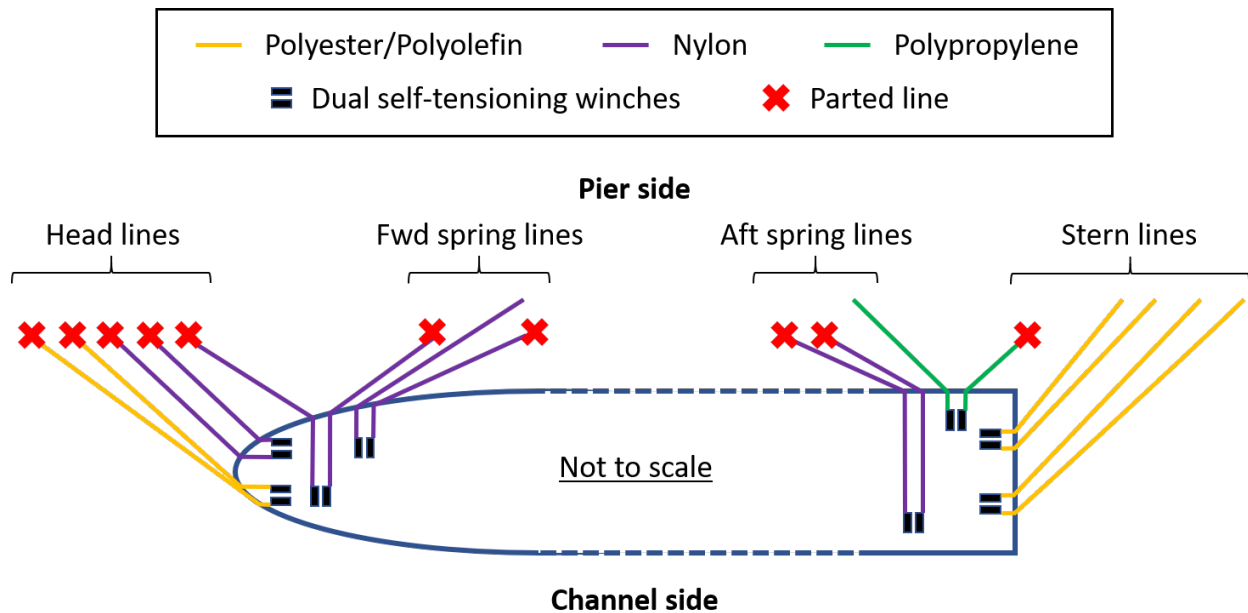
Mooring lines. The *CMA CGM Bianca* was equipped with a mix of mooring lines constructed of either nylon (polyamide), dual fiber polyester/polyolefin, or polypropylene. Each line was certificated by its manufacturer to be in conformance with designed specifications and breaking strength. The breaking strength of the nylon and polyester/polyolefin lines was 108 tons; the breaking strength of the polypropylene lines was 106 tons. During the accident, seven of eight nylon lines parted, two of six polyester/polyolefin lines parted, and one of two polypropylene lines parted. Each of the lines parted close to the eye on the end closest to the bollard on the pier.

CMA CGM Bianca mooring line arrangement.

The mooring lines on the *CMA CGM Bianca* were made of three different materials: nylon (polyamide), dual fiber polyester/polyolefin, or polypropylene. Lines constructed of different materials may have similar or equal breaking strengths, as was the case with the lines on the accident vessel, but they may have other differing properties that effect performance. For example, if lines with less elasticity are combined with lines with more elasticity, the less elastic lines may

take greater load than the more elastic lines when under heavy tension. In extreme conditions, this may result in unexpected failure of the less elastic lines and successive failure of all lines. Self-tensioning winches can assist in evening the load between lines, but they were not engaged on the *CMA CGM Bianca* due to the captain's concern over unintended payout. The impact of the differences in mooring line materials was beyond the scope of this investigation, but it is possible that these differences contributed to the containership's lines parting.
