National Transportation Safety Board

Marine Accident Brief

Engine Room Fire aboard Fishing Vessel *Master Dylan*

Accident type	Fire/Explosion	No. DCA21FM009
Vessel name	<i>Master Dylan</i>	
Location	Gulf of Mexico, about 32 miles west-southwest of Port Fourchon, Louisiana ¹ 28°55.7' N, 090°48.0' W	
Date	December 1, 2020	
Time	0745 central daylight time (coordinated universal time – 6 hours)	
Injuries	None	
Property damage	\$300,000 est.	
Environmental damage	None reported	
Weather	Visibility 10 miles, clear skies, winds east at 8 knots, seas east 1 foot, air temperature 52°F, water temperature 71°F, sunrise 0647	
Waterway information	Gulf of Mexico

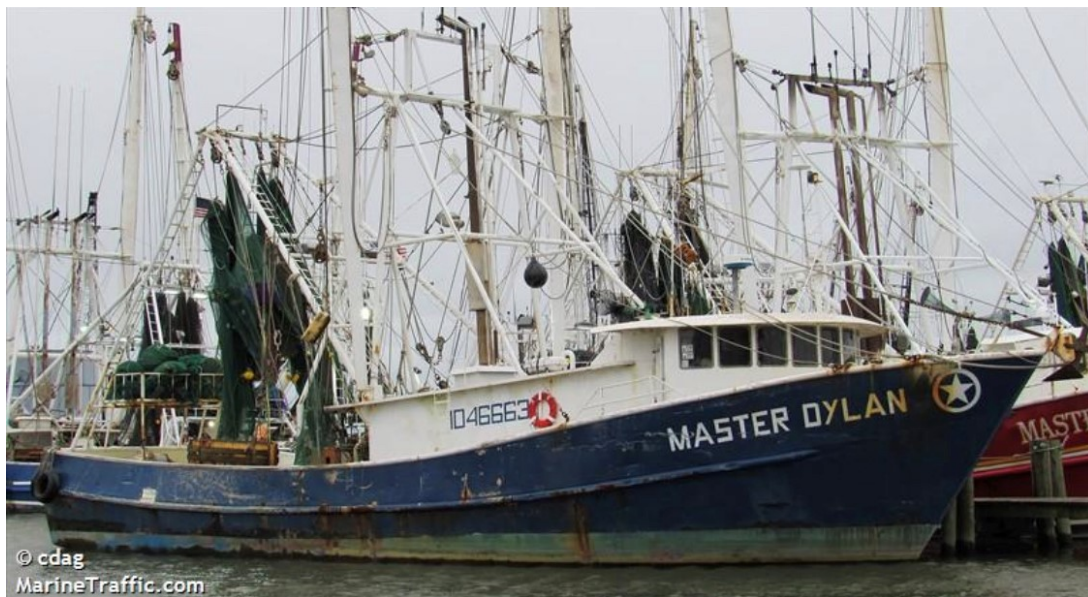
The *Master Dylan* before the accident. (Source: Marine Traffic)

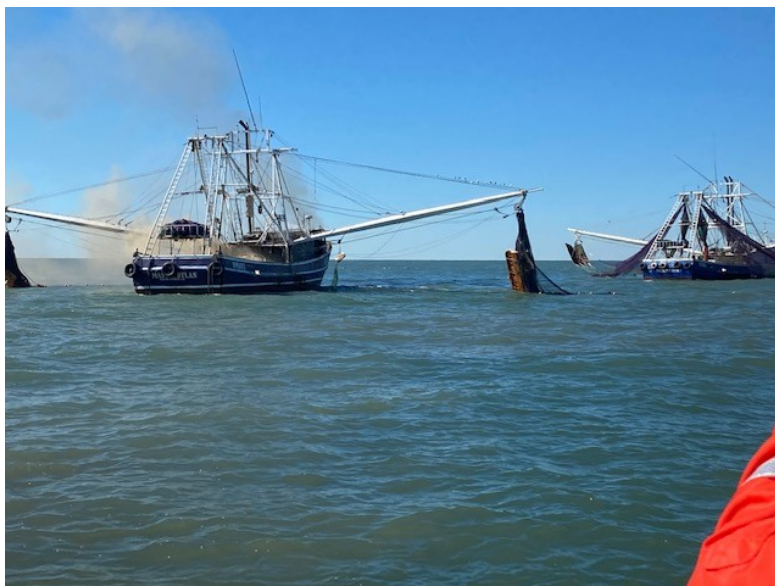
At 1240, about an hour after beginning the tow, the *Master Dylan* grounded on a sandbar that the towing vessel had passed over. Shortly after the grounding, the fire re-flashed. No further firefighting efforts were made. The Coast Guard small boat arrived on scene at 1304 and monitored the situation. The *FMS Courage* departed shortly after the arrival of the Coast Guard small boat.

Photo taken from the Coast Guard small boat showing the *Master Dylan* aground after being towed by the *Master Dustin II*. (Source: Coast Guard)

Investigators also assessed the cause of the vessel sinking, which occurred about 27 hours after the fire began. Because there were no further firefighting efforts after 1140 on the accident day, additional flooding must have occurred after the *Master Dylan* grounded and the fire re-flashed. The destruction of the hoses in the engine room connected to through-hull fittings, due to the long-term exposure to the heat of the fire, most likely resulted in the sinking of the vessel. As the hoses failed, water would have entered the hull, causing the vessel lose stability, roll, and sink.
