Fire Aboard Small Passenger Vessel *Conception*
Platts Harbor, Channel Islands National Park,
Santa Cruz Island, 21.5 miles South-Southwest of
Santa Barbara, California
September 2, 2019

Marine Accident Report

NTSB/MAR-20/03
PB2020-101011

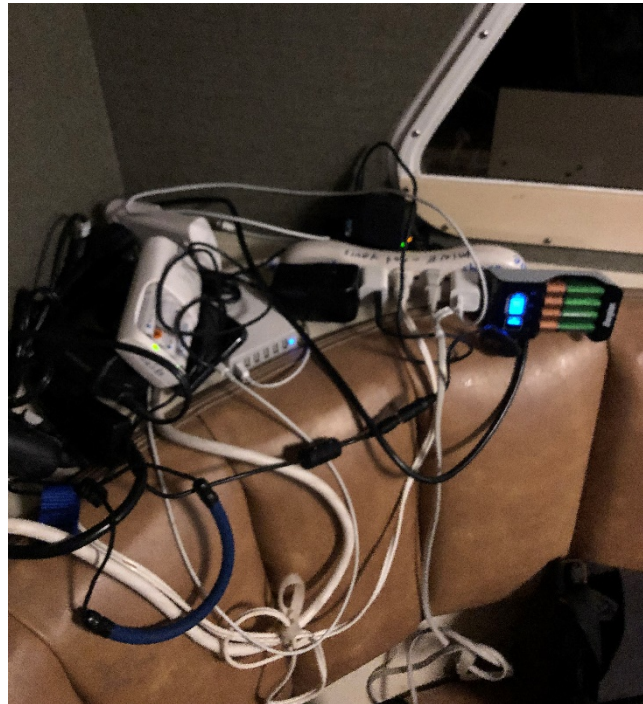
Once the divers were back on board, the flashlights and cameras that they used during the dive were stowed on the two aft tables in the salon. During interviews, crewmembers stated that some of these electronics, along with cell phones and tablets, were plugged in to recharge via 110-volt alternating current (AC) receptacle outlets located between the bench seat padding and on the aft bulkhead ([figure 8](#)). Crewmembers remembered seeing at least one passenger-owned power strip being used to recharge the electronics.

Figure 8. Photo taken during accident voyage (August 31, 2019) of devices plugged in to charge at the port side aft corner of the salon on the *Conception*. (Source: J. Dignam).

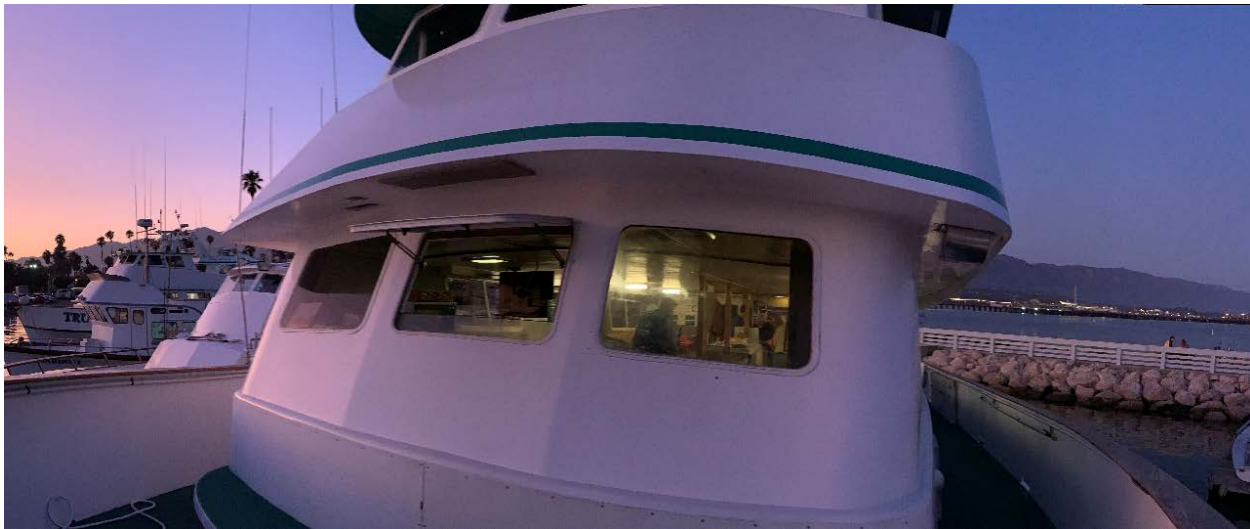
Figure 9. Preaccident photo of *Conception* forward salon windows. In this photo, the center window is open. However, during the accident, the window was closed and secured as the crew attempted to access the space. The port and starboard windows were not designed to be opened. (Source: T. Thompson)

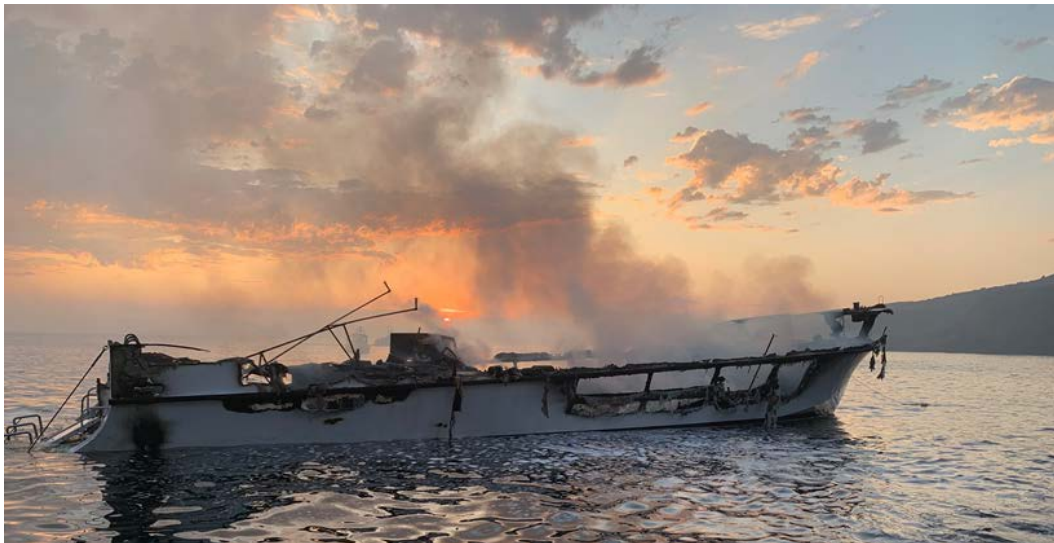
The fire was first reported extinguished at 0508 but re-flashed several times in the area of the fuel tanks and on the bow. Burned-out through-hull penetrations—where the main engine exhausts had been—eventually submerged, and the vessel sank stern first at 0654, approximately 20 yards from shore, in 61 feet of water. First responders were not able to safely board the vessel before it sank. Underwater recovery divers later found the wreckage lying on the seafloor in an upside-down position.

Figure 12. Small passenger vessel *Conception* at sunrise prior to sinking. (Source: VCFD)

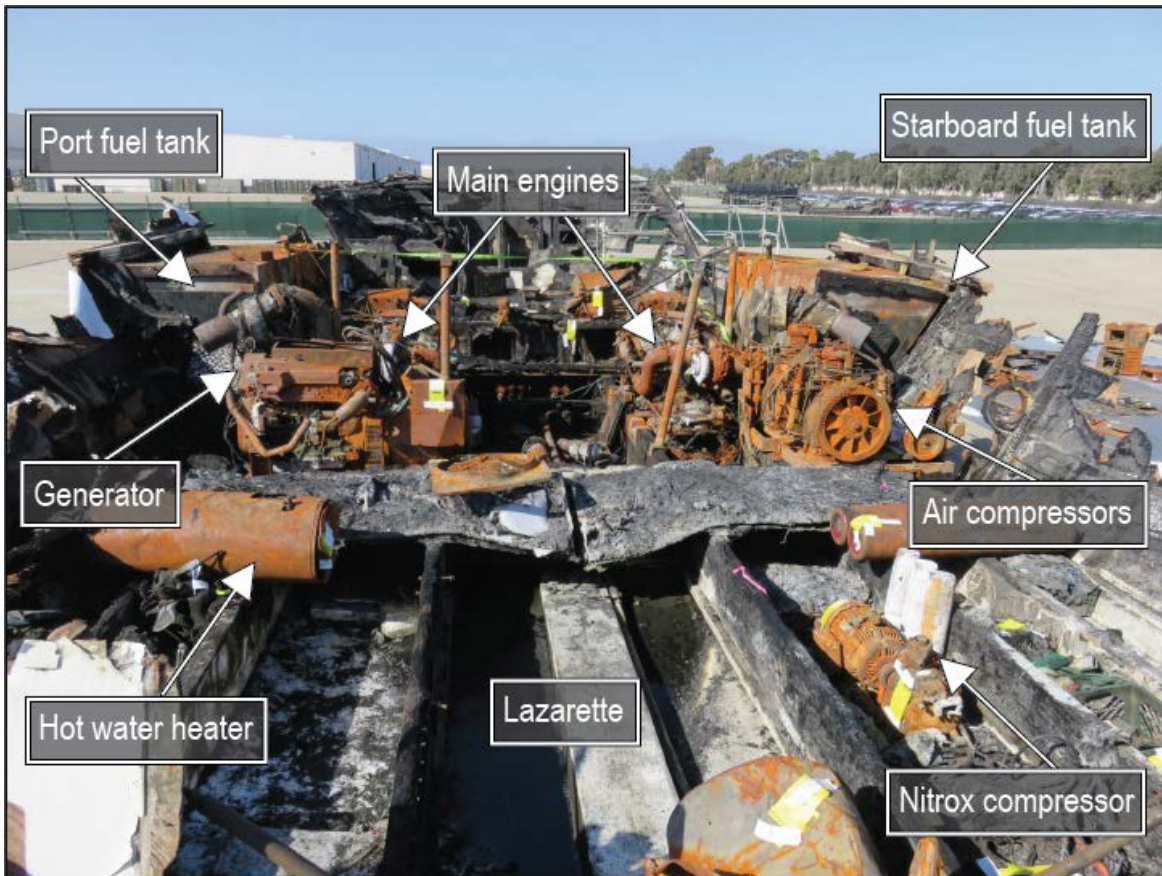
Figure 13. The salvaged hull of the *Conception*, looking from aft to forward, with recovered engine room and lazarette equipment placed in their original installed location (with the exception of the water heater, which was located on the starboard side).

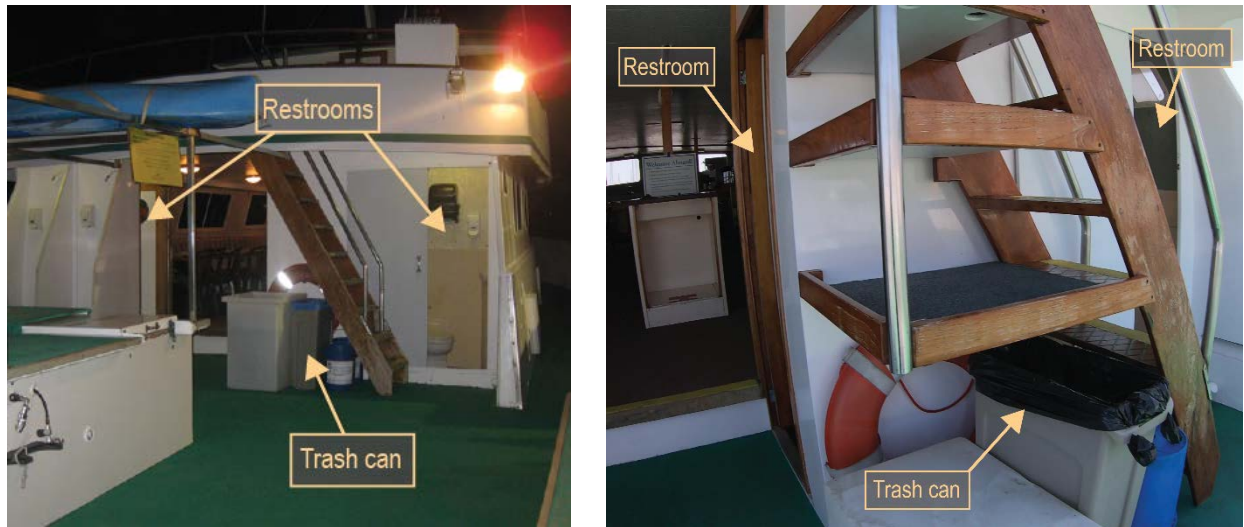
In eyewitness photos and videos of the *Conception*, large polyethylene trash cans can be seen throughout the interior and exterior areas of the vessel, including the bunkroom. The trash cans were manufactured by Rubbermaid from 2016 onward. Neither the Old T nor the New T regulations allow for these types of trash cans to be used in passenger bunkrooms and instead require that trash cans be constructed of non-combustible materials. New T regulations extend the prohibition on combustible trash cans to all compartments, but only apply to existing (Old T) vessels when the trash cans are replaced. Throughout the inspection history of the *Conception*, there were no remarks or deficiencies related to the waste receptacles on board.

Figure 18. Left: Photo from a previous voyage of stairway to the upper deck and restrooms of the *Conception*. Note the regular stowage of a polyethylene trash can under the stairway aft of the salon. Right: Still image from a 2019 video taken of the stairway on board the *Conception* with shelving installed. (Source: M. Ryan [left], R. Clevenger [right])

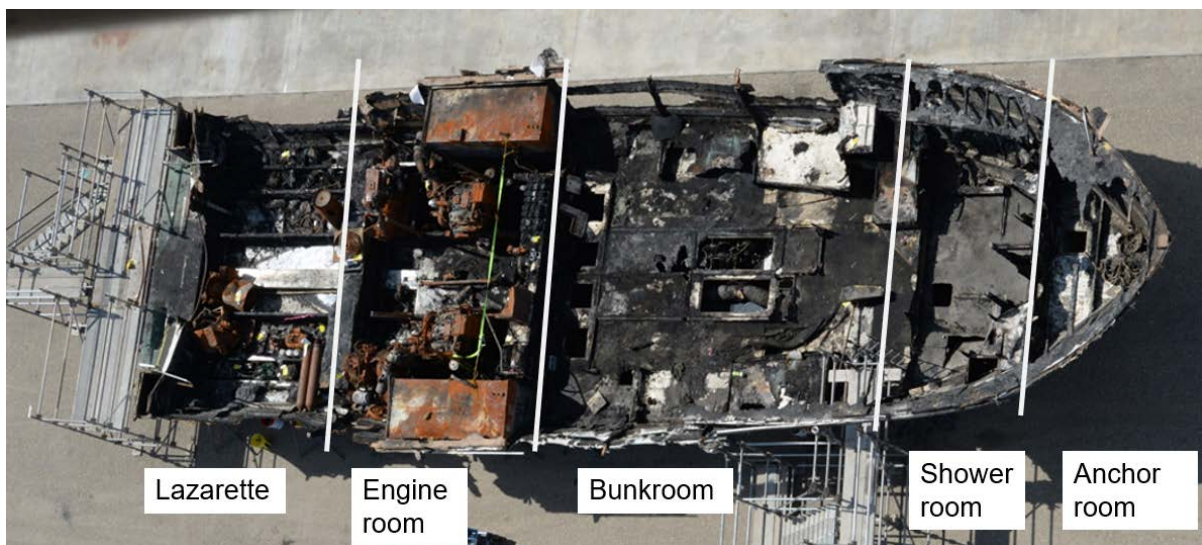
The hull of the *Conception*, where the below-deck compartments had been located, represented the bulk of the remaining structure. The transverse bulkheads were severely fire damaged, eliminating the separation of the below-deck compartments between the anchor room, shower room, bunkroom, engine room, and lazarette from forward to aft. The entire interior of the below-deck space was charred. Overall, the interior of the below-deck compartments had burned all the way down to the floor in the bunkroom and shower room and had consumed the floor, exposing the longitudinal frames, in both the engine room and lazarette ([figure 20](#)).

Figure 20. Below-deck areas of the *Conception*. The solid white lines mark the approximate boundaries of each compartment. (Source: FBI Evidence Response Team)

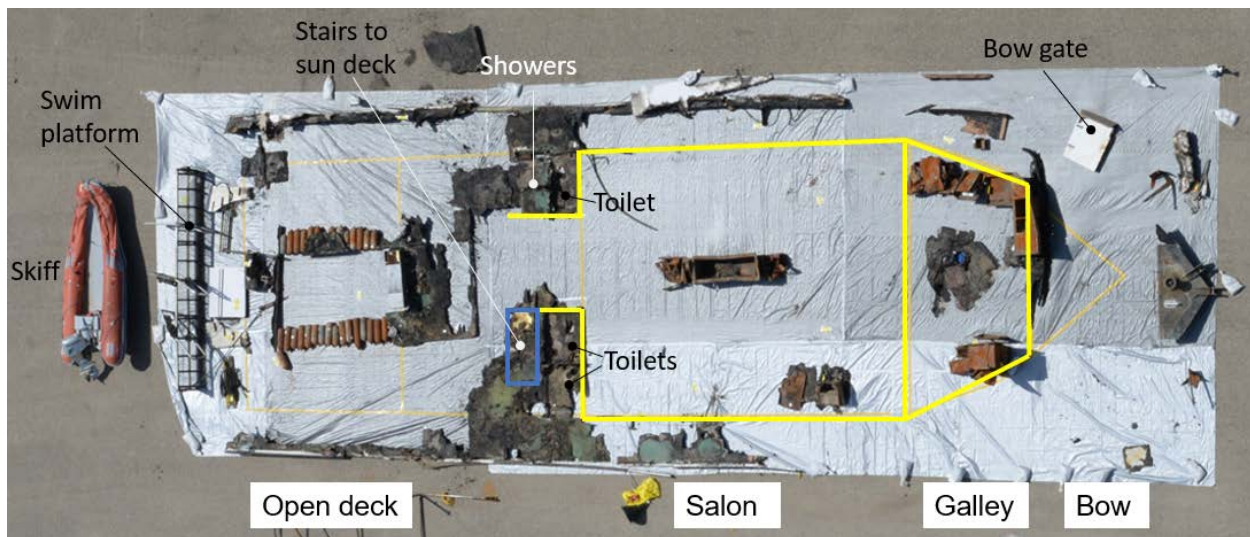
The structure and items recovered belonging to the main deck of the vessel consisted mostly of a few pieces of partially charred deck material and the noncombustible remains of the galley and salon equipment ([figure 21](#)). The decking material that remained belonged to the three restrooms on the main deck and small portions of the port and starboard walkways that were adjacent to them.

Figure 21. Wreckage belonging to the main deck of the *Conception*. Solid yellow lines indicate the enclosed spaces on the deck. The blue box marks the location of the stairway to the sun deck. (Source: FBI Evidence Response Team)

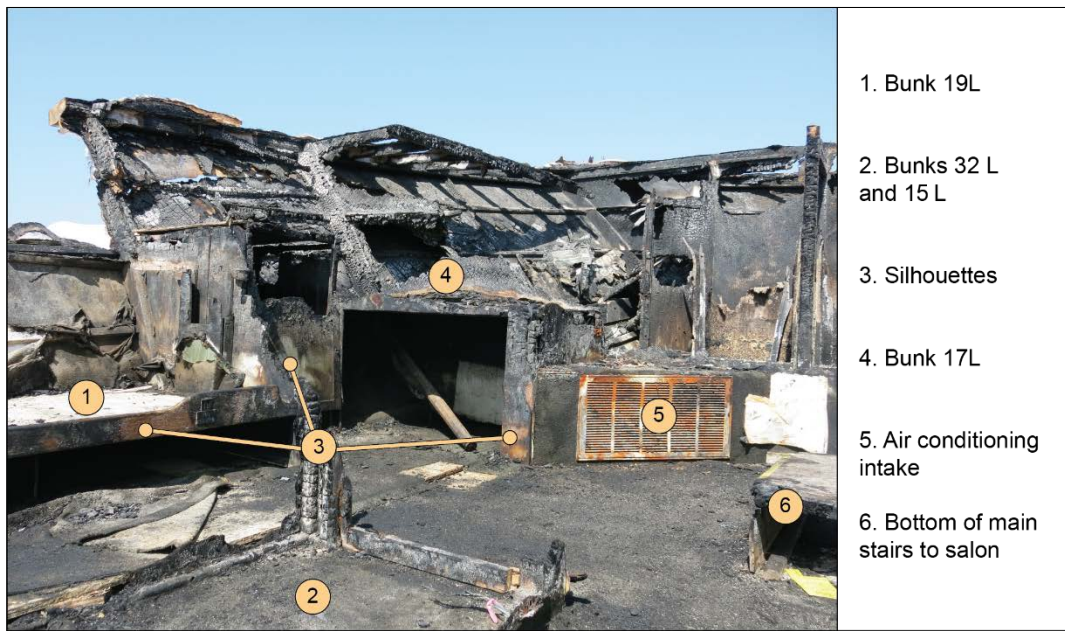
Figure 22. Postaccident photo of the bunkroom looking from the starboard aisle forward and to port.

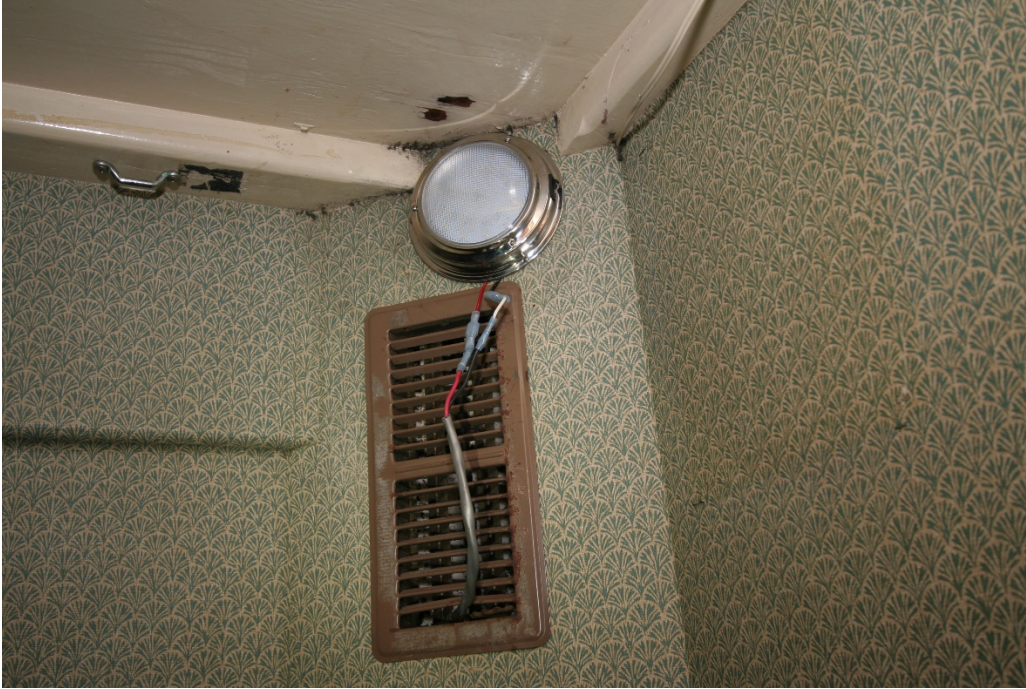
Investigators examined the *Vision's* salon for potential ignition sources. There were cable runs located behind the seatback of the bench-type seating and receptacle drops just under the seatbacks. The electrical cable runs were not enclosed in protective conduit, were often not supported, and did not have the appearance of a professional installation. Similar installations were also observed in the bunkroom ([figure 23](#)).

Figure 23. Power cable for lighting routed through ventilation grille in the *Vision's* bunkroom.

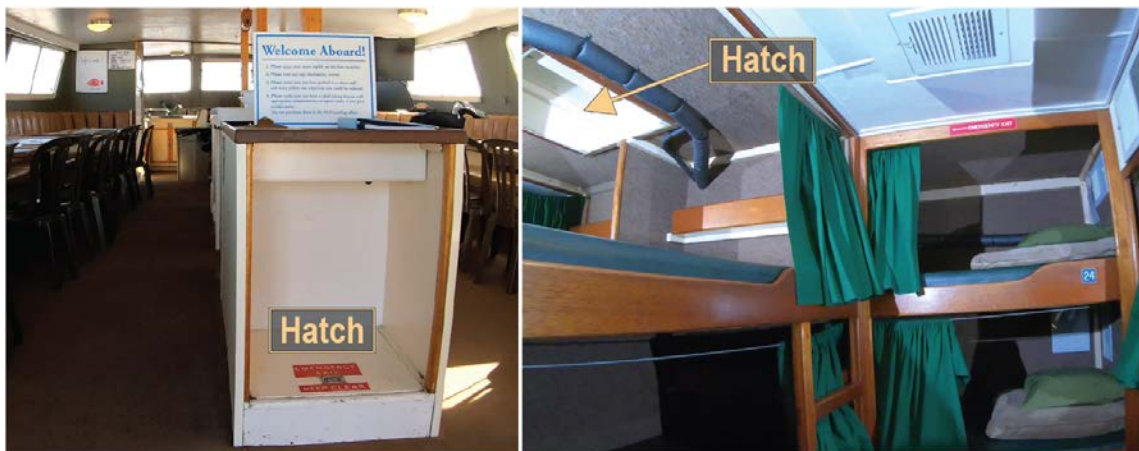
From the *Conception*'s bunkroom, there were two means of escape, both leading to the salon above: (1) the spiral stairs forward in the bunkroom ([figure 28](#)), and (2) the escape hatch installed centerline at the aft end of the bunkroom ([figure 29](#)). The hatch, marked with a two-inch plastic sign, was accessible from either aisle by climbing a wooden ladder, located in the corner where the aftermost middle and aft athwartship tiers of bunks were, onto the upper bunk; crawling to the centerline; and then pushing the plywood escape hatch up and out of the way. The hatch opened below the centerline countertop in the salon. Investigators measured the *Vision*'s escape hatch, which, according to the owner, was similar to the *Conception*'s escape hatch. The opening dimensions were approximately 22 inches by 22 inches through the main deck, with the aft-facing vertical opening having a clearance of about 35 inches from the main deck to the countertop above, or 28 inches from the top of the 7-inch main deck coaming. The two means of escape were at opposite ends of the bunkroom (so as to minimize the possibility of one incident blocking both escapes) and did not pass through a watertight door, thereby fulfilling the regulations applicable to the *Conception*. In the available documentation and inspection history of the vessel, no deficiencies or modifications were found related to the emergency escape hatch or the bunk ladders to the hatch.

Figure 29. The *Conception* bunkroom escape hatch from above in the salon (left) and in the bunkroom from the port side (right). (Source: R. Clevenger [left]; Truth Aquatics [right], annotated by NTSB)

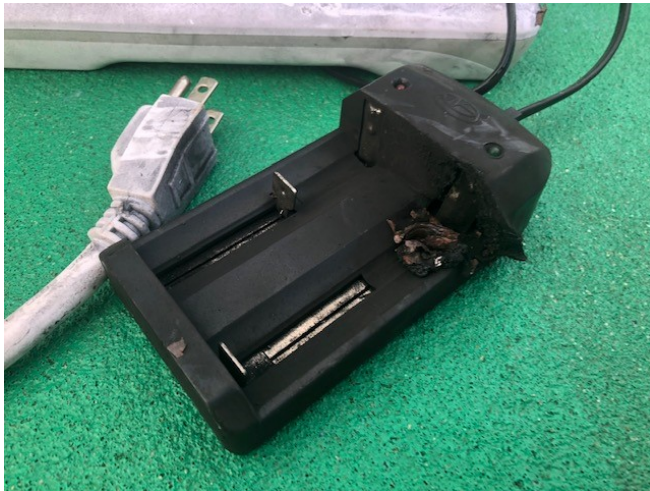
A small fire involving the charging of a lithium-ion battery took place on board the Truth Aquatics small passenger vessel *Vision* about a year before the fire aboard the *Conception*. On October 8, 2018, between 0415 and 0430 in the morning, a passenger, who was awake and in the galley, heard a “hissing” noise and then a loud “bang” that came from the bookshelf located at the aft starboard side of the salon (the *Conception* did not have a bookshelf in the same area). Another passenger, who was returning to the bunkroom after using the restroom on the aft deck, also heard the noise, which drew his attention to a fire on the bookshelf. He stated that the fire looked like a “torch” flame, and a battery charger (which was charging two lithium-ion batteries) was emitting smoke. The passenger in the galley grabbed a dry chemical extinguisher from the galley, and both passengers went to the battery charger. The passenger without the fire extinguisher unplugged the charger, grabbed the unburnt end of the charger, brought it out to the main deck, and threw it in to the rinse bin located under the stairs to the sun deck. The passenger with the fire extinguisher stated he discharged one “shot” on the bookshelf after the battery charger had been removed to extinguish the smoldering paper books on the shelf. He then grabbed a sponge and wetted the bookshelf and items on it to prevent reignition.

Figure 33. Photograph taken of the battery charger that caught fire on the *Vision* (with the batteries removed).
