Adopted December 1, 2021

# Fire aboard Roll-on/Roll-off Vehicle Carrier *Höegh Xiamen*

Pier 20, Blount Island

June 4, 2020

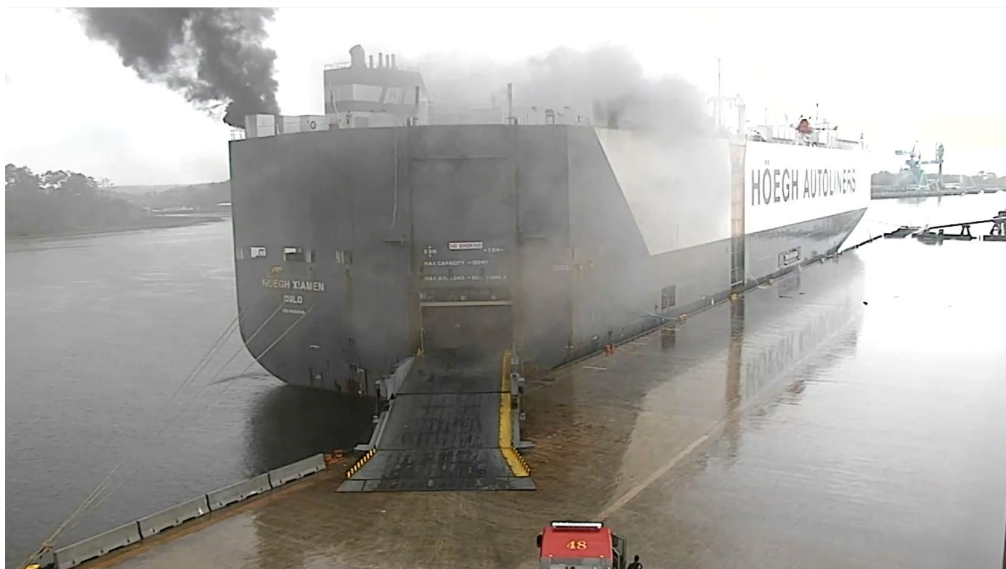
**Figure 4.** Smoke coming from aft cargo deck ventilation housing exhausts about 1603.

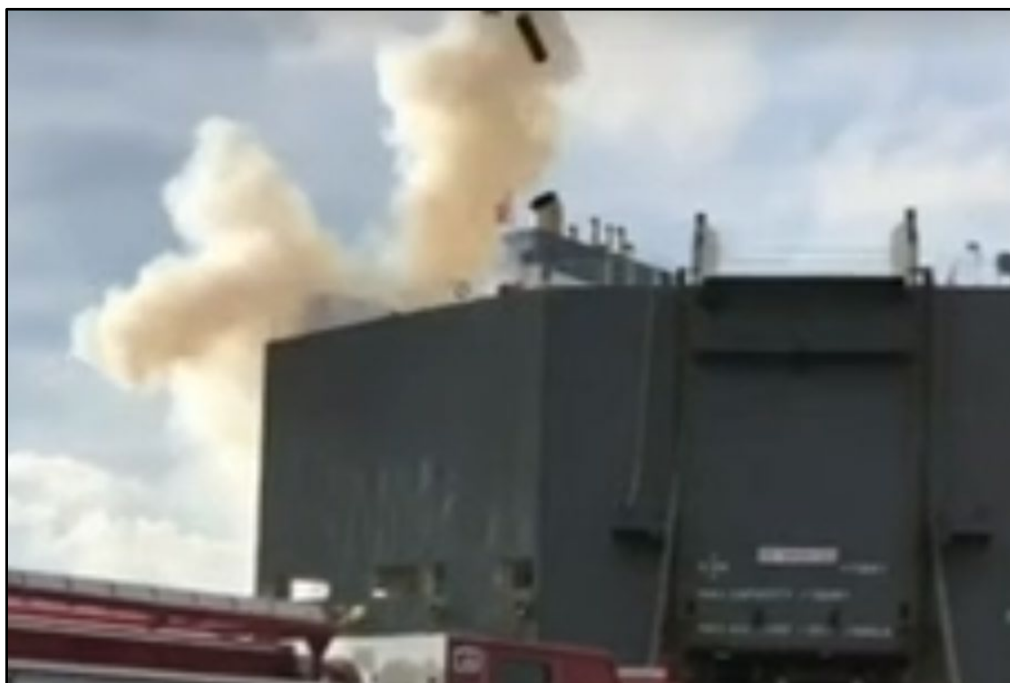
Upon opening the access door to the portside exhaust ventilation housing for deck 9, firefighters on deck 12 heard “a loud roar that sounded like a jet engine” as the exhaust housing “exploded” (see figure 5). The ventilation housing threw debris in the air. From the exterior of the ship, firefighters witnessed a tall column of grey-white smoke projecting from the stern on the weather deck and debris flying. According to firefighters, there may have been multiple explosions of varying magnitude. Firefighters in the port aft stairwell and on deck 5 described feeling intense heat and hearing a “roaring sound of rushing air.” Nine firefighters who were working in the stairwell or who had been staged on deck 5 were burned, five of them seriously, by the superheated air that rushed down the stairwell. Firefighters working on decks 7, 8, and 12 were unharmed.

**Figure 5.** Explosion of deck 9 ventilation exhaust housing. Note debris in air at top center of image. (Source: WJXT)

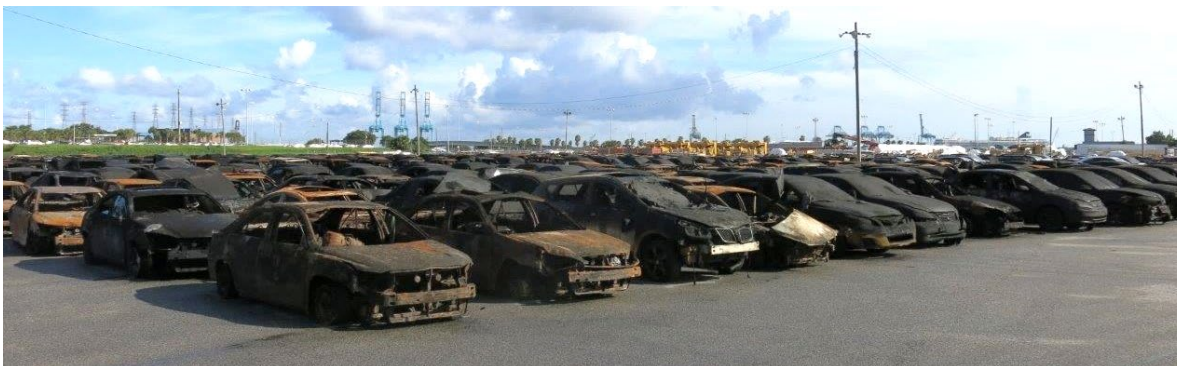
The *Höegh Xiamen* and its cargo of 2,420 used vehicles were declared a total loss valued at \$40 million (see figure 7). Salvage operations began on July 9, 2020. On August 30, after salvage operations were completed, the anchor-handling tug, *Alp Striker*, towed the ship from Jacksonville to Aliaga, Turkey, where the *Höegh Xiamen* was recycled.

**Figure 7.** Thermally damaged vehicles after removal from the *Höegh Xiamen*, Blount Island, Jacksonville, Florida, July 23, 2020.

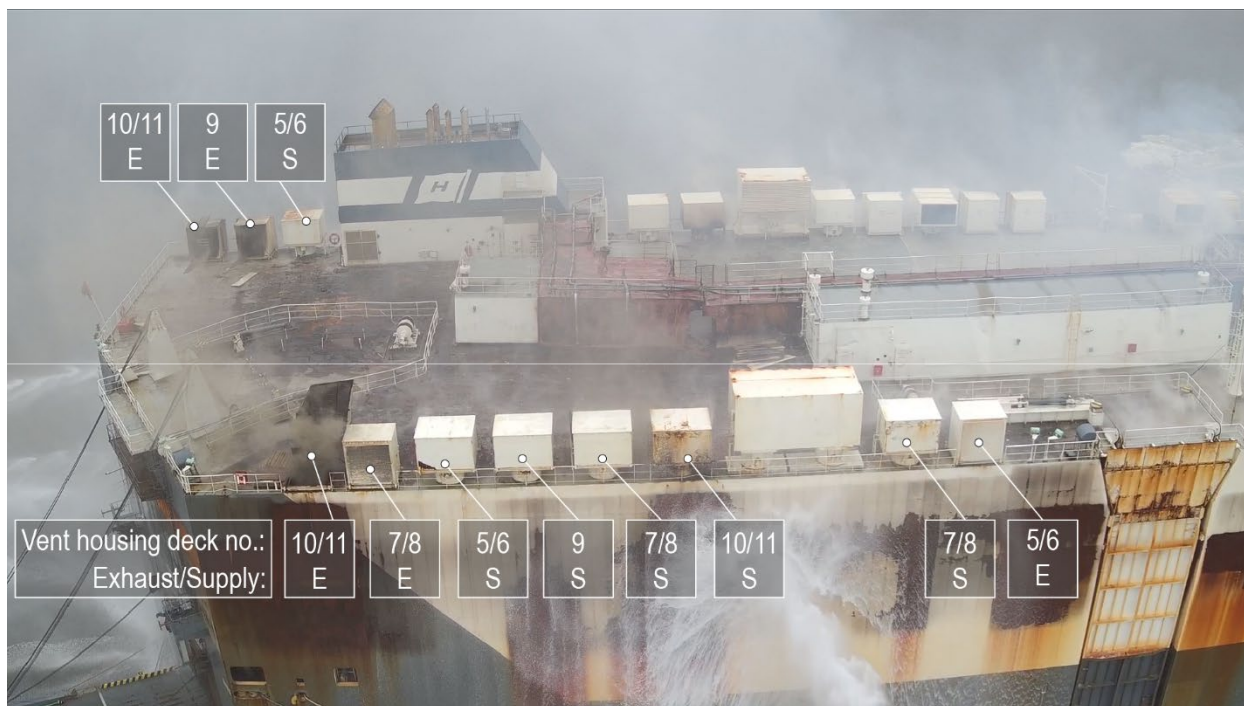
After the accident, the JFRD and the Coast Guard examined the vessel's ventilation housings during walkarounds of deck 12. (Figure 11 shows the damaged aft housings.) The condition of the housings fell into three categories: 43 had no signs of external sooting or mechanical damage; 8 exhibited external sooting but no mechanical damage; and 7 exhibited both external sooting and mechanical damage.

**Figure 11.** Damaged aft ventilation housings after the reported explosion of portside vent housing for deck 9 (9E in the photo). (Background source: JFRD)

The ventilation housings associated with decks 7/8, 9, and 10/11 exhibited sooting, and the housings associated with decks 9 and 10/11 exhibited mechanical damage. The ventilation housings for deck 10/11 exhibited greater levels of mechanical damage than those of deck 9.

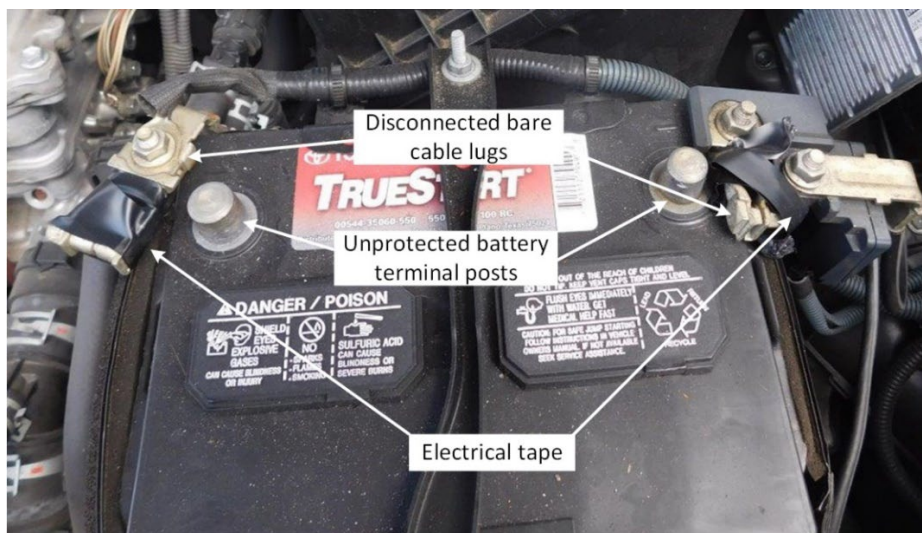
The sample of 39 forklift vehicles loaded in Jacksonville included 12 vehicles that did not have batteries and 3 vehicles with battery cables that had not been disconnected from the battery terminal posts. Of the 24 remaining vehicles, 22 had exposed battery terminal posts; none of these were protected with plastic caps. Instead, the battery cable lugs were partially wrapped with electrical tape, leaving exposed metal on the lug (see figure 14). Investigators also found 14 instances of disconnected and exposed battery cable lugs resting above or on top of the vehicle battery and touching or nearly touching the exposed battery terminal posts. All of the forklift vehicles examined (except those without batteries) were found to have batteries not secured in accordance with Grimaldi's procedures.

**Figure 14.** Battery in forklift vehicle removed from deck 5. The disconnected battery cable lugs were located near terminal posts, and the battery terminal posts were unprotected. (Source: Coast Guard)

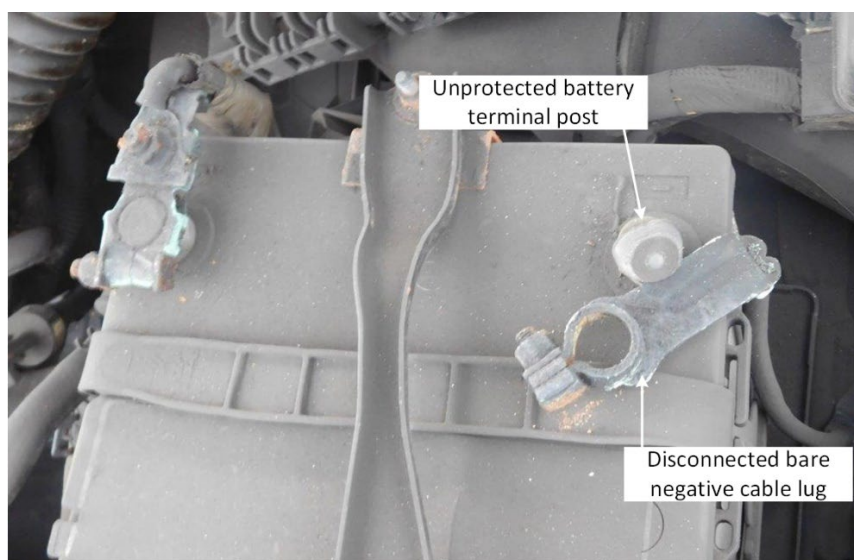
The sample of 20 towed vehicles loaded in Jacksonville included one vehicle that did not have any battery in the engine compartment and two vehicles with battery cables that had not been disconnected from the negative battery terminal posts. Sixteen of the remaining 17 vehicles were found with visibly exposed battery terminal posts that were not protected with plastic caps. Investigators also found 13 instances of disconnected and exposed battery cable lugs resting above or on top of the vehicle battery and touching or nearly touching the exposed battery terminal posts (see figure 15). All the towed vehicles examined (except the one without a battery) were found to have batteries not secured in accordance with Grimaldi’s procedures. Table 4 summarizes the towed vehicle examination.

**Figure 15.** Battery in towed vehicle removed from deck 7. The disconnected bare cable lug was in physical contact with unprotected battery terminal post. (Source: Coast Guard)

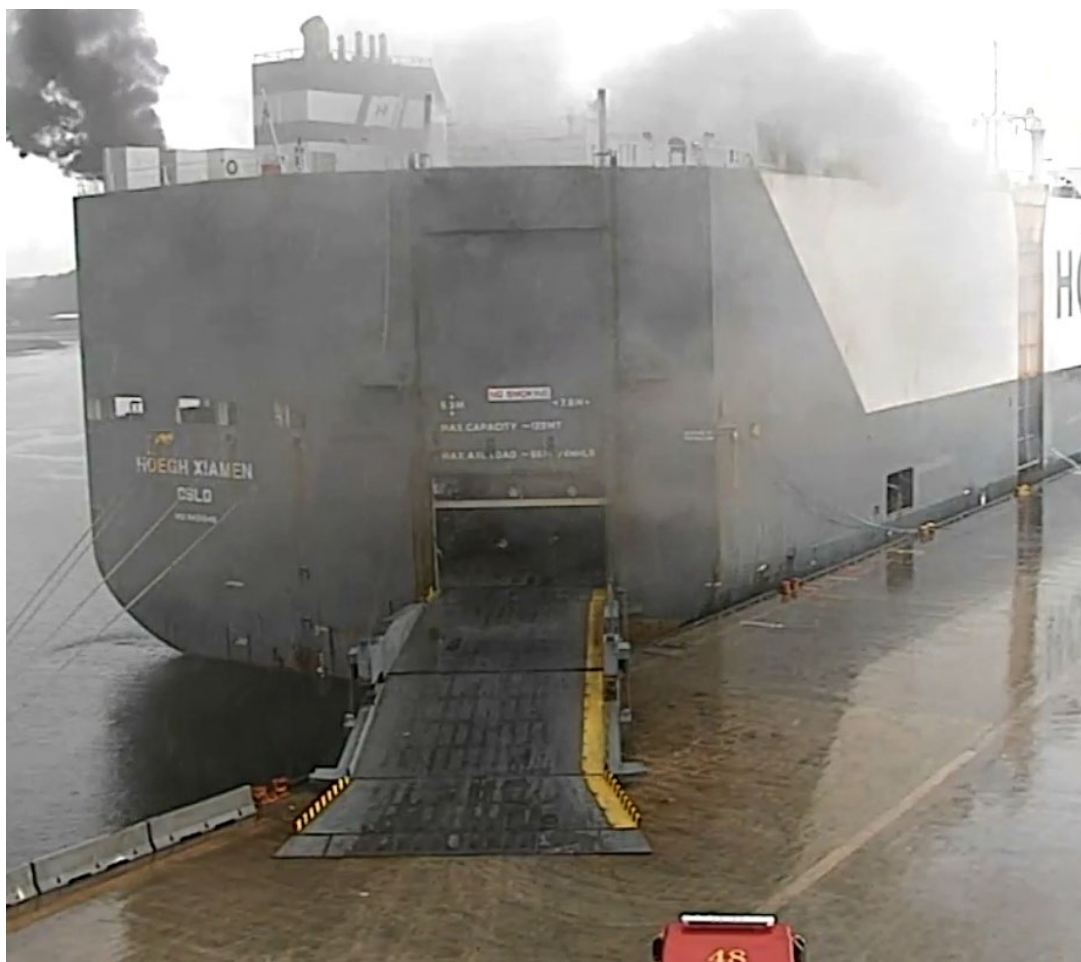
The video showed that when Engine 48 arrived, there was smoke flowing from the two aftmost exhaust vents on the port side (corresponding to decks 9 and 10/11) and the two aftmost exhaust vents on the starboard side (corresponding to decks 10/11 and 7/8) (see figure 16). At the time of Engine 48's arrival, the white paint on the starboard side of the *Höegh Xiamen* did not appear to have any thermal discoloration.

**Figure 16.** Engine 48 arriving on scene about 1603. Starboard vents 10/11E and 7/8E and port vents 10/11E and 9E exhibit smoke flow. (Source: Jacksonville Port Authority)

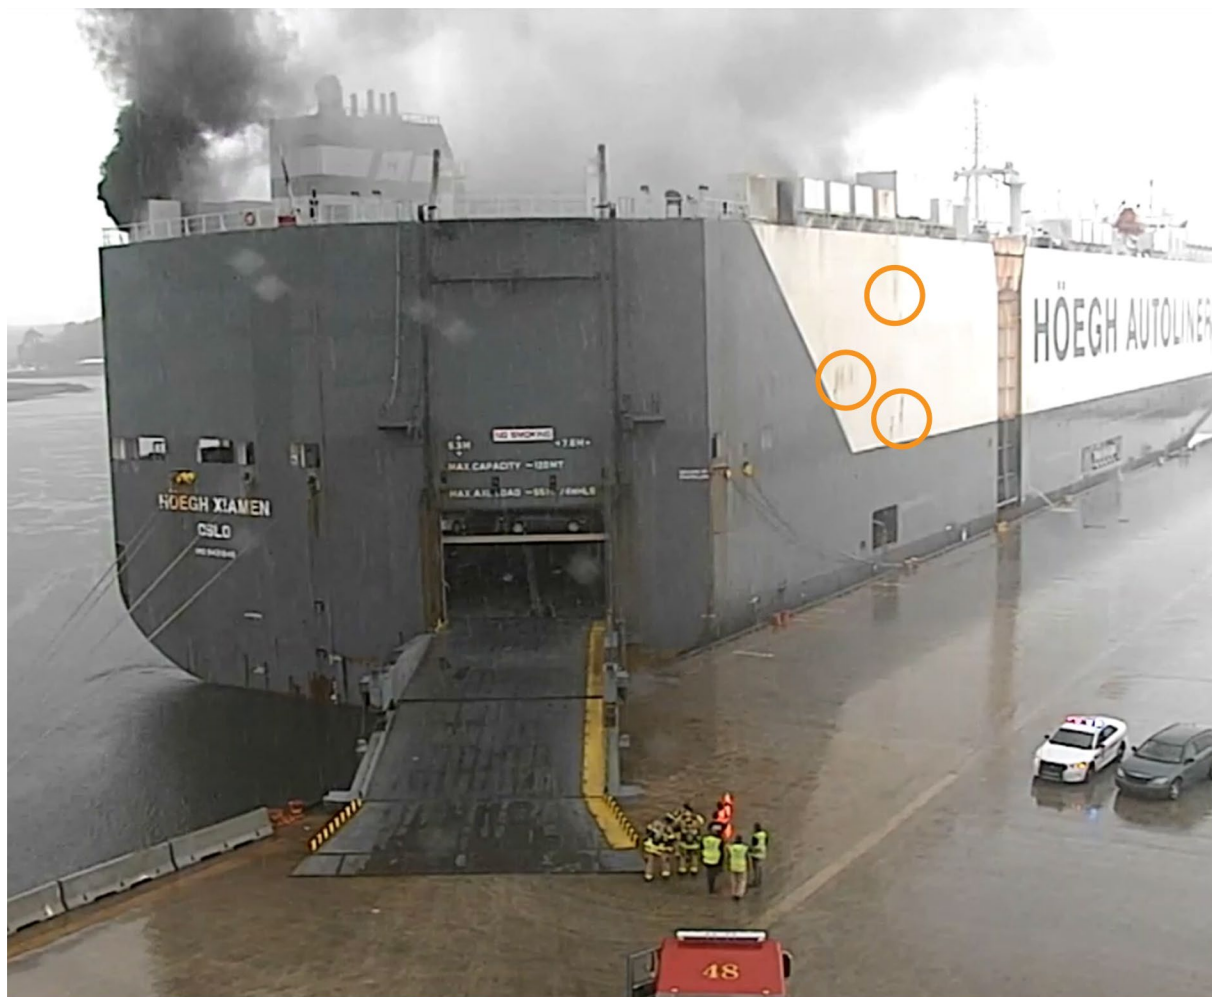
About 5 minutes after the fire department first arrived on scene, the video showed firefighters and one crewmember at the edge of the vessel's stern ramp. Smoke continued to rise from the vents on the ship's stern, with a much darker, thicker plume emitting from the port side. The video showed that, at this time, the white paint on the vessel's starboard side was beginning to exhibit thermal discoloration in areas corresponding to the fire zones associated with decks 7/8 and 10/11 (see figure 17). About 5 minutes later, the discoloration became more pronounced, and the discoloration continued to darken over the next 15 minutes.

**Figure 17.** About 1608, 5 minutes after Engine 48's arrival, the white paint on the starboard side of the vessel exhibits thermal discoloration (circled in orange). Starboard vents 10/11E and 7/8E and port vents 10/11E and 9E exhibit smoke flow. (Source: Jacksonville Port Authority)
