**Accident Investigation Report -
Pedestrian Bridge Collapse at Florida
International University**

**UniversityCity Prosperity Project
Miami, Florida**

Prepared by:
Munilla Construction Management (MCM)
6201 SW 70th Street
Second Floor
Miami, FL 33143

Date:
September 20, 2019

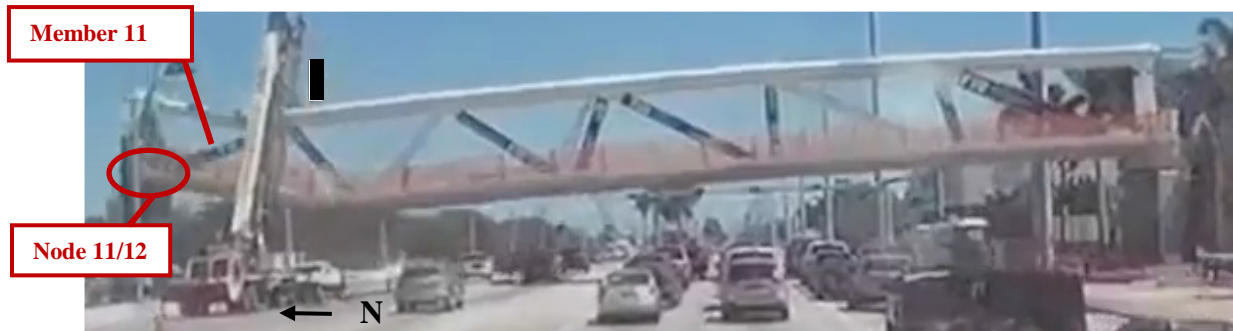
Figure 1. Frame from dashboard video of Main Span during collapse, showing that the failure originated near the north end of the Main Span.¹

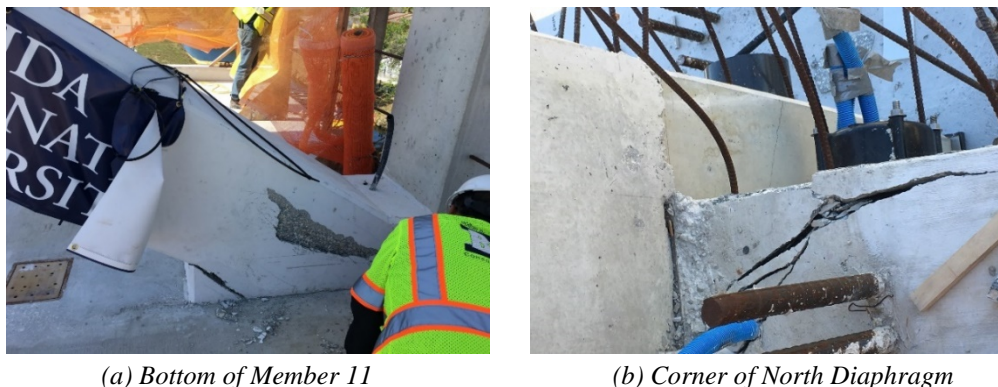
Figure 2. Cracks at north end of Main Span (Node 11/12) on March 14, 2018, showing examples of cracking discovered in the Main Span prior to the collapse.²

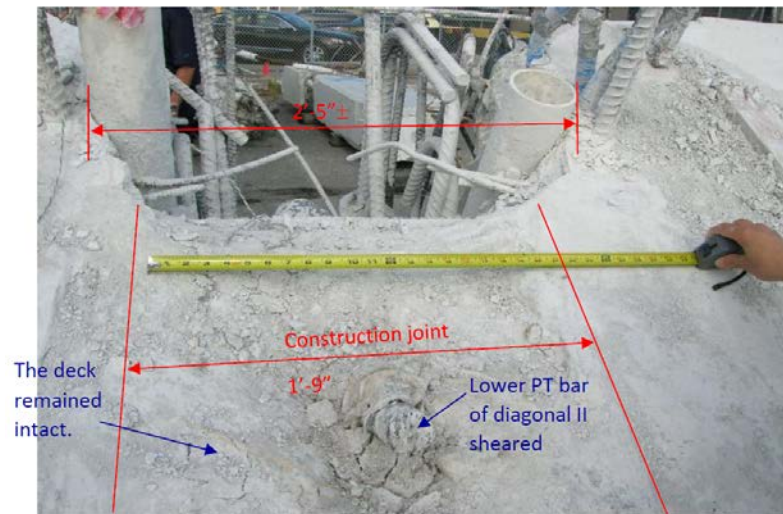
Figure 32. Post-collapse image of the joint between Node 11/12 and the Deck.¹⁰³

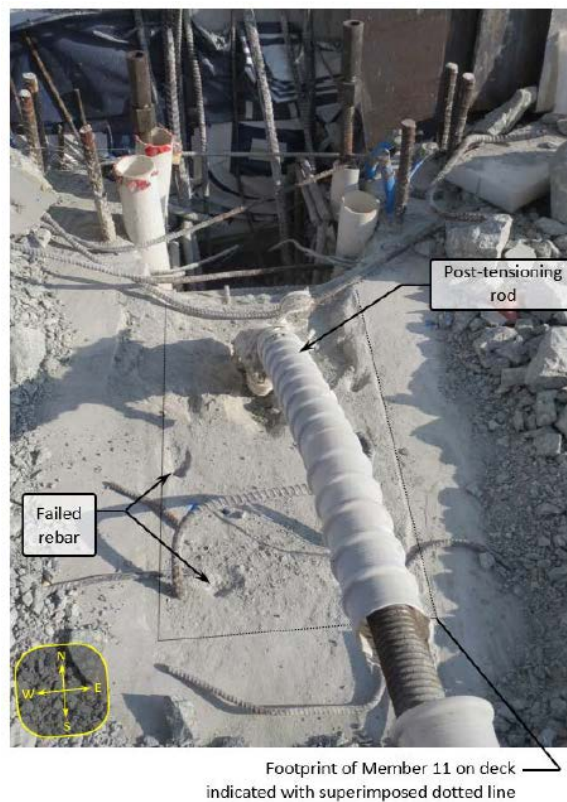
Figure 33. Post-collapse image of the joint between Node 11/12 and the Deck.¹⁰⁴

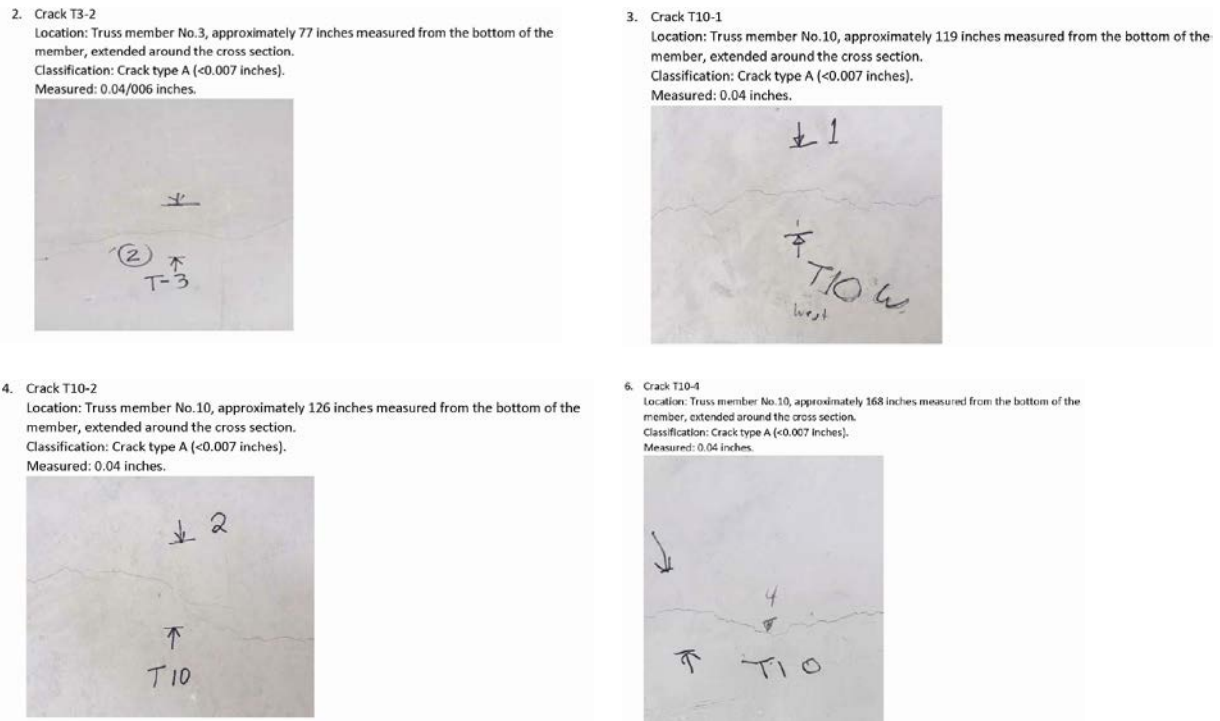
Figure 35. Cracks in Truss Members 3 and 10 on February 6, 2018, after application of PT in Members 2 and 11.¹¹⁴

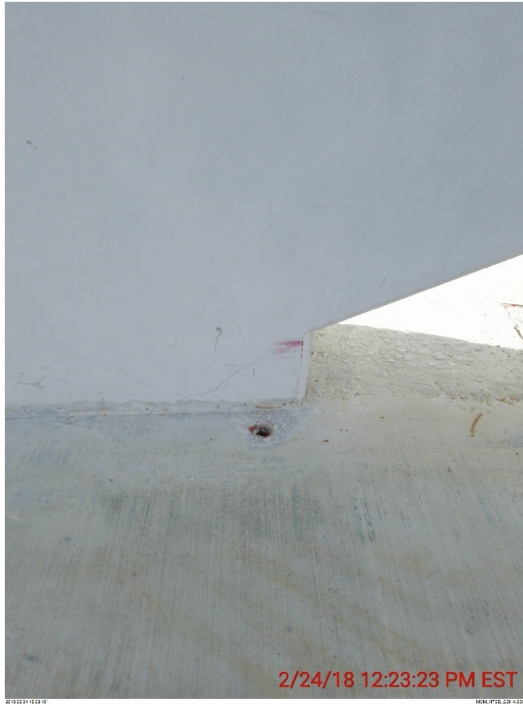
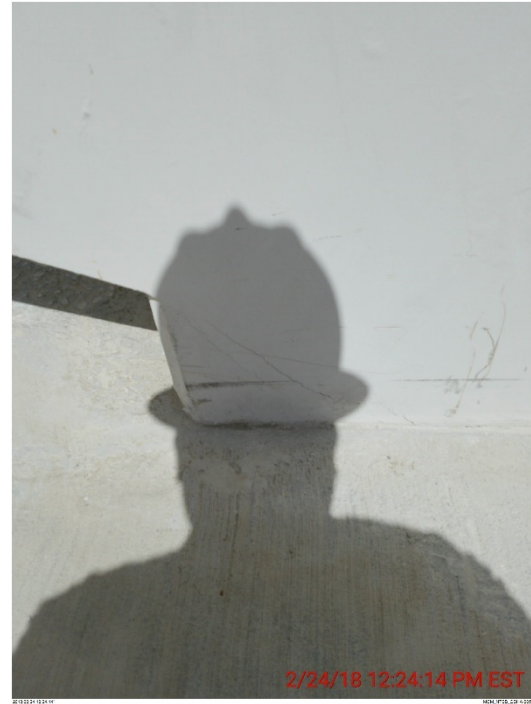
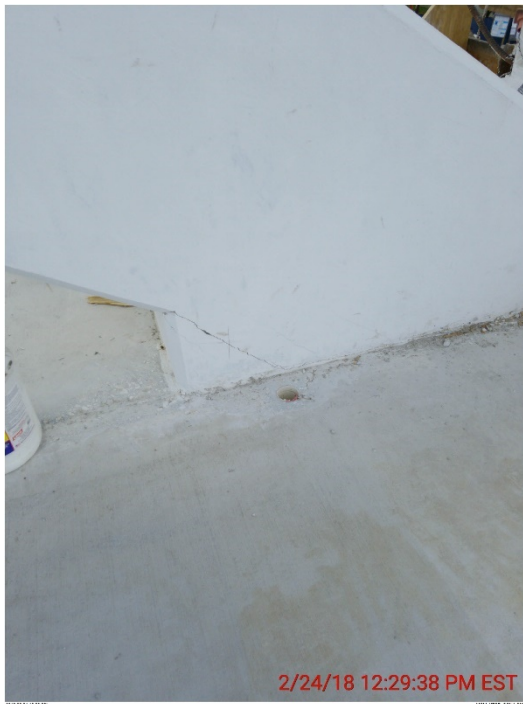
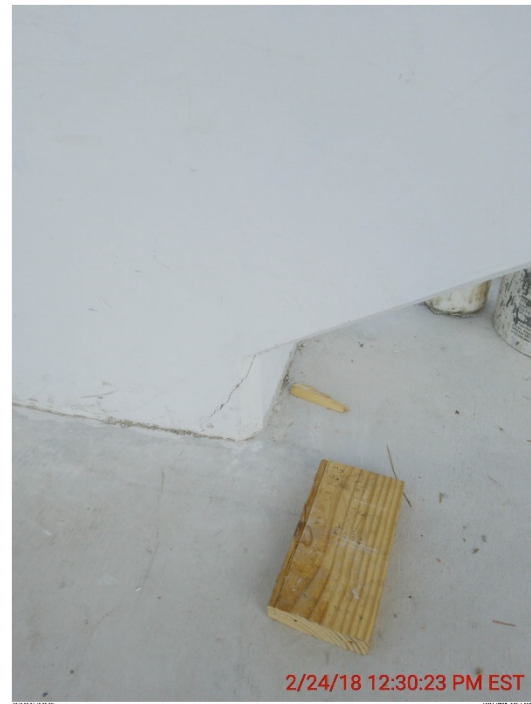
Figure 36. Cracks documented on February 24, 2018, before complete removal of shoring.¹²¹

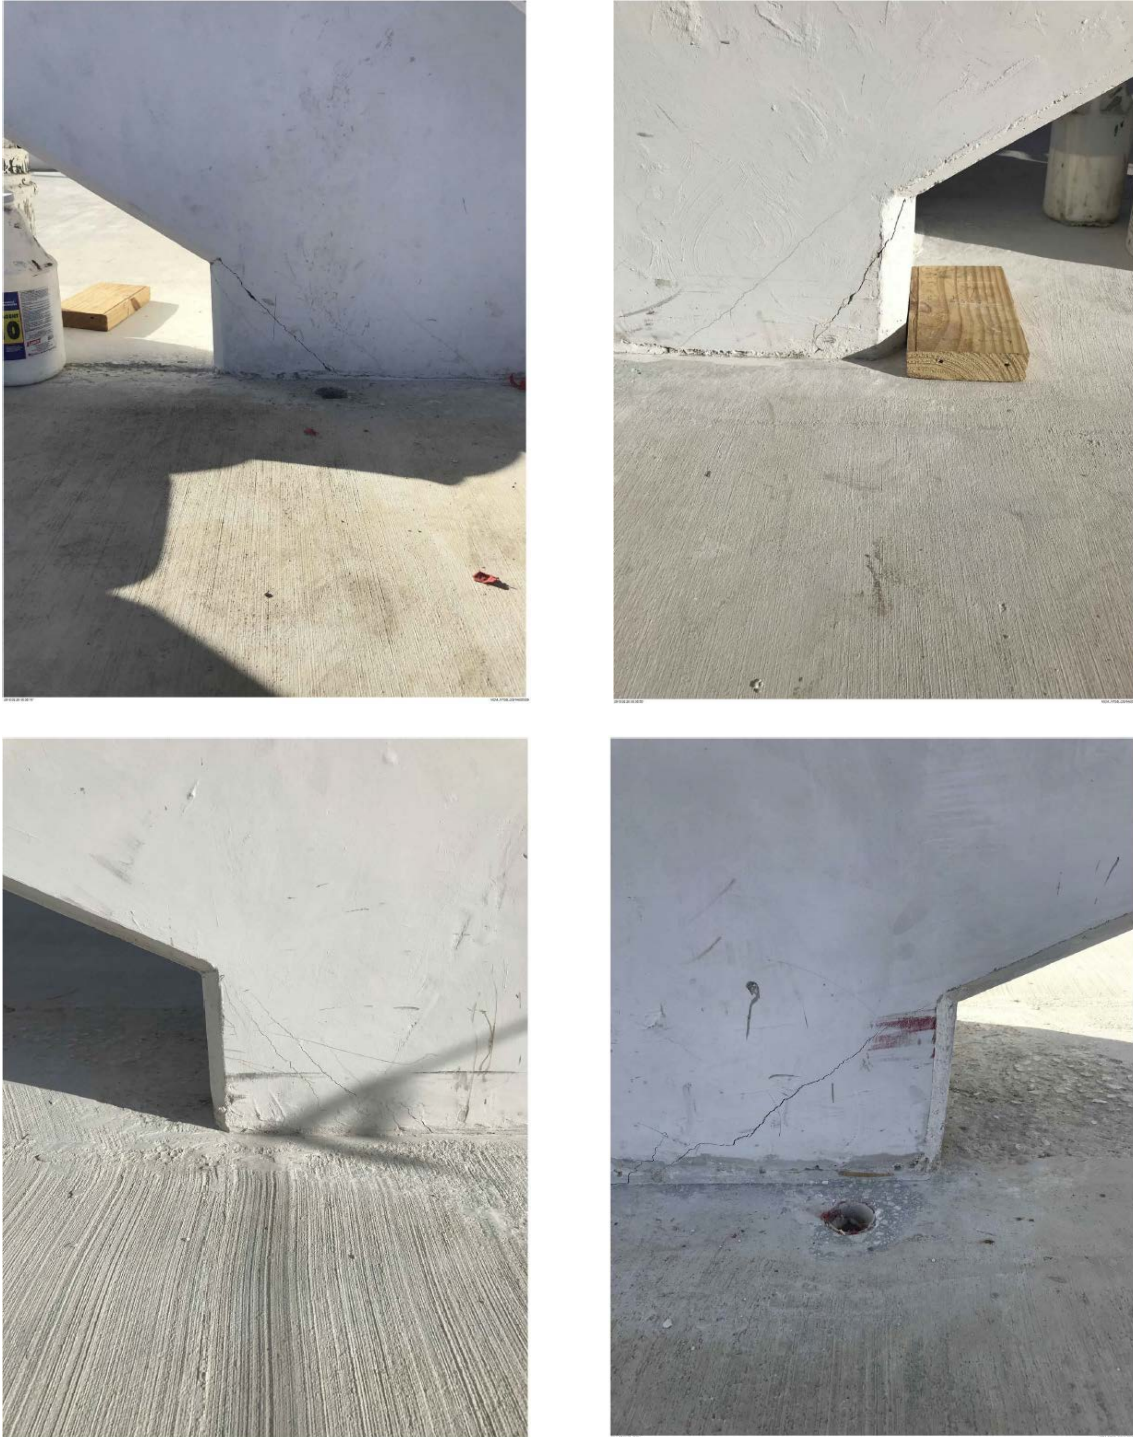
Figure 37. Cracks after removal of forms and shoring on February 26, 2018.¹²²

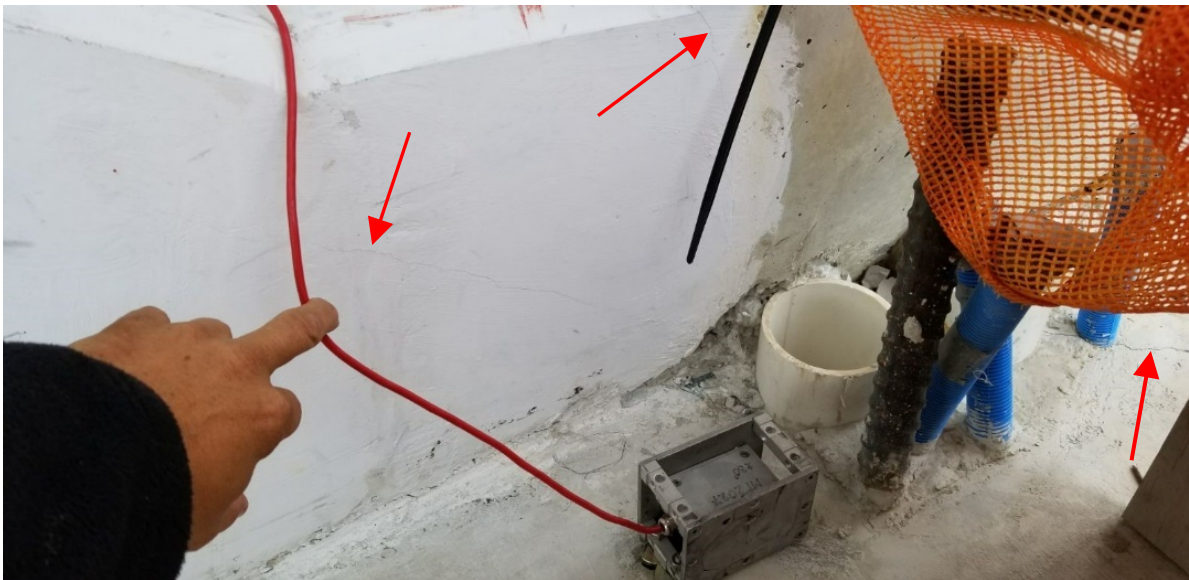
After the Bridge was installed, BPA observed cracks in Node 11/12 *before* the destressing of the PT bars in the end Diagonals (Figure 39). A frame from a video of the Main Span just after erection shows diagonal cracks under Member 11 at the south end of Node 11/12, which had been repaired prior to the move. Cracks near Node 11/12 did not open during and immediately after the move (Figure 40).

Figure 39. Cracks in and near Node 11/12 after erection and before destressing of Member 11 PT (indicated with red arrows).¹²⁸

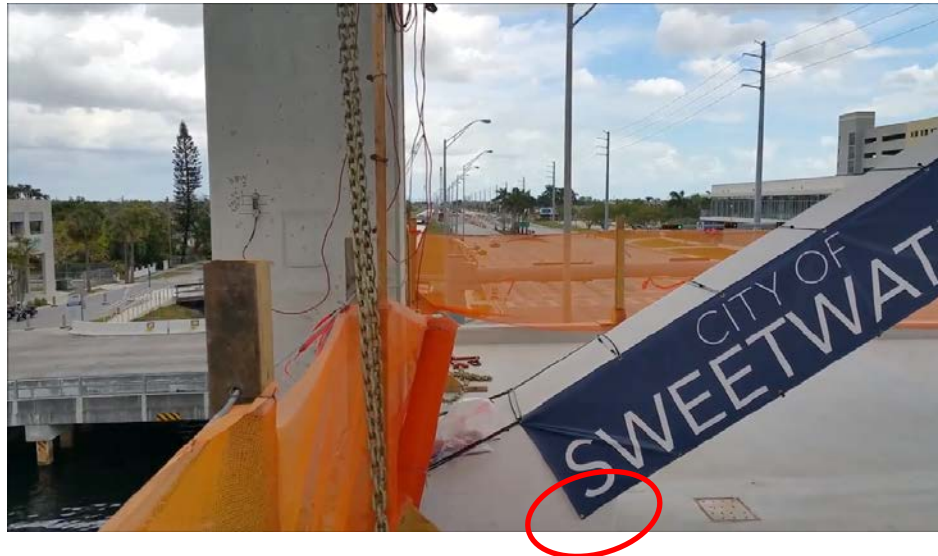
Figure 40. Node 11/12 after erection and before destressing of Diagonals 2 and 11 (location of repaired crack indicated with red circle).¹²⁹

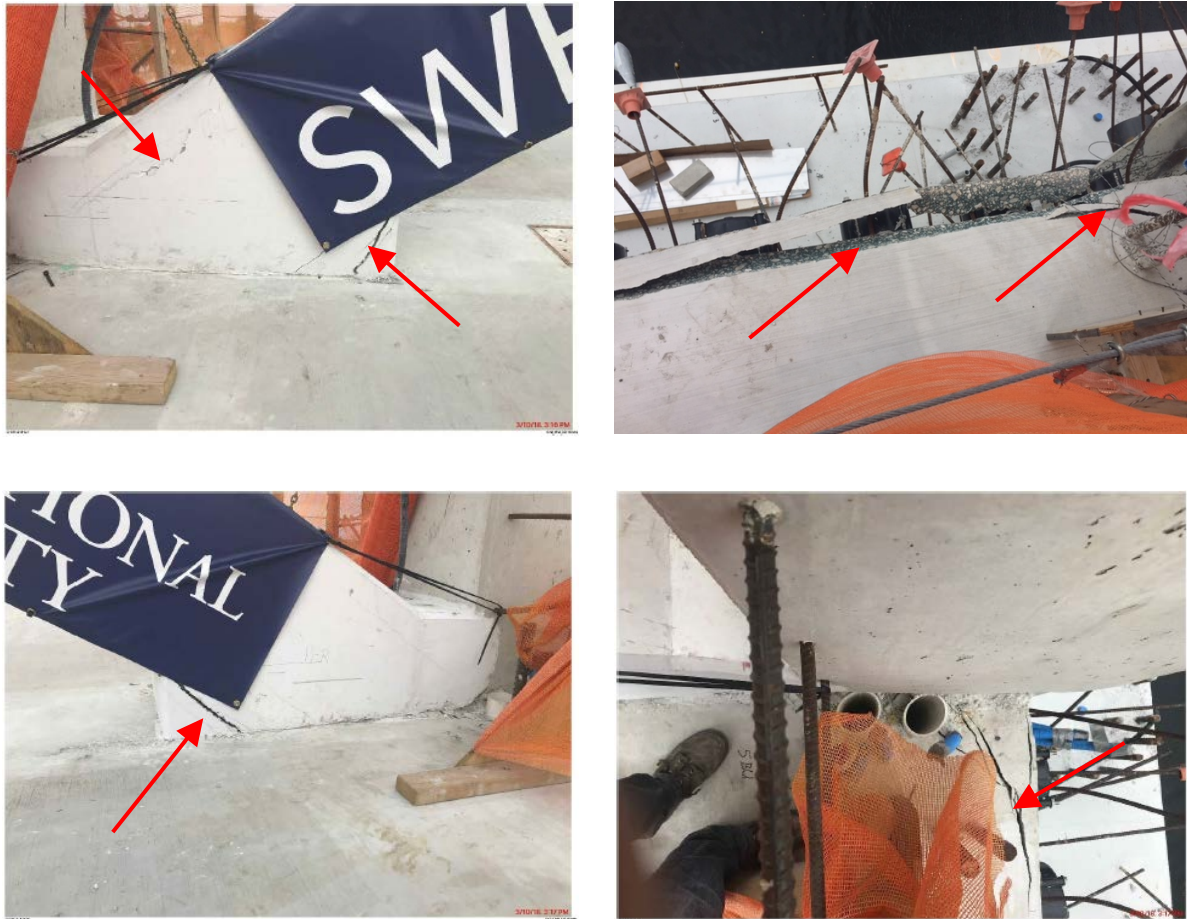
Figure 41. Cracks observed after initiation of destressing on March 10, 2018, at north end of Main Span (indicated with red arrows).¹³⁴

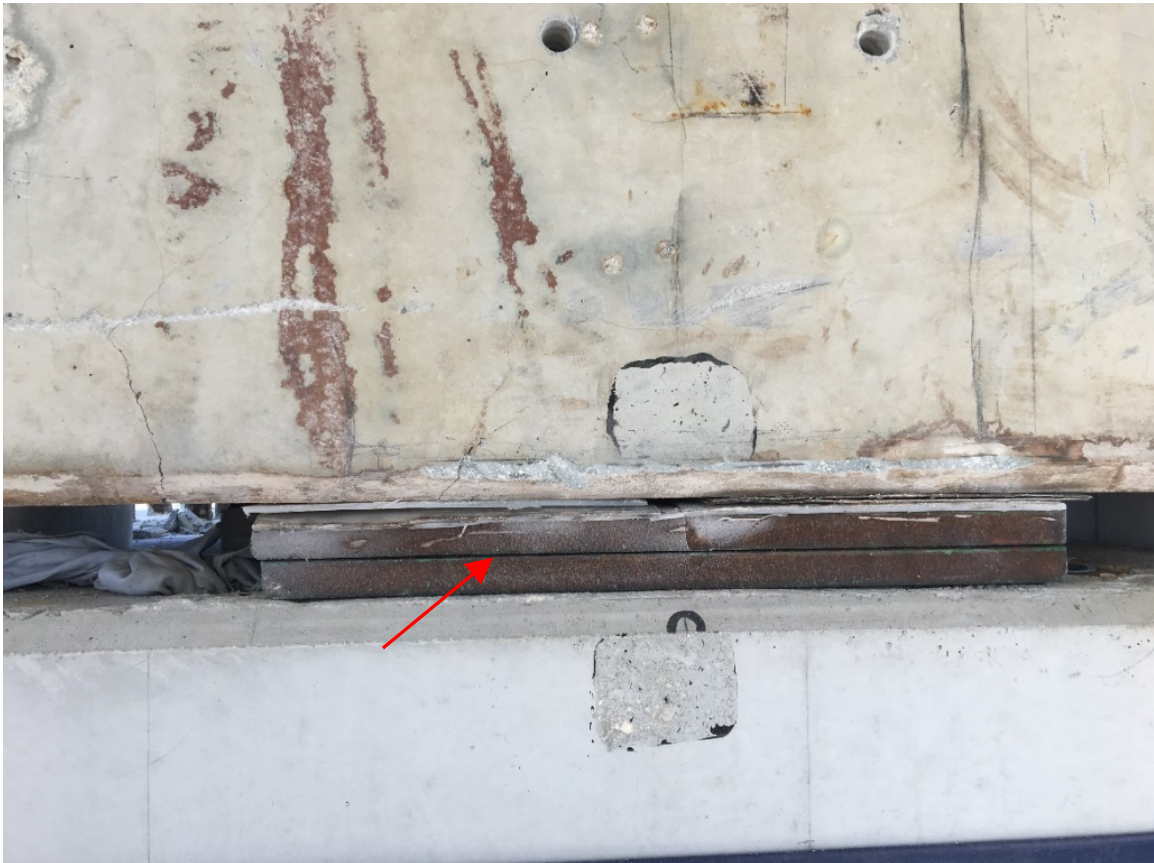
Figure 42. Steel shims under vertical Member 12 on March 13, 2018 (indicated with red arrow).¹⁵¹

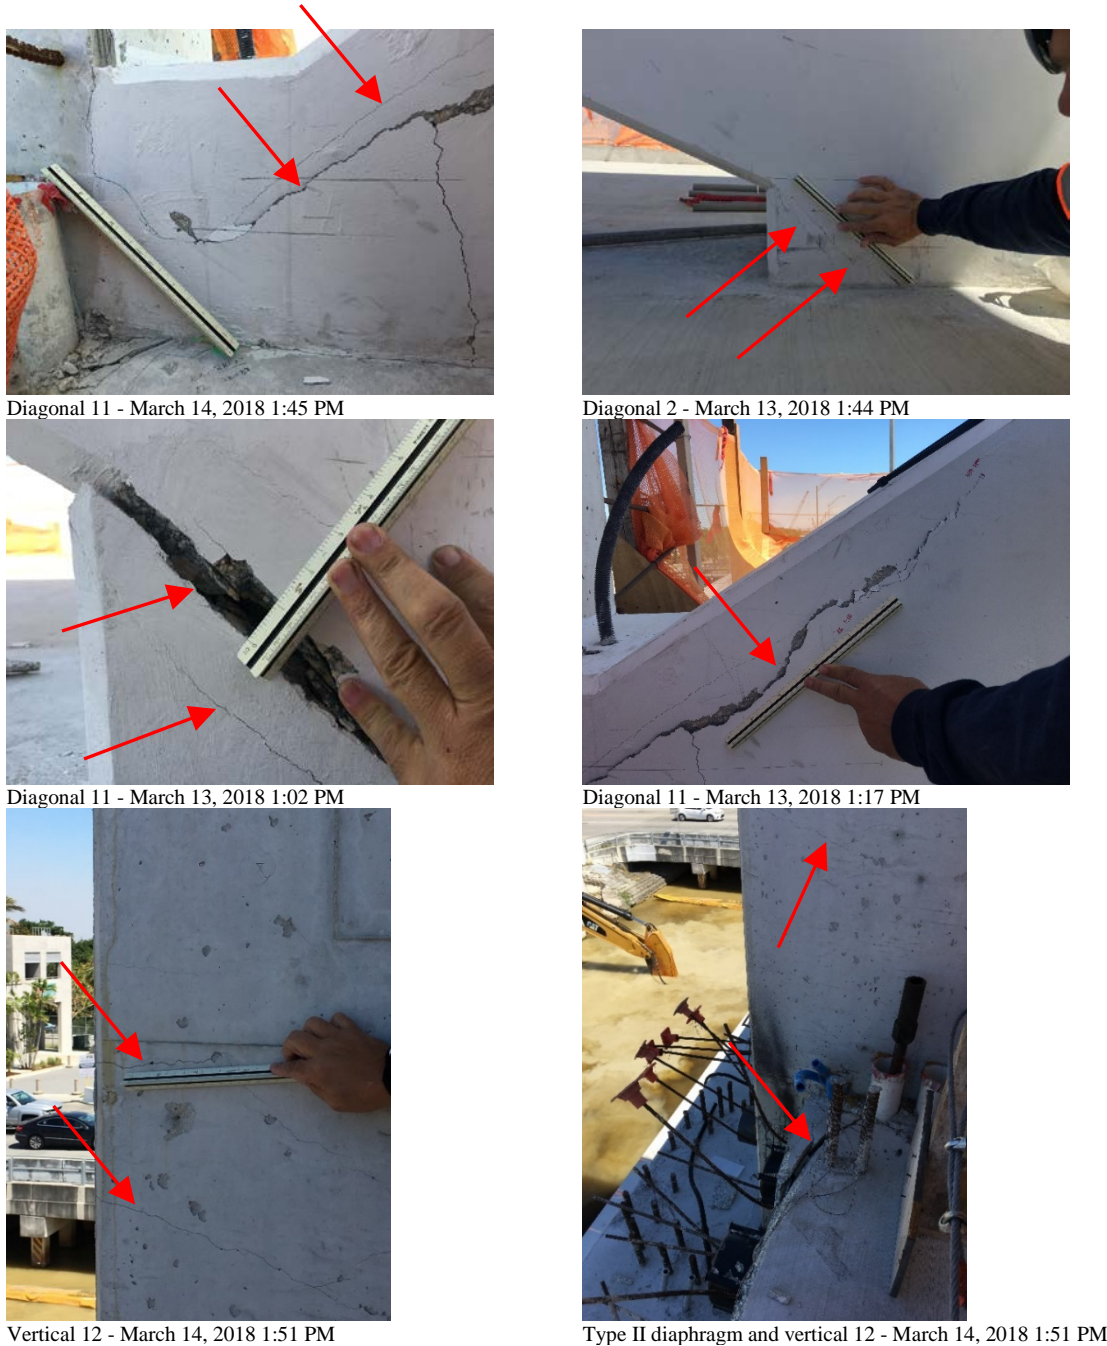
Figure 43 shows cracks observed near the bases of the Truss end Members and north side of Member 12 after the erection of the Main Span and destressing of PT bars in Members 2 and 11.

Figure 43. Cracks observed by BPA near bases of Truss end Members after destressing of PT in diagonal Members 2 and 11 (indicated with red arrows).¹⁵²

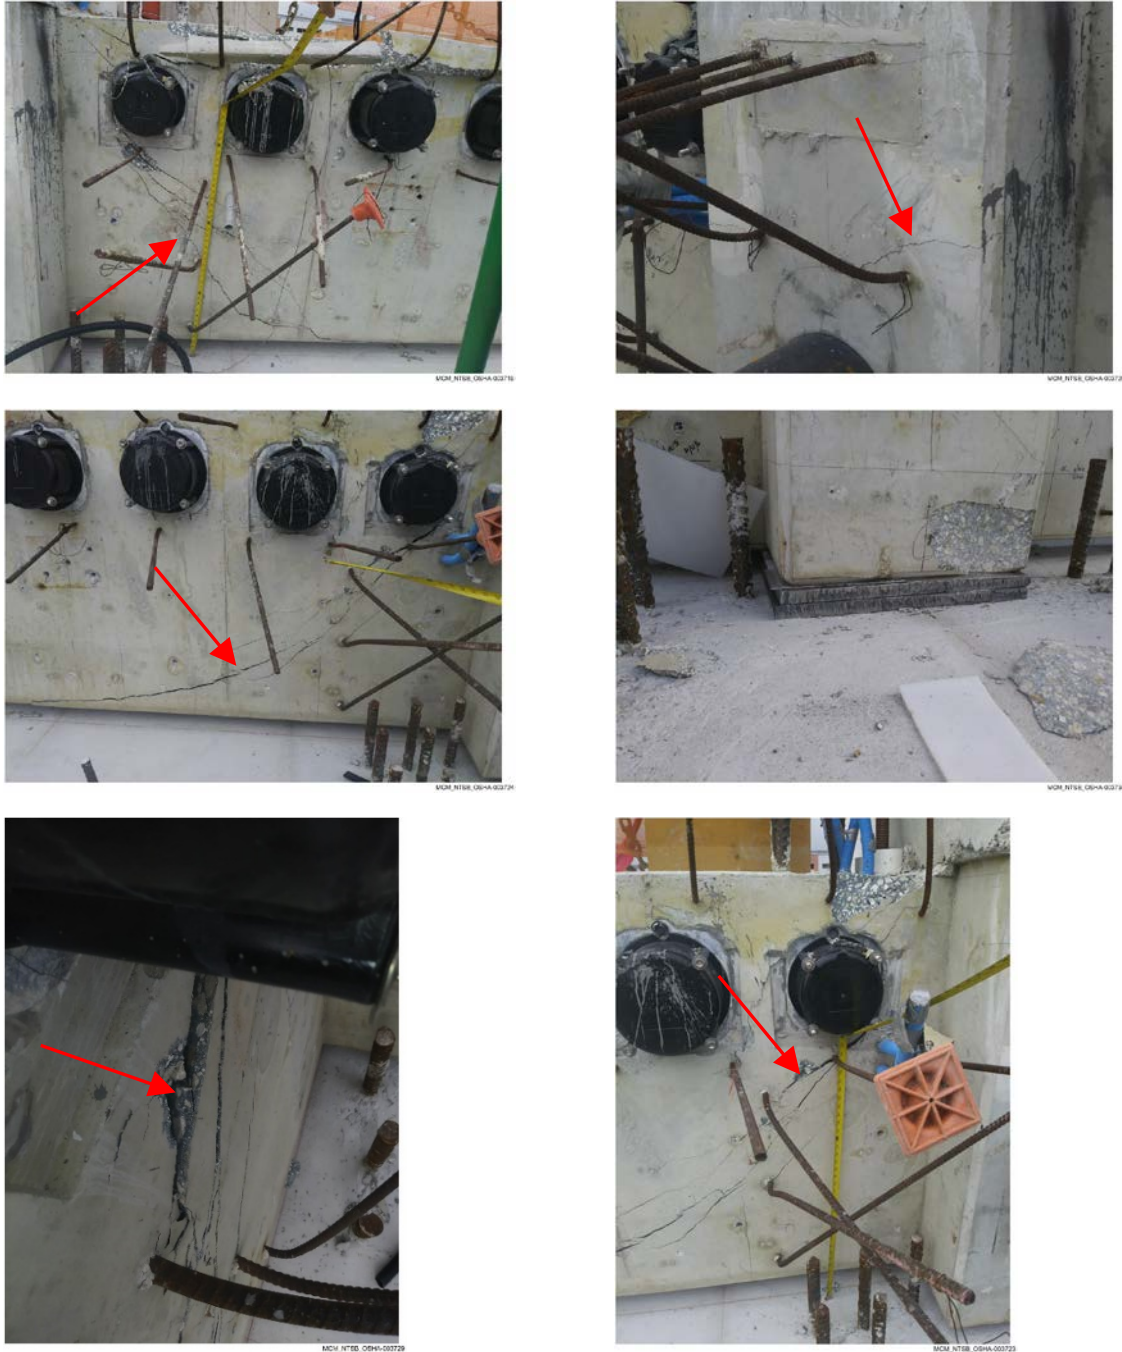
Figure 44 shows the condition of the Type II Diaphragm at the north end of the Main Span after erection of the Main Span and destressing of PT bars in Members 2 and 11.

Figure 44. Type II Diaphragm condition after erection and destressing (indicated with red arrows).¹⁵³

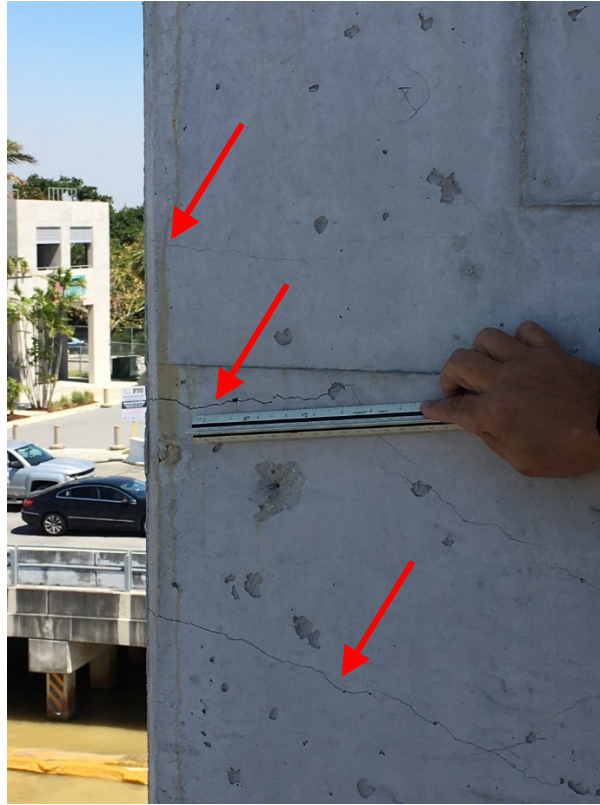
According to this analysis, cracking was anticipated on the north side of Member 12, at the south corner of Node 11/12, and on the north face of the Type II Diaphragm. These results are validated by the observations of cracks prior to collapse, as shown in Figure 51 and Figure 52. The extent of the flexural cracks on the north face of Member 11, however, raises questions about the adequacy of the design of this Member that will be addressed in Section 6.

Figure 51. Flexural cracks on north face of vertical Member 12 (indicated with red arrows).¹⁹²

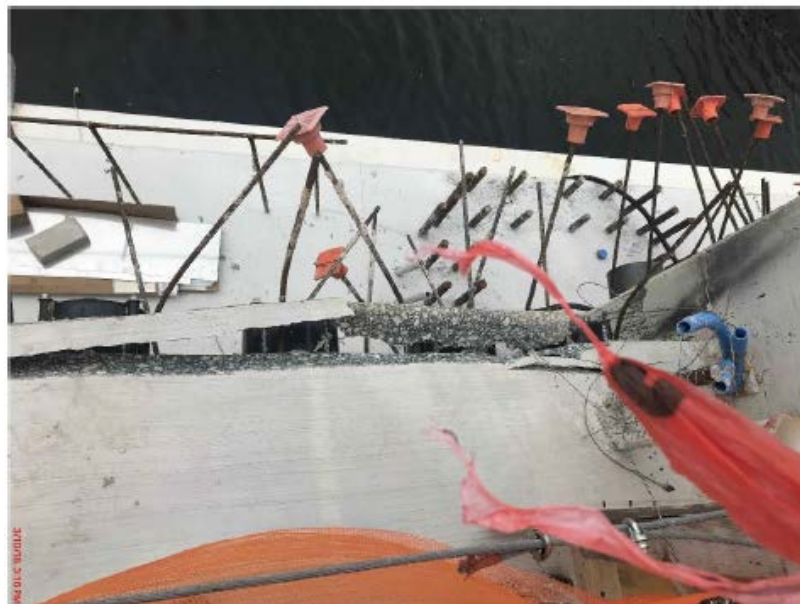
Figure 52. Spalling along top corner of Type II Diaphragm.¹⁹³

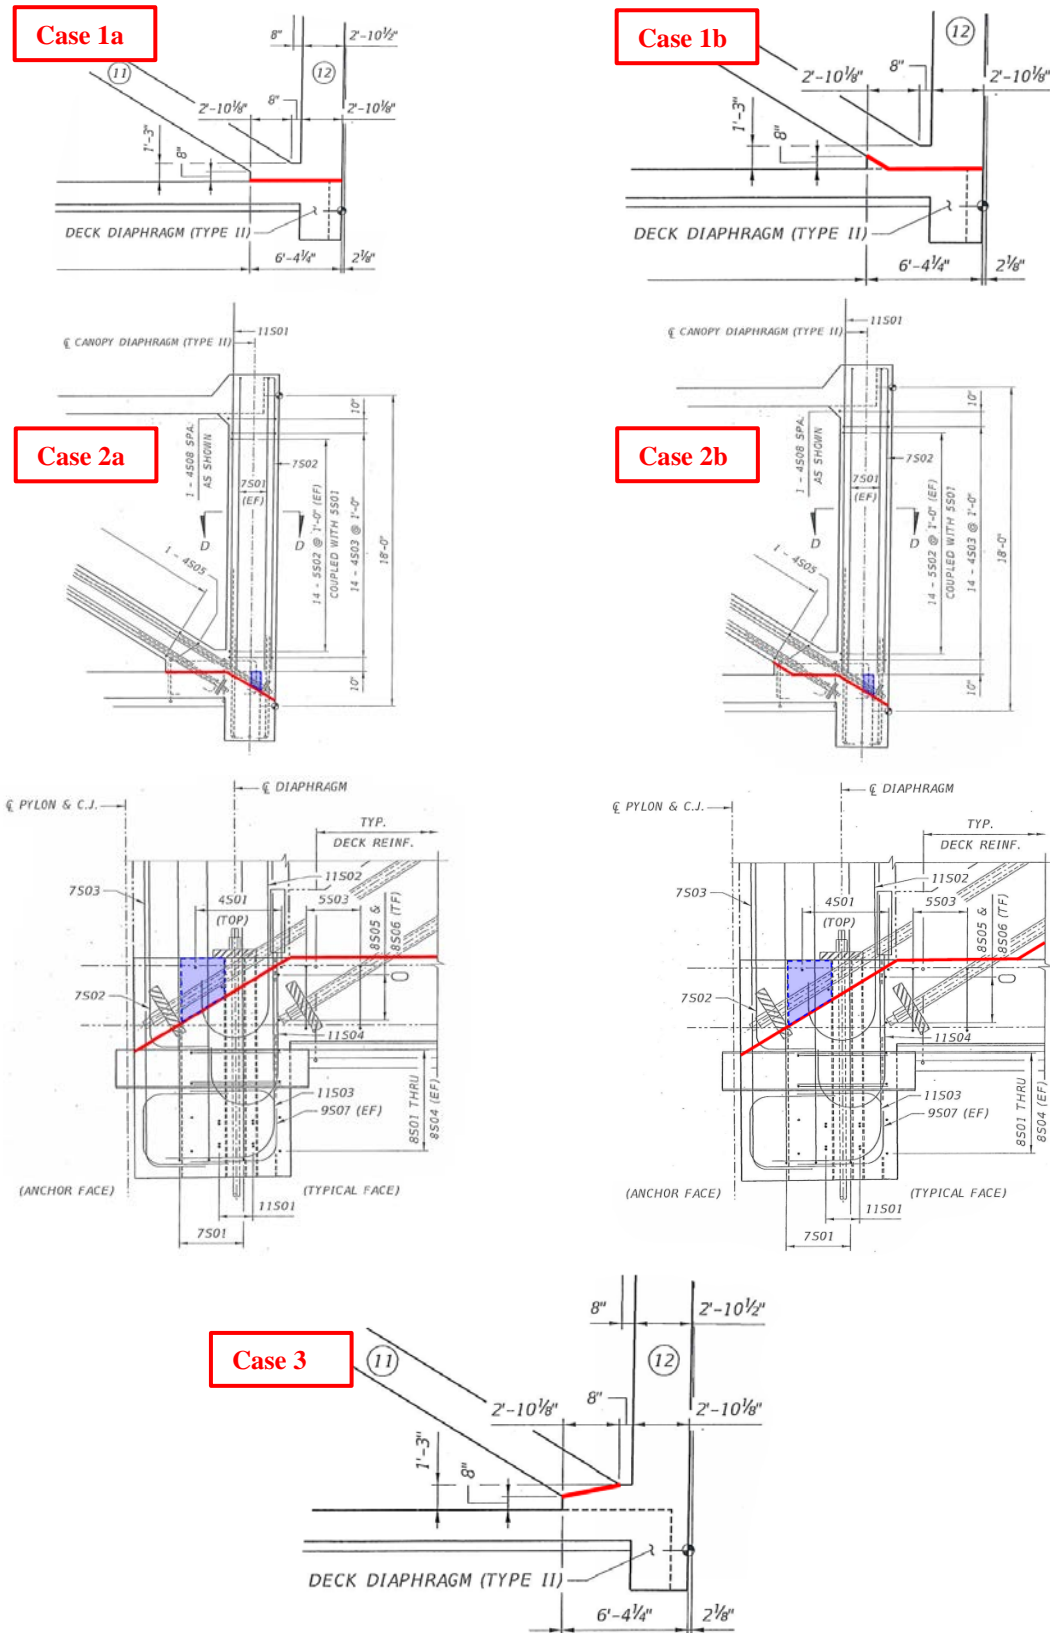
Figure 56. Interface shear failure surfaces.

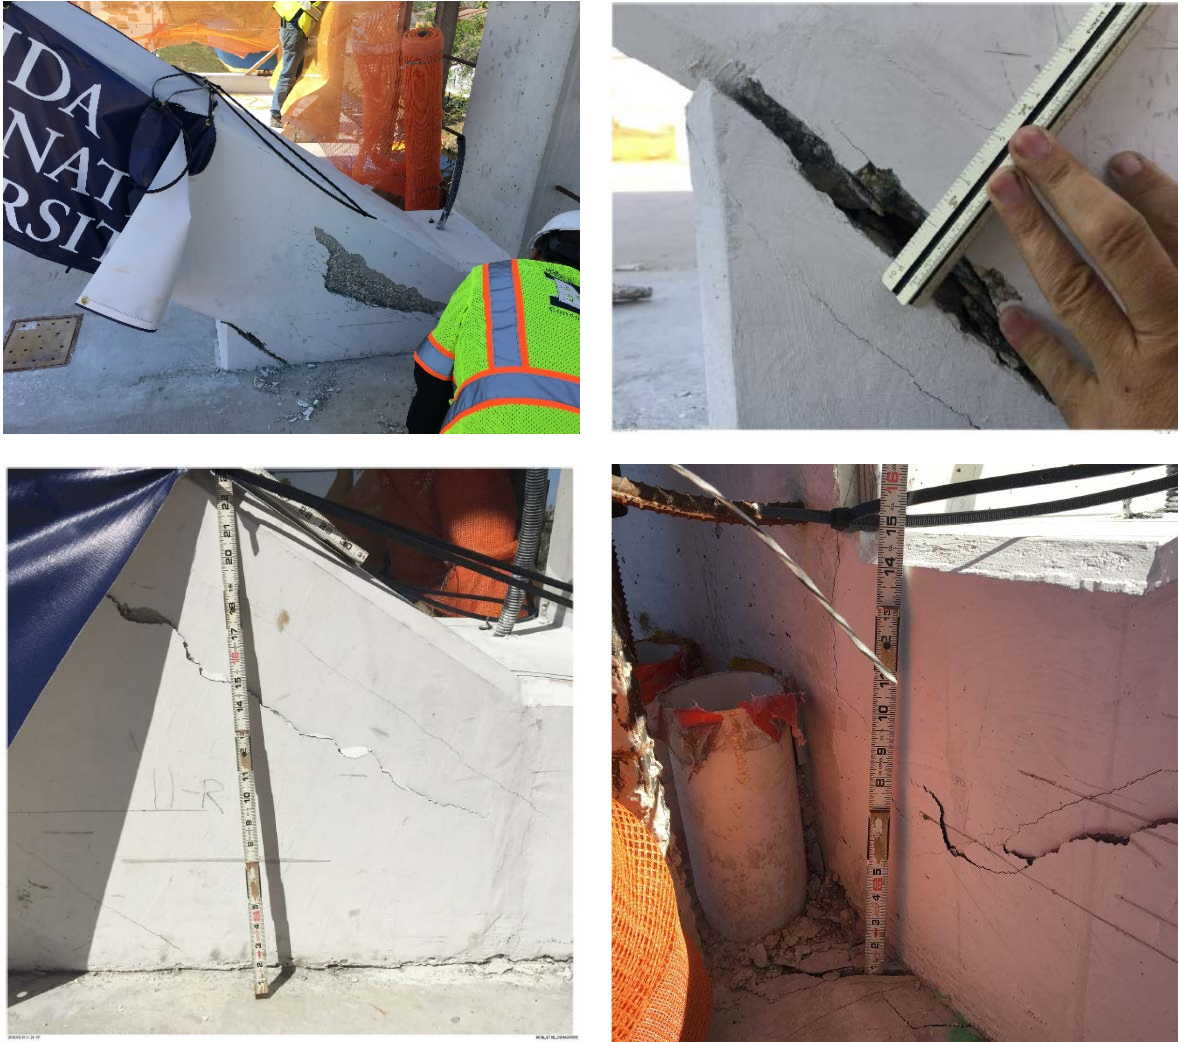
Figure 57. Northward displacement of Node 11/12 relative to Deck.²⁰⁰

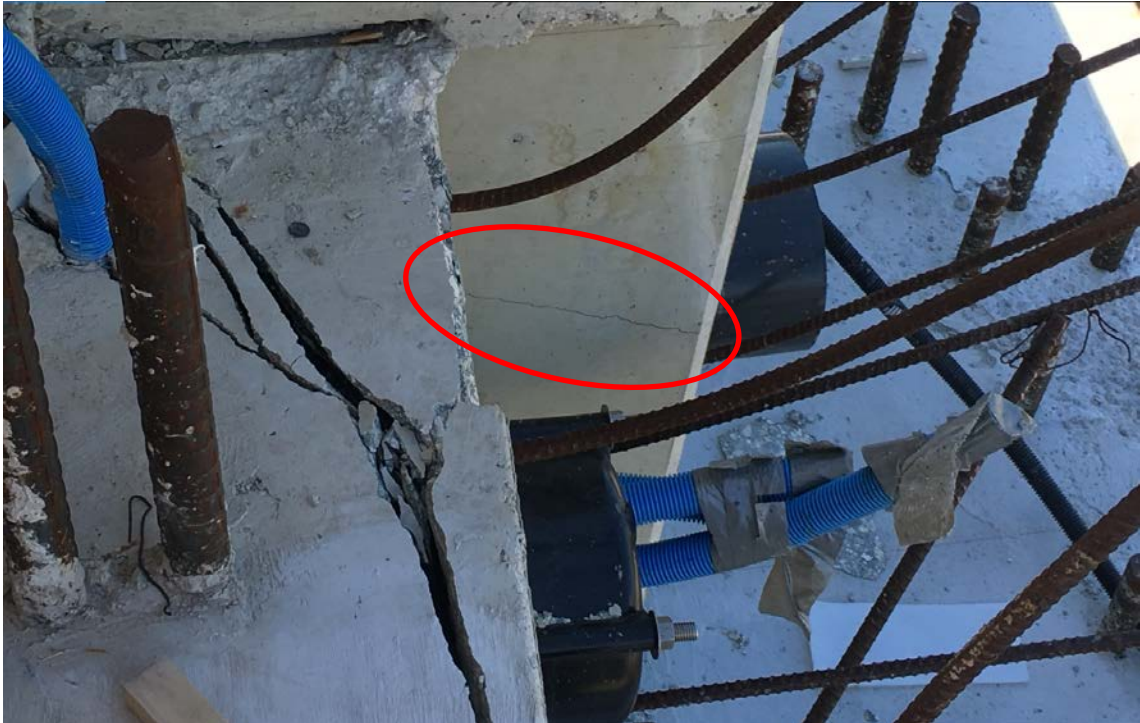
Figure 58. Diagonal crack in vertical Member 12 (indicated with red circle).²⁰¹

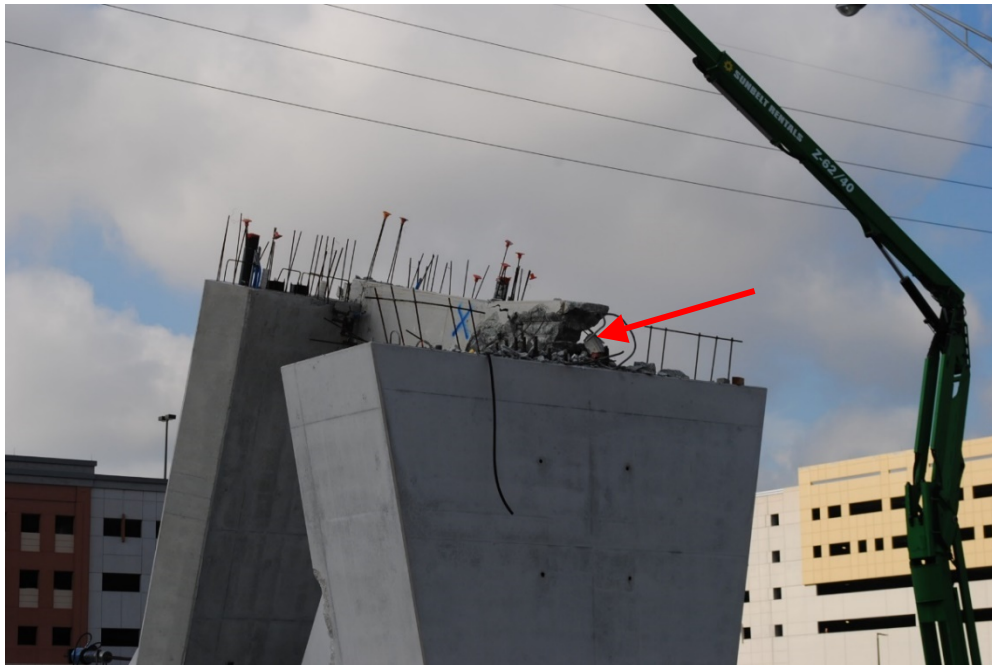
Figure 59. Fractured surface at base of Member 12 (indicated with red arrow).

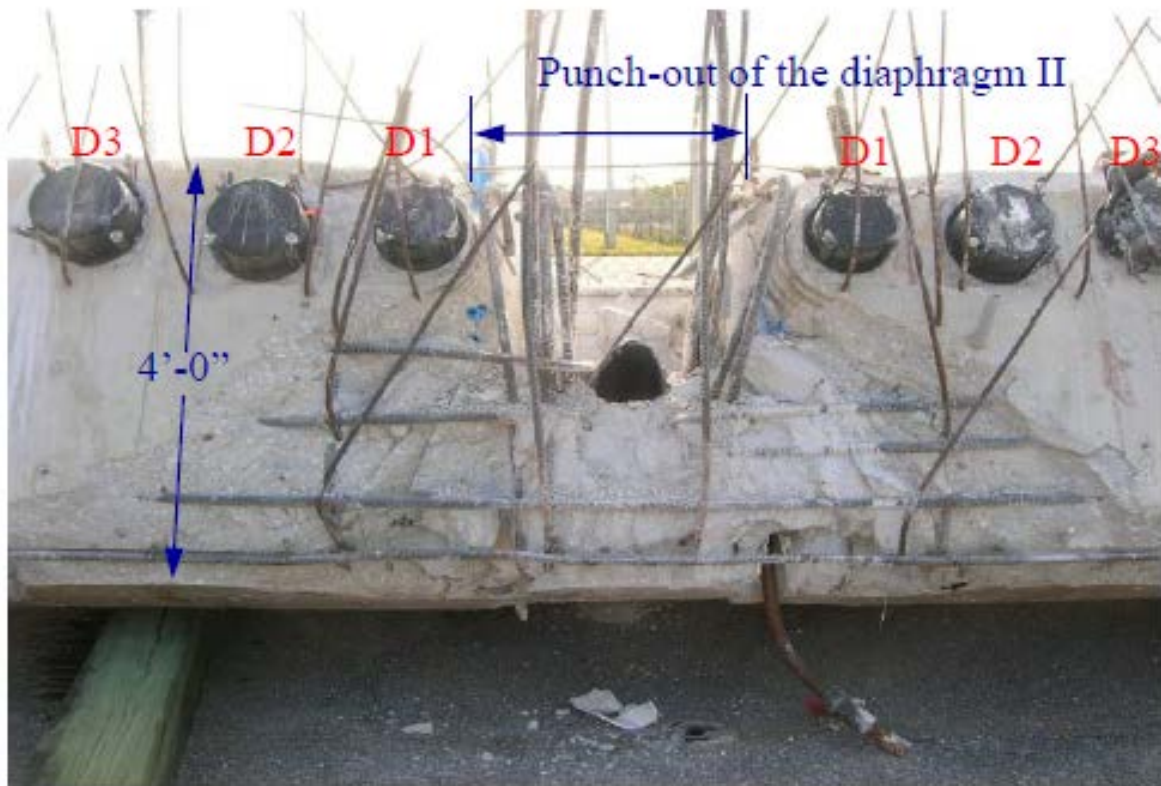
Figure 60. Fractured surfaces in Type II Diaphragm.²⁰²
