June 28, 2024

MIR-24-15

Fire aboard Passenger Vessel *Qualifier 105*

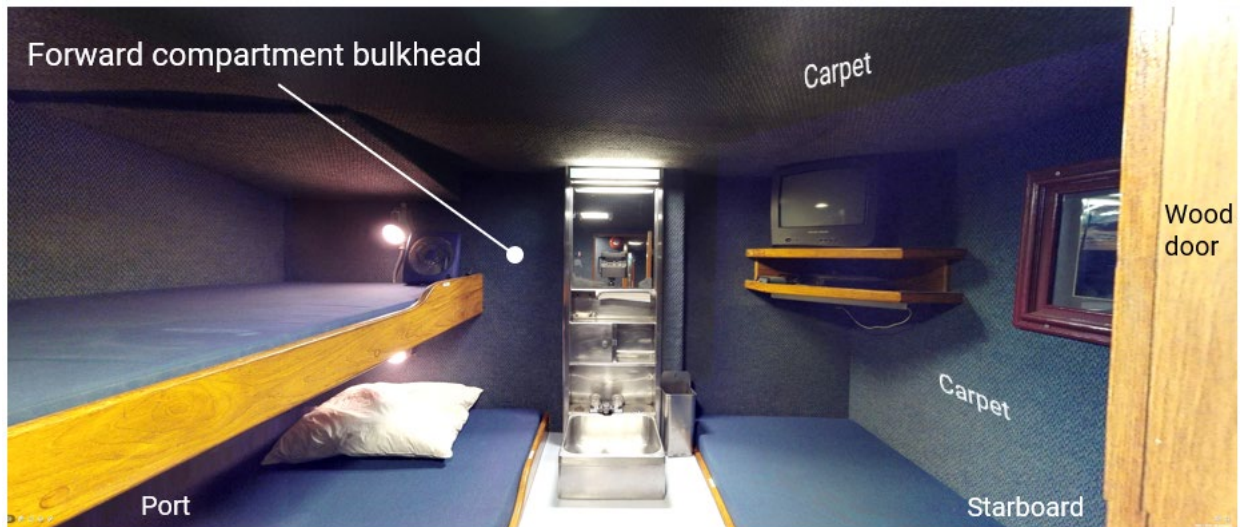
The vessel's aft stateroom compartment was bounded by forward and aft subdivision bulkheads of 0.1875-inch plate and an overhead (the salon/cabin deck) of 0.25-inch plate, all constructed of aluminum. Stateroom J was forward in the compartment, to the port side of the centerline, adjacent to the outboard stairwell. Stateroom J contained three bunks and a sink (see figure 4). The overhead in the compartment consisted of an aluminum-framed drop ceiling; its panels were plywood covered with carpet. Electrical system wiring was above the plywood. Plastic sheeting protected the carpet-covered bulkheads and overheads in the aft stateroom compartment.

Figure 4. *Qualifier 105* stateroom J interior before the fire. (Background source: Support Vessels of Alaska)

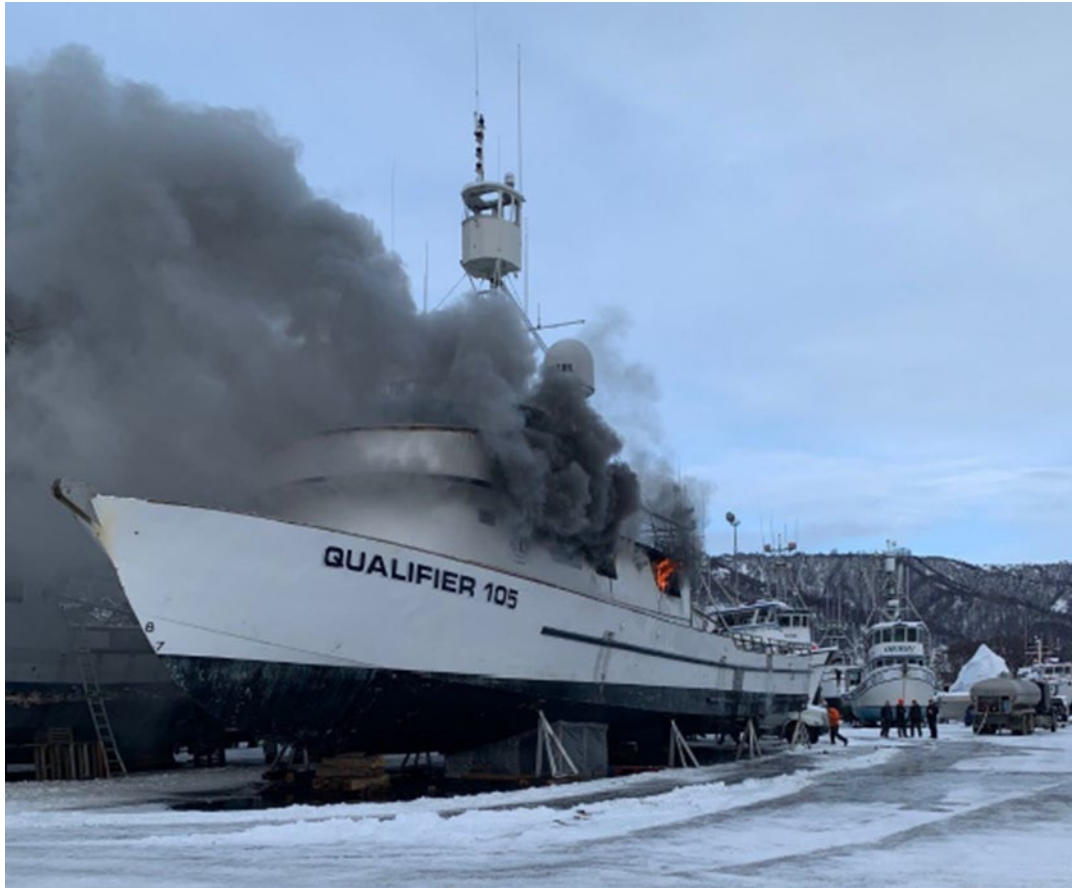
Welder 1 found that the passageway was now filled with smoke from the overhead down to his waist. He noted the plastic sheeting for the passageway overhead was hanging down “like ... a bubble” that extended downward from the overhead to about 3 feet above the deck. Behind the bubble, near stateroom J and on the starboard side at the other end of the passageway, was black smoke. Welder 1 got on his back and slid toward stateroom J under the plastic bubble. Still on his back, he discharged the fire extinguisher into stateroom J. He then left the vessel, using the stairs to the salon, and exited through the aft salon doors. On his way out, he noted flames in the salon, with the most flames on the starboard side. He also unplugged and removed the still-operating fan from the escape hatch. Within a minute, the entire salon was engulfed in flames (see figure 7). Shortly after, the fire watch and welder 2 left the vessel.

Figure 7. *Qualifier 105* on fire in the boatyard. (Source: Homer Volunteer Fire Department)

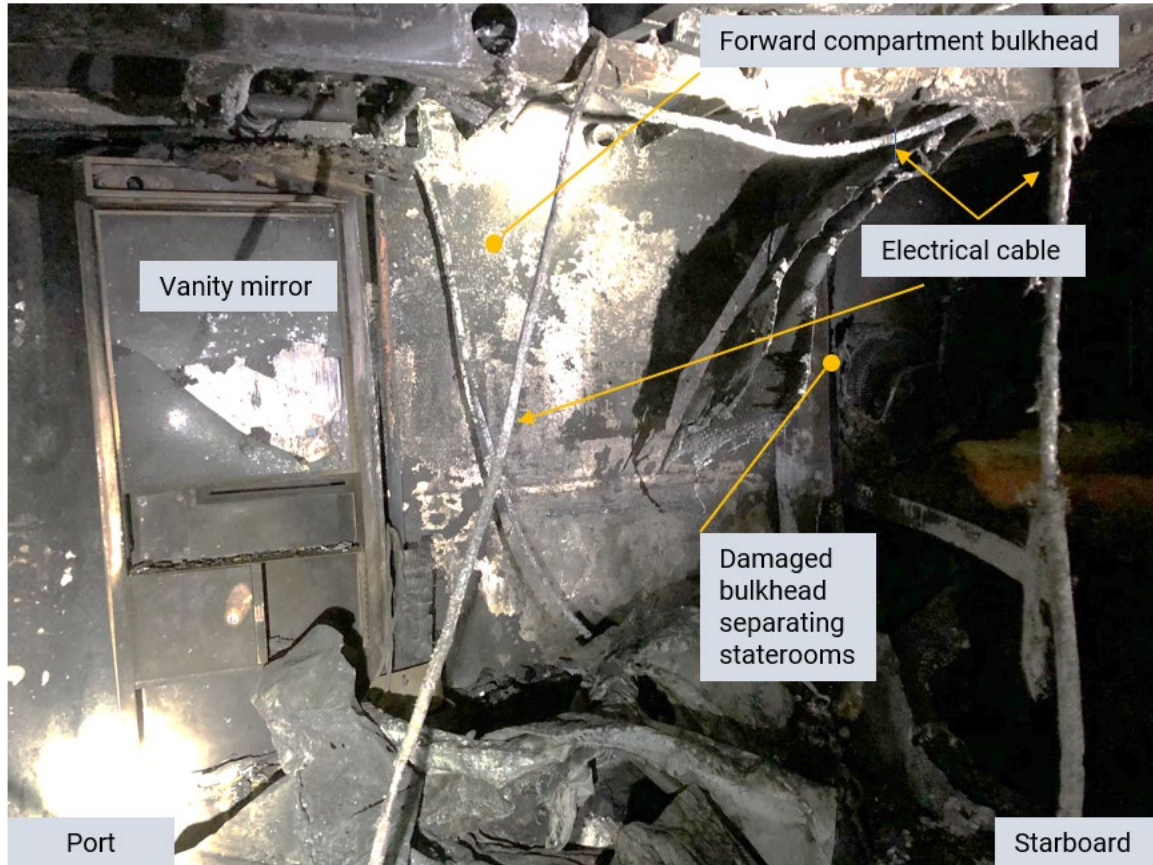
Areas of the aft stateroom compartment, the salon (including the galley), and an upper deck storeroom behind the wheelhouse were damaged (see figure 8). The welding machine was undamaged.

Figure 8. *Qualifier 105* stateroom J interior postfire. (Background source: Coast Guard)

The fire watch and welder 1 each saw a small flame on two different bunks in stateroom J—the first sign of a fire observed. Those small flames were likely caused by hot droplets of plastic sheeting—used to protect the carpet-covered, plywood drop ceiling above—that had melted and caught fire from heat or fire between the aluminum overhead and the drop ceiling. Therefore, it is likely that the initial ignition source and the eventual fire in stateroom J originated from the overhead. The accommodation spaces contained combustible materials—including carpet, wood framing, and plastic sheeting—in the overhead and on the bulkheads that further fueled the fire.

The National Transportation Safety Board determines that the probable cause of the fire aboard the passenger vessel *Qualifier 105* was an undetermined electrical source that ignited a stateroom ceiling. Contributing to the extent of the fire damage was the substantial use of combustible materials composing the stateroom ceilings and bulkheads throughout the vessel's accommodation spaces.

Stray welding current is a fault condition in which current goes through unintended conductors and back to the return terminal of a welding machine; it can cause fires by overheating wires. To avoid potential fires caused from stray welding current, maintenance personnel, owners, and operators should follow industry practice to place the work clamp (the return current clamp) of the welding machine as close as possible to the point of welding.
