July 10, 2024

MIR-24-18

Engine Room Fire aboard Towing Vessel *Desperado*

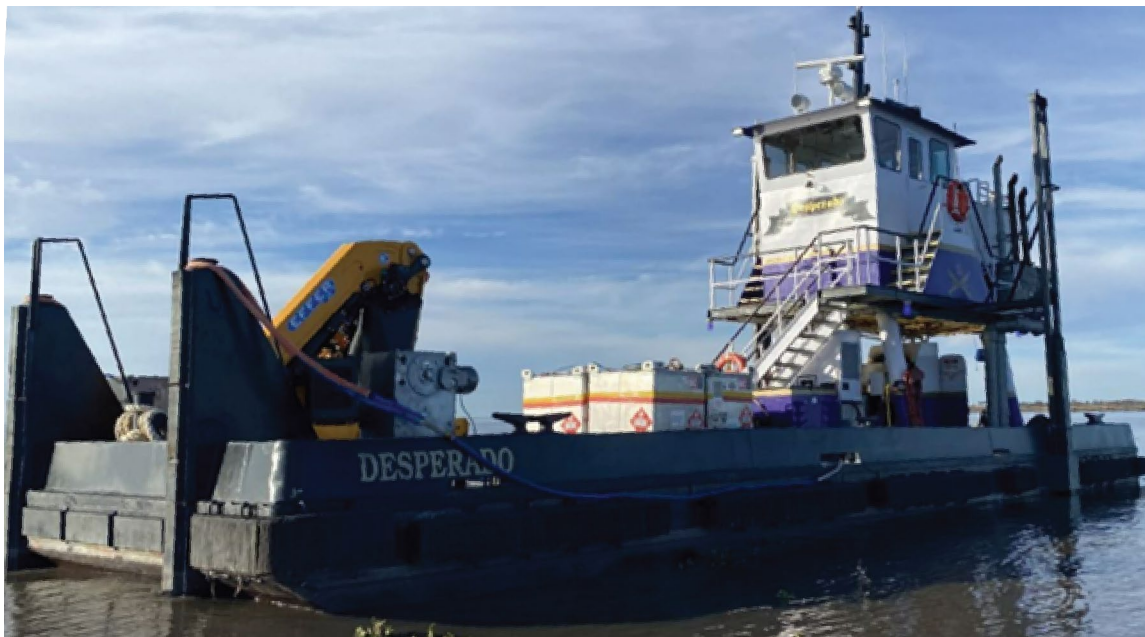
Figure 1. The *Desperado* spudded down in Lake Salvador after the fire.
(Source: US Coast Guard)

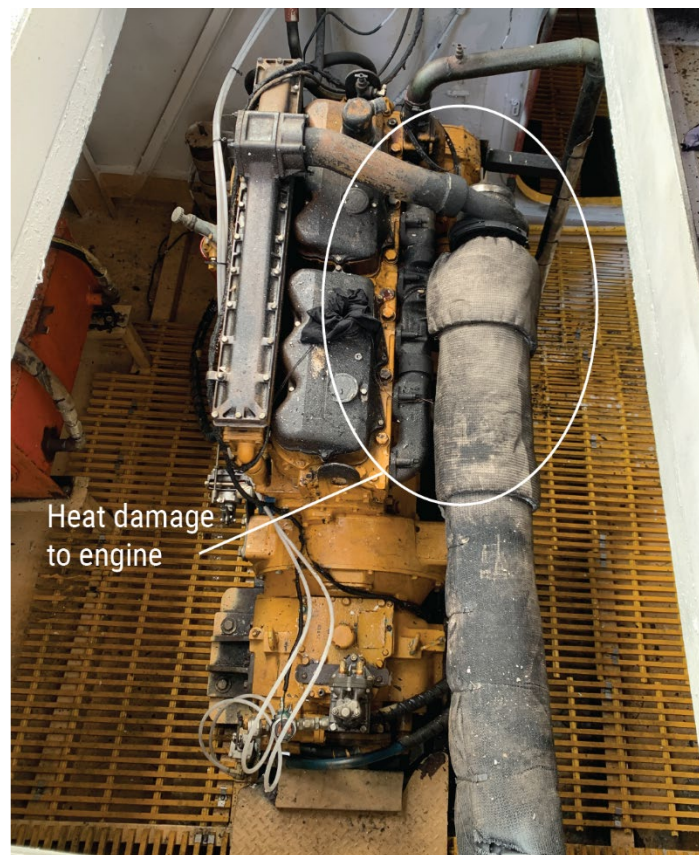
On February 18, the day after the fire, at 0900, the captain and two deckhands returned to the *Desperado* to survey the damage. The vessel was in the same location where the captain had dropped the port spud the day before. When the crew opened the hatches to the engine room, they found heat damage in the area of the port main propulsion engine. Dark soot was present in the overhead and area directly above the port main propulsion engine and pathway leading up to the engine room centerline entrance. The port main engine electrical wiring harnesses for pressure and temperature sensors were damaged, along with jacket water cooling hoses and hydraulic lines (see figure 3). The starboard main propulsion engine and the generator were in good working condition. All navigation equipment and electronics were in good working condition. According to the captain, "Except the one [port] engine that was burnt, everything else was pretty much normal." Six gallons of hydraulic oil were lost from the steering gear system and consumed by the fire. The vessel sustained \$30,000 of damage.

Figure 3. Port main propulsion engine damage on the *Desperado* after the fire.

The captain told Coast Guard investigators that most of the fire damage was to the port main propulsion engine and portside steering pump manifold, actuator, and hydraulic storage tank. The rudder steering system components and tank were located outboard of the port engine. The steering pumps were driven from the power take-offs on the propulsion engines. He said he had found a ruptured hydraulic line on the portside steering pump directional manifold valve, which subsequently caused flammable hydraulic fluid to disperse onto the port main propulsion engine exhaust manifold and turbocharger and ignite (see figure 4). The line was 1/2 inch in diameter and about 16-and-1/2 inches long, and the rupture was found near the hose end crimped fitting. The single-braid hose was manufactured in Mexico on October 7, 2018; however, it is unknown when the hose was installed on the vessel.

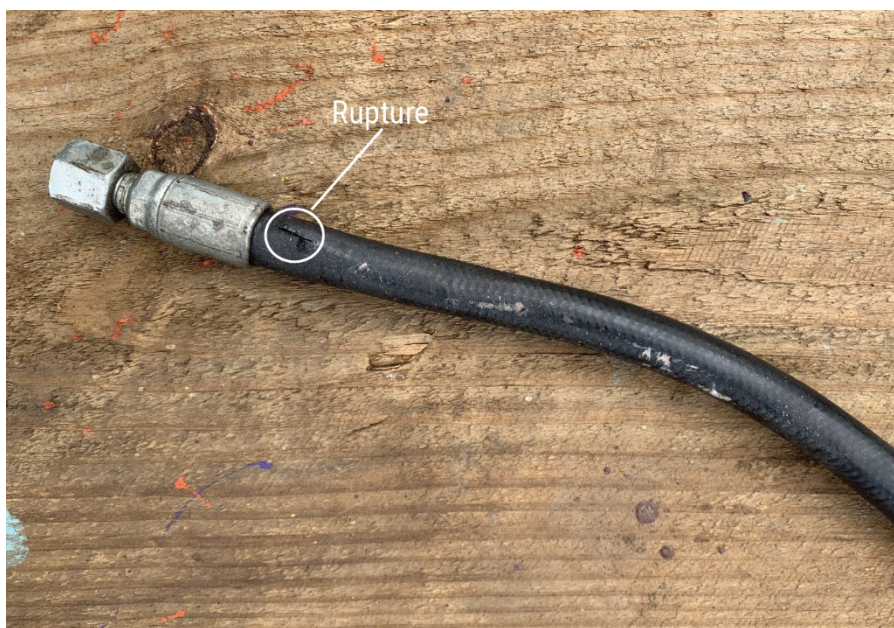
Figure 4. The ruptured port steering pump hydraulic hose, after the fire.

The captain told the Coast Guard that the cause of the fire was a ruptured hydraulic line on the portside steering pump, which subsequently caused flammable hydraulic oil to spray onto the hot port main propulsion engine exhaust manifold and turbocharger and ignite.

After reviewing photographs of the area where the fire occurred and where the replacement hydraulic hose was installed, investigators identified issues with how the hose had been installed. Contrary to manufacturer guidance, the hose appeared to exceed the bend radius; it was not guided with clamps, fittings, or adapters; and it did not have any protective cover (see figure 5). The manufacturer guidance warned that an improperly installed hose could fail. Given that the original hydraulic hose that ruptured was the same length and diameter as the replacement hose, it is likely that the same issues existed for the ruptured hose. Therefore, the lack of adherence to the hose manufacturer’s guidance on installation likely resulted in the hose exceeding its bend radius, rupturing, and spraying fuel, which led to the fire.

The National Transportation Safety Board determines that the probable cause of the fire aboard the towing vessel *Desperado* was a hydraulic hose that likely exceeded its bend radius, eventually causing the hose to rupture, resulting in hydraulic oil spraying onto a hot engine exhaust manifold and turbocharger and igniting.

Mariners and technicians who design, install, and maintain systems should follow the manufacturer's guidance on the minimum bend radius for a hydraulic hose. The minimum bend radius is the radius below which an object cannot (or should not) be bent. Bending or flexing a hose to a radius smaller than the minimum recommended, or subjecting a hose to tension or torque, can place excessive stress on the hose and severely reduce the ability of the hose to withstand pressure. Tight space constraints may cause a hose to bend severely around corners. A machine or cylinder extending and retracting can also bend a hose. Hoses attached to moving parts may bend more than a hose in or near a machine's stationary position. Actions to avoid hose damage or failure include clamping a hose in place to provide support, rerouting a hose assembly by installing fittings and adapters, and using a hose with more reinforcement (two braid instead of one braid).

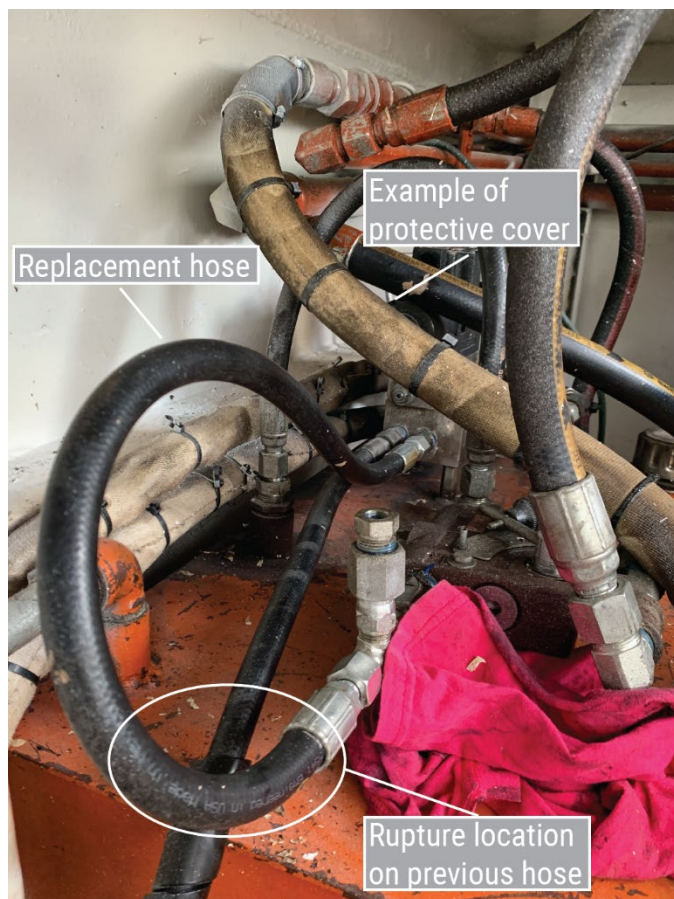
Figure 5. The replacement hydraulic hose, with the location of the rupture on the previous hose circled.

The captain and deckhands removed the ruptured hydraulic line from the portside steering pump directional manifold valve and replaced the hose with an onboard spare (in-kind replacement) (see figure 5).
