Issued February 15, 2022

MIR-22/03

## Grounding of Fishing Tender Barge *SM-3*

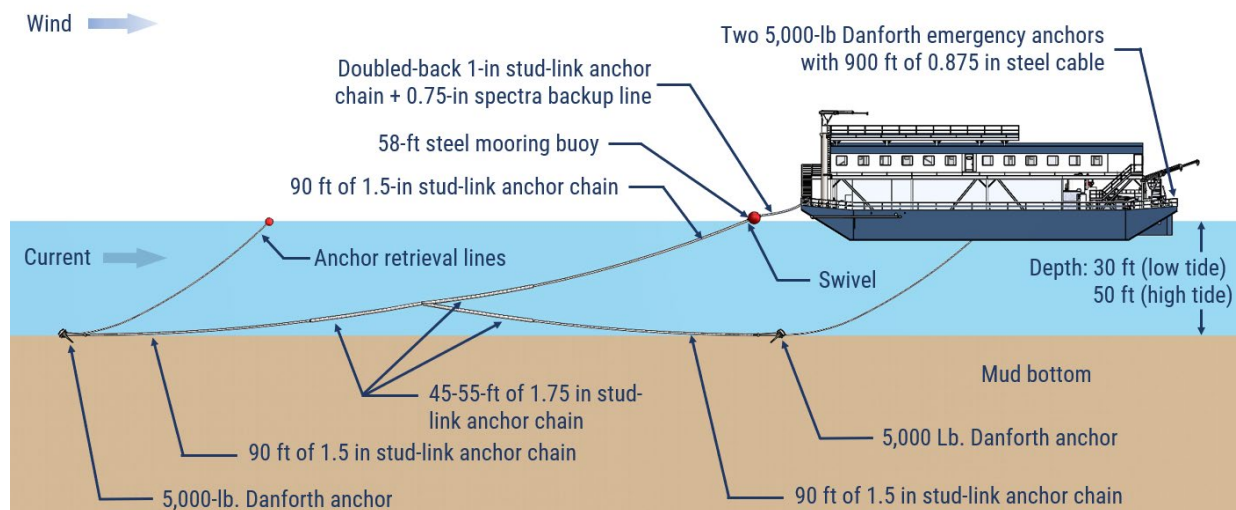
**Figure 5.** *SM-3* ground tackle system at the time of the casualty when the water depth was about 40 feet. (Source: Northline Seafoods)

It is possible that the mooring buoy failed due to a problem with the design of either the buoy itself or the ground tackle system as a whole. Based on the company's description of the ground tackle system, 270 feet of anchor chain connected the anchors to the mooring buoy. Having adequate scope—that is, the ratio of anchor chain to water depth—ensures that the anchor's designed holding power is achieved and prevents dragging. In light to moderate weather, the minimum scope generally accepted is 5:1, and in worsening conditions, the scope can be increased.<sup>2</sup> At the location where the *SM-3* was anchored, the maximum depth of the Nushagak Bay was 50 feet at high tide, meaning that there would be about 5 feet of anchor chain for each foot of depth in the bay (a scope of about 5:1), which was appropriate for the barge's safe anchorage in the area under normal conditions. According to the National Oceanic and Atmospheric Administration, about 2300, when the barge separated from the buoy, the water depth was 40 feet, at which point the anchor chain had a scope of 6.75:1. Regardless, there was no indication that either of the primary anchors dragged, so scope was likely not a factor. Therefore, the effect of the storm on the barge resulted in forces that exceeded the capability of the weakest link in the ground tackle system's components—in this case, the mooring buoy.

The lowest known general rating for a component in the ground tackle system was the breaking strength of the swivel, about 143,000 pounds. Requests to the supplier for exact design and manufacturing specifications for the mooring buoy went unanswered. Investigators were therefore unable to determine if the capability of the buoy was exceeded, or if there was a design flaw or manufacturing error.

In addition to fitting mooring chains of sufficient length to provide adequate scope for anchorages, mariners must consider the strength of each component of a ground tackle system and should reference marine standards for design. Bending loads can be significantly higher than straight-line pull. The working load limit of each component should be equal to or greater than the ground tackle system's maximum calculated load to avoid weak points in the system.

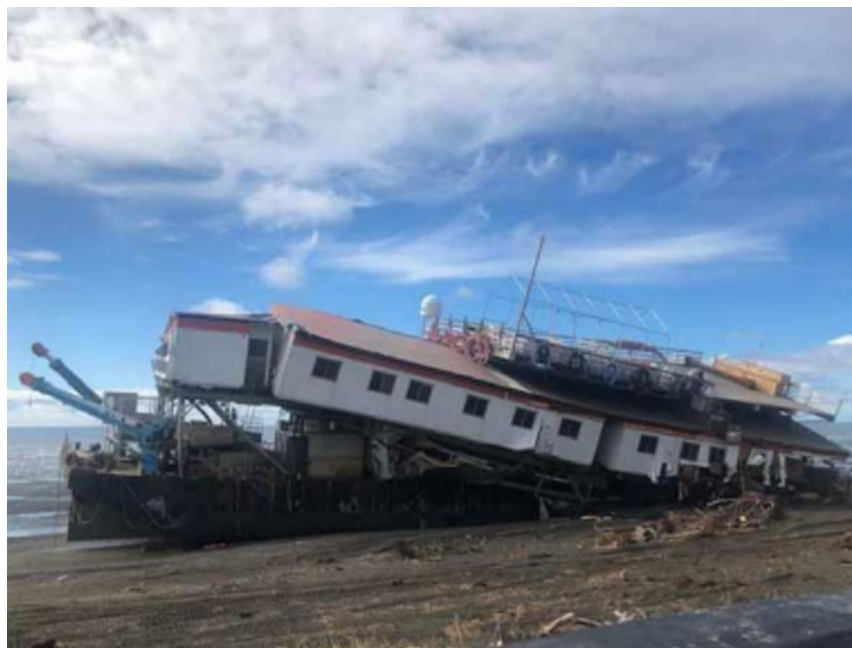
**Figure 6.** *SM-3* after the grounding. (Source: Alaska Marine Surveyors, Inc.)

On September 3, a marine surveyor attended the grounded barge in Ekuk. The surveyor's preliminary damage report stated that the barge's hull sustained structural damage in the engine room. Additionally, the superstructure, which included the top, berthing, and main decks, had collapsed on and crushed the fish house, and the entire superstructure was shifted to the starboard side partially on the beach. The report stated that there was an extensive debris field, which extended 1.5 miles on each side of the barge, and a slight diesel odor. The cost to repair the barge and replace equipment was estimated to be \$4.5 million.

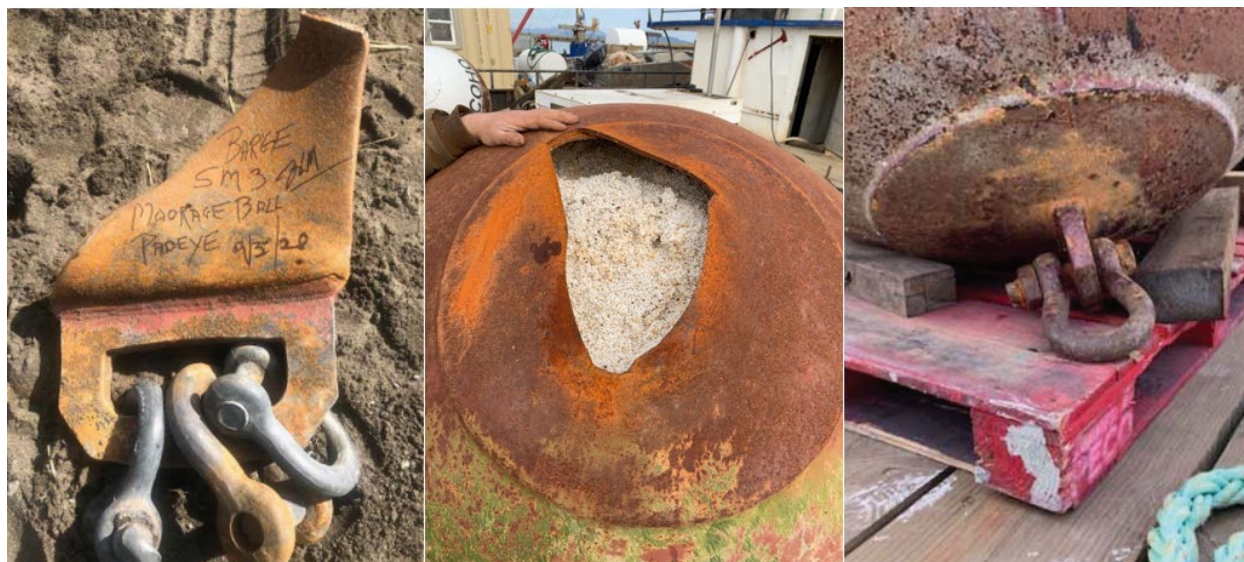
After the grounding, the mooring buoy's damaged upper round curved cap piece was cut off and sent, along with the upper padeye assembly, to a materials testing laboratory for failure analysis. The laboratory reported that the buoy had "functionally failed—a separating crack had formed at the fillet weld of the topside padeye [which connected to the barge via a chain and line], thus allowing the uncontrolled separation of the padeye." The laboratory found that a small fatigue crack had been present at one end of the buoy's topside padeye, thus "providing a mechanical stress riser;" the crack initiated at the outer surface of the padeye at the base of the fillet weld and progressed inward radially. The fatigue zone reached a depth of about 5 millimeters (0.2 inches), and the section total thickness in that area was about 7.3 millimeters (0.3 inches). The crack proceeded into and across the shell in overstress, ultimately separating the padeye and adjoining shell material from the rest of the buoy. The materials testing laboratory found no metallurgical or welding-related defects.

**Figure 7.** SM-3 mooring buoy: failed padeye (with three shackles) that separated from buoy (left), damaged top with padeye missing (center), and undamaged bottom padeye (right). (Source: Alaska Marine Surveyors and Northline Seafoods)

During the storm, the mooring buoy's topside padeye separated from the buoy (and the ground tackle system), causing the *SM-3* to drift and eventually ground on a beach about 2 miles east of the location where it had anchored. A postcasualty examination of the buoy showed that a 1.25-inch-wide fatigue crack had formed at the padeye's fillet weld, moving across nearly two-thirds of the weld before failing abruptly and tearing the cap plate it was welded to. Investigators were unable to determine whether the fatigue crack existed before the storm or developed as a result of it. If the crack existed before the storm, a visual inspection may have revealed it, particularly if the area was painted; however, the crew did not report any issues with the mooring buoy, and the company did not report regularly inspecting it. The buoy had been purchased in 2019 and was deployed in relatively calm weather (with only one instance of rough weather) during the 2019 and 2020 seasons. Therefore, the padeye may not have been

The National Transportation Safety Board determines that the probable cause of the grounding of the fishing tender barge *SM-3* was a fatigue crack in one of the mooring buoy's padeye welds, which resulted in the padeye separating from the buoy's

spherical steel plating, causing the barge to break free from its buoy and anchors and drift ashore during a storm.

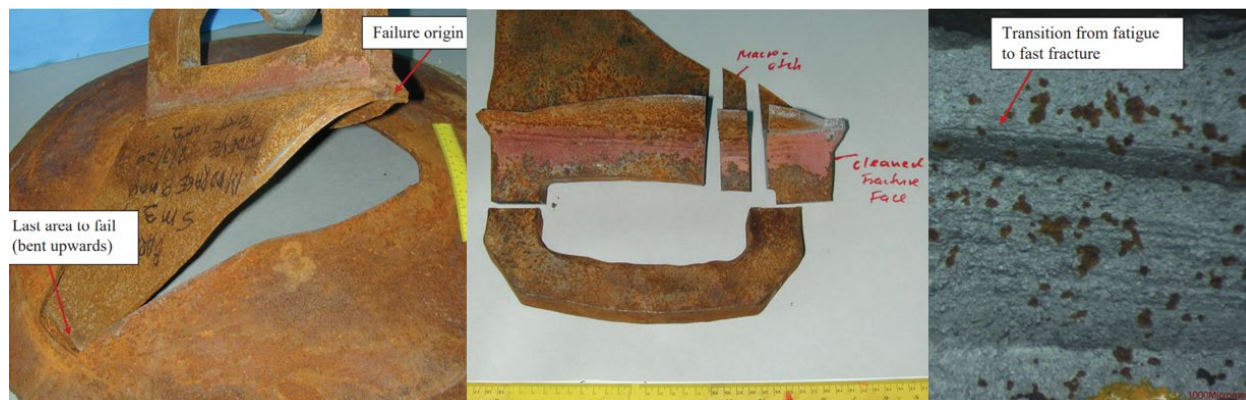
**Figure 8.** Simulated direction of the tear/shear failure from buoy shell (left); padeye removed, cross-section removed from weld macro-etched and fractured face cleaned (center); close-up of the fatigue crack (right). (Source: Simon Forensic, LLC)
