Issued March 16, 2022

MIR-22/07

Contact of Tanker *Riverside* with Moda Ingleside Energy Center No. 4 Loading Dock

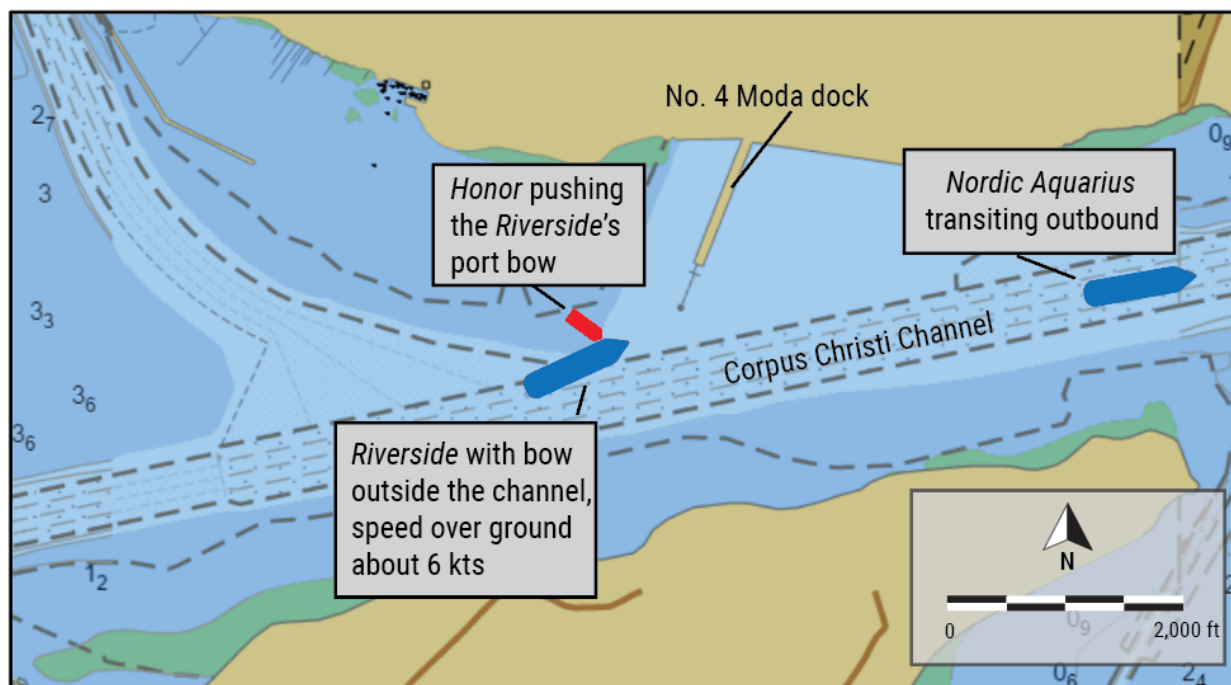
Figure 4. Approximation of *Riverside* at 1300, just before the contact with the no. 4 Moda dock dolphin and catwalk, with the tug *Honor* pushing its port bow; the *Nordic Aquarius* has departed the no. 4 Moda dock and is transiting outbound. (Background source: NOAA)

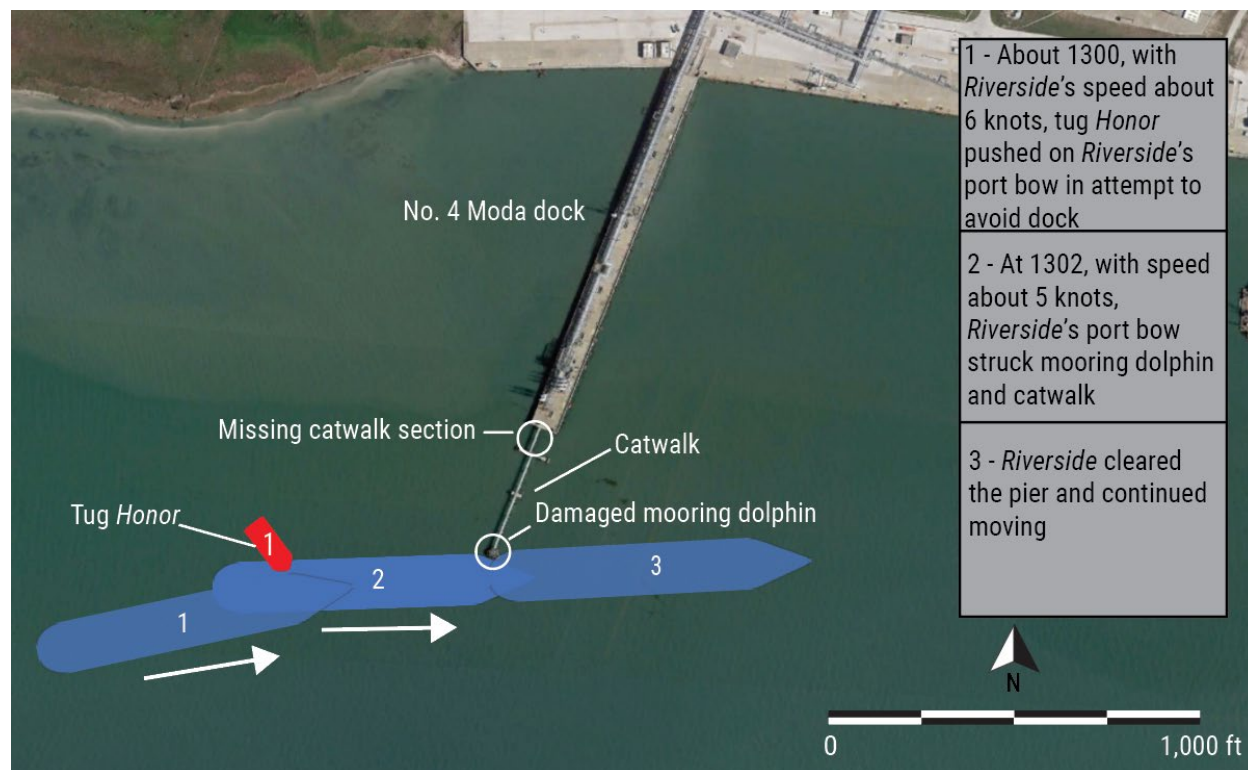
Pilot 2 noticed that the captain was focused on adjusting the engine controls and inquired if there was a problem. The captain informed him that they had “lost the engine.” In response to that notification and realizing that the *Riverside* was heading toward the no. 4 Moda dock, pilot 2 contacted a nearby tug, *Honor*, which was standing by on the west side of the no. 4 Moda dock, and requested that the tug push on the *Riverside*’s port bow in an effort to clear the pier. The tug pushed against the *Riverside*’s port bow and was able to affect the vessel’s direction back toward the channel, but the tug had to move out of the way to avoid becoming trapped between the pier and the vessel. Pilot 2 ordered dead slow astern, and the chief engineer tried to start the engine astern locally, but it failed to start. Pilot 2 and the captain considered dropping the starboard anchor, but they decided against that action out of concern the anchor might puncture the vessel’s hull due to the vessel’s speed (about 5 knots) and shallow water near the no. 4 Moda dock. At 1302, the *Riverside*’s port bow struck the mooring dolphin and catwalk at the end of the no. 4 Moda dock at 5 knots. The *Riverside* continued past the pier, and the tug *Honor* maneuvered to the vessel’s stern, attached a line on the stern, and, with the assistance of the tugs *Strength*, *America*, and *Courageous*, stopped the vessel about 1,600 feet past the no. 4 Moda dock. After the vessel stopped, the tugs assisted in docking the *Riverside* at the Flint Hills dock no. 4, a facility next to the Moda Ingleside Energy Center.

Figure 5. Final events surrounding the *Riverside's* contact with the no. 4 Moda dock. (Background source: Google Earth)

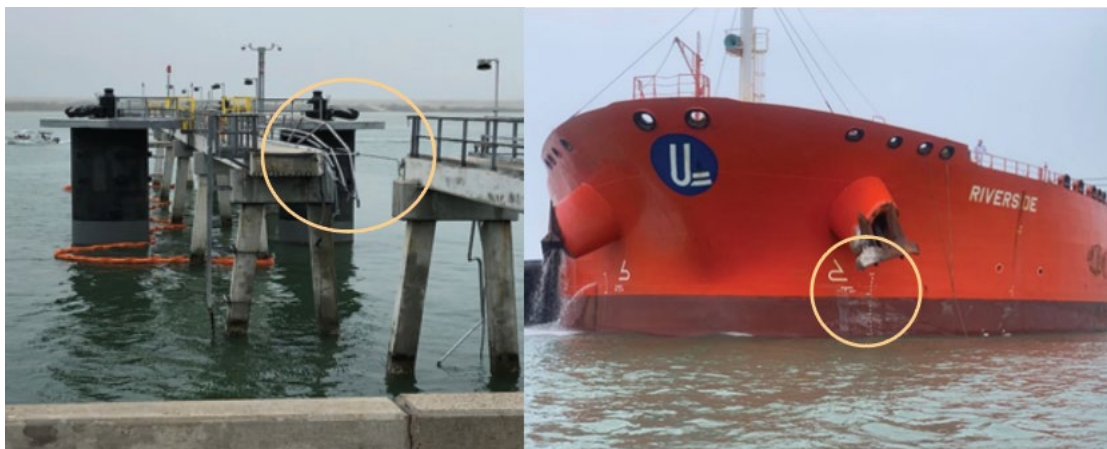
A damage survey determined that the no. 4 Moda dock and mooring dolphin sustained significant damage; a portion of the no. 4 Moda dock's catwalk between the mooring dolphins was missing. According to the classification society report on the damage to the *Riverside*, dated March 16, 2021, the vessel sustained several bent internal frames and hull indents to the fore void space, forepeak tank, and the no. 1 port water ballast double bottom side tank. Additionally, the port anchor shank was bent 20°, and there was scraping damage to the hull.

Figure 6. Damage to the no. 4 Moda dock catwalk (left) and the *Riverside* (right), circled. (Source: US Coast Guard)

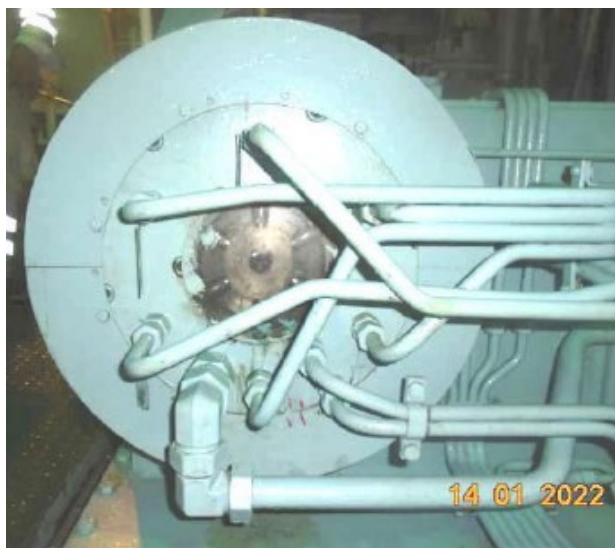
The main engine used a 435-psi (30-bar) pneumatic system for starting in both the ahead and astern directions. It also used a 100-psi (7-bar) control air system to maintain its operation. During a main engine starting air system evaluation, technician 1 determined that the piston slide valve on the no. 6 starting air actuator within the starting air distributor was sticking, which prevented the 7-bar pneumatic signal (pilot air) from opening the no. 6 cylinder air valve. When the actuator and housing were removed, the technician found hardened grease and dirt within the actuator, which he concluded prevented the actuator from moving properly.

The distributor directed 30-bar starting air via a pilot line (pilot air) to each of the cylinder's starting air valves to open and close them. When open, the start air valves admitted a large volume of 30-bar starting air into the cylinder. The distributor timed the delivery of pilot air to cylinders' start air valves to correspond to the engine's firing order—beginning rotation in the ahead or astern direction until combustion began. The technician told investigators that the buildup on the actuator may have been a result of

moisture accumulation within the start air tanks and piping system due to insufficient draining of the system on a routine schedule. After the actuator was cleaned, the technicians tested the engine and started it in both in the ahead and the astern modes from the bridge, the engine control room, and locally at the main engine with no further issues.

Figure 7. The main engine's starting air distributor containing the no. 6 starting air actuator valve. (Source: Thome Ship Management)

Technicians identified that the cause of the main engine start failures was the inability of the no. 6 actuator to initiate piston rotation due to hardened grease and dirt, preventing proper movement. Following the casualty, technicians discovered other problems within several main engine systems, including the fuel pumps, the control air drying system and start air system, and numerous pneumatic air control valves.

The technicians told investigators that the engine start system failed because the vessel's engineers did not clear moisture from the start air system by draining the air tanks on a routine basis. The chief engineer's written standing orders required daily draining during machinery space rounds. However, based on the technicians' assessments, it appears this routine maintenance was not regularly performed. Over time (and before the vessel arrived in Corpus Christi), this allowed hardened grease to build up in the actuator.

The National Transportation Safety Board determines that the probable cause of the contact of the tanker *Riverside* with the Moda Ingleside Energy Center no. 4 loading dock was the ineffective evaluation and incorrect solution for a main engine start issue by the company and shipboard engineers, overlooking the fouling of the main engine's no. 6 air start actuator valve within the starting air distributor. Contributing to the casualty was the presence of moisture in and lack of routine drainage of the air start system, which allowed the buildup of hardened grease within the air start actuator valve.

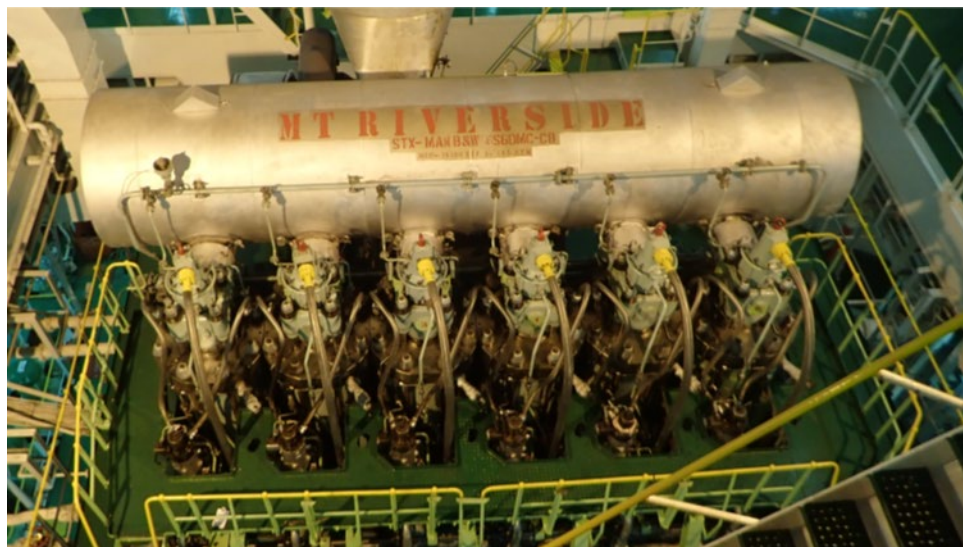
During the evaluation of all systems related to the main engine, technician 2 identified minor issues with the fuel system pumps, which showed signs of wear and would eventually need to be replaced. Additionally, the technicians found leaking air control valves that required maintenance while the technicians were on board to return them to their proper operational status. Although these deficiencies needed to be addressed, the technicians did not indicate that they contributed to the main engine's failure to reliably start.

Figure 8. The top of the *Riverside* main engine. (Source: Coast Guard)
