Issued March 17, 2022

MIR-22/08

Contact of *Kevin Michael* Tow with Melvin Price Locks and Dam Guide Wall

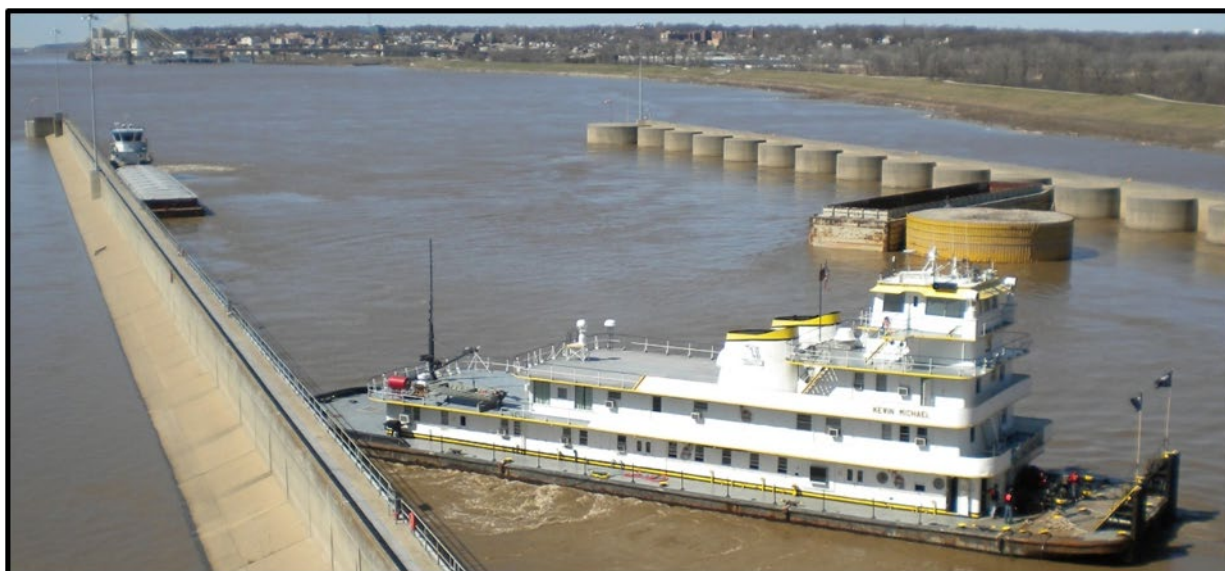
Figure 1. *Kevin Michael* under way at the Melvin Price Locks and Dam after the casualty. (Source: US Coast Guard)

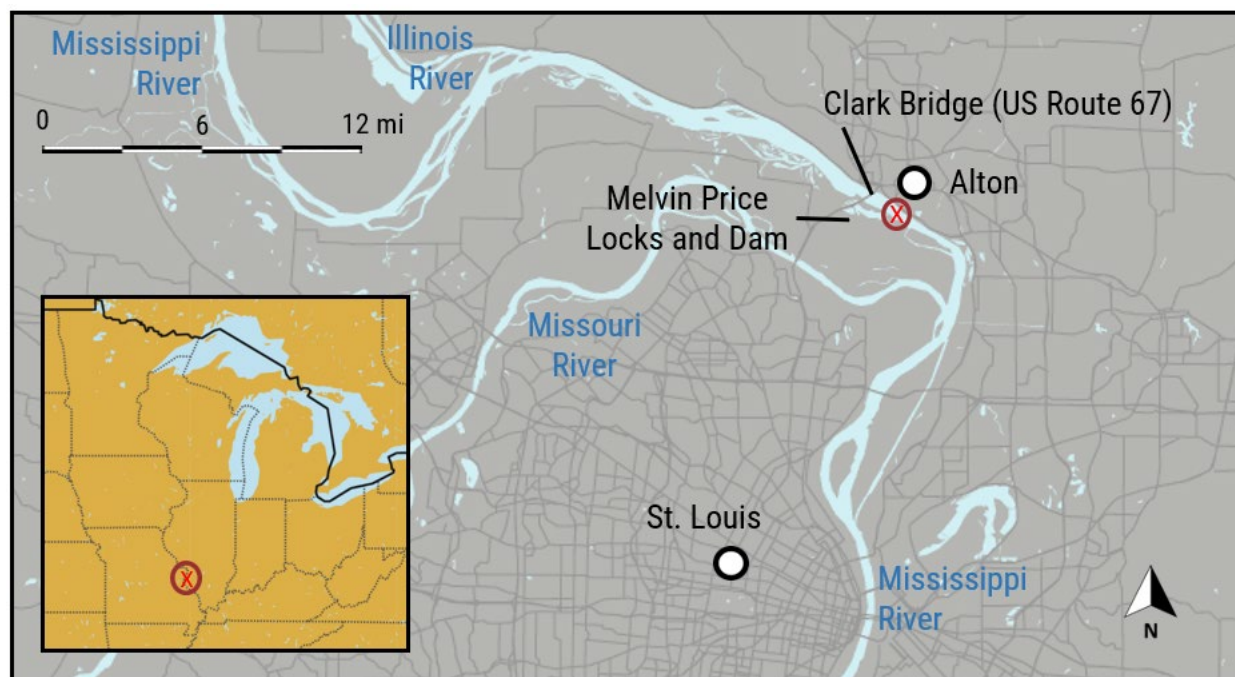
Figure 2. Area where the *Kevin Michael* tow contacted the Melvin Price Locks and Dam guide wall, as indicated by the red X. (Background source: Google Maps)

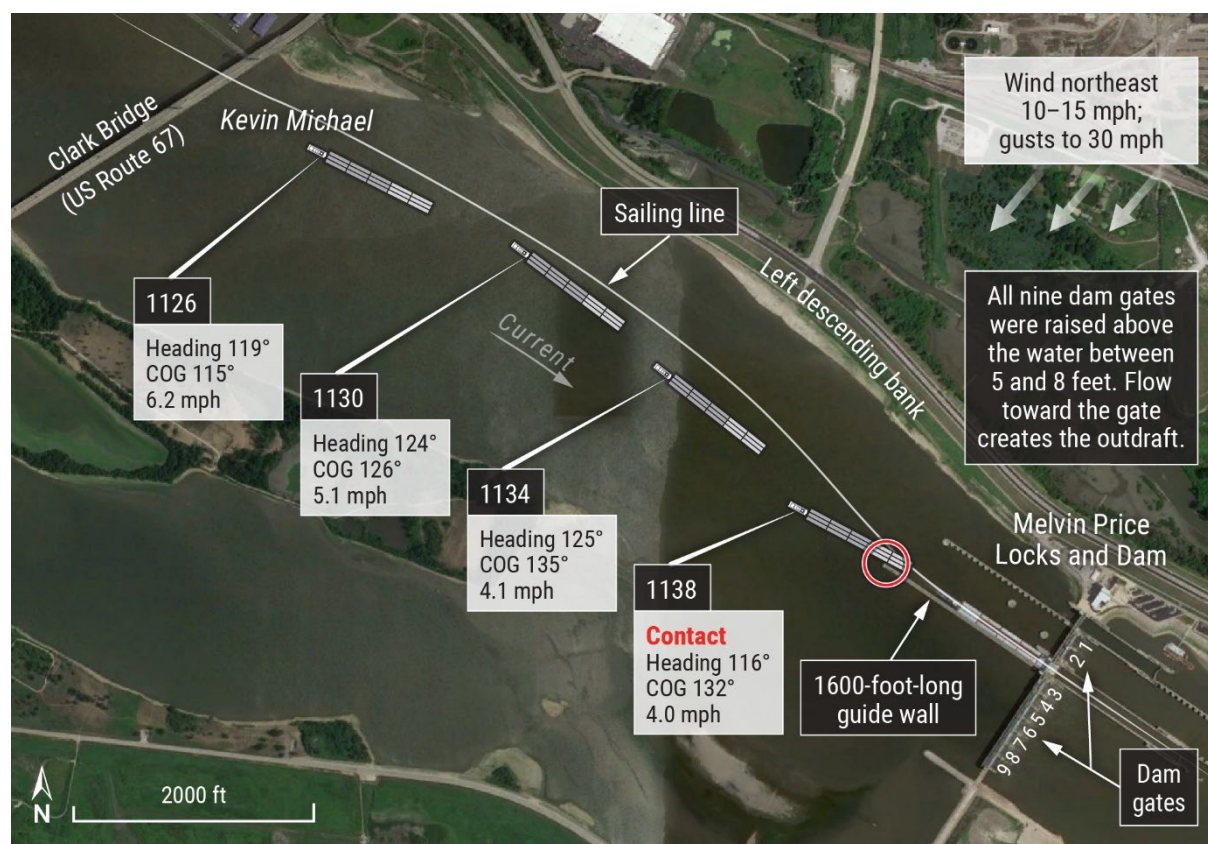
Figure 4. Annotated electronic chart system track history of the *Kevin Michael* tow over the last 12 minutes leading up to the casualty. (Background source: Google Earth)

Between 1130 and the time of the contact 8 minutes later, the lateral slide indicator showed the bow and stern moving to starboard (toward the center of the river) with a few short movements to port. The pilot told investigators that when the head of the tow was about 1,000 feet from the bull nose of the main lock chamber guide wall (between 1135 and 1136 based on ECS data), he became concerned with the approach into the lock chamber because the outdraft “really got strong,” and the wind was pushing the tow sideways across the river more than he anticipated. The pilot radioed his concern to the two crewmembers at the head of the tow who were providing him with distances to the guide wall.

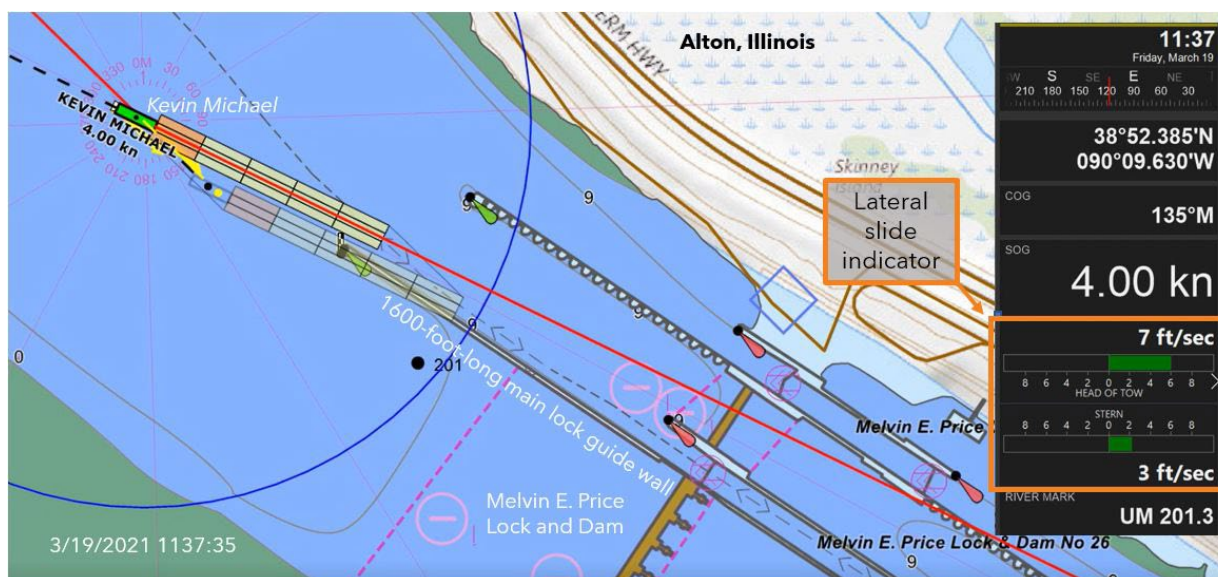
Figure 5. Screenshot of the *Kevin Michael* ECS at 1137 with the bow and stern sliding laterally to the right at 6.1 and 2.1 feet per second (rounded to 7 and 3 feet per second in lateral slide indicator).

At 1138, the empty outboard barge in the second row on the starboard side string contacted the guide wall bull nose, causing the tow to break apart. At the time of the contact, the tow's speed over ground was 4 mph, its heading was 116°, and its course over ground was 132°. In the minute before the contact, the lateral slide indicator showed speeds as high as 6.1 feet per second (4.1 mph) at the bow and 2.1 feet per second (1.4 mph) at the stern.

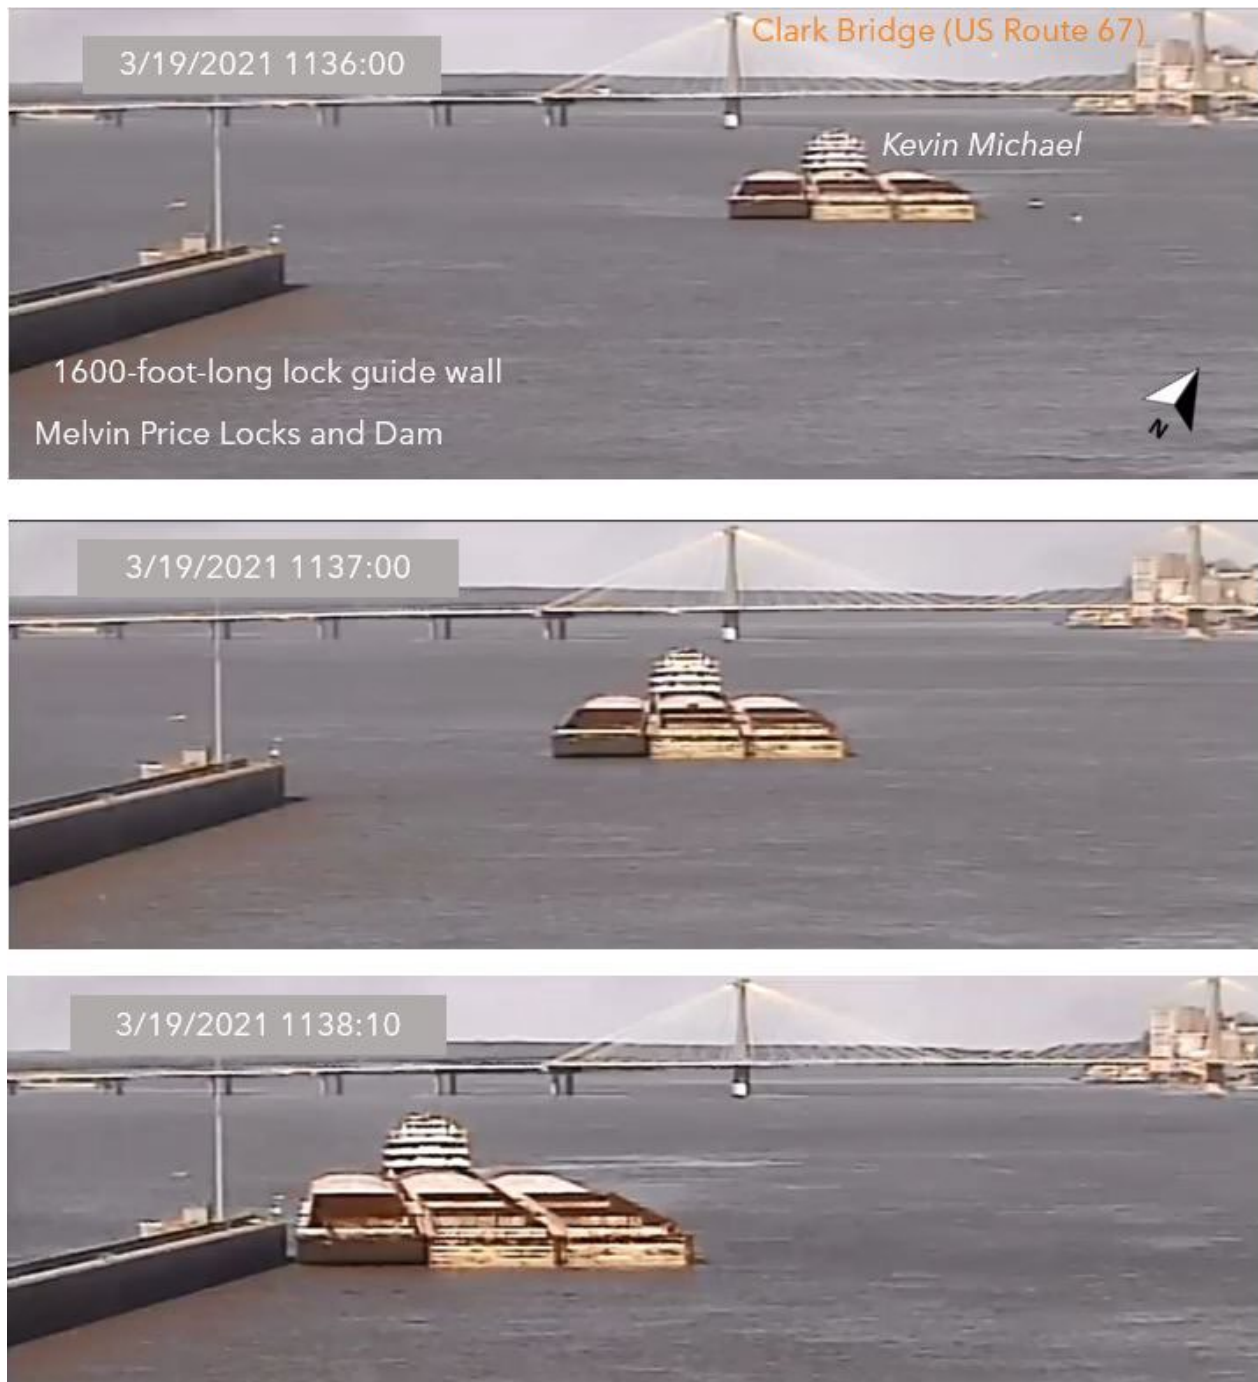
Figure 6. Screenshots of the *Kevin Michael* tow, starting 2 minutes before the contact. (Source: US Army Corps of Engineers)

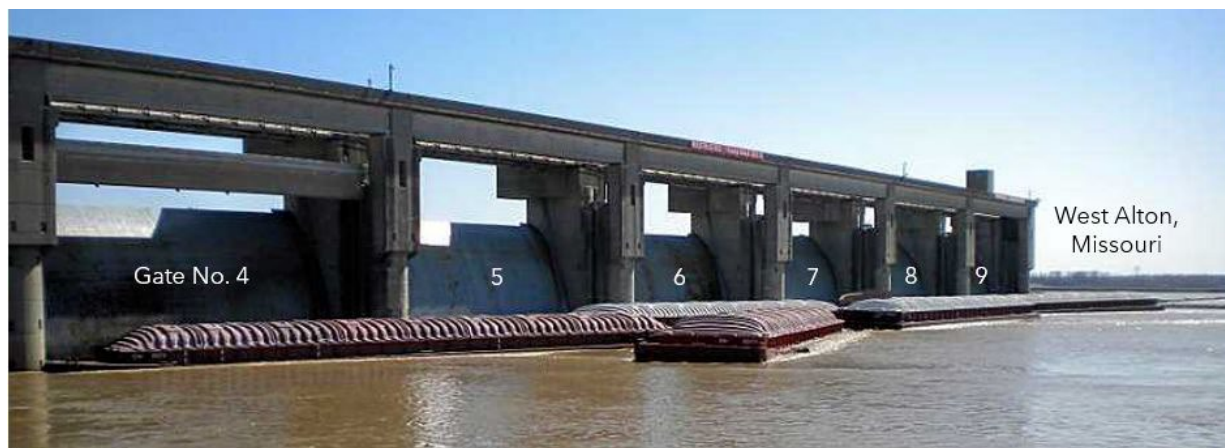
Eight barges drifted into the forebay area north of gates 1 and 2, with one barge entering the open main lock chamber. Seven barges drifted into gates 3–9. Following the barge breakaway, the lock was closed to traffic. Nearby towing vessels rounded up the barges. The lock reopened the next day, March 20, at 1950. The lock closure delayed seven southbound and three northbound tows.

Figure 7. Barges upstream of the Melvin Price Locks and Dam west of the guide wall following the casualty. (Source: Coast Guard)
