Issued March 21, 2022

MIR-22/09

## Contact of *Ava Claire* Tow with Leland Bowman Lock Gate

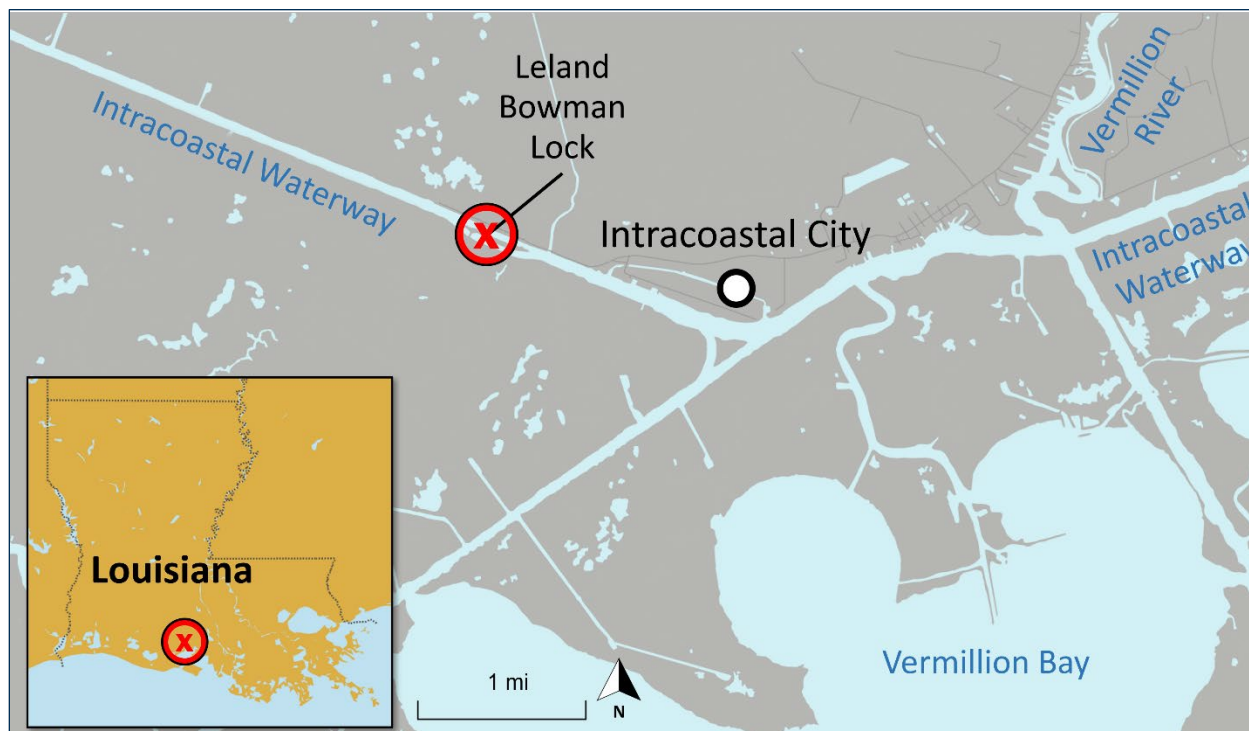
**Figure 2.** Area where the *Ava Claire* tow contacted the Leland Bowman Lock gate, as indicated by the red X. (Background source: Google Maps)

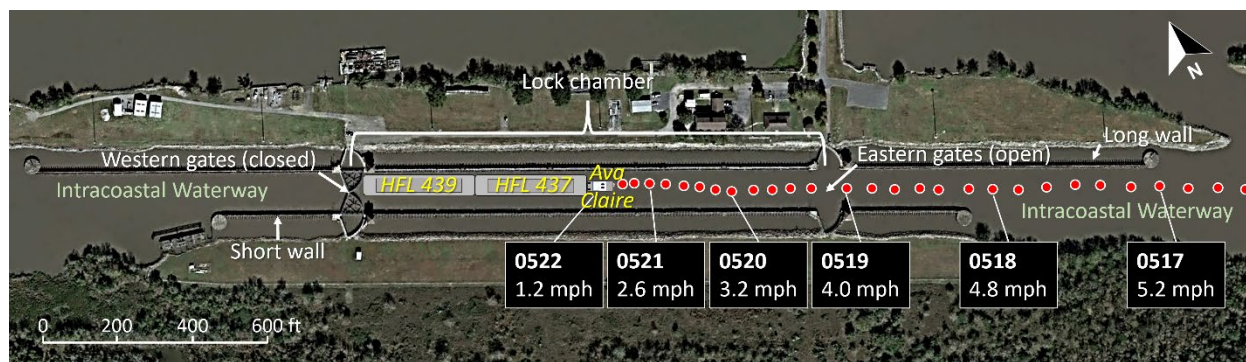
**Figure 3.** Automatic identification system (AIS) track of the *Ava Claire*, as indicated by the red dots, with a scaled representation of the tow added. The AIS antenna was located on the towing vessel, about 615 feet aft of the bow of barge *HFL 439*. (Background source: Google Earth)

According to the captain, when the head of the tow was about 600 feet from the western gates, he moved the engine throttles to slow astern. Based on automatic identification system (AIS) data, the tow’s speed at the time was 3.7 mph and decreasing.

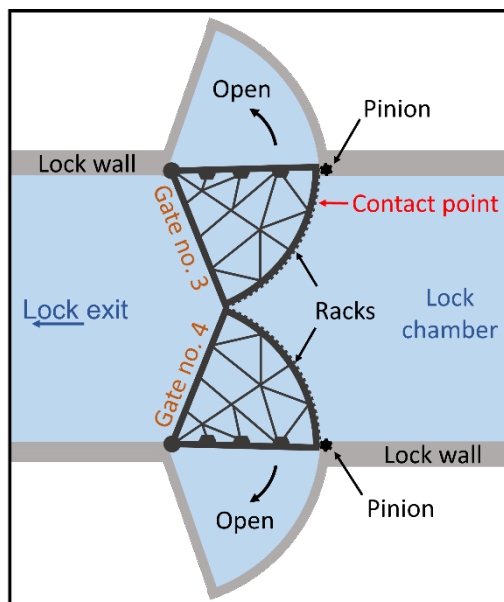
The deckhand stated that radio communications improved when the head of the tow was about 250 feet from the western gates. At this time, the captain was able to hear the deckhand’s distance calls. AIS data shows that the vessel’s speed was 3 mph. The captain said that when the tow was about 200 feet from the gates, he put the engines at full astern. The tow continued to slow but did not fully stop before the starboard bow of the *HFL 439* struck gate no. 3 on the northwest side of the lock at 0522. The tow’s speed when it contacted the gate was 1.2 mph.

**Figure 4.** Simplified illustration of Leland Bowman Lock western gates showing the point of contact by barge *HFL 439* (in red).

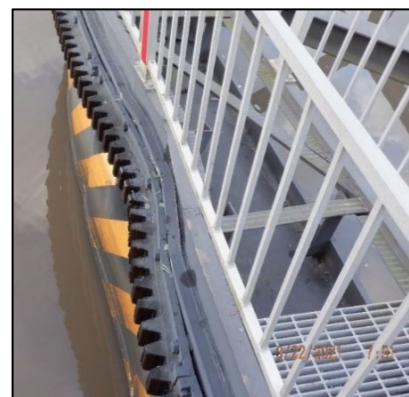
Steel plating, internal framing, and sections of the rack on lock gate no. 3 were bent 12 inches inward where the barge struck the gate. The gate structure was also knocked out of alignment, preventing it from being

**Figure 5.** Damaged steel plating and rack on gate.

fully opened. At the time of this report, damage below the waterline had not been assessed, nor the gate repaired.
