Issued March 31, 2022

MIR-22/11

Grounding of Tanker *Bow Tribute* and Subsequent Contact with River Intake Fender Systems

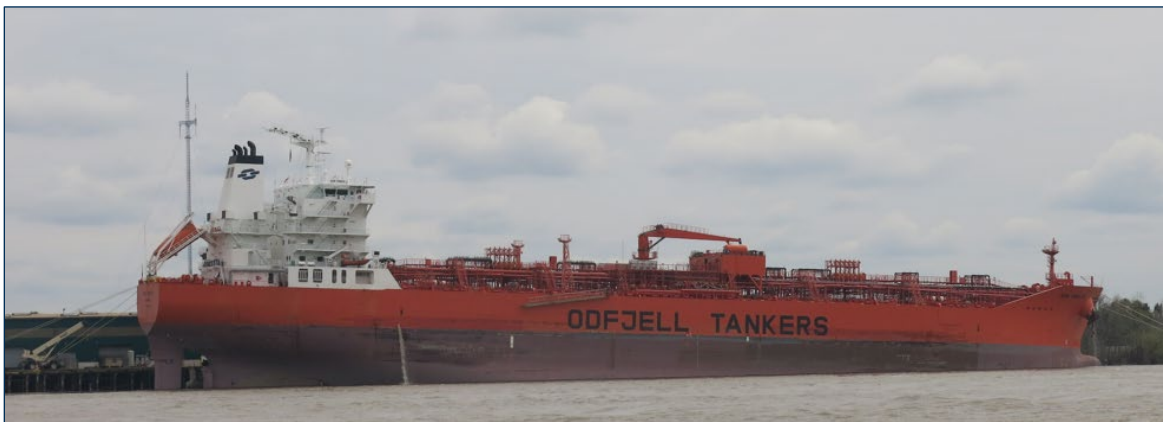
Figure 1. *Bow Tribute* moored alongside a dock after the casualty.

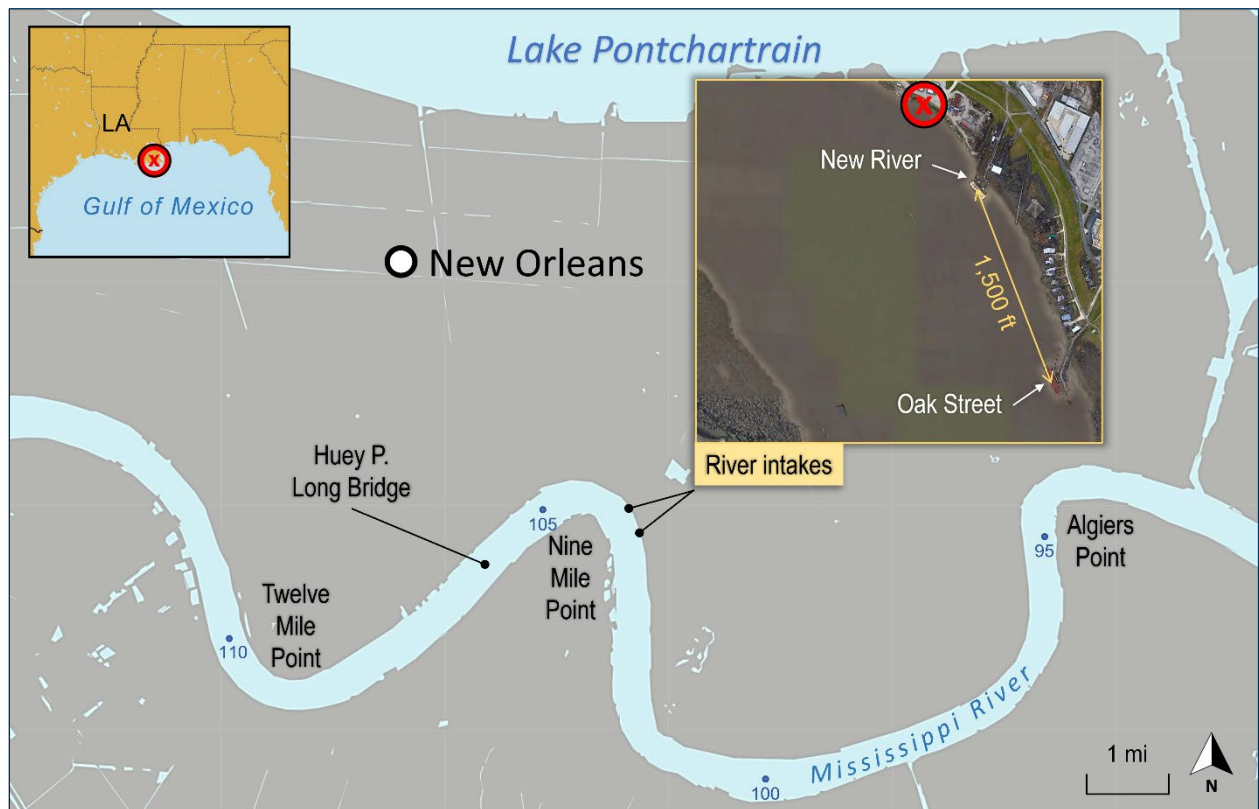
Figure 2. Area where the *Bow Tribute* grounded as indicated by a red X, and then struck the New River and Oak Street river intake fender systems. (Background source: Google Maps)

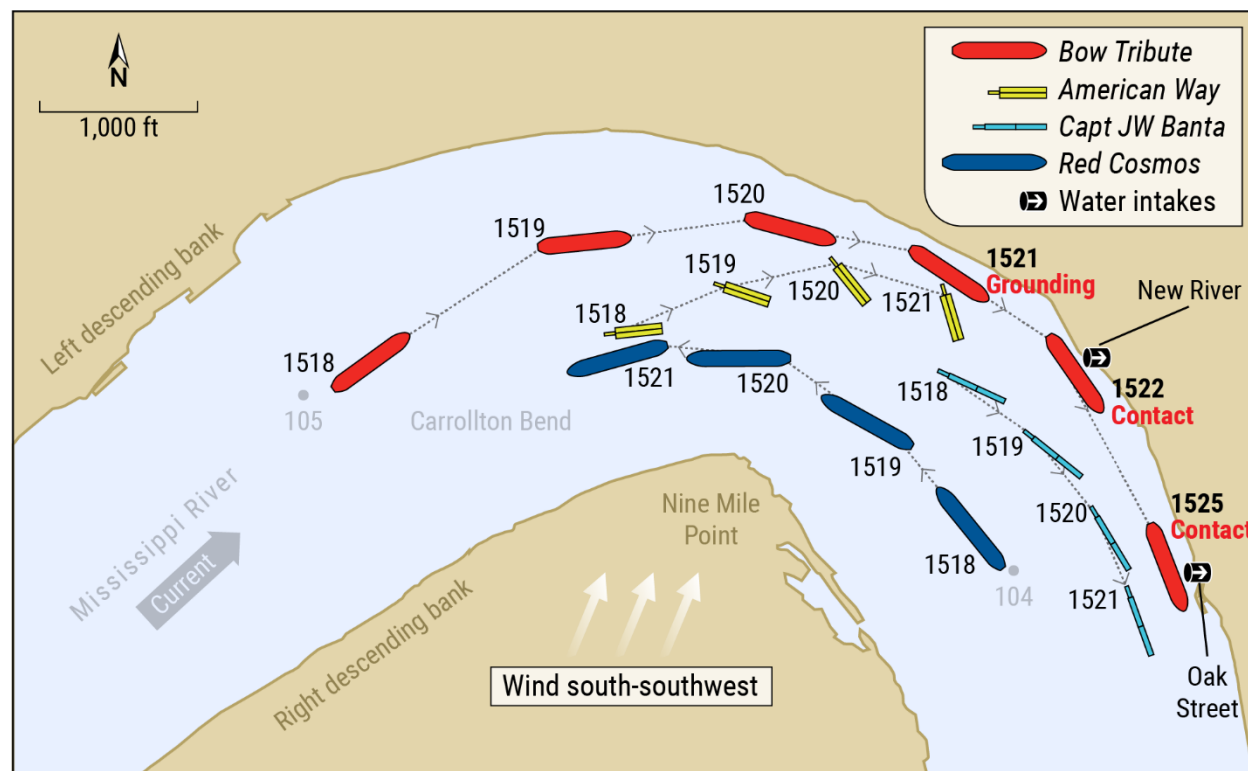
Figure 3. Positions of the *Bow Tribute*, *American Way*, *Capt JW Banta*, and *Red Cosmos* (approximate scale) in the Carrollton Bend in the minutes leading up to the casualty, based on automatic identification system data. The *Bow Tribute*'s subsequent contact at the two river intakes is also identified.

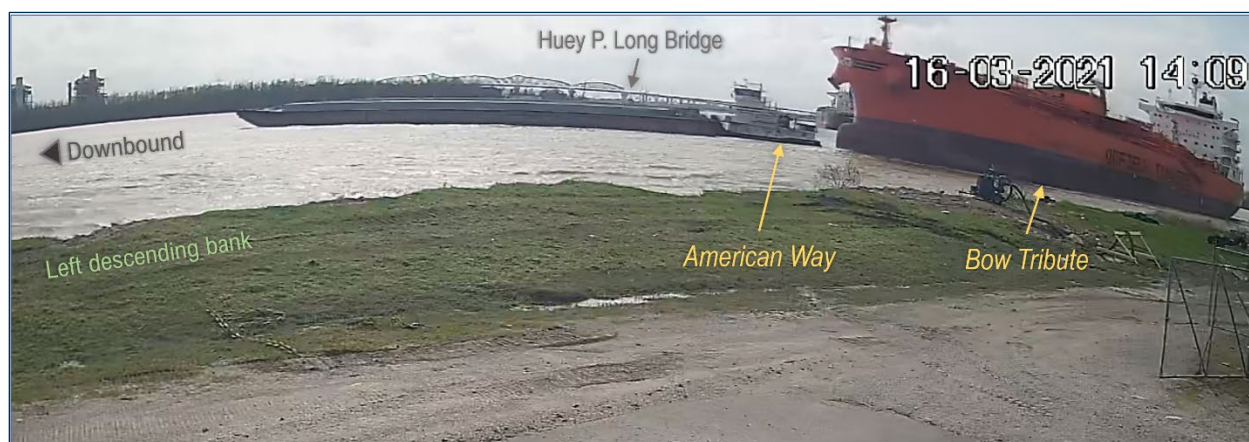
At 1520:35, as the stern of the *American Way* was about 130 feet off the starboard bow of the *Bow Tribute*, the NOBRA pilot on the *Bow Tribute* issued a series of helm orders to port and midship, followed by multiple soundings of the ship’s whistle. He announced over the radio that the tanker was “colliding at Nine Mile” and requested harbor tug assistance. The pilot then gave various rudder orders and then ordered the engine to full astern to maneuver the *Bow Tribute* clear of the *American Way*.

Figure 4. CCTV footage looking upriver at 1521 shows the *Bow Tribute* near the left descending bank with the *American Way* by the tanker’s starboard bow. (Timestamp is 1 hour 11 minutes behind the actual time.) (Source: Crosby Dredging)

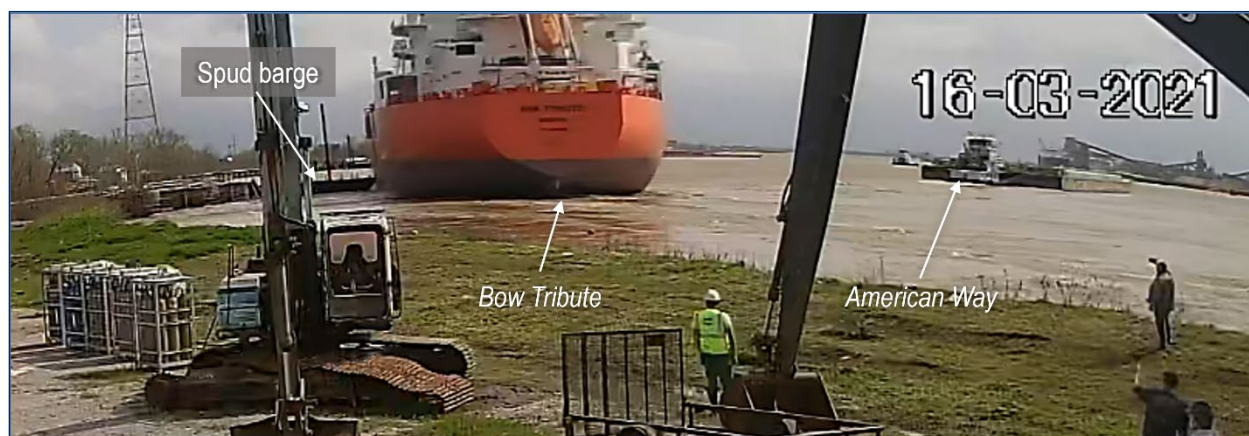
Seconds later, at 1522:26, the port side of the *Bow Tribute* struck a spud barge moored at mile 104.1 for the New River water intake system owned by the Sewerage and Water Board of New Orleans. The barge was part of a fender system to protect the river intake pipes. After being struck, the barge broke free from its spuds and moorings and drifted downriver. The NOBRA pilot on the tanker issued a series of rudder orders to port and starboard and, at 1522:38, ordered the starboard anchor let go, seeing the *American Way* was not at risk of being below the *Bow Tribute*'s starboard anchor. The second officer relayed the order to the bosun on the bow, who let go the starboard anchor without delay.

Figure 5. CCTV footage looking downriver at 1522:26 shows the *Bow Tribute* when it struck the spud barge protecting the New River water intake pipes. (Source: Crosby Dredging)

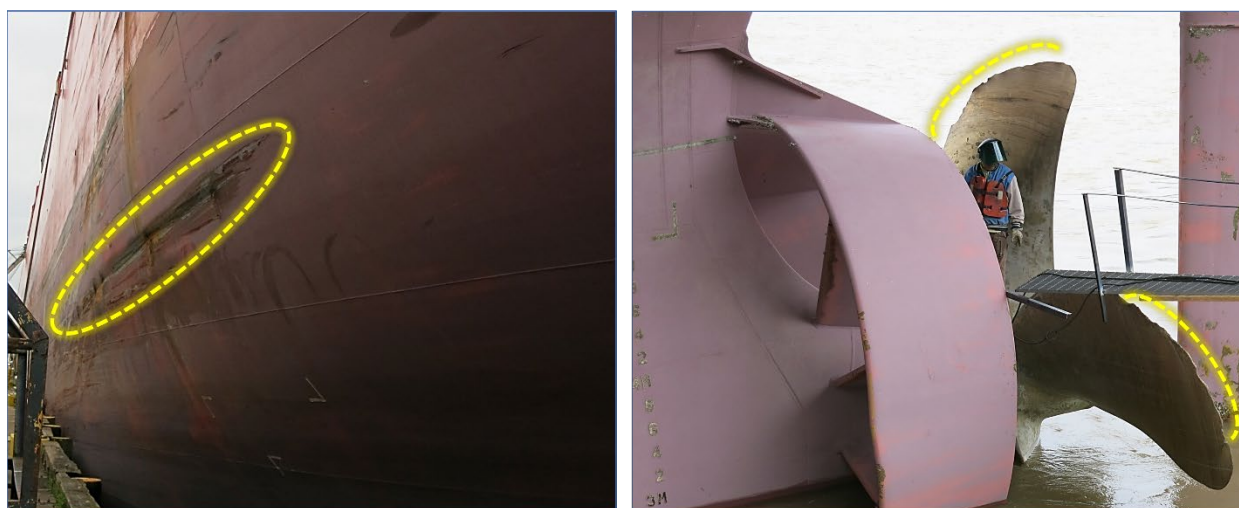
Neither the *American Way* nor its barges sustained any damage. On the *Bow Tribute*, all four of the propeller's blades were found with indentations, bends, and loss of material on their edges, as well as there was damage to the stern tube shaft seals. There was also damage to the portside hull shell plating: below the waterline near the aftmost cargo tanks and machinery spaces and above the waterline outboard of the machinery spaces (where there were scrapes and an indentation). The portside accommodation ladder was also damaged.

Figure 6. Postcasualty damage to the *Bow Tribute*'s portside aft hull (*left*) and propeller (*right*), as indicated by yellow dashed lines.

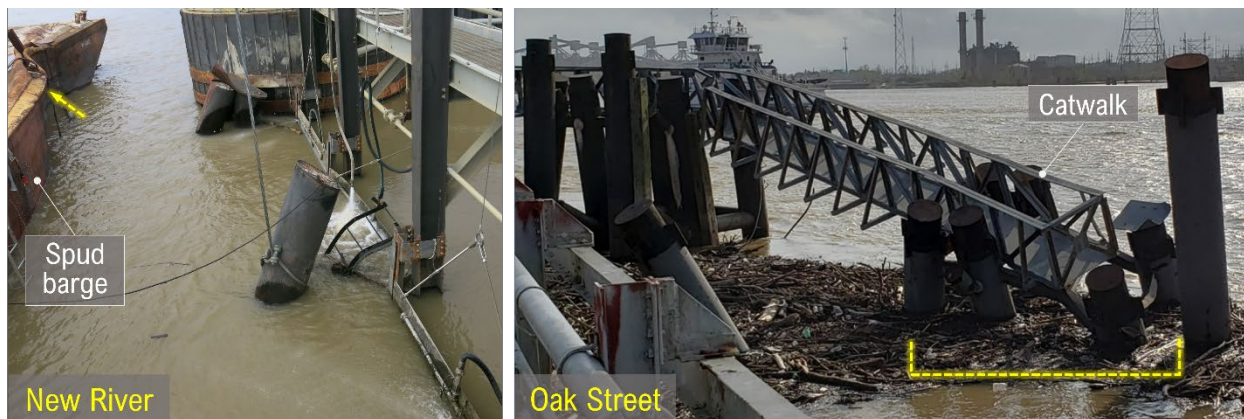
The fender systems for both river intakes sustained damage, but there was no damage to their pipes; the intake systems continued functioning without interruption. As a result of the protection barge being pushed into the fender system at the New River water intake, the dolphin piles, cells, and intake screen incurred damage. Also, the protection barge that broke free (but was later recovered by a nearby tugboat and returned to its original location) sustained compression damages and a crack in the hull. The Oak Street water intake fender system had a catwalk destroyed, and there was damage to its dolphin piles. Both river intake fender systems had been damaged during a previous casualty 5 years prior (on February 2, 2016) when struck by the tanker *Nordbay*; overall, they had not been repaired or replaced prior to the contact by the *Bow Tribute*.⁶

Figure 7. Damage to the river intake fender systems: (left) arrow shows damage to the spud barge at New River; (right) bracket identifies the damaged catwalk and dolphin piles at Oak Street downriver. (Source: Coast Guard [right photo])
