Issued April 6, 2022

MAB-22/12

Flooding and Sinking of Towing Vessel *Proassist III*

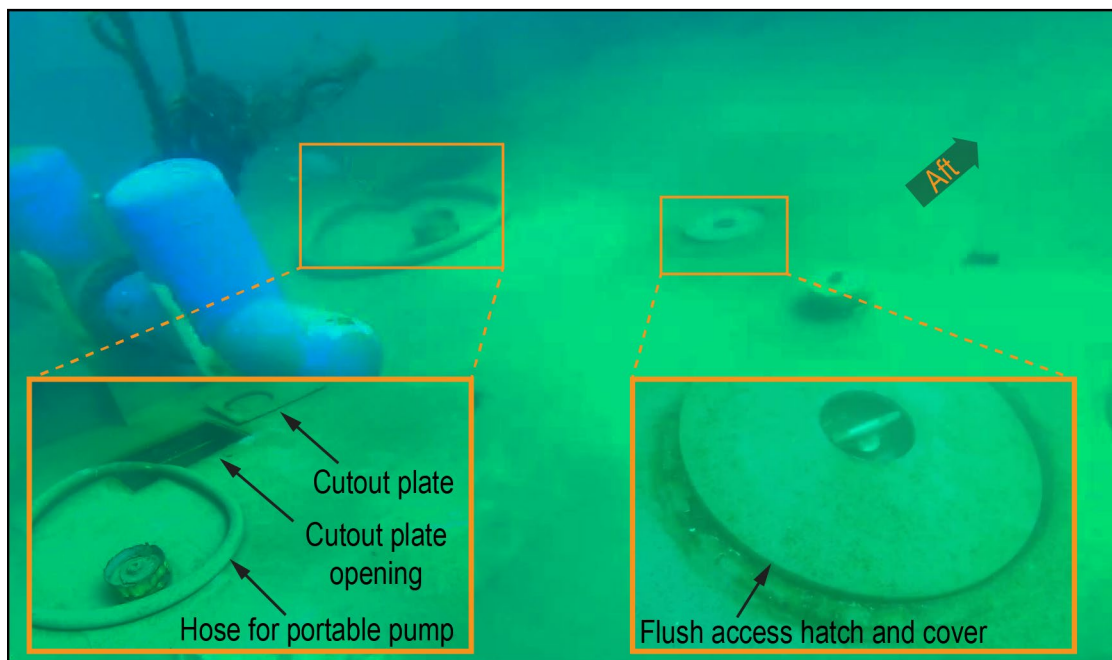
After the sinking, divers hired by the owner examined the vessel under water. After the examination, the NTSB reviewed the video, which showed the starboard-side rectangular cutout plate to the flanking rudder compartment laying on the deck next to its opening. The quick-acting flush access hatch opening that the plate encompassed was missing its cover (see figure 5). A portable pump hose, which the deckhands said had been used to pump water from the compartment out through the center flush hatch opening, could be seen extending into the compartment through the cutout plate opening. The cutout plate did not appear to have securing device or bolts to keep it in place, nor a gasket or gasket material, and the edges of the plate and the plate frame appeared wasted (corroded). Additionally, the center quick-acting flush hatch cover to the flanking rudder compartment was found unseated.

Figure 5. Starboard-side cutout plate with missing quick-acting flush access hatch cover (*left*) and unseated center quick-acting flush access hatch cover (*right*) to flanking rudder compartment. (Background source: Jorge Oller Reyes)

The underwater survey showed that the starboard deck cutout plate that encompassed the quick-acting flush access hatch to the flanking rudder compartment was displaced. The portable pump discharge hose was found with a loop on deck and both ends leading down through the cutout plate opening, indicating that the pumping the crew described was likely occurring through the cutout plate. With the cutout plate open, any water on deck would have drained into the flanking rudder compartment. Further, since the cutout plate (a flat steel plate inset resting on a framed lip) had no apparent gasket or means to be secured, water on deck would have drained through its seams even if it had been in place.

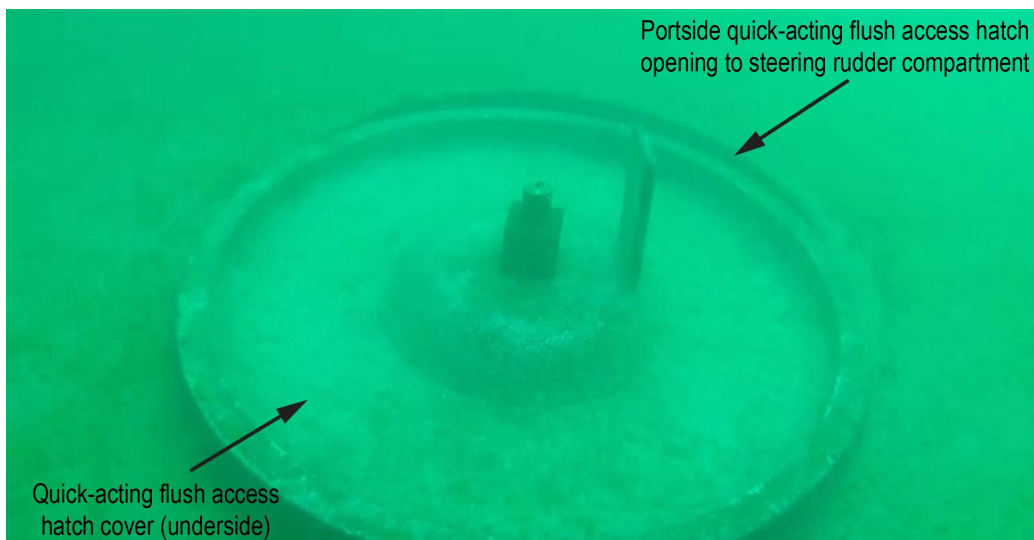
Video of the two quick-acting flush access hatches for the steering rudder compartment showed that the portside hatch cover was upside down and laying so that it covered more than half of the opening (see figure 6). A gasket was missing, and the underside of the cover was absent any dogs or mechanism to secure it in place.

Figure 6. Upside down portside quick-acting flush access hatch cover and opening to the steering rudder compartment. (Background source: Jorge Oller Reyes)

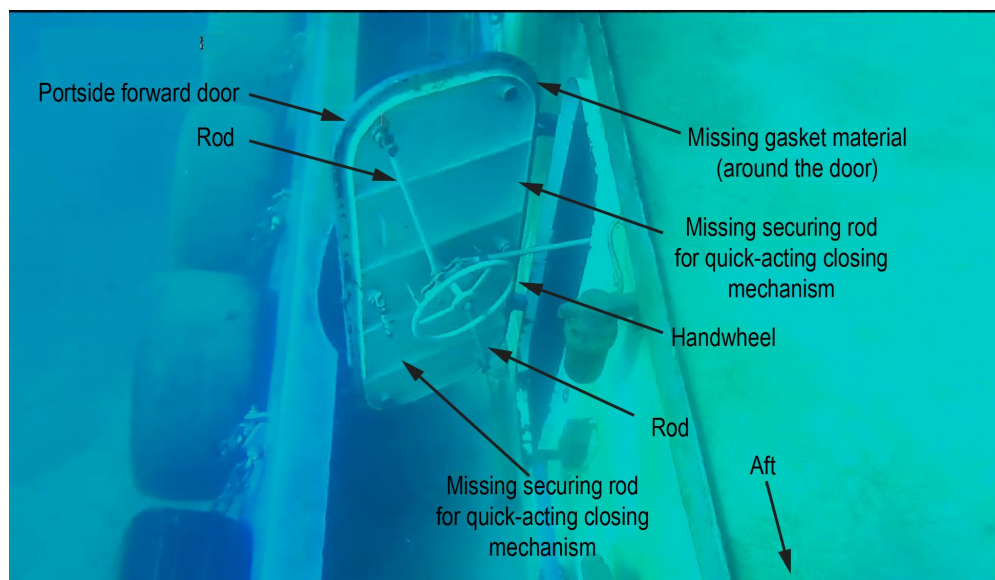
The aft weathertight door on the port side and the only door on the starboard side of the house (which was also weathertight) were shown open in the video (see figure 7). Portions of the quick-acting closure devices used to secure the corners of the open doors appeared to be missing, as well as gasket material used to keep water from seeping into the interior of the vessel when each door was closed on its frame. In addition, the starboard-side door was missing a lower rod, and the two top rods appeared to not be connected to the top of the door and still connected to the hand wheel. The unsecured rods appeared to have swung downward and stretched across the sides of the door, preventing the door from being closed.

Figure 7. Portside forward quick-closing weathertight door on the main deck. (Background source: Jorge Oller Reyes)

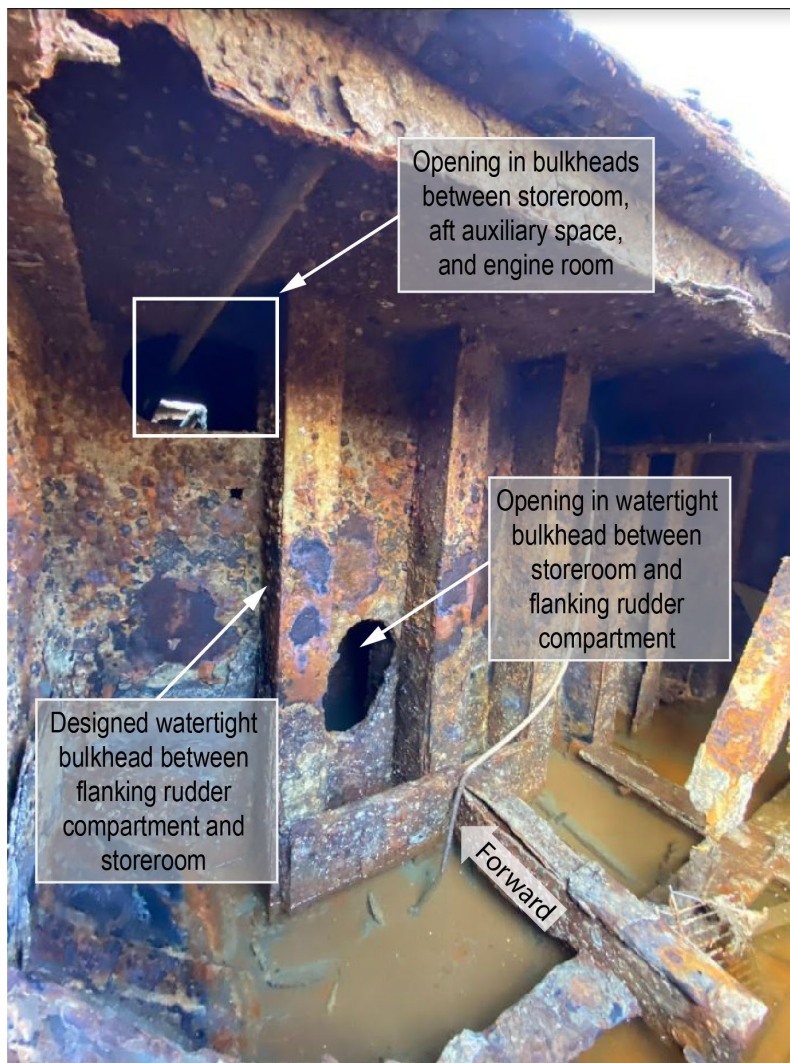
The *Proassist III* was refloated and brought shoreside to Puerto Yabucoa on September 27, 2021. During an examination of the recovered vessel on November 17, 2021, investigators found several openings in designed watertight bulkheads: there were openings for a pipe running through the bulkheads separating the engine room, auxiliary machinery space, storeroom, and flanking rudder compartments; there were openings in the watertight bulkhead between the storeroom and the flanking compartments; and the section of the watertight bulkhead between the flanking and steering rudder

compartments, similar to the bulkhead shown in figure 8, was missing. During the examination, investigators determined the distance from the stern of the vessel to the bulkhead between the storeroom and flanking rudder compartments was 27.5 feet, and from the deck to the bottom of the vessel in the flanking rudder compartment and the steering rudder compartment measured 7 feet 7 inches and 5 feet 1 inch deep, respectively. The owner told investigators he planned to scrap the vessel.

Figure 8. Flanking rudder compartment after recovery. Openings in bulkhead shown also typical of other bulkheads below the main deck separating compartments. (Source: Coast Guard)
