Fire aboard Fishing Vessel *Nobska*

On April 30, 2021, about 1810 local time, a fire erupted aboard the fishing vessel *Nobska* while the five-member crew was ground fishing in Georges Bank, about 80 miles east of Cape Cod, Massachusetts.¹ The fire started in the engine room and quickly engulfed the vessel. When attempts to extinguish the fire proved unsuccessful, the crew prepared to abandon ship and activated the vessel's emergency position indicating radio beacon (EPIRB). A US Coast Guard helicopter rescued the crew from the stern of the fishing vessel. Neither injury nor pollution was reported. The *Nobska*, valued at an estimated \$2.4 million, was declared a total constructive loss.

Casualty type	Fire/Explosion
Location	Georges Bank, about 80 miles off Cape Cod, Massachusetts 41°45.0' N, 68°15.0' W
Date	April 30, 2021
Time	1810 eastern daylight time (coordinated universal time -4 hrs)
Persons on board	5
Injuries	None
Property damage	\$2.4 million est.
Environmental damage	None
Weather	Clear, visibility 10 nm, winds southwest 28 mph, air temperature 59°F, water temperature 48°F
Waterway information	Atlantic Ocean, Georges Bank, depth 12-300 ft

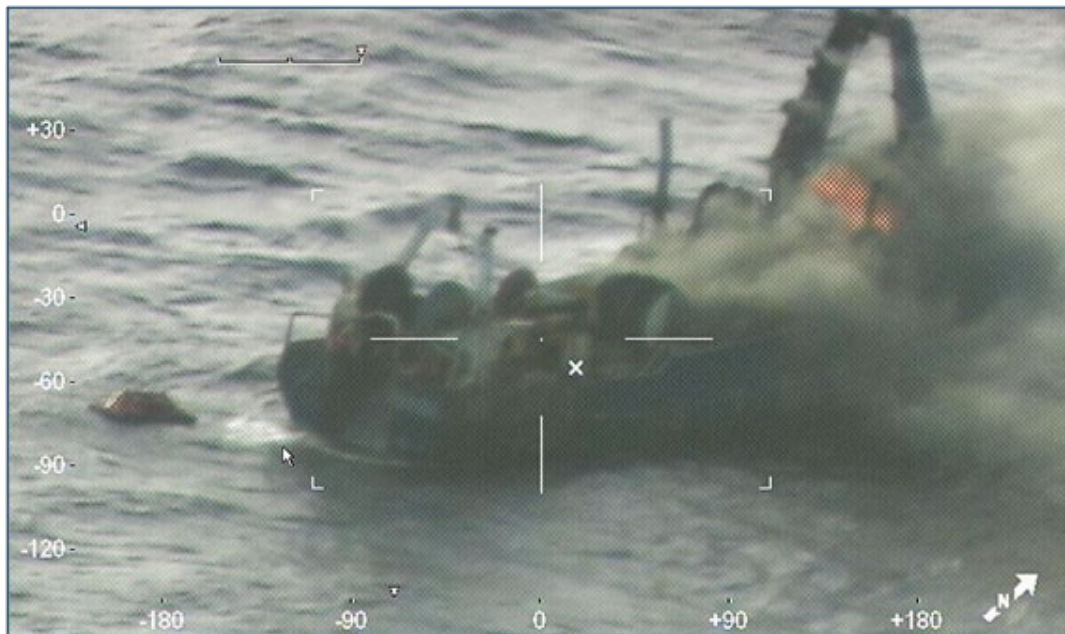
Figure 3. Photo taken from the Coast Guard HC-144 aircraft at 1827 shows the bow of the *Nobska* on fire before the rescue. The deployed liferaft appears on the left. (Source: US Coast Guard)

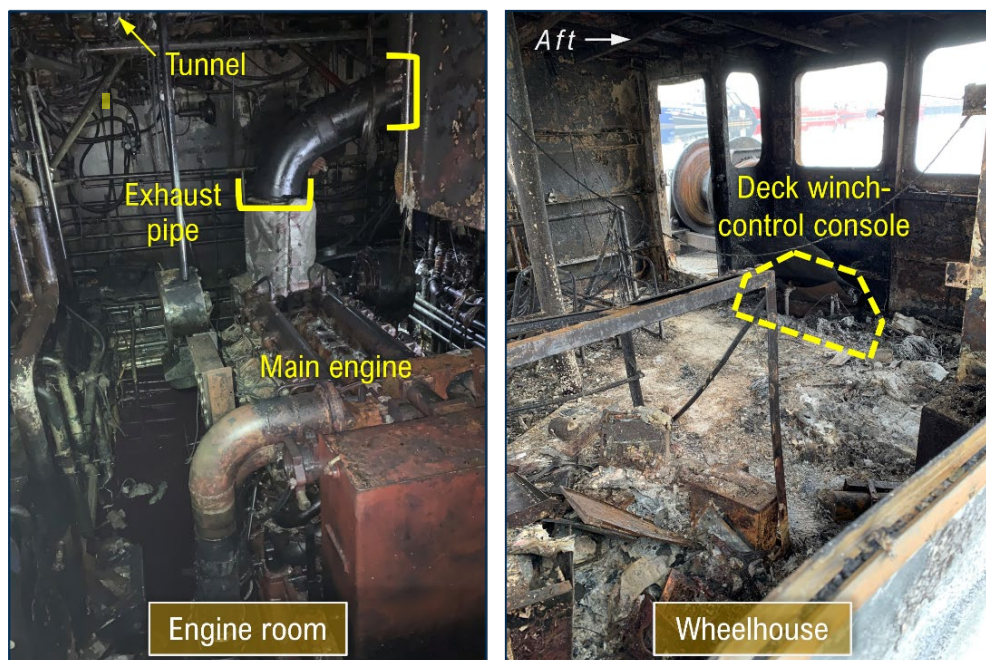
After the fire extinguished itself about 2 days later, the *Nobska* was towed to New Bedford on May 4. The next morning, investigators examined the vessel and found an extensive amount of fire damage within the vessel and throughout the engine room. All combustible materials in the forward part of the vessel were incinerated, leaving only the steel decking and structure. In addition, there were several overhead frames in the engine room that had warped and separated from deck plating above.

Figure 4. Post-fire damage of the engine room, where the crew removed the lagging from the exhaust pipe, as indicated by the yellow brackets (*left*), and of the wheelhouse, where the captain observed black smoke emanating from under the deck winch-control console (*right*).

console to engulfing the wheelhouse moments later indicates that the source of the fuel for the fire was abundant and volatile. Once the lagging was removed from the main engine exhaust, there was no insulation providing protection in the event flammable liquids, such as hydraulic fluid or diesel fuel oil, contacted the hot exhaust pipe's surface. Since the hydraulic fluid used in the system was located within the engine room and had a flash point of about 420°F, the second fire likely was the result of another hydraulic hose leak. When the fluid left the hydraulic hose under pressure, the fluid atomized before it contacted a hot surface, most likely the exposed main engine exhaust pipe, and flashed into a fire.

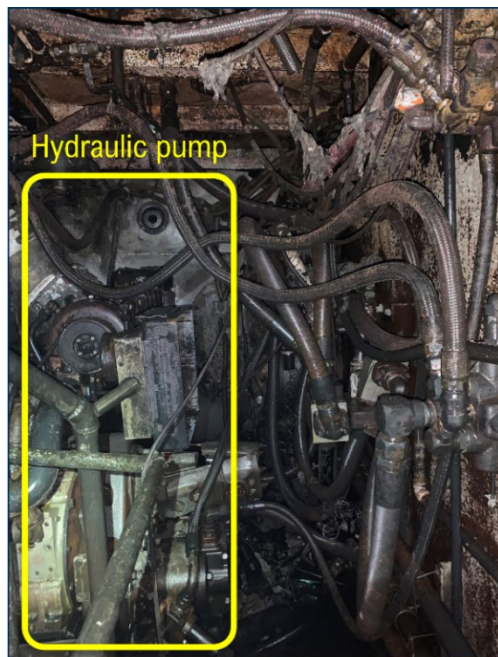
During the examination, it was noted that the fire damage to the main diesel engine, diesel engine generator, and hydraulic system diesel engine was limited to the melting of plastic parts. Damaged hydraulic hoses were found on the bulkhead aft of the main diesel engine and within the tunnel located in the overhead of the engine room 2 feet away from the main diesel engine. Due to the extent of the fire, it could not be determined if the damage to the hydraulic hoses occurred before or during the fire that engulfed the vessel, nor could the location of where the second fire initiated be

Figure 5. Post-fire hydraulic pump and hoses inside the engine room.

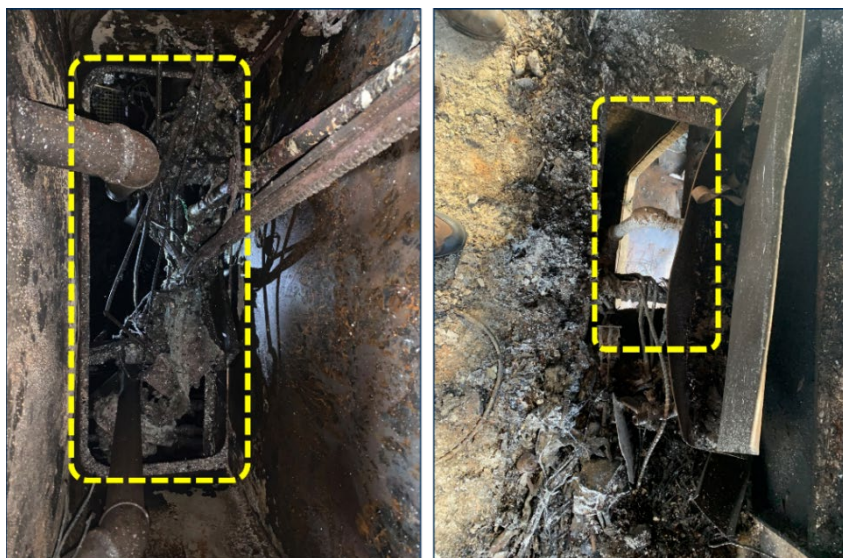
A 1-by-2-foot rectangle-shaped pipe/hose tunnel extended vertically from the overhead of the engine room up two decks to the deck winch-control console in the wheelhouse. Within this tunnel, there were fifteen 0.25-inch-diameter hydraulic hoses connecting to the console that were bundled tightly together. There were no pipe/cable fire stops or other methods to prevent the passage of smoke, heat, and fire from the

Figure 6. Damaged pipe/hose tunnel, as identified by yellow rectangles, looking up from the engine room (*left*) and down onto the deck winch-control console location (*right*).

The fire started within the engine room and spread quickly up two decks to the wheelhouse, where it ignited combustible materials and spread further. The deck between the engine room and the accommodation space on the *Nobska* was made of steel but had no fire insulation to slow or prevent the passage of heat. Consequently, the pipe/hose tunnel running between these two spaces acted like a chimney, funneling the heat, smoke, and flames up to the wheelhouse.

As an uninspected commercial fishing vessel, the construction of the tunnel on the *Nobska* was not subject to any structural fire-protection regulations, as required for the construction of Coast Guard-inspected vessels. Had the tunnel opening on the *Nobska* been sealed, including pipe/cable-type fire stops, and its surrounding structure insulated with fire-retardant materials, the fire would not have been able to rapidly spread, and damage may have been limited/contained to the engine room.

The pipe/hose tunnel on board the *Nobska*, which extended from the engine room up two decks to the wheelhouse, did not have any insulation, pipe/cable fire stops, or other barriers to prevent the passage of smoke, heat, and fire—known as structural fire protection. This type of unprotected vertical tunnel has the potential to provide a pathway for a fire to spread quickly outside of the space of origination. Vessel owners and operators should identify such openings between decks and ensure they are structurally fire protected to prevent the spread of a fire.

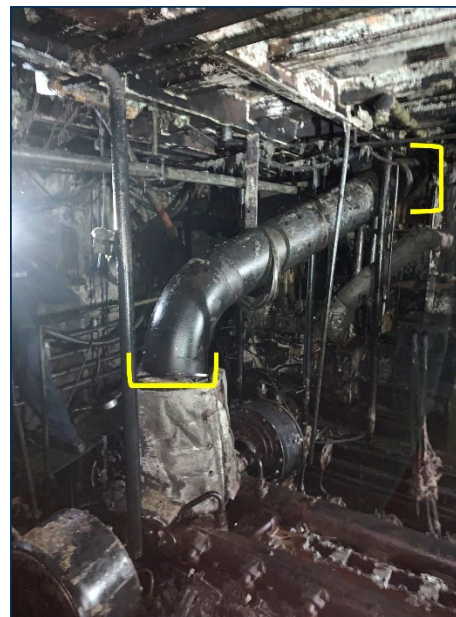
Figure 7. Missing main engine exhaust pipe lagging, as identified by yellow brackets.
