MIR-22/19

Engine Room Fire aboard Bulk Carrier *Roger Blough*

Sturgeon Bay, Wisconsin

February 1, 2021

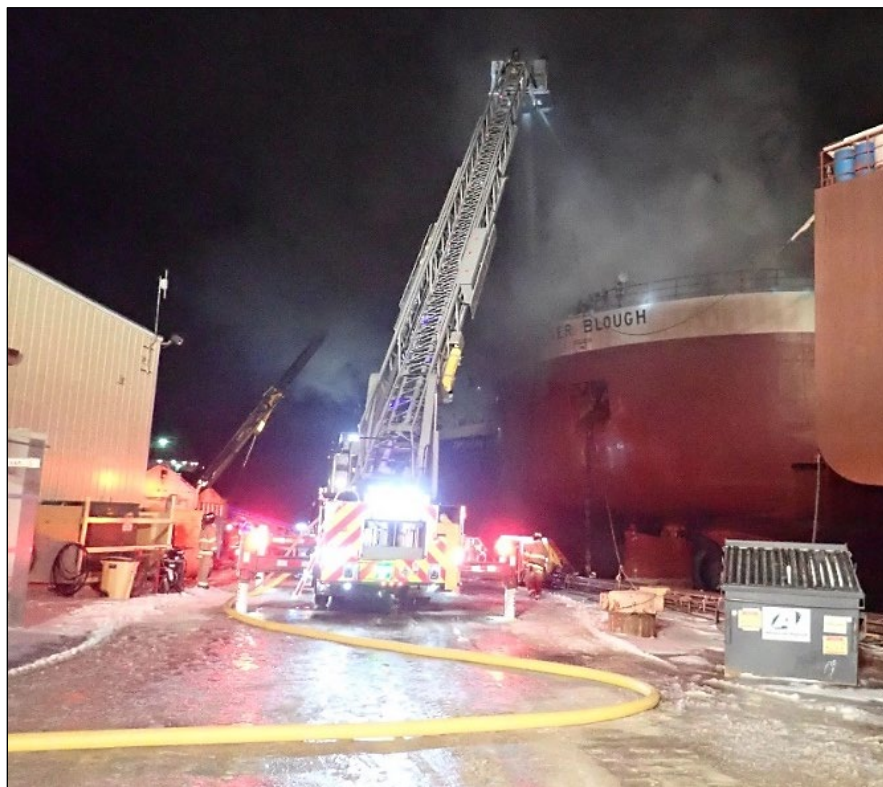
Figure 4. Stern of the *Roger Blough* during firefighting efforts. (Source: Coast Guard)

The first units from the fire department arrived at 0143 to fight the fire, which was starting to expand into the galley on the poop deck (see figure 4). Upon assessing the fire, firefighters determined it had traveled through the port and starboard conveyor belt trunks that angled up to the poop deck, to the aft cargo-unloading booms on the spar deck below, and throughout the engine room on the lower deck. The fire was extinguished later that day at 1300. It did not spread to any of the neighboring vessels.

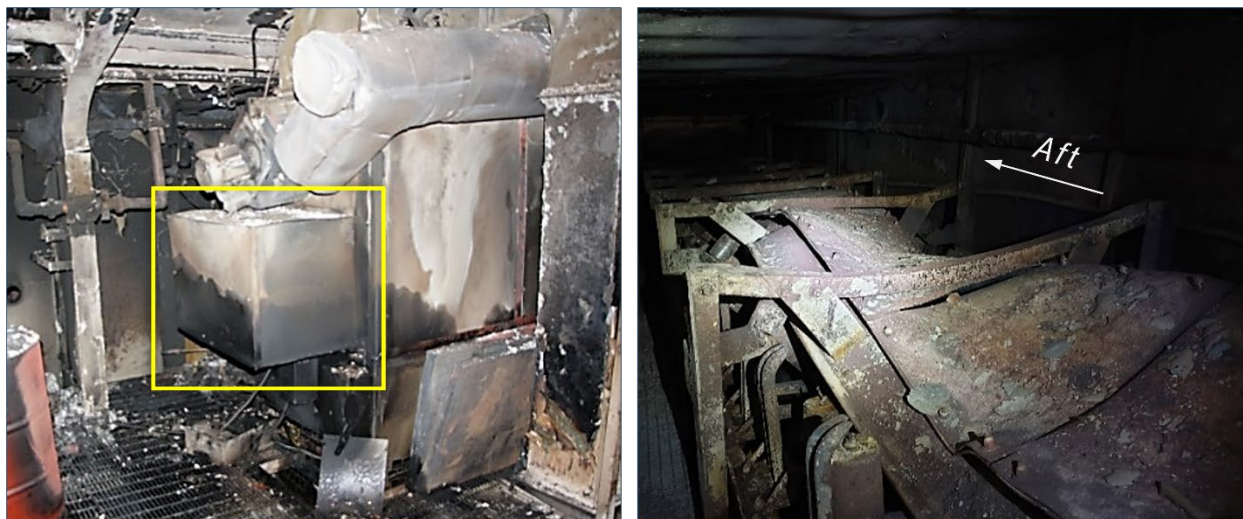
The fire investigation discovered extensive damage throughout the engine room spaces as well as to parts of the aft house, self-unloading cargo booms, and the section of the conveyor belt trunks passing through the engine room (see figure 5, right). US Coast Guard investigators noted that most of the fire damage in the engine room was centrally located on the lower deck near the furnace and on the level above leading up to the stack (operating deck).⁶ On the lower level, there was significant smoke and thermal damage in and around the furnace. Nearby metal objects did not burn but sustained thermal damage on surfaces facing the furnace. There was also extensive smoke and thermal damage above the furnace where the portside conveyor belt trunk was located. A closer examination of the furnace showed extensive thermal damage specifically at the burner enclosure, where there was noticeable discoloration of the metal structure and significant soot (see figure 5, left). When the enclosure was opened by investigators, the burner showed significant fire damage, including melting and warping of the cast aluminum framing. The soot line was primarily above the burner

assembly, which was resting on the bottom of the enclosure, while below and behind it, there were no indications of soot or heat damage.

Figure 5. Furnace with burner enclosure outlined (*left*), and fire-damaged conveyor belt within the conveyor belt trunk above the furnace (*right*). (Source: Coast Guard)

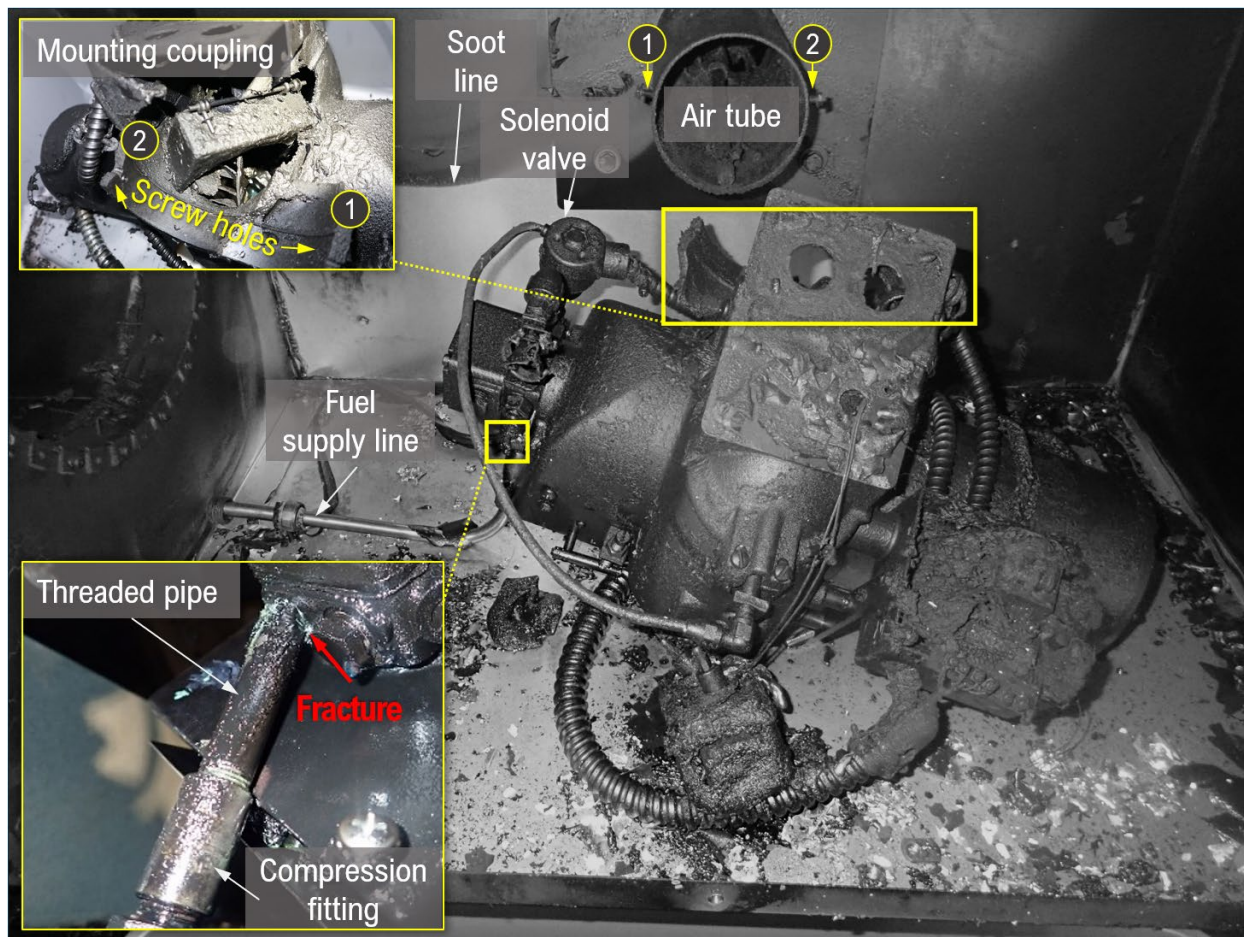
Investigators found the burner assembly detached from the air tube and resting on the bottom of the burner enclosure. The fuel supply line was connected to the burner with a compression fitting from the fuel supply line tubing to a short pipe (a few inches) located at the underside of the burner assembly that threaded into the burner body. The threaded pipe, which had bent about 10° to the right when facing the burner assembly, was fractured. The location of the fuel supply line fracture was before the burner's fuel shutoff solenoid valve (see bottom inset of figure 6). The 4,144-gallon storage tank that supplied fuel to the furnace was found empty after the fire.

Figure 6. Photo of the fire-damaged burner detached from the air tube, lying on the bottom of the enclosure, shows the fracture point where the fuel supply pipe threaded into the burner assembly (*bottom inset*) and the fractured mounting coupling (*top inset*, interior view). (Source: Coast Guard)

In addition, the burner's aluminum mounting coupling, which overlapped onto the steel air tube by a half inch, was fractured on both sides at the hole for each set screw used to secure it to the air tube (see also figure 6, top inset; nos. 1 and 2 indicate the location of the screws). The fracture separated the top part of the coupling from the bottom. The two set screws were found still threaded into the air tube. The technical service manager from the burner manufacturer, who had worked for the company for 27 years, said, "I haven't seen a failure like this before." Except for the mounting coupling, no other structures or framing supported and held the burner in place.

Furthermore, investigators found the soot line inside the burner enclosure was distinguishable above the burner assembly, which was resting on the bottom of the enclosure (see figure 6). This demarcation indicated that an uncontrolled fire occurred after the burner assembly disconnected from the air tube in the furnace and fell; had the fire erupted while the burner assembly was still connected to the air tube, the soot line would have been higher. Thus, it is likely that the coupling was the initial failure point. Therefore, the NTSB concludes that the repeated removal and reinstallation of the burner assembly during the ship's engineers' attempts to repair it without consulting the manual or the manufacturer may have damaged the mounting coupling and thereby led to its eventual failure.

Following the failure of the coupling, the burner dropped to the bottom of the enclosure. As a result, the weight of the burner assembly likely caused the vertically oriented fuel supply line and pipe connected to its underside to bend downward and fracture at the point where the pipe was threaded into the burner assembly. Because this fracture was located before the burner's internal pump and fuel shutoff solenoid valve, fuel under head pressure from the fuel oil storage tank a deck above released into the enclosure. Therefore, the NTSB concludes the furnace's burner assembly became detached from the air tube and fell when the mounting coupling fractured, which likely bent and fractured the fuel supply line to the burner, thereby allowing fuel to spray onto the operating burner and ignite within the enclosure.

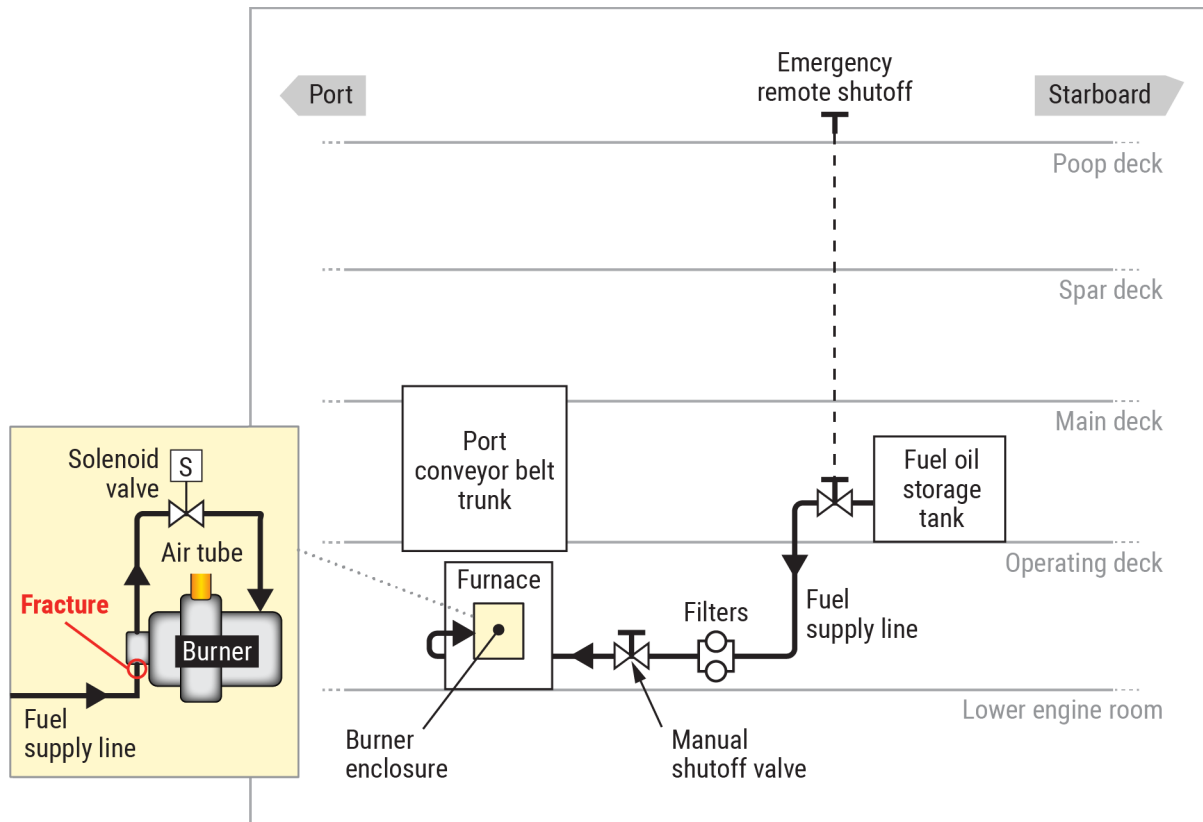
Figure 7 provides a simplified section view of the ship (looking forward). The location of the furnace relative to the portside conveyor belt trunk—which passed over the furnace—and the flow of fuel from the diesel fuel oil storage tank to the furnace are shown. The storage tank, also in the engine room, was located on the operating deck, a deck above the furnace. The fuel supply line had a manually operated shutoff valve at the tank that could be closed remotely during an emergency from the starboard side of the poop deck. Next to the furnace, about 10 inches away, another manual shutoff valve on the fuel supply line as it entered the burner enclosure could isolate the furnace from the fuel system but could only be operated locally. Lastly, a fuel shutoff solenoid valve on the burner assembly would close and stop pressurized fuel from entering the furnace’s combustion chamber in the event of a signal from the furnace’s control system.

Figure 7. Simple section view of the engine room with arrangement of the furnace's fuel supply (not to scale).

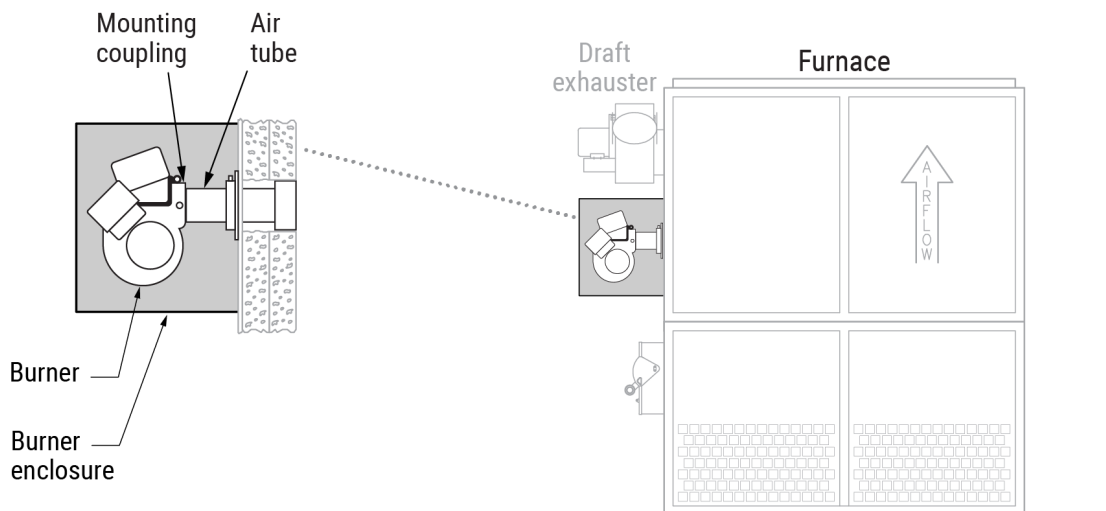
The cast aluminum burner housing was designed to be mounted on the furnace's horizontally positioned air tube or, for some installations, to be supported by a pedestal (see figure 9). In the furnace of the *Roger Blough*, it was mounted to the air tube with a coupling, an arrangement that did not require the pedestal. A technical service manager from the manufacturer, Carlin Combustion Technology, told investigators that while the burner can be mounted without the pedestal, it is common practice for installers to use the pedestal to provide support below the burner to ensure it will not move. The company that installed the furnace submitted to the vessel's owner a furnace design proposal that did not include the pedestal support for the burner.

Figure 9. Diagram showing the burner assembly within the enclosure as mounted on the furnace on board the *Roger Blough*.
