Issued August 25, 2022

MIR-22/22

Collision between *Baxter Southern* Tow and BNSF Coal Train

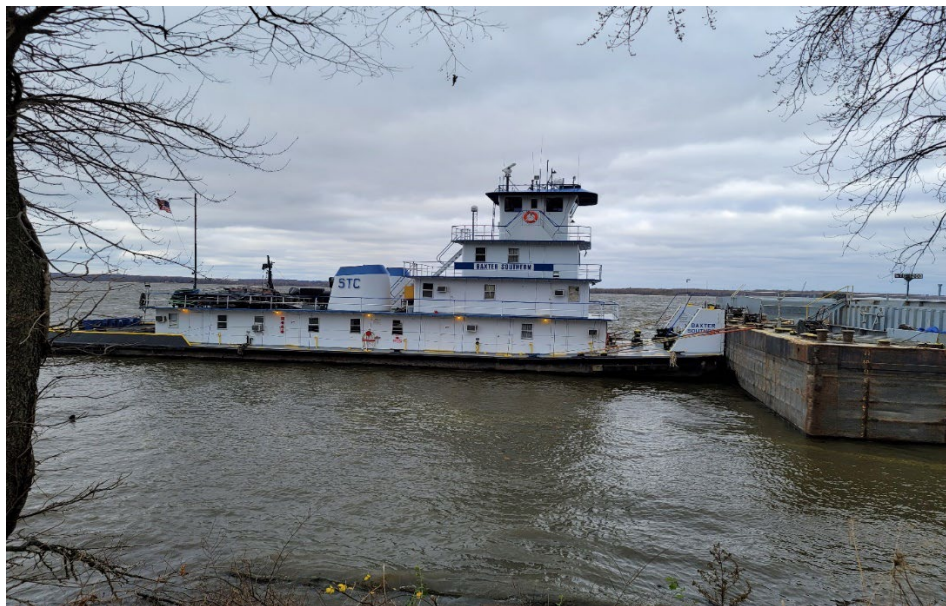
Figure 1. The *Baxter Southern* after the casualty. (Source: US Coast Guard)

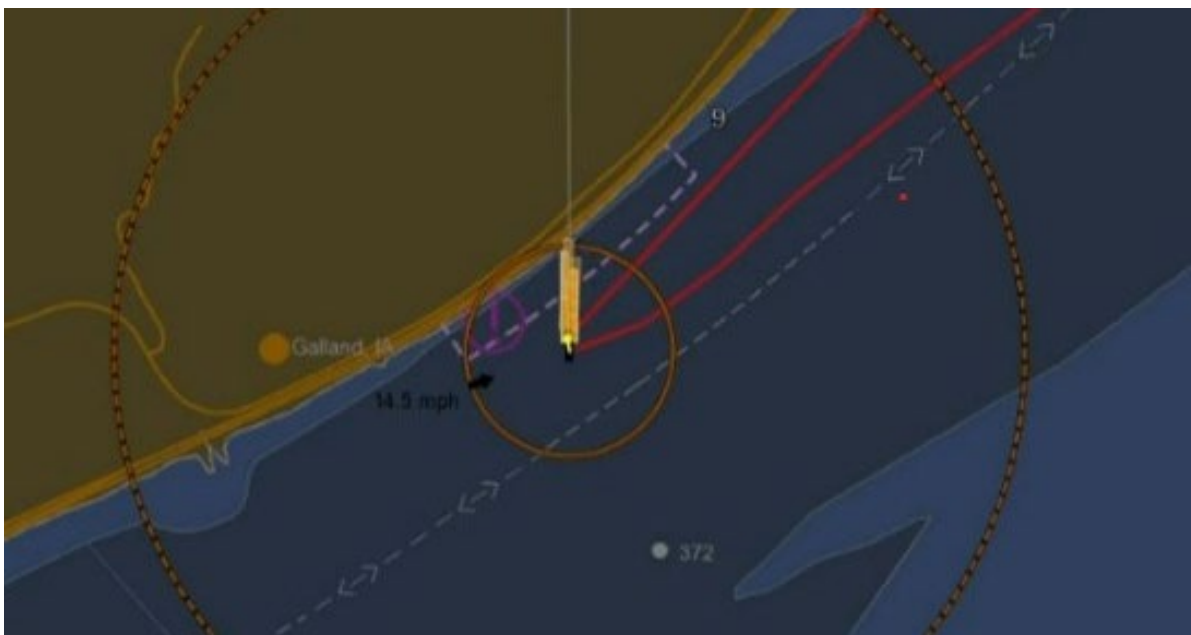
a magenta dashed line on the electronic navigation chart next to railroad tracks at mile 372, and both said they believed the area represented a fleeting area and that it would be safe to push up against the bank within it. The electronic navigation chart showed railroad tracks along the riverbank but did not provide the distance from the river to the tracks. The captain told the pilot to head to the marked area on the chart at mile 372 and place the tow up against the riverbank at that location to wait out the weather.

Figure 3. Snapshot of *Baxter Southern* ECS playback at 2336 showing the area marked by a magenta dashed line and the vessel pushed up against the riverbank. (Source: Southern Towing Company)

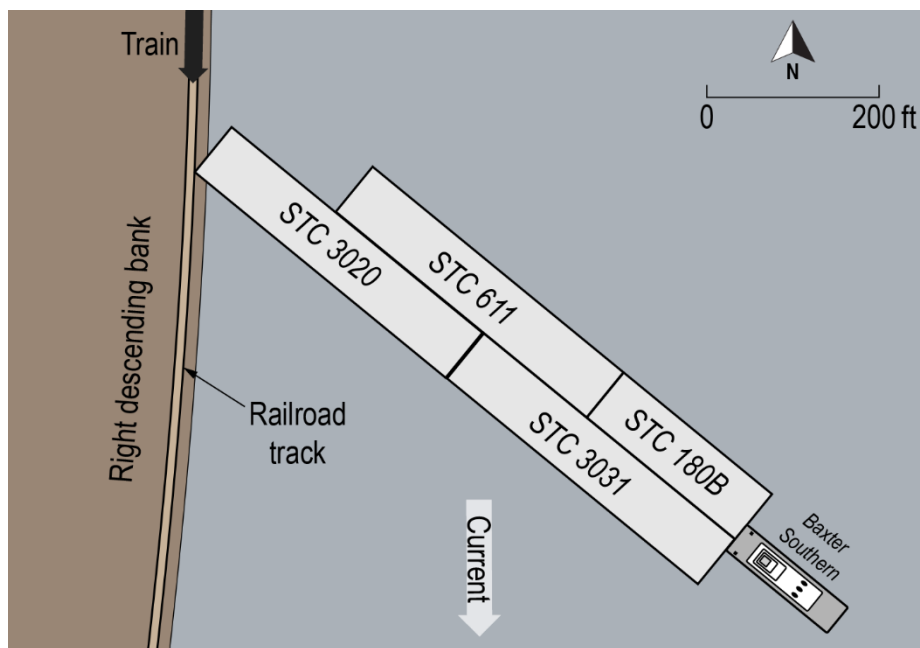
Before the three crewmembers (who were now on the *STC 3020*) could check the track clearance, they saw the headlight of the approaching train's lead locomotive as it appeared to the starboard side of the tow, coming around a slight bend in the tracks behind some trees about 2,000 feet away.

Figure 4. Approximate position of *Baxter Southern* tow pushed up against the riverbank as the train approached (scale approximate).

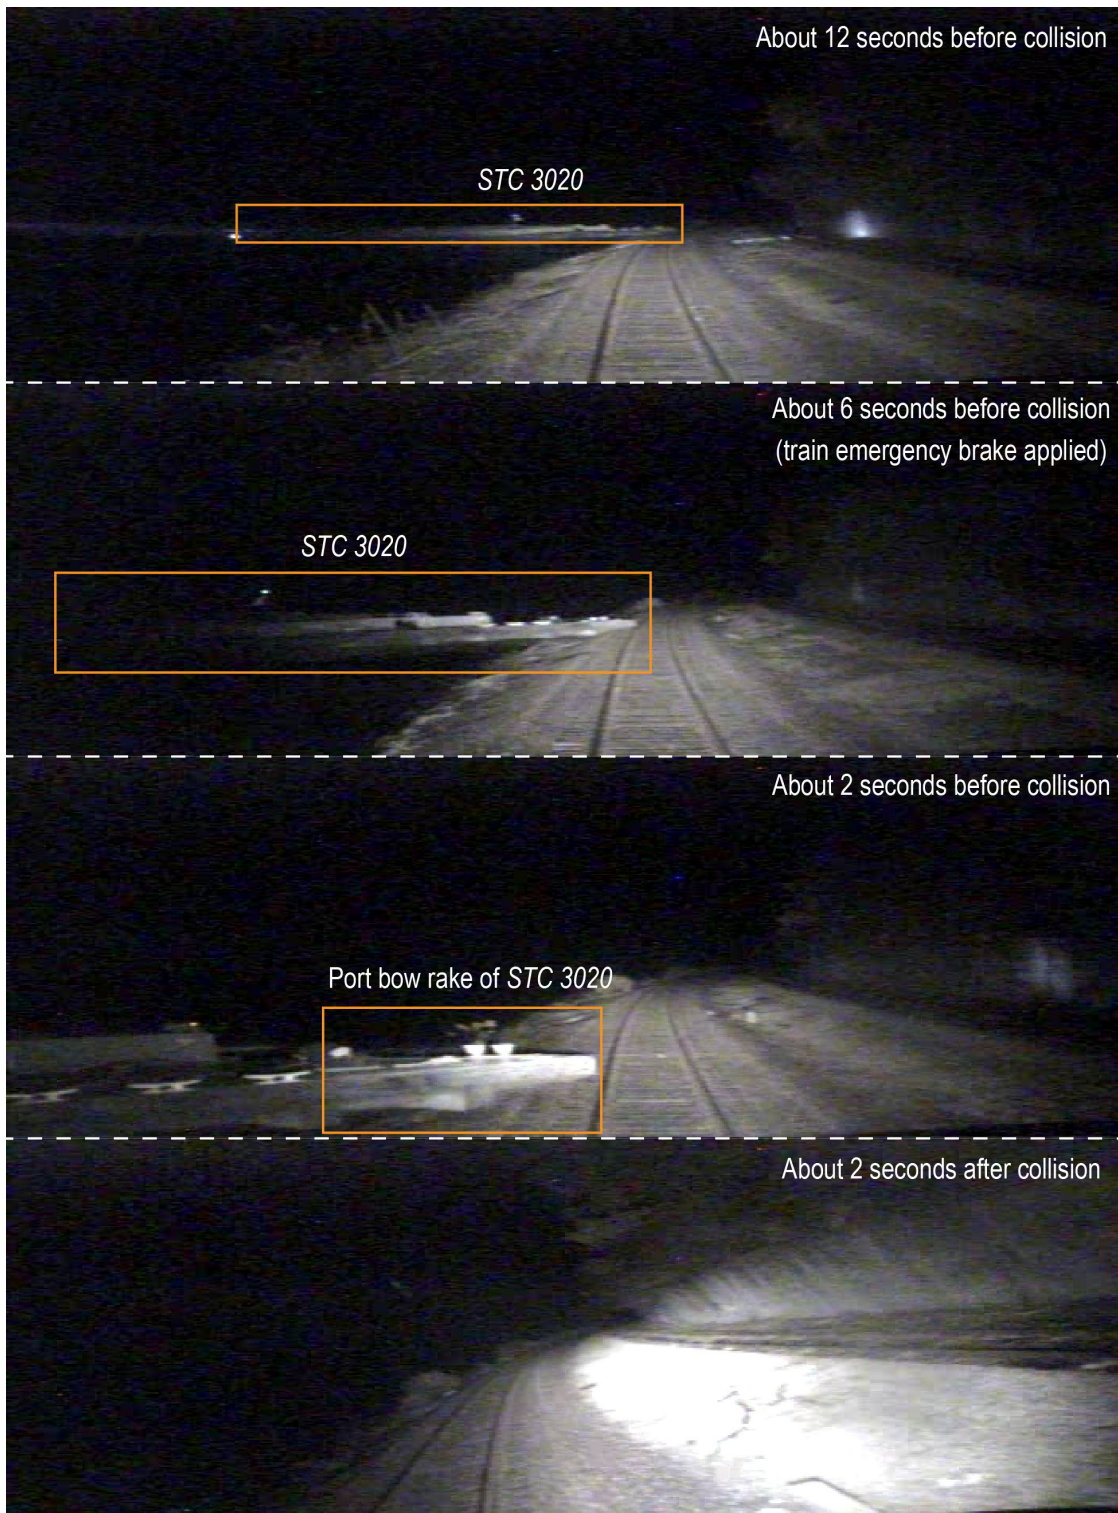
About 2343:51, the left side of the lead locomotive, BNSF 9251, collided with the port corner of the *STC 3020's* bow, and the 2-foot overhang of the train impacted the deck of the barge, pushing it into the ground. The captain, who was in the galley and had felt a "slight bump," heard the general alarm and proceeded to the wheelhouse. The first locomotive derailed and tipped over to the right, landing on its side after impacting the barge, skidding on the ground before stopping, and causing the second locomotive, BNSF 9109, and ten hopper cars to also derail. Six of the hopper cars entered the river. The BNSF train's conductor and the engineer evacuated the forward locomotive on their own but sustained minor injuries.

Figure 5. Still images of video footage from locomotive BNSF 9251's recorder as the train approached the barge and derailed after hitting the barge. The forward barge of the *Baxter Southern* tow is outlined in orange. (Source: BNSF)

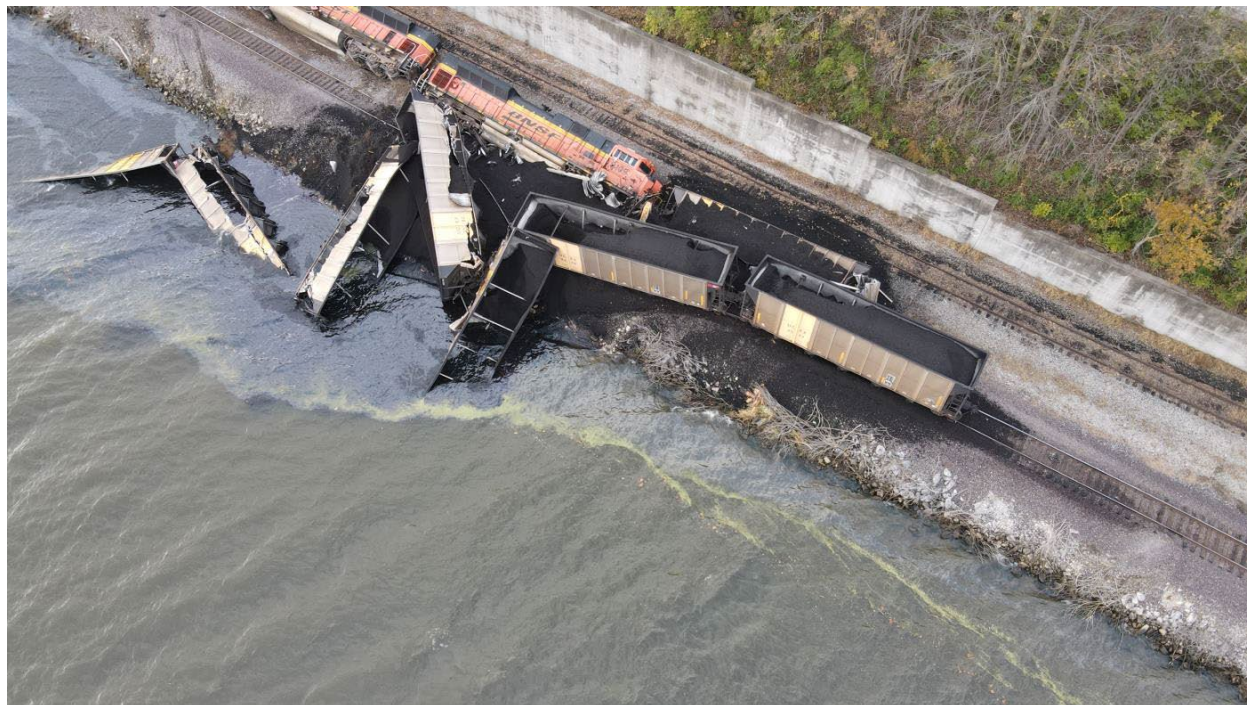
Figure 6. Aerial photo of the postcollision derailment of the two locomotives and eight hopper cars. Two additional hopper cars are submerged in the river. (Source: BNSF)

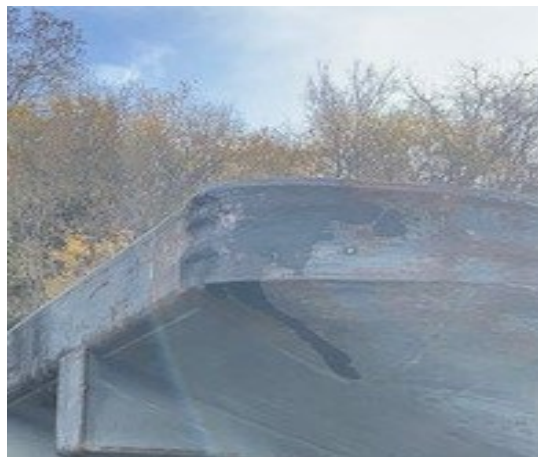
A damage survey of the barge *STC 3020* by a marine surveyor determined that damages resulting from the casualty were minor and did not appear to affect the structural integrity of the vessel. Investigators identified three horizontal indents on the forward port section of the bow rake and scraping to the deck just above the indents.

Figure 7. Postcasualty photo of the minor damage to the port bow rake of barge *STC 3020*. (Source: Coast Guard)

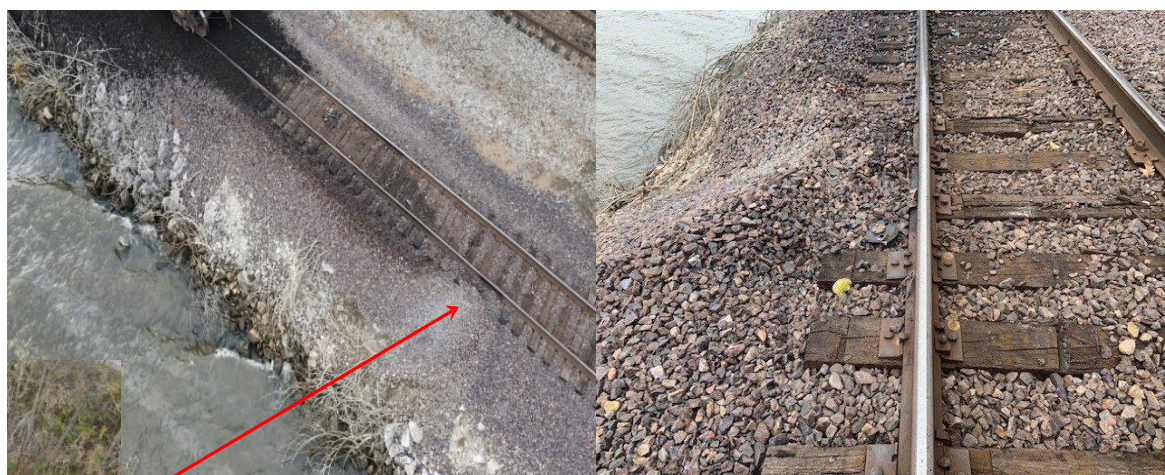
After the casualty, investigators reviewed video from the locomotive BNSF 9251. The video showed that the port bow rake of barge *STC 3020* extended about a foot over the railroad tie but did not cross over either rail. Postcasualty photos of the location showed an indentation where the barge had been pushed up against the riverbank. Coast Guard investigators determined that the distance from the railroad track to the riverbank was about 10 feet at the time of the casualty.

Figure 8. Aerial drone photo of the casualty site with a red arrow pointing to the indentation remaining in the ground where the forwardmost barge *STC 3020* was located (*left*). Close-up of the indentation from the barge in the shoreline next to the railroad track (*right*). (Sources: BNSF [*left*], Coast Guard [*right*])

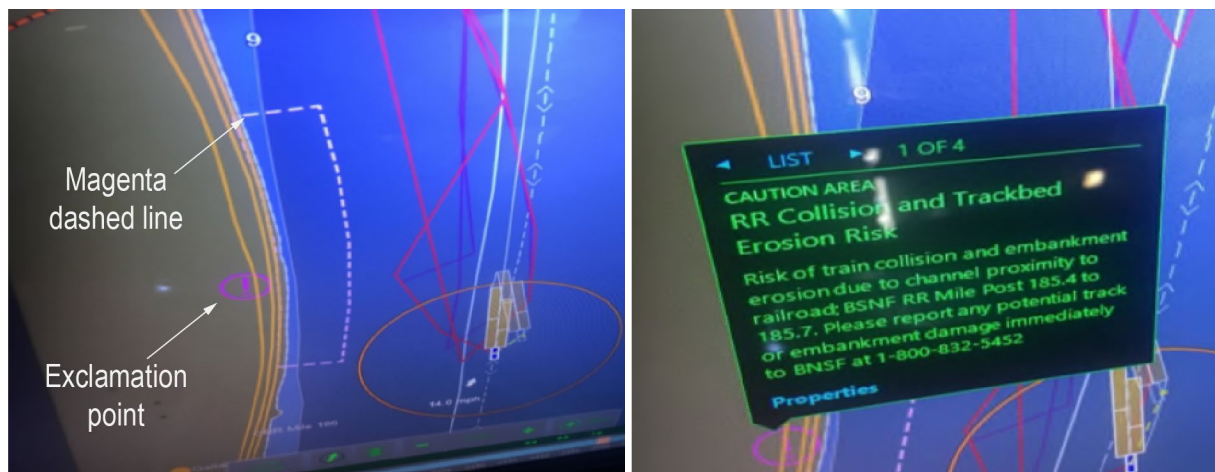
Next to the magenta dashed line near mile 372 on the electronic chart was an exclamation mark icon, which indicated that the area within the magenta dashed line was a "Caution Area" according to the ECS symbol reference table. On ECS navigational charts, magenta dashed lines with an exclamation mark show the limit of a caution area where mariners should be "made aware of circumstances influencing the safety of navigation"; there are no navigational chart symbols for a fleeting area.⁴ In Rose Point, a user could learn more information about the caution area by selecting the exclamation mark via "cursor pick" (moving the mouse pointer over the area and clicking the right button of the mouse) to read the corresponding caution note. When the exclamation mark icon next to the magenta dashed line near mile 372 was selected, a box displayed the following information: "Caution Area: RR [Railroad] Collision and Trackbed Erosion Risk" and "Risk of train collision and embankment erosion due to channel proximity to railroad." Both the captain and pilot said they had training in using the ECS, but they stated they did not see the exclamation point icon by the magenta dashed line because the screen setting was in nighttime mode, making the exclamation point difficult to see.

Figure 9. *Baxter Southern* Rose Point in nighttime display showing the area marked by the magenta dashed line and exclamation point (left, annotated by NTSB) and information contained in the corresponding caution note (right). (Source: Southern Towing Company)

The National Transportation Safety Board determines that the probable cause of the collision between the *Baxter Southern* tow and BNSF coal train was the tow's pilot and captain not correctly identifying a caution area on the electronic chart before deciding, due to the high wind's effect on the tow's empty barges, to push the tow up against the riverbank alongside a railroad track.

Mariners should ensure they understand all symbols and applicable advisories identified in their ECS, and owners and operators should ensure that their crews are proficient in the use of ECS. For more information about chart symbols, mariners should refer to [U.S. Chart No. 1: Symbols, Abbreviations and Terms used on Paper and Electronic Navigational Charts](#) or the US Army Corps of Engineers' [Inland Electronic Navigational Charts](#).
