Issued September 29, 2022

MIR-22/24

Engine Room Fire on board Towing Vessel *Capt. Kirby Dupuis*

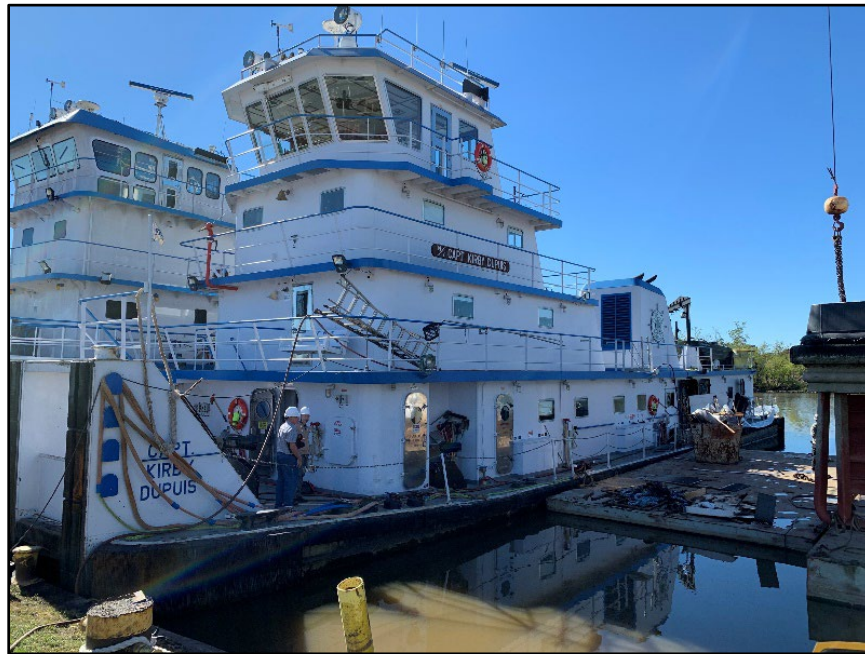
Figure 1. *Capt. Kirby Dupuis* docked after the casualty.

departments.² The fire caused extensive heat and smoke damage to the vessel's engine room. The upper and lower engine room bulkheads and overheads were completely burned by the fire as well as the machinery, fixtures, and equipment in the upper engine room. A marine surveyor estimated the damages to be 1.8 million dollars.

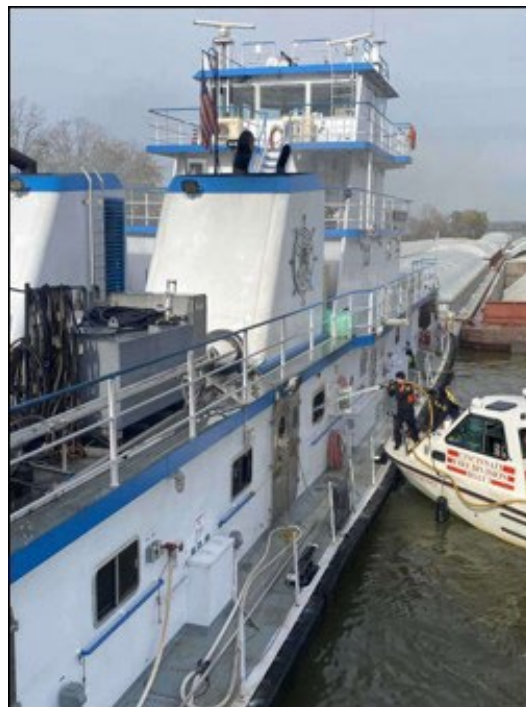
Figure 3. Firefighters deploying water into the engine room of the *Capt. Kirby Dupuis* through an open window. (Source: LT Meghan G. Keith, Dearborn County Water Rescue)

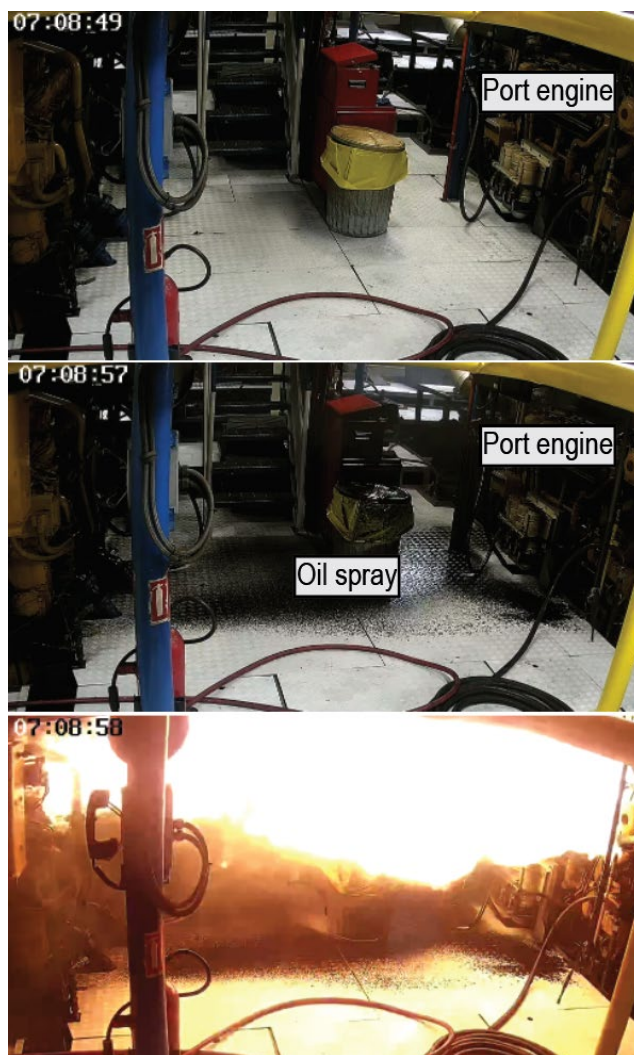
The day after the fire, investigators reviewed the vessel's video system. At 0708:50, lube oil began to spray inboard from the port main engine into the center of the engine room toward the starboard main engine. About 10 seconds later, a flame at the top of the forward part of the engine by the exhaust manifold erupted inboard toward the starboard engine. The video lasted about 1 minute, until the camera stopped recording.

Figure 4. Screenshots from the *Capt. Kirby Dupuis* engine room video camera (looking aft) at 0708:49-0708:58.

The engine room video showed that, within 10 seconds of the leak starting, the oil sprayed inboard into the center of the engine room and upward onto the exhaust manifold on top of the running engine. Immediately after contacting the hot surface of the exhaust manifold, the oil ignited and started the fire. Forced air from the running ventilation supply fan discharging above the engine fueled the fire with oxygen and propelled it across the engine room, damaging the starboard engine and the equipment in the upper engine room.

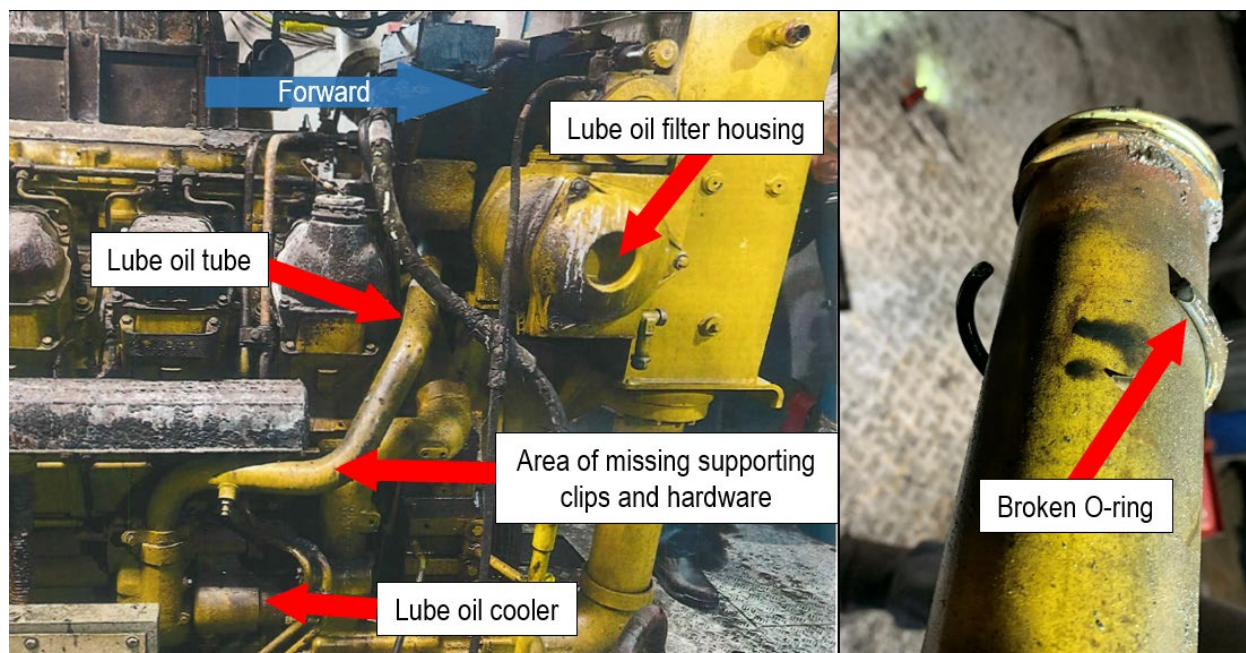
A senior technical service manager from Louisiana Cat (Caterpillar) reviewed the video and inspected the damaged port main engine. He found a broken piece of an O-ring seal on top of the front cover of the engine, directly below the upper joint area of a lube oil tube that connected the lube oil filter housing to the lube oil cooler. (The typical operating pressure of the system was about 55 pounds per square inch.)

Figure 5. Port main engine lube oil components (*left*). Port main engine lube oil tube with broken O-ring after removal on upper section of tube (*right*). (Source: Louisiana Cat, annotated by NTSB)

When the service manager removed the tube from the engine, he found the remainder of the broken O-ring and observed that the retaining ring, which should have been installed to secure the tube in its joint, was missing where the tube connected to the lube oil filter housing. It is unknown when the tube had last been removed from the engine. Upon further inspection, the technician discovered “wear to the seal O-ring groove lip” on the upper section of the removed tube.

The initial cause of the *Capt. Kirby Dupuis* port main engine (a Caterpillar model 3512C) fire was an oil leak from the pressurized lube oil system at the tube connection to the lube oil filter housing, which released oil that came in contact with a hot surface, likely the exhaust manifold on the engine. The retaining ring that was supposed to be installed behind the O-ring lip of the lube oil tube was missing, so the O-ring was not properly sealed nor supported in the joint for an unknown amount of time, leading to its failure. The wear found on the seal O-ring groove lip of the lube oil tube indicates that there was movement of the tube in the joint due to natural vibration of the operating engine. It is likely that at some installation, after maintenance that required removal of the tube, the retaining ring was not re-installed on the tube.

The National Transportation Safety Board determines that the probable cause of the engine room fire aboard the towing vessel *Capt. Kirby Dupuis* was a lube oil tube on the port main engine that vibrated out of a joint due to a missing retaining ring and

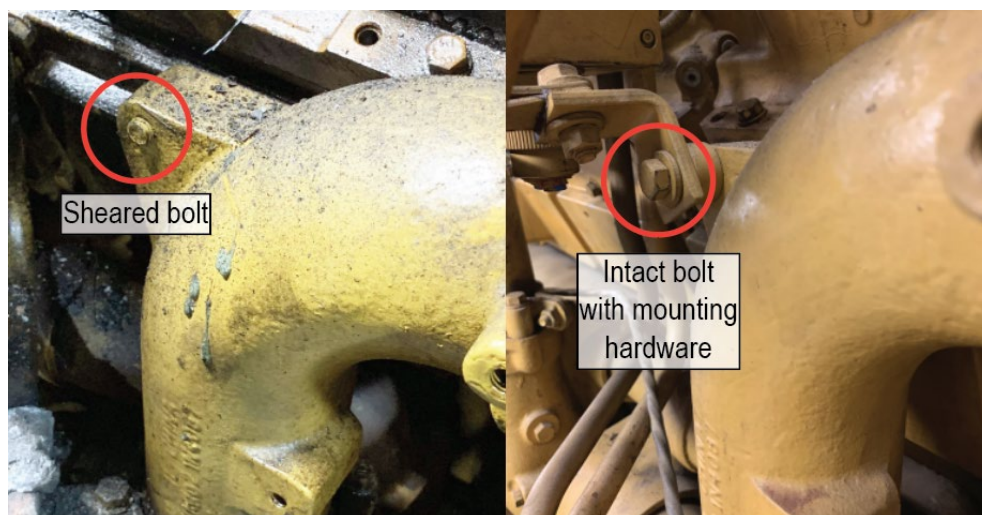
Additionally, supporting clips and mounting hardware for the lube oil tube were missing on the port main engine in the mid-section area, and the bolt that had held the supporting clips appeared to be sheared. The service manager’s report concluded that the cause of the fire was “a severe oil leak” that sprayed onto the exhaust manifold of the port main engine near the no. 1 cylinder and ignited. “Ventilating air from the air duct above the [port main] engine supplied the fire with oxygen and blew the fire across the engine room damaging the stbd. [starboard] main engine.”

Figure 6. Sheared bolt for lube oil tube mounting on *Capt. Kirby Dupuis* port main engine (left). Proper arrangement of supporting clips and mounting hardware on board similar FMT towing vessel *David McNemar* (right).

Additionally, the supporting clips and hardware were also missing from the mid-section of the lube oil tube, preventing it from being secured in accordance with the manufacturer's design. It is unknown how long the supporting clips and hardware had been missing from the engine. The last major work on this engine was in May 2018 when a top end overhaul was conducted, and it is possible that the oil tube was removed during that work. However, none of the parts associated with the tube were ordered at that time. A sheared bolt found postcasualty indicates that the supporting clips and hardware had originally been installed on the engine but had failed at some point. Without the supporting clips and hardware, the tube was unsupported in the mid-section area and more susceptible to vibration and associated movement.

Caterpillar 3512 main engines throughout their fleet for proper installation of supporting clips and mounting hardware on the lube oil tubes. About 10% of the inspected engines required attention and were corrected.

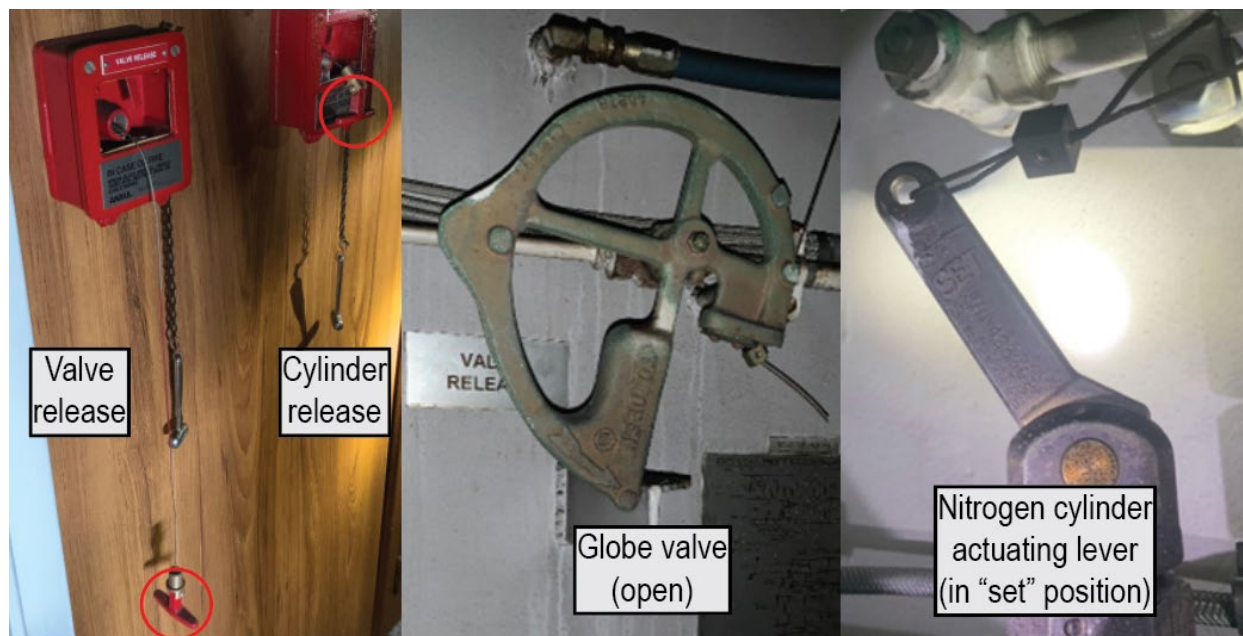
When investigators inspected the fire-extinguishing system, they observed that the “valve release” remote pull lever was pulled out as per the instructions, and its corresponding globe valve was open. However, the “cylinder release” remote pull lever was not fully extended, and its corresponding nitrogen cylinder’s actuating lever remained in the “set” position.

Figure 8. Remote pull stations for *Capt. Kirby Dupuis's* fixed fire-extinguishing system as found after the fire. Red pull levers are circled (*left*). Globe valve in open position after the fire (*center*). Nitrogen cylinder's actuating lever in the "set" position as found after the fire (*right*). (Source: Coast Guard).

Although the crew attempted to activate the vessel's fixed fire-extinguishing system—and believed they had successfully discharged the fire suppression fluid—investigators determined that the system was not activated during the fire. After the fire, the nitrogen pilot cylinder lever was found in the “set” position and its cylinder was still fully charged. Both suppression fluid cylinders were also found full to capacity after the fire. Despite the deckineer stating that he pulled both remote pull levers, only the “valve release” lever was found to be fully extended; its attached cable properly opened the globe valve. However, the “cylinder release” remote pull valve handle was found only slightly extended from its stowed position in the cradle; therefore, the nitrogen gas from the pilot cylinder had not been discharged. Lacking pilot pressure, the sequence for release could not activate: the siren did not sound, and the remote shutdowns of the engines and ventilation fans were not activated.

mounting bracket, spraying pressurized oil that made contact with a hot exhaust surface and ignited. Contributing to the severity of the fire damage was the crew's unfamiliarity with activation procedures for the fixed fire-extinguishing system, which resulted in an unsuccessful attempt to release the fire suppression fluid and extinguish the fire.

None of the drills or procedures included familiarization or training on the fixed fire-extinguishing system. As of the date of this report, FMT is developing a training video on fixed fire-extinguishing systems that will become required training for their crews.
