Issued October 4, 2022

MIR-22/25

Grounding of Passenger Ferry *Commodore*

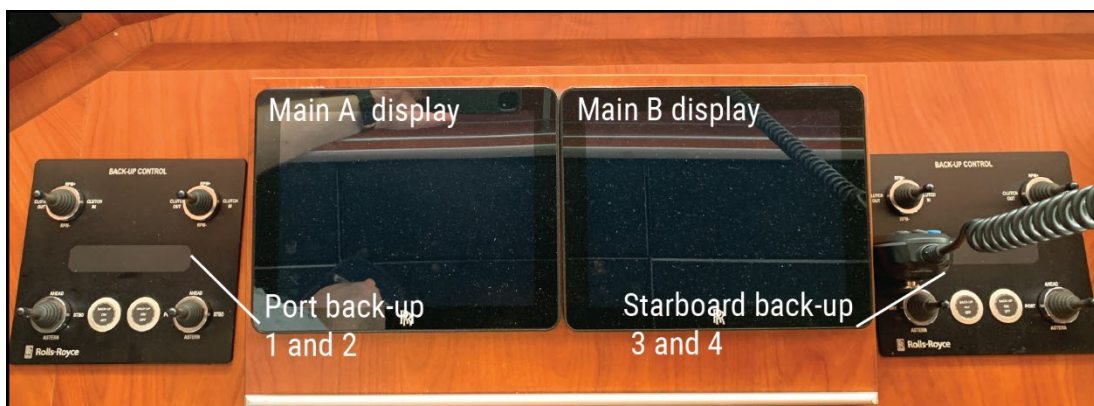
When a control failure bucket/steering is detected, the bucket/steering is frozen in the position it had when the failure occurred (the hydraulic control valve(s) of the bucket/steering are disconnected). The bucket/steering of the jet can no longer be changed with the control lever, only with the back-up system.

Figure 6. *Commodore's* main control station main A and main B display screens and back-up controls (port back-up 1 and 2 and starboard back-up 3 and 4).

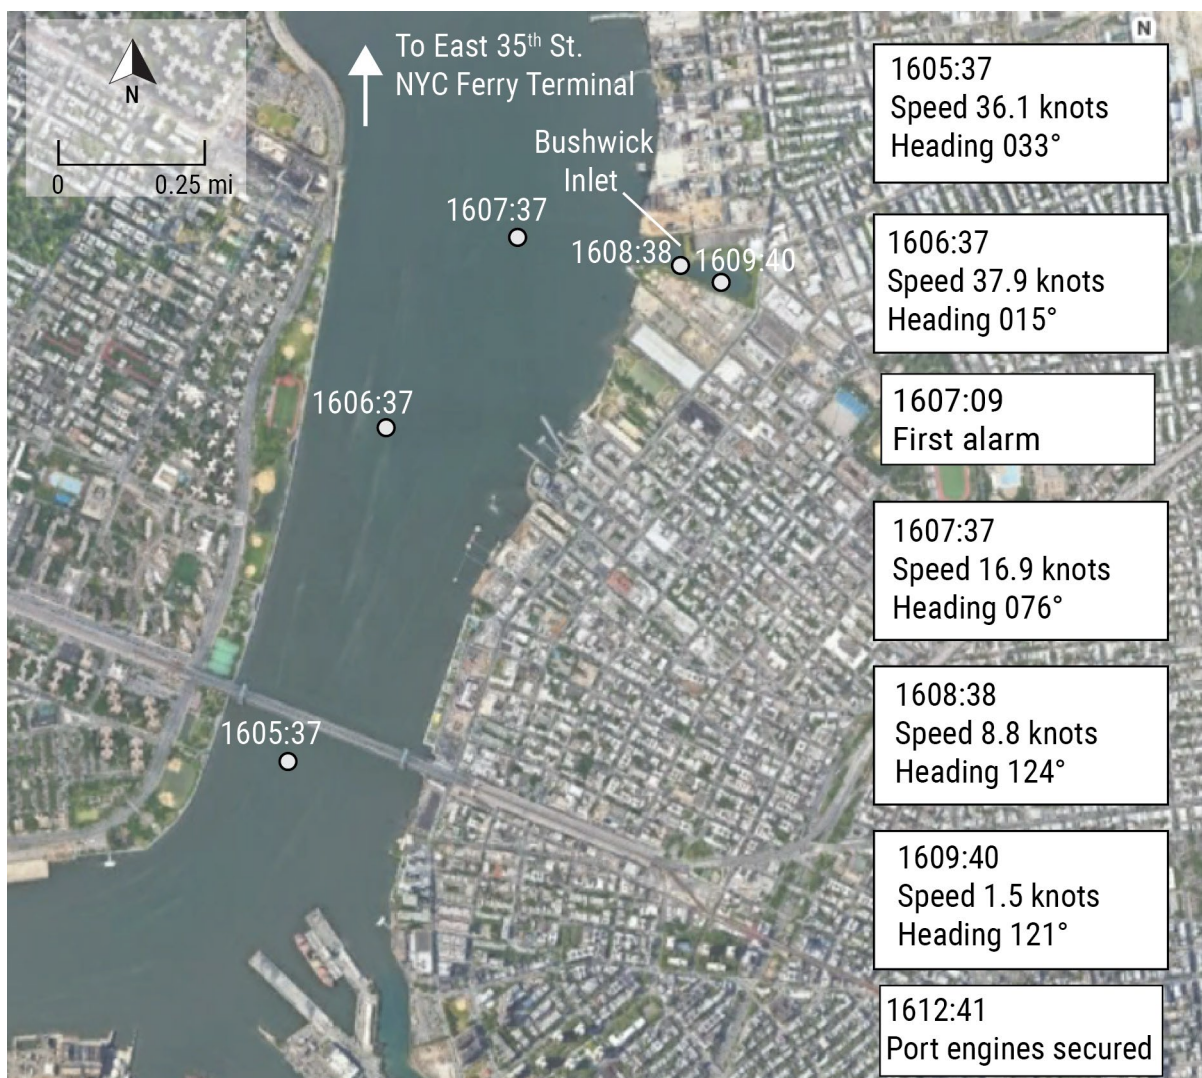
The captain told investigators that he then placed the throttles and steering controls in “harbor [auto] mode.” At 1608:08, both starboard engines reduced from 1,400 rpm to 750 rpm after the captain pulled the joystick backward, attempting to reverse the thrust direction on all water jets to stop the vessel’s forward movement. The main A display screen was still blank. About 10 seconds later, the captain left the main control station and ran to the port wing station. At 1608:40, the captain transferred control to the port wing station via the port wing touchscreen display and tapped on one of the red triangles, again attempting to reconnect the water jet controls. However, the captain told investigators that the system would not reconnect. The captain placed both thrust levers in the full reverse position and pushed the steering tiller hard to port. He told investigators that he believed he received the same nonresponse that he had received at the main control station.

Figure 7. *Commodore's* position, speed, and heading in the minutes surrounding the grounding (from AIS). (Background source: Google Earth)
