MIR-22/26

Capsizing of Liftboat *SEACOR Power*

Port Fourchon, Louisiana

April 13, 2021

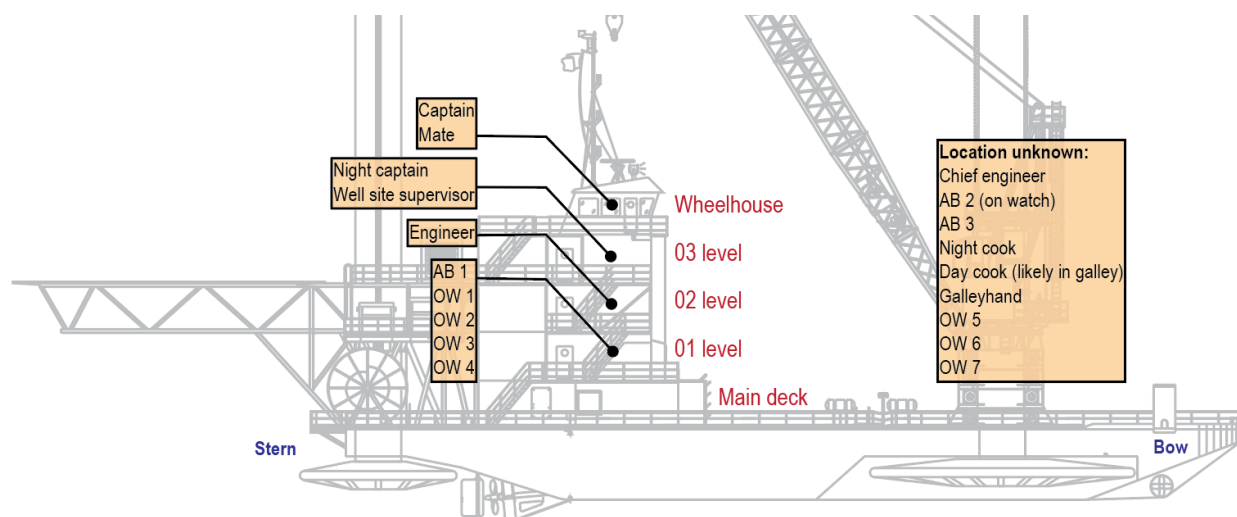
Figure 4. Known crewmember locations at the time of the capsizing.

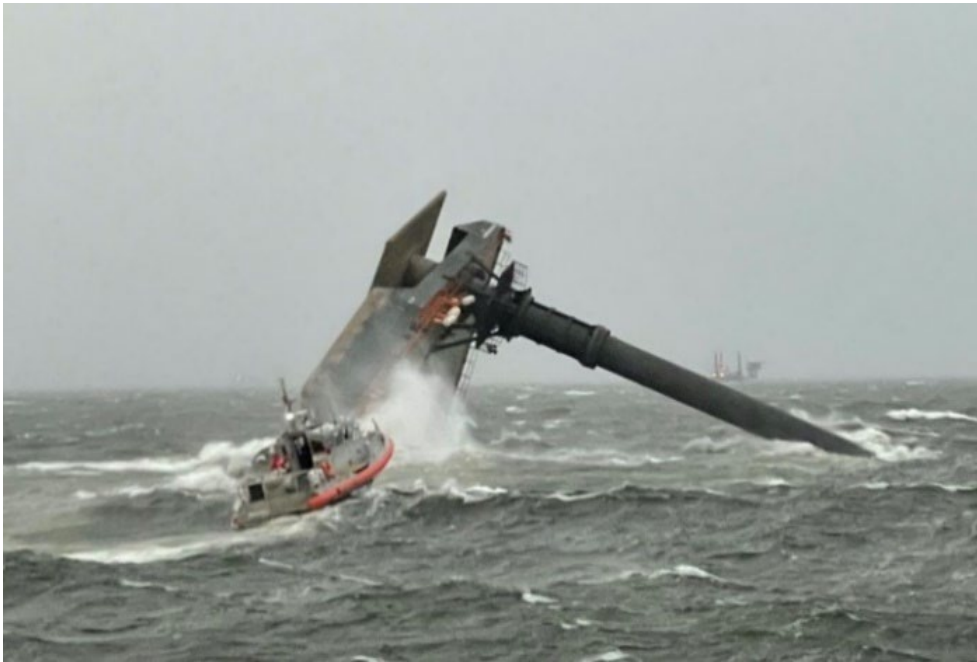
Figure 8. *SEACOR Power* capsized on its starboard side on the evening of the casualty, with a Coast Guard RB-M in the foreground and the liftboat *Rockfish* in the background. (Source: Coast Guard)

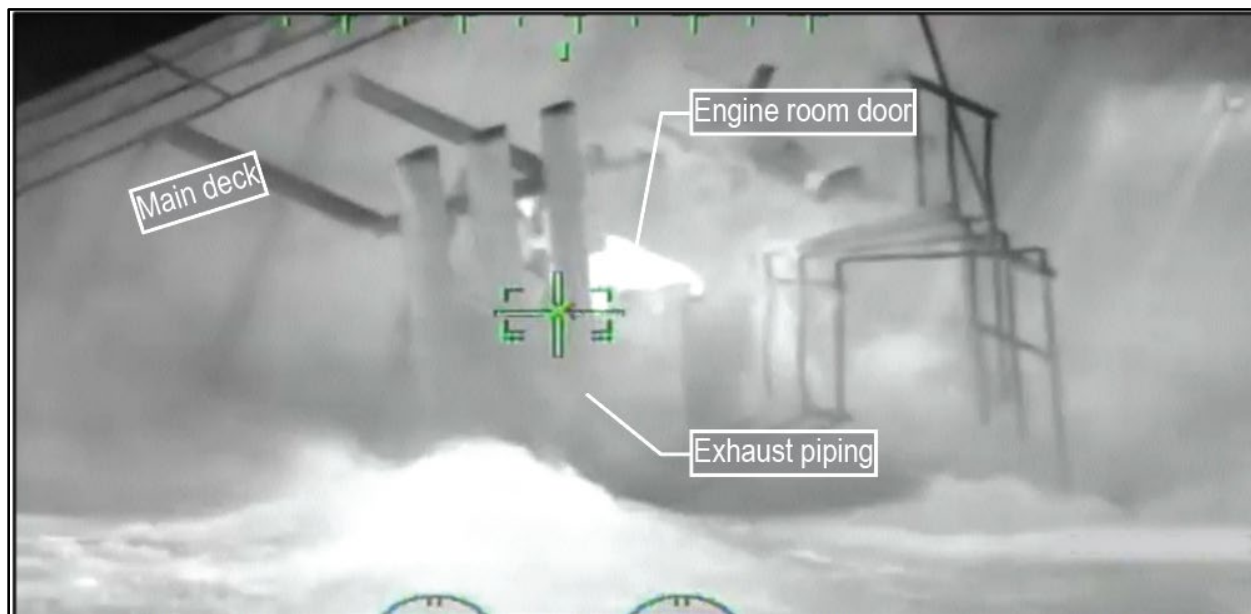
Figure 9. Door to engine room as it was opened at 2153, as seen by the *Glen Harris*. (Source: *Glen Harris*)

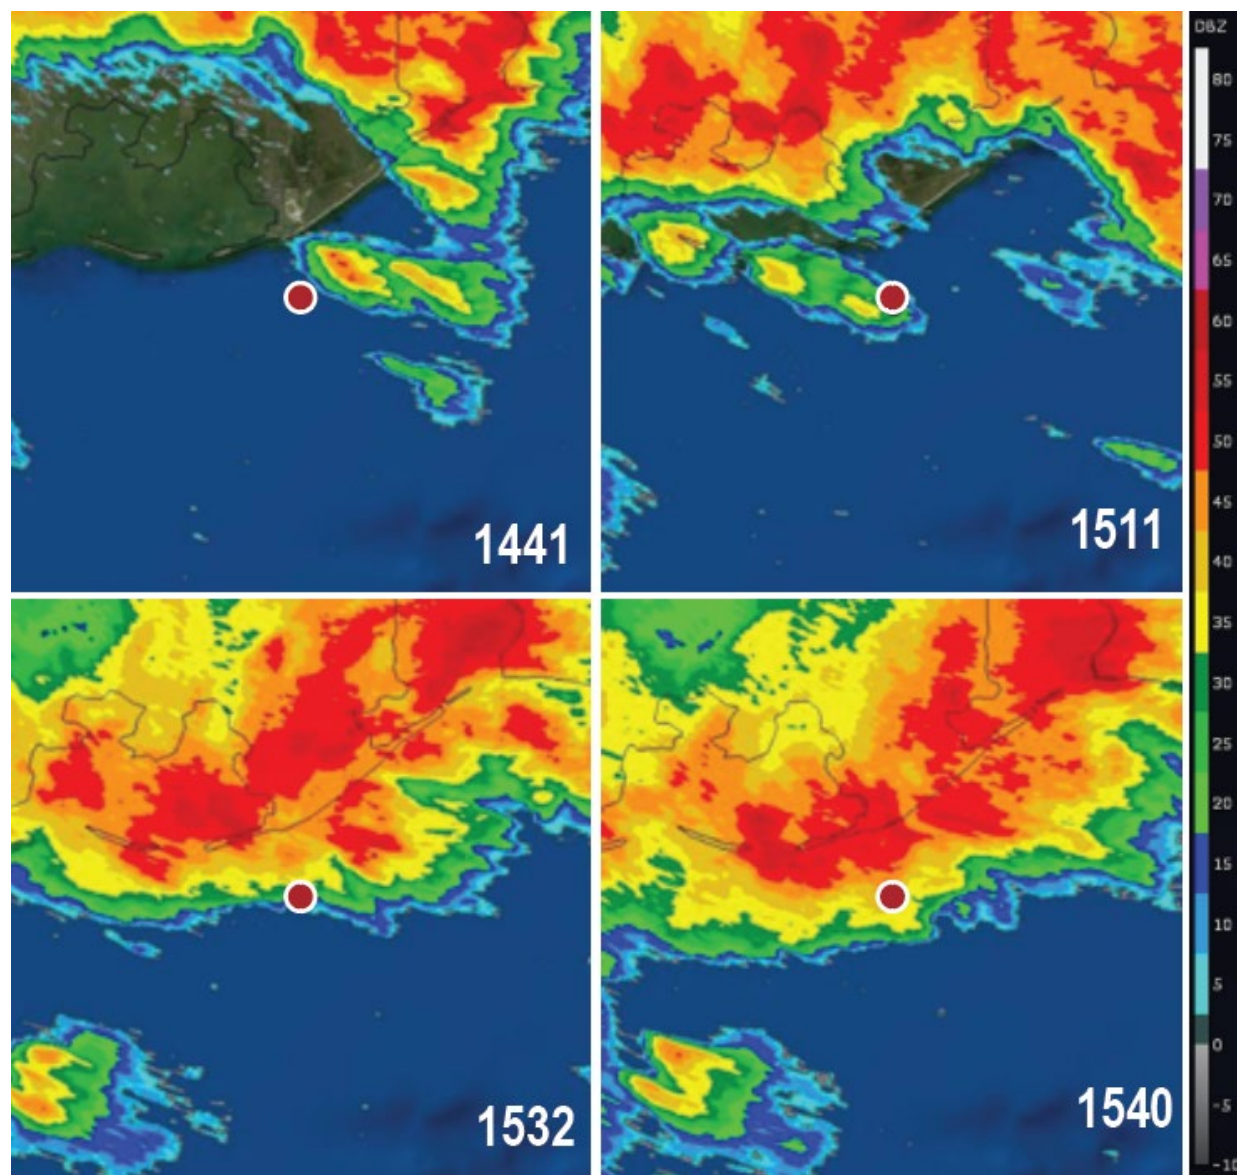
Figure 18 presents KLIX weather radar reflectivity imagery 1) about one hour before the casualty (about 1441), 2) 30 minutes before the casualty (about 1511), 3) as light reflectivity associated with the leading edge of the MCS initially moved over the vessel (about 1532), and 4) about the time of the casualty.

Figure 18. KLIX Level-II 0.525° base reflectivity images from sweeps initiated about 1441, 1511, 1532, and 1540. Casualty site is denoted by the red circle. The colors represent the strength of returned energy to the radar expressed in values of decibels (dBZ). The color scale is located to the right. Generally, as dBZ values increase so does the intensity of precipitation. (Source: NWS)
