Issued November 3, 2022

MIR-22-28

# Grounding of Towing Vessel *Marquette Warrior*

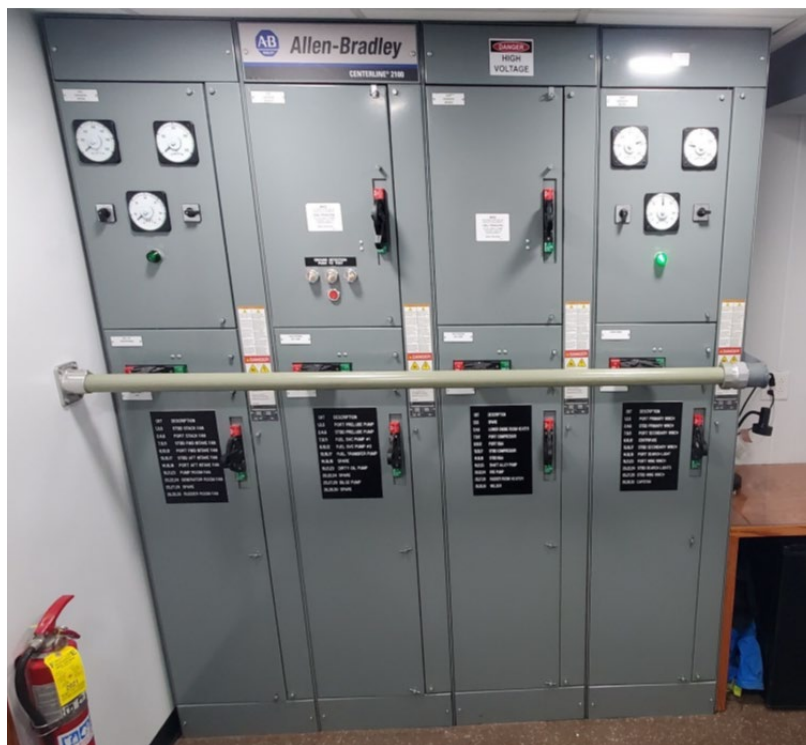
investigate. He observed a ground fault indication on the switchboard and suspected that the fault might have been the reason for the flickering lighting.<sup>3</sup>

**Figure 3.** Main switchboard located in the engine control room aboard the *Marquette Warrior*. (Source: Marquette Transportation Company)

In an effort to determine the cause of the ground fault, the engineer opened several electrical breakers to isolate nonessential equipment. However, the fault did not go away, and the lights continued to flicker. Using the vessel's intercom system, the engineer then called the pilot in the wheelhouse to inform him of the lighting issue. The engineer also asked the pilot to push up against the riverbank so he could troubleshoot in a safer, controlled condition. The pilot was still navigating the vessel through the Leland Dikes at 10.5 mph. He informed the engineer that it would be another 25-30 minutes before he could safely push the tow in on a bank and stop the vessel. The pilot then radioed the on-watch deck crew on the barges and requested that they return to the towboat to assist the engineer with troubleshooting and to ensure they were not on the barges in the event of an issue. Immediately after his call with the pilot, the engineer walked forward to the galley to inspect the lighting. As he arrived in the galley, the lights on "the whole boat started flashing." The engineer returned to the engine room, where he was met by the mate. The engineer called the wheelhouse again and

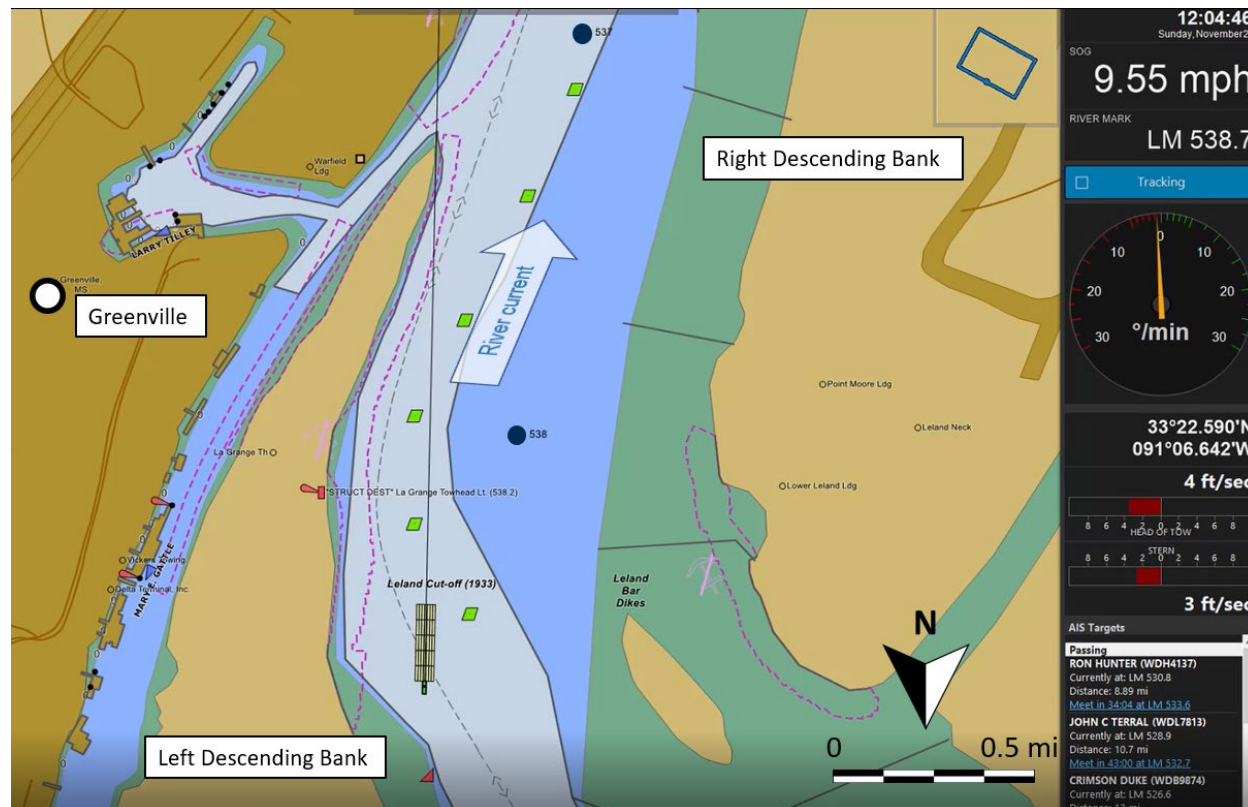
About 1205, 5 minutes after the engineer first notified the pilot of an electrical issue, the pilot attempted to initiate a turn to starboard at the La Grange Towhead Light and realized that the rudders were not responding. The pilot immediately radioed the mate, who was with the engineer, and informed them that the vessel had lost steering. After sounding the general alarm, the pilot attempted to change over the hydraulic steering pumps using a switch in the wheelhouse, but it had no effect. Using the main engine throttles in the wheelhouse, the pilot brought the engines astern to slow the vessel's speed.

**Figure 4.** Electronic chart system screenshot from the *Marquette Warrior* during the casualty, showing the tow about 1205, when the vessel lost steering. (Source: Marquette Transportation Company)

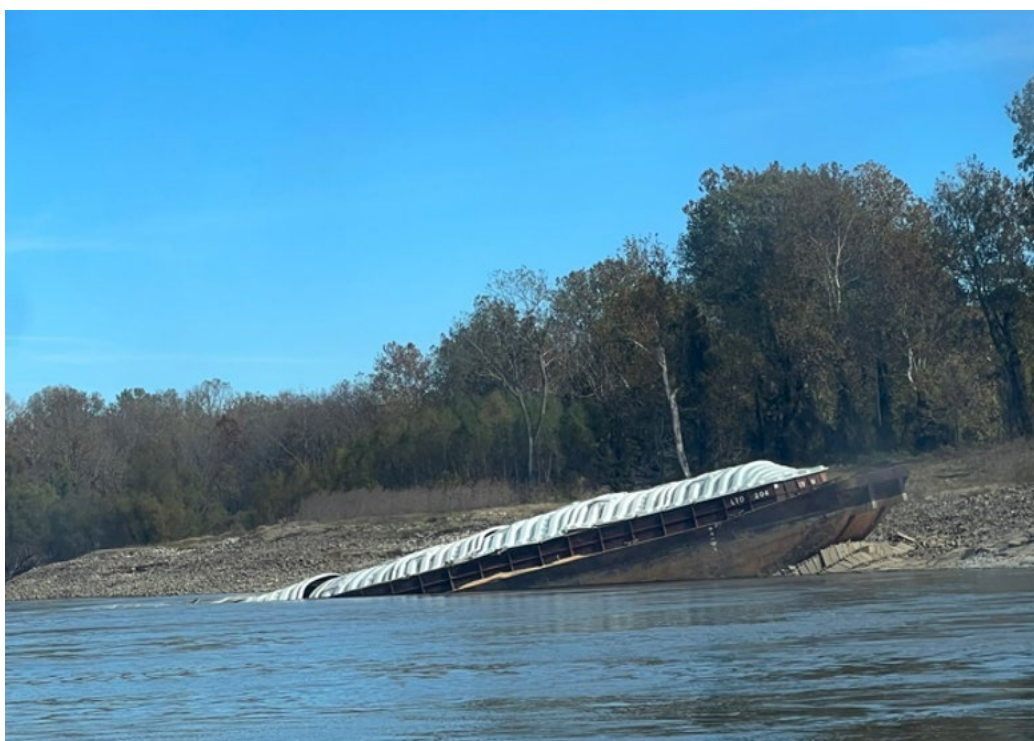
Following the grounding, the *Marquette Warrior*, aided by several nearby Good Samaritan vessels, corralled the scattered barges and rebuilt the tow. Four of the barges sustained damage, mostly to their rake bottoms and side shell plating, with the steel plating being dented or inset. One barge partially sank and was later salvaged; its bean cargo was contaminated with water and was declared a loss. The total damage to the barges was estimated to be \$215,000, and the lost cargo was estimated to be worth \$1,020,000. The *Marquette Warrior* also sustained an estimated \$7,500 in damage as a result of the casualty.

**Figure 5.** A barge that grounded and partially sank following the casualty. (Source: Marquette Transportation Company)

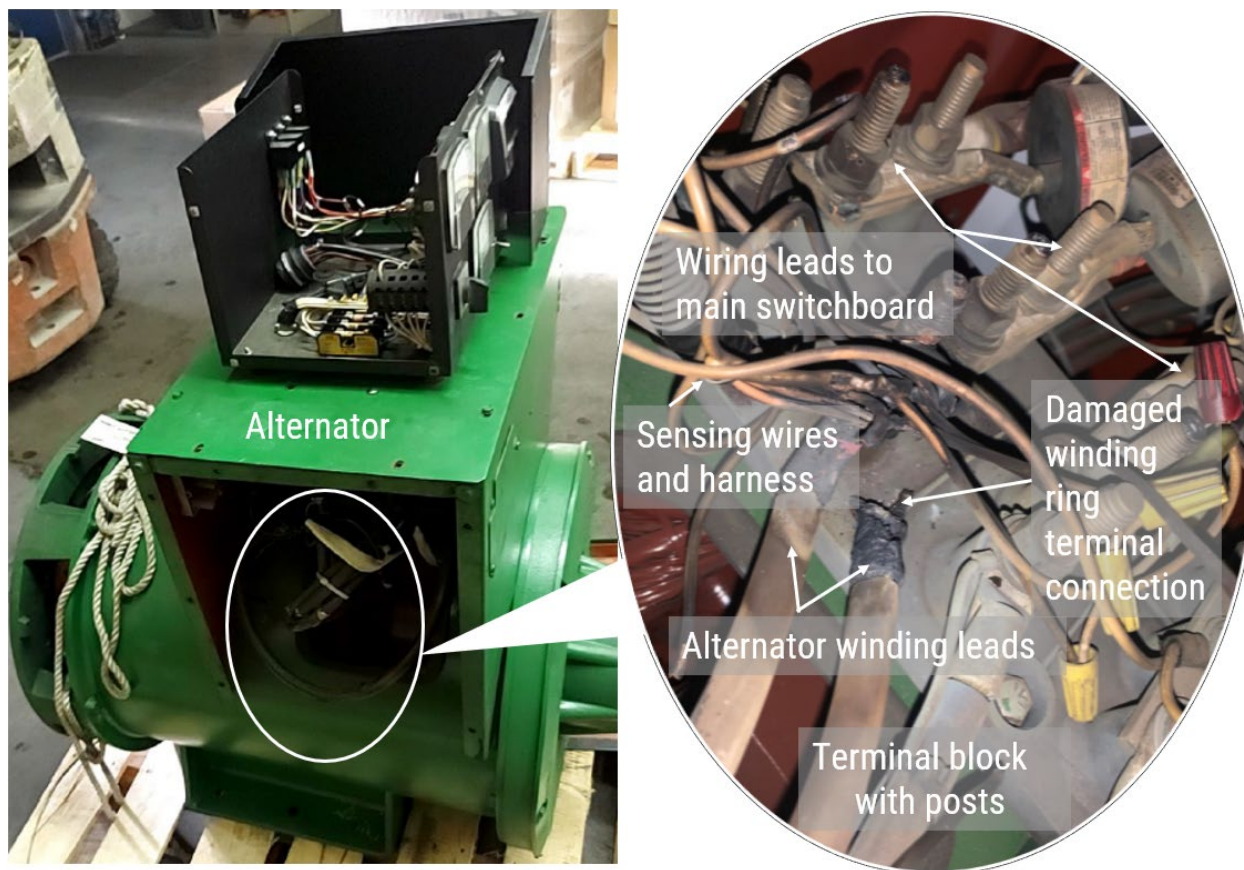
Suspecting an issue with the port genset, the vessel's engineer notified the company's port engineer, who arrived on board within a few hours of the casualty with a new alternator. The port genset's alternator was changed out and shipped back to the company's facility for inspection. The port engineer who assisted the vessel's engineer with the replacement indicated that he observed "burnt terminals" on the terminal block within the alternator and determined this to be the cause of the failure. The fiber terminal block had threaded steel studs (posts) where the leads from the alternator's windings, the main switchboard, sensing wires, and current transformers were secured with 1/2-inch nuts and lock washers. Once the damaged alternator arrived at the company's facilities, it was inspected by a supervisory port engineer, who also said he observed multiple burnt wires. He suspected that a loose wire may have been the reason for the alternator failure.

**Figure 6.** Port alternator with side cover removed (*left*) and close-up of terminal block (*right*), after being taken from the *Marquette Warrior* postcasualty. The control box (with cover removed) is mounted on the top panel. (Sources: Warden Electric [*left*], Marquette Transportation Company [*right*])

The company then sent the failed alternator to the same company that had refurbished the unit several months prior for inspection and repair. The repair facility personnel observed a burnt winding lead terminal connection (ring terminal connection) that had become separated from the terminal block post (also identified by the port engineers). They also identified that three of the center posts on the terminal block had arcing residue built up on their tops, indicating that an item had been coming in contact with them. Further, a wiring harness containing sensing wires, which led from the terminal block up into the control box, mounted on the top panel of the alternator, was “blown completely in half.” They suspected that this wiring harness, normally routed clear of the terminal block posts, had been lying across the posts, rubbing through the jacketing of the harness and eventually through the wires’ insulation. Once the bare sensing wires contacted the posts (studs), arcing occurred. They compared this arcing to a welding arc, where small bits of the metal wire would be deposited onto the posts. An electrician from the repair facility also explained that, along with the arcing, excess heat would deteriorate the insulation for the wires attached to the terminal block. The repair

facility personnel suspected the wire insulation deteriorated over a prolonged period, until a point where the arcing and heat became severe enough to cause the winding terminal connection to fail. The electrician suspected that, during this period, there would have been flickering lights and fluctuations in the vessel's voltage and amperage.

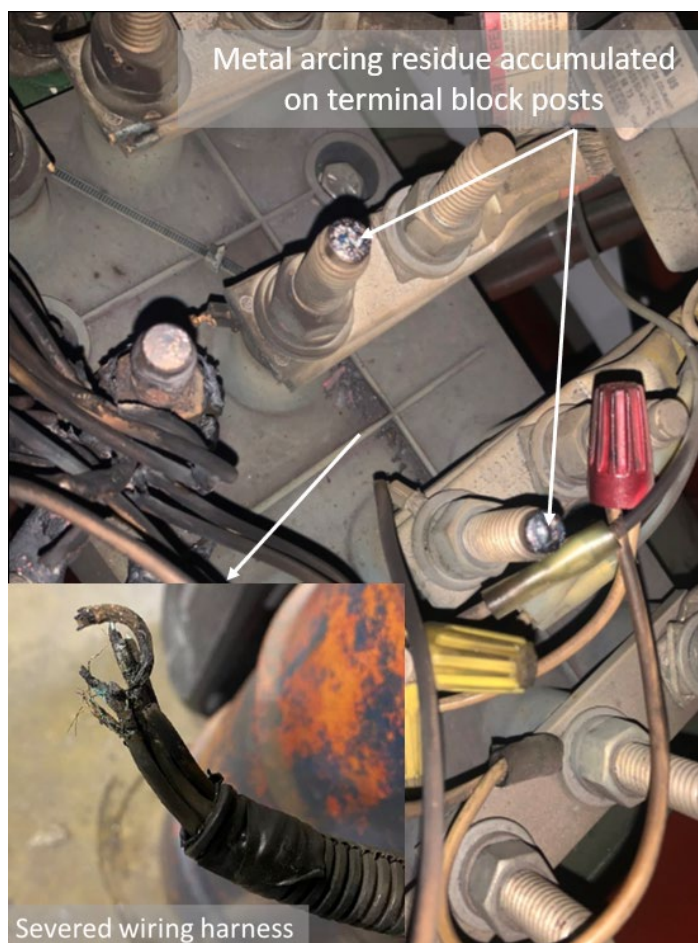
An electrical supervisor from the shipyard who reviewed pictures of the burnt and disconnected winding lead terminal connection after the casualty suspected that once the alternator terminal connection failed and became separated from the terminal block post, the alternator would no longer be able to supply 3-phase power. He expected that there would have been heavy fluctuations of the alternator's voltage and amperage output, as well as the flickering of the vessel's lights. Additionally, the 3-phase electric motors for the steering pumps (and all other 3-phase equipment) would not have been able to produce any torque and would have stopped (a condition known as single-phasing motor).

**Figure 7.** Port alternator terminal block showing metal arcing residue on the terminal block posts. Inset shows the severed wiring harness. (Source: Marquette Transportation Company)

failed, causing the alternator to lose one of its phases and the steering pump motors (and all other 3-phase equipment) to stop due to a lack of available torque. Electricians from the company that had recently refurbished the alternator also observed the burnt and damaged ring terminal, and in addition they discovered arcing metal residue on three terminal block posts and a severed wiring harness. According to the electricians, this indicated that the wiring harness had been lying across, rubbing against, and eventually arcing to the terminal block posts for a prolonged period. All parties involved agreed that the way the alternator failed would have caused fluctuations in the alternator output voltage and amperage and that the vessel likely would have experienced flickering lights.

The ring terminal connection that was observed to be burnt and damaged following the casualty had been secured to the terminal block post while being refurbished. According to the alternator servicing facility, a lock washer was used to prevent inadvertent loosening of the connection. The electrical alternator unit was then bench-tested satisfactorily. When shipyard electricians later installed the port genset's alternator in the vessel, there was no need for them to touch the winding leads on the terminal block, as these only needed to be changed if the voltage of the unit was to be altered, something that had already been completed. The shipyard would have only connected the outgoing leads to the terminal block, which did not show signs of failure after the casualty. The unit field tested satisfactorily following shipyard installation. Also, the vessel's engineer stated that during a recent preventive maintenance inspection of the port genset alternator, he did not need to use a wrench to tighten connections. Because the alternator only had 675 hours (about 28 days) of operating time since being refurbished, it is unlikely that the genset's winding terminal connection that was burnt and damaged had become loose.

The November 7 preventive maintenance performed by the vessel's engineer required the removal of the port genset alternator's cover panel to inspect "all wires/connection" for wire fray, chaffing, and loose connections. Electricians' analysis of the alternator following the casualty indicated that the most likely cause of the failure was rubbing or chaffing of the sensing wiring harness, which led to arcing between terminal block posts, heat buildup, insulation failure, and eventual winding ring terminal failure. Because the onboard engineer did not notice any damage within the terminal box or to the sensing wiring harness during his inspection, it is likely the chaffing of the wiring harness took place over the 72 hours the genset ran between the November 7 maintenance inspection and the casualty on November 21. While it is possible the wiring harness could have shifted onto the terminal posts due to vessel vibrations, it is more likely that the wiring harness was inadvertently displaced during the vessel engineer's preventive maintenance inspection on November 7 and went unnoticed during his reinstallation of the cover panel.

The National Transportation Safety Board determines that the probable cause of the grounding of the towing vessel *Marquette Warrior* was a loss of steering, likely due to a wiring harness within an electrical generator that was improperly positioned during a maintenance inspection, resulting in the harness contacting the terminal posts, eventually causing the loss of 3-phase electrical power to the steering pump motors.

Proper operation and maintenance of electrical equipment is required to avoid damage to vessel critical systems and prevent potentially serious crew injuries, particularly for electrical systems with high and medium voltage and equipment with uninsulated and exposed components. Electrical equipment should be installed, serviced, and maintained by qualified personnel familiar with the construction and operation of the equipment and the hazards involved.
