Issued December 22, 2022

MIR-22-29

Collision between Yacht *Utopia IV* and Tank Vessel *Tropic Breeze*

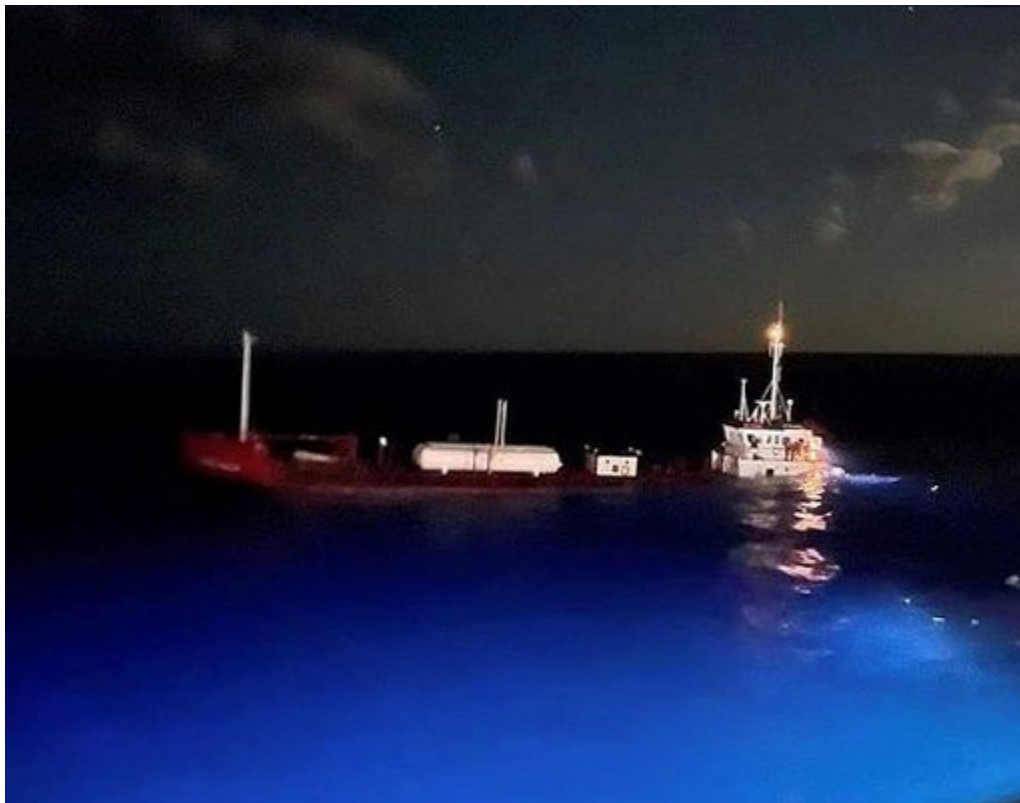
Figure 5. *Tropic Breeze* sinking by its stern about 15 minutes after the collision.

The *Utopia IV* penetrated through the *Tropic Breeze*'s empty aft peak ballast tank, reported by the *Tropic Breeze*'s operator to be 3.9 meters (12.9 feet) longitudinally (forward and aft), to the engine room, flooding both the tank and engine room. The *Tropic Breeze*, valued at \$5.1 million, sank in 9,300 feet of water. Lost cargo, valued at \$343,881, was not recoverable.
