Issued February 1, 2023

MIR-23-02

Engine Room Fire aboard Passenger Vessel *Natchez*

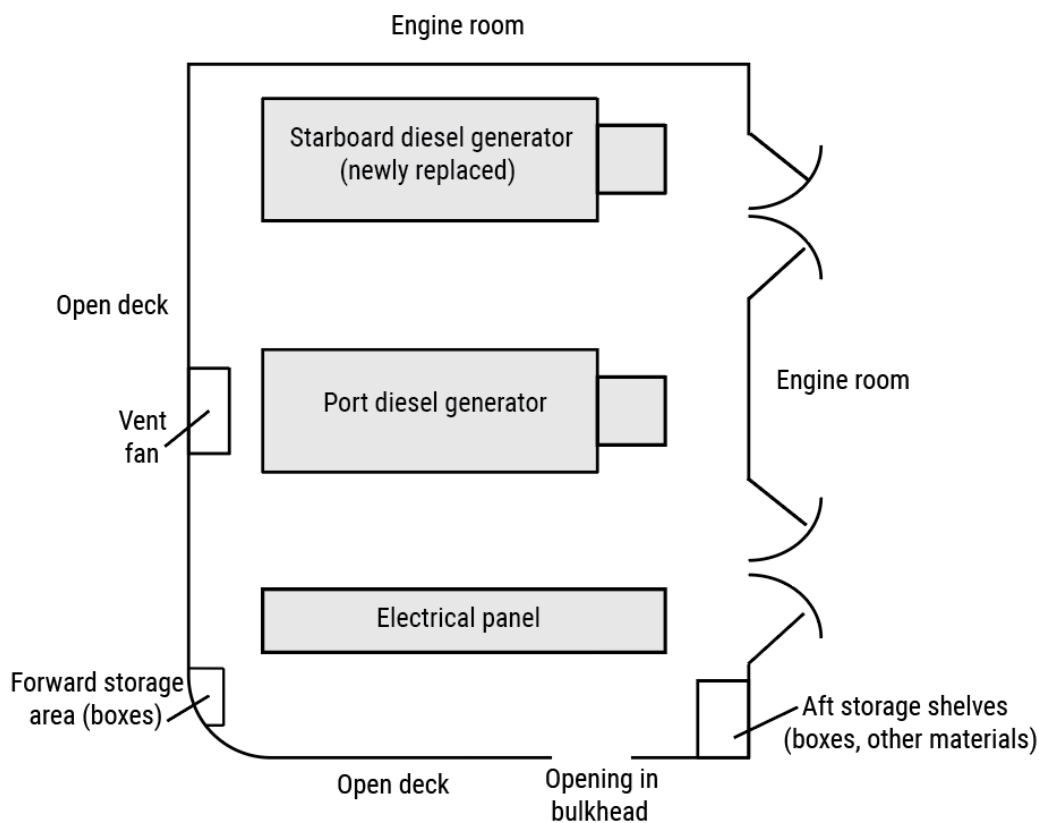
Figure 4. Layout of the *Natchez* generator space, located on the main deck in the forward port corner of the engine room (not to scale).

The work to remove the electrical panel, located on the port side of the generator space, started with the removal of the electrical components by a contractor, Bluewater Electric. Once that was completed about 0830, the project superintendent from the contractor responsible for hot work, Dixie Marine, evaluated the space to determine if it was safe for hot work, including checking the environment for flammable vapors, looking for oil on deck, and ensuring there were no combustible materials next to the hot work area. Once the space was determined safe for hot work, the employees used an acetylene torch to cut the panel's metal framing so it could be removed. As one worker was cutting with the acetylene torch, the other served as the fire watch and had a bucket of water, charged garden hose, and fire extinguisher at the ready in case a fire started. While the hot work was underway, the chief engineer had two *Natchez* crewmembers place a piece of sheet metal along the side of the port generator, about 3 feet from the hot work at the electrical panel, so that the sparks from the acetylene torch cutting would not damage it.

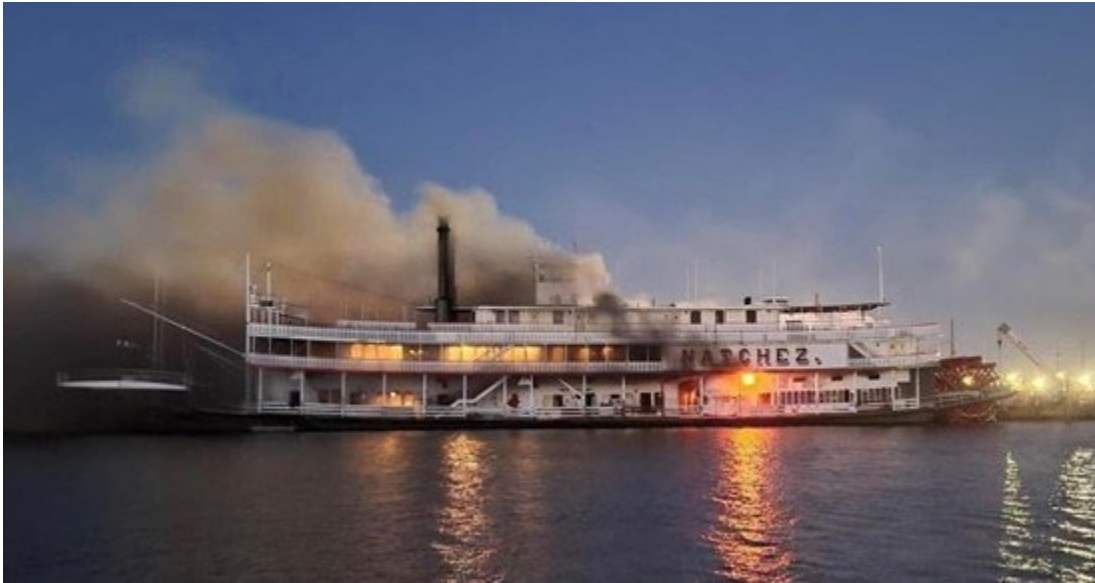
Figure 5. The *Natchez* on fire. (Source: Unidentified witness via US Coast Guard)

The New Orleans Fire Department arrived on scene about 2025, and the fire was reported extinguished about 2139. Most fire damage was contained within the generator space, with minor heat damage to the engine room and minor smoke damage to the external passenger decks located directly above the fire.

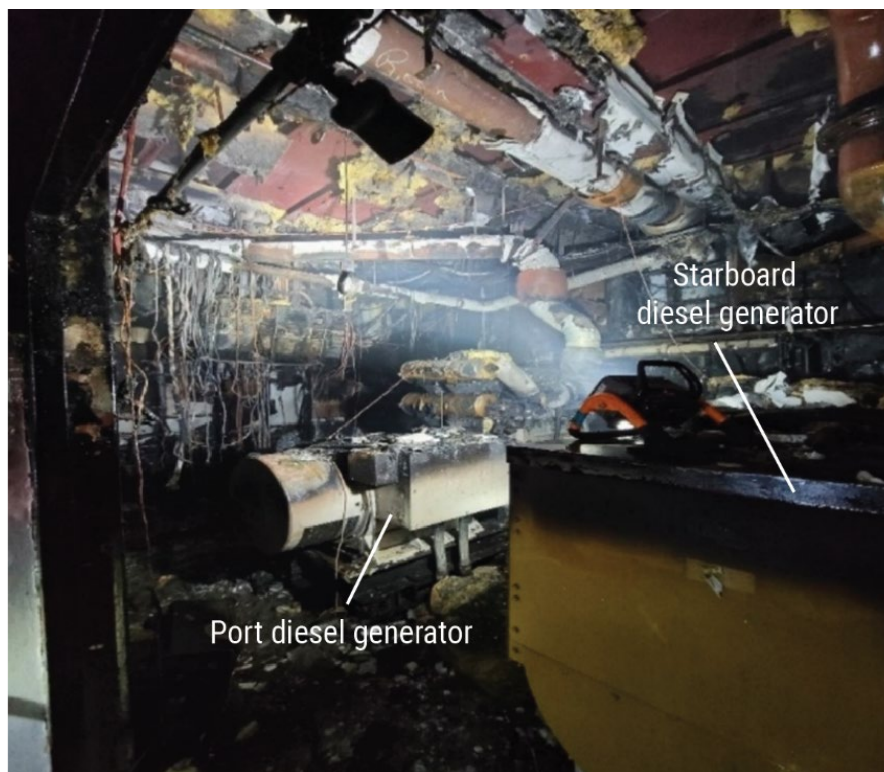
Figure 6. Looking forward in the fire-damaged generator space. The electrical panel foundation where hot work occurred before the fire is in the background, behind the port diesel generator. (Background source: New Orleans Steamboat Company)

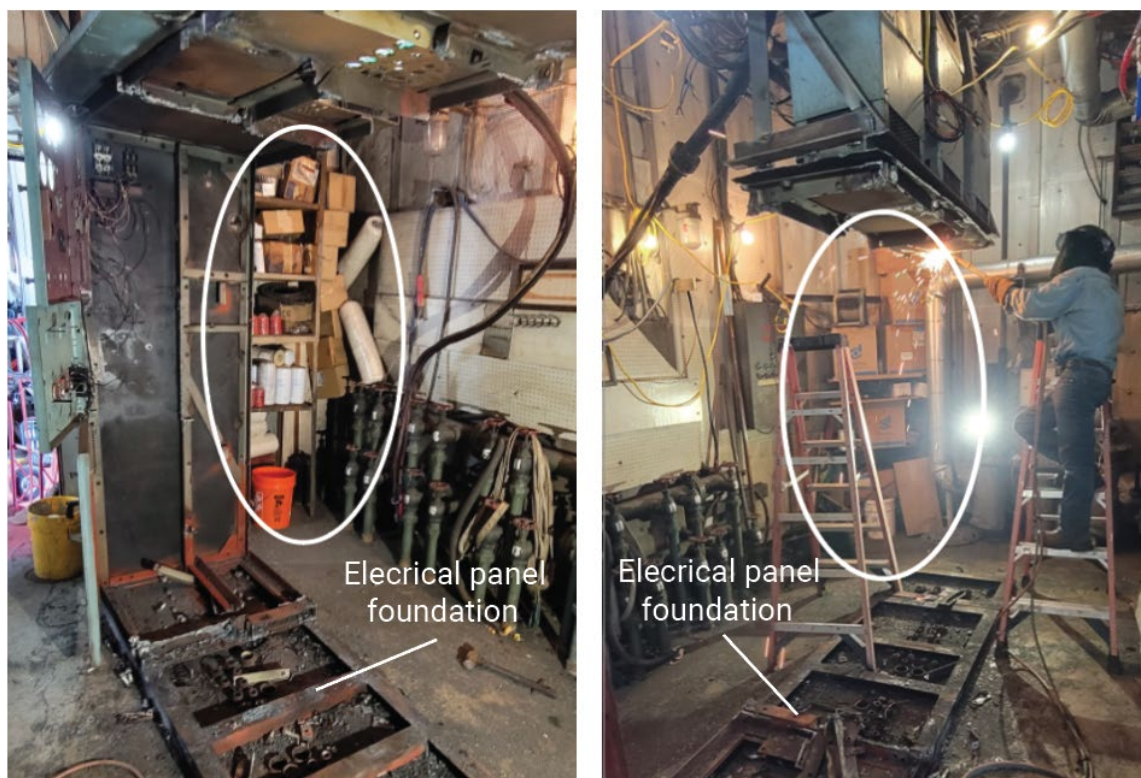
Figure 7. The *Natchez* generator space before the fire. Left photo, looking aft, shows exposed boxes and plastics (circled in white) stored aft of the metal foundation for the electrical panel that was removed during the hot work. Right photo, looking forward, shows exposed boxes (circled in white) forward of the foundation. (Background source: New Orleans Steamboat Company)

During the postfire examination of the generator space, investigators determined that the approximate distance between the area where the hot work was performed and the storage areas that contained combustible materials (forward and aft) was 2-3 feet.

During the examination of the generator space following the fire, ATF fire investigators noted a distinctive V-shaped fire pattern on the forward bulkhead of the generator space, which indicated that this was most likely where the fire started. Based on the photos provided to investigators, combustible materials (cardboard boxes) were stored in the ignition area (forward storage area in the generator room), which was located about 2 feet from where the hot work occurred. Although the electrical panel removal work had stopped about 1545, a smoldering hot spot had most likely formed within the boxes from the sparks generated from the acetylene torch cutting the metal electrical panel. Between 1545 and when the fire was discovered at 1945, the hot spot expanded and eventually ignited. The combustible materials provided ample fuel for the fire as it expanded within the generator space.

A smoldering fire can long outlast the time a fire watch observes an area following hot work. Therefore, it is critical to evaluate work areas for fire hazards and ensure that combustibles are relocated or protected with flameproofed covers/curtains or otherwise shielded with sheet metal. In addition, crewmembers involved in hot work should be trained to identify hazards such as combustibles and to take action to remove or protect them from hot work.

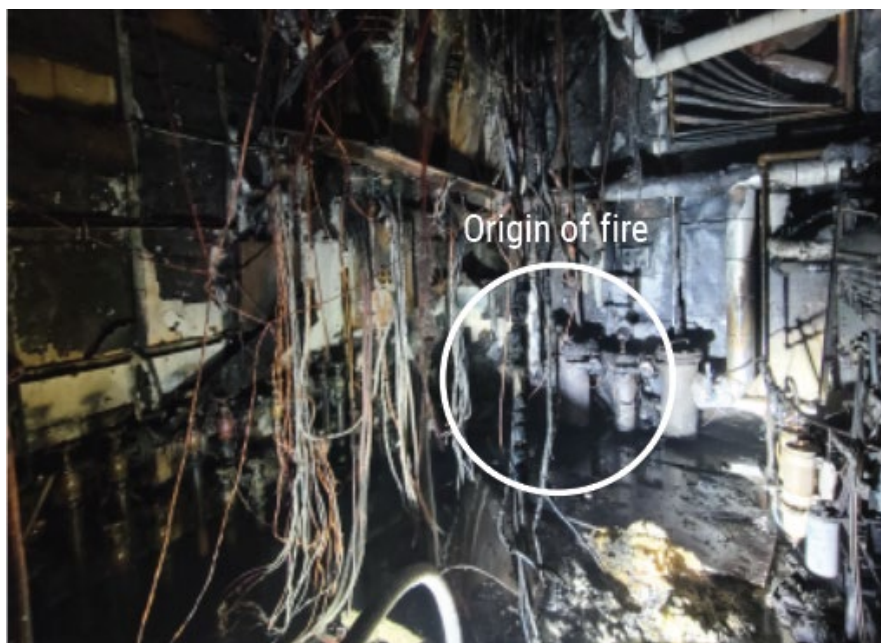
As the ATF fire investigators examined the generator space to identify the location of the initial fire, they discovered a “distinctive V-shaped” fire pattern on the forward bulkhead that was 2 feet away from the forward section of the electrical panel framing. The fire investigators also observed clean burn patterns on the forward bulkhead above the V-shaped pattern and below the vent fan. Based on their observations and examinations, the ATF fire investigators determined that the clean burn patterns were consistent with the type and size of available fuels: the combustible materials that were located along the forward bulkhead as shown in the photos taken the same day before the fire. The fire patterns found within the generator space were determined by the ATF fire investigators to be consistent with a fire originating near the deck along the forward bulkhead, adjacent to where the hot work was performed. Except for the hot work conducted before the fire, no other potential source of ignition was discovered.

Figure 8. The generator space postfire, looking forward, showing the location on the forward bulkhead identified by the ATF as the fire's origin. (Background source: New Orleans Steamboat Company)

The National Transportation Safety Board determines that the probable cause of the fire on board the passenger vessel *Natchez* was the failure of contractor and vessel personnel to identify and then either remove or adequately protect combustible material near hot work.
