MIR-23-03

# Loss of Crane on board Construction Barge

## *Carolyn Skaves*

On February 8, 2022, about 0725 local time, the construction barge *Carolyn Skaves* was spudded down in the Willoughby Bay area on the south side of the Hampton Roads Bridge Tunnel in Norfolk, Virginia, when the crane operator shifted the position of the onboard crawler crane toward the stern, and the crane toppled off the barge into the water.<sup>1</sup> The crane was later recovered and declared a total constructive loss. An oil sheen was visible after the casualty; there were no injuries reported. The value of the crane was estimated at \$2 million.

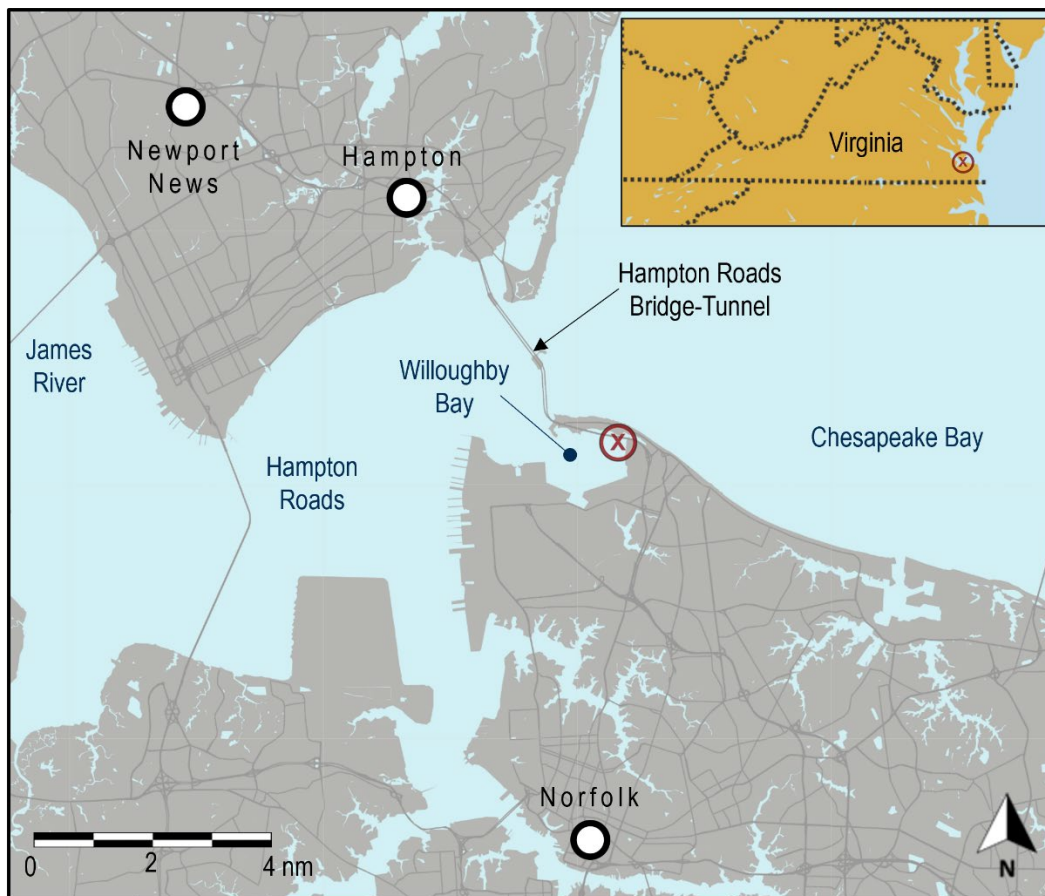
**Figure 2.** Area where the crane toppled off the deck of the barge *Carolyn Skaves* as indicated by a red X. (Background source: Google Maps)

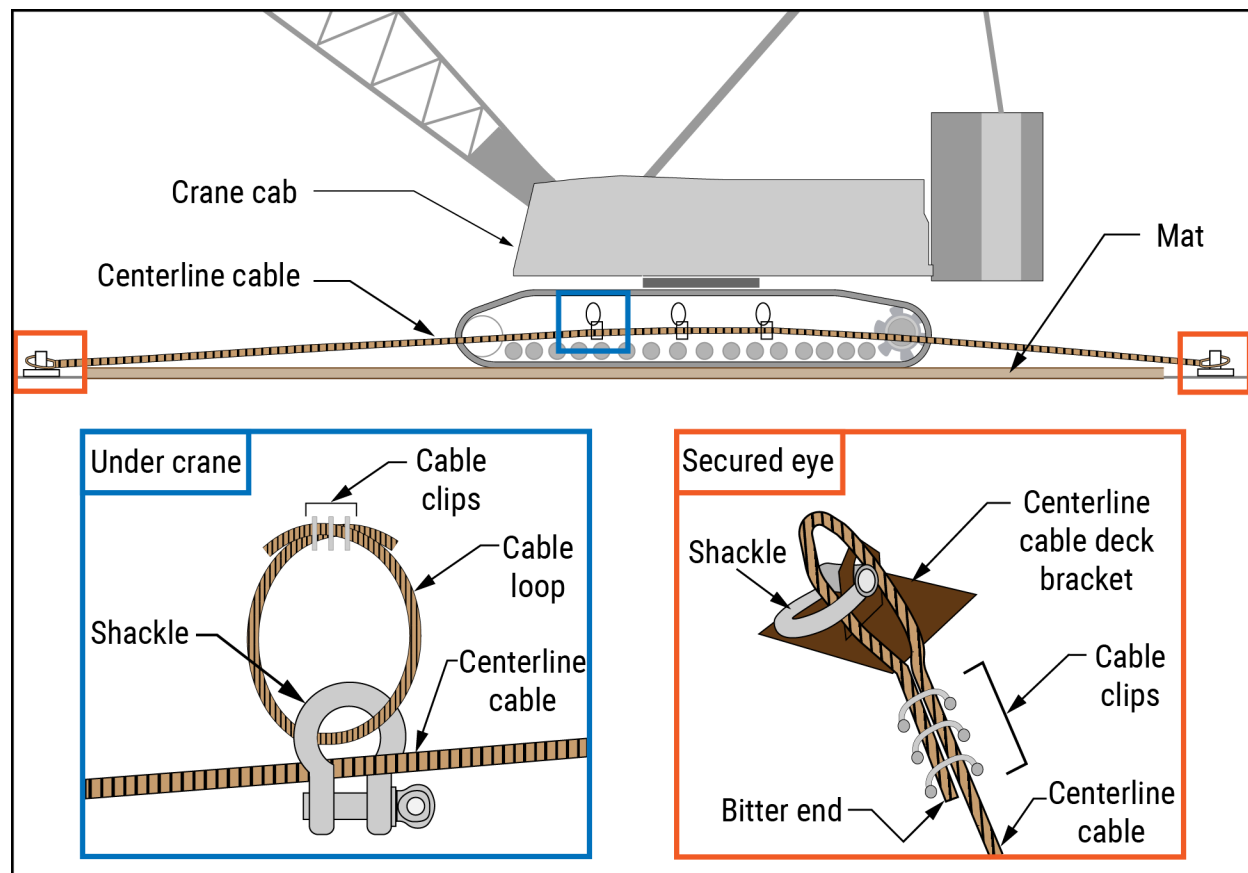
**Figure 4.** Depiction of centerline cable system, including cable loops securing the centerline cable to the underside of the crane and the two eyes, each secured to the barge's deck bracket with a shackle and cable clips (not to scale).

After the casualty, investigators found the cable eye that secured the centerline cable to the aft deck shackle and bracket had opened. The bitter (dead) end of the wire rope had slipped through three cable clips and out of the shackle. OSHA regulations required the centerline cable system, which included the method and components used to secure the cable to the barge deck, to be of sufficient strength to keep the crane on the barge.<sup>4</sup> OSHA issued Seaward

OSHA regulations required the *Carolyn Skaves* to have a centerline cable (wire rope) system of sufficient strength to keep the crane on board the barge. However, after the casualty, investigators found the centerline cable's aft eye (loop) had opened, disconnecting it from the aft deck bracket, causing the cable system to fail. The cable disconnected due to the tension exerted on it as the crane moved aft, causing the bitter end of the cable to slip through the cable clips that closed the loop (the noise the crane operator heard as he was moving the crane aft was likely the centerline cable striking the underside body of the crane as it disconnected). A centerline cable system of sufficient strength, per OSHA regulations, would have prevented the crane from being driven off the barge (as occurred in this casualty). Measures to secure the crane on the barge such as the cable system (or the corral system that the operator will now use because of this incident) are the last line of defense to keep a crane on board a barge.

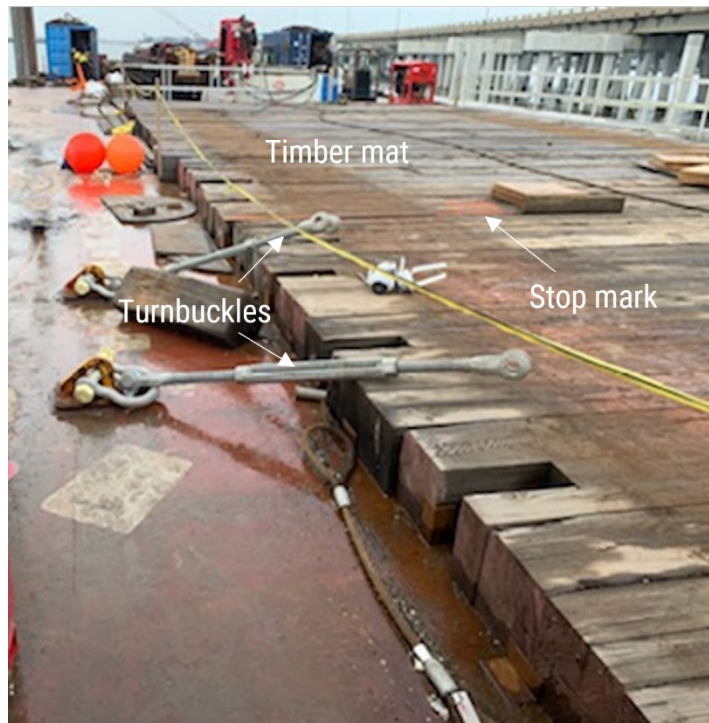
**Figure 6.** Location of turnbuckles near timber mat and stop mark painted orange on the mat. (Background source: US Coast Guard)

A stop mark, which defined the permitted crane area, was painted aft on the timber mat, as required by OSHA regulations; however, the operator told investigators that he was behind the stop mark by the time he noticed it, just before he jumped from the tipping crane. Investigators found that, sitting in the cab, the crane operator's height of eye was about 10.5 feet. From his line of sight, the operator would not have seen the stop mark until the crane tracks were about 8 feet from the stern and had traveled about 2 feet off the 12-inch-high timbers of the mat (as estimated by investigators based on barge drawings) (see Figure 9). Company policy required the use of a spotter to monitor the crane's position in relation to the stop mark. In addition to not being able to see the stop mark until the crane tread was off the mat, the operator was looking forward and monitoring the position of the crane's block (relative to the rigging on the deck) as he moved the crane aft. He did not assess the crane's position in relation to the permitted area on the barge. With no spotter, it is likely that the crane operator lost situational awareness by becoming fixated on the task at hand: maneuvering the crane block into position above the special rigging.

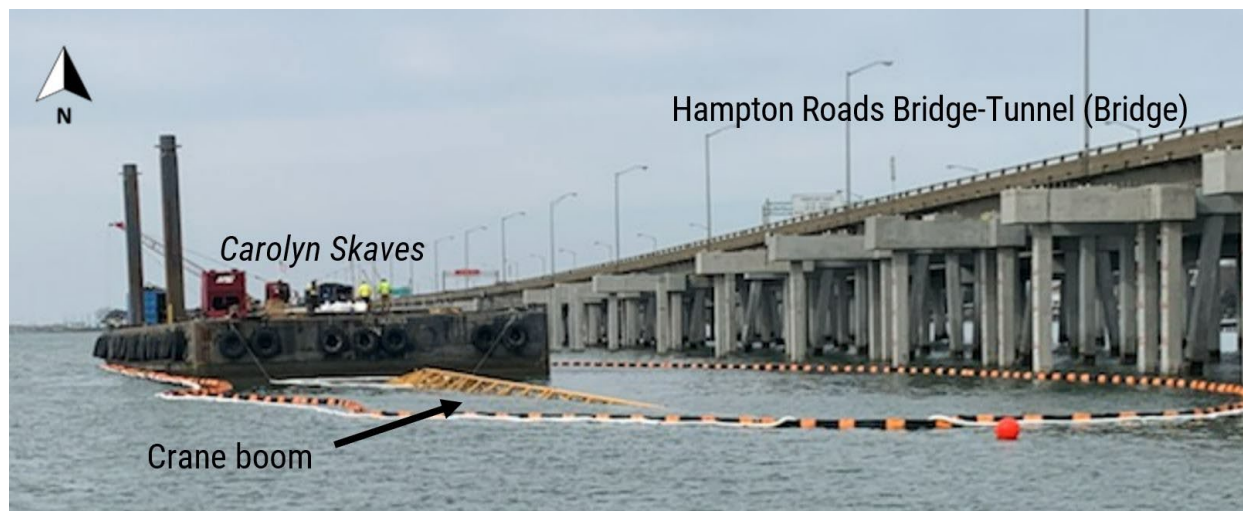
Diesel fuel from the crane was released into the surrounding water, and an oil sheen about 75 feet by 75 feet was observed. The workers used oil absorbent pads stored on the barge to soak up some of the sheen, which dissipated. The crane operator was not injured. The crane was recovered on March 24 and declared a total constructive loss.

**Figure 7.** The *Carolyn Skaves* and its crawler crane (in the water), surrounded by a turbidity curtain (silt barrier), after the casualty about 0930 (crane boom is visible aft of the barge). (Background source: Coast Guard)

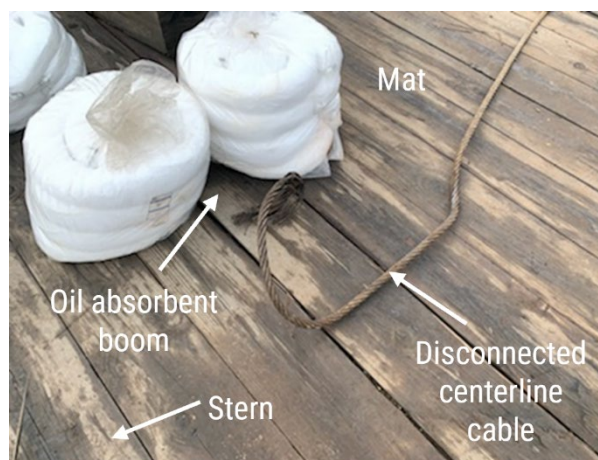
**Figure 8.** End of centerline cable, which had been secured to the aft deck bracket, after the casualty. (Background source: Coast Guard)

All repositioning of a crawler crane on a construction barge—no matter how routine—should be adequately planned and risk-assessed. All personnel involved in movement operations should be clearly identified and their duties understood, including spotting. A method such as a cable system or other physical attachment to prevent the crane from falling off the barge must also be in place before moving the crawler crane as required by Occupational Health and Safety Administration regulations.

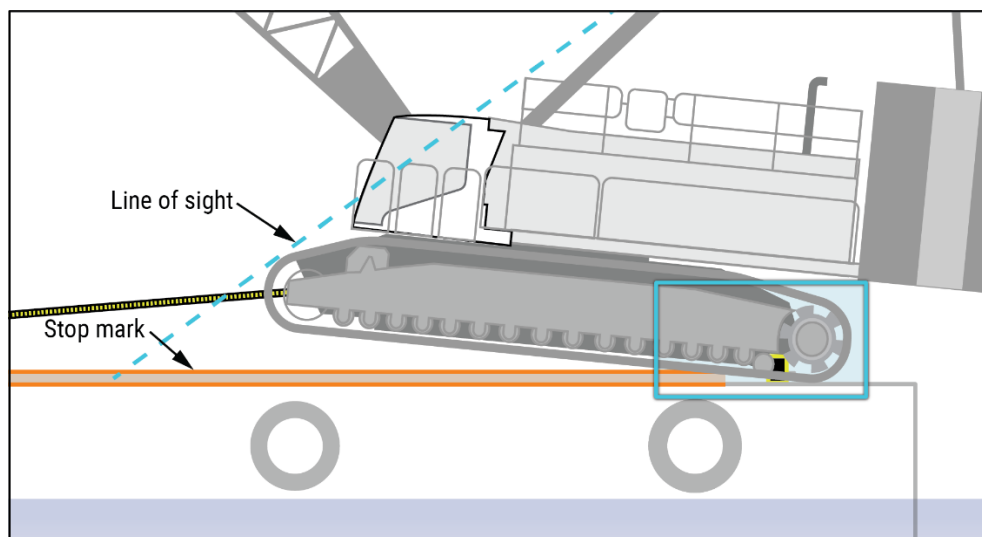
**Figure 9.** Simple representation of the *Carolyn Skaves* crane operator's line of sight from a seated position in the crane cab as the crane moved off the mat and began to topple (not to scale).
