Issued February 9, 2023

MIR-23-04

Contact of *Miss Mollye D* Tow with Route 182 Bridge

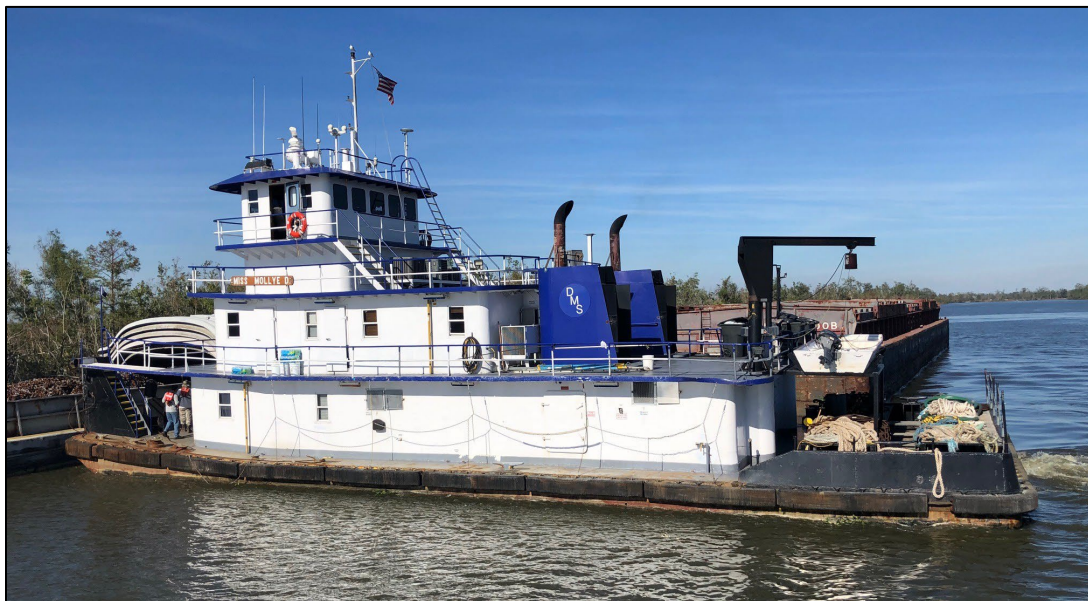
Figure 1. *Miss Mollye D* moored following the casualty. (Source: US Coast Guard)

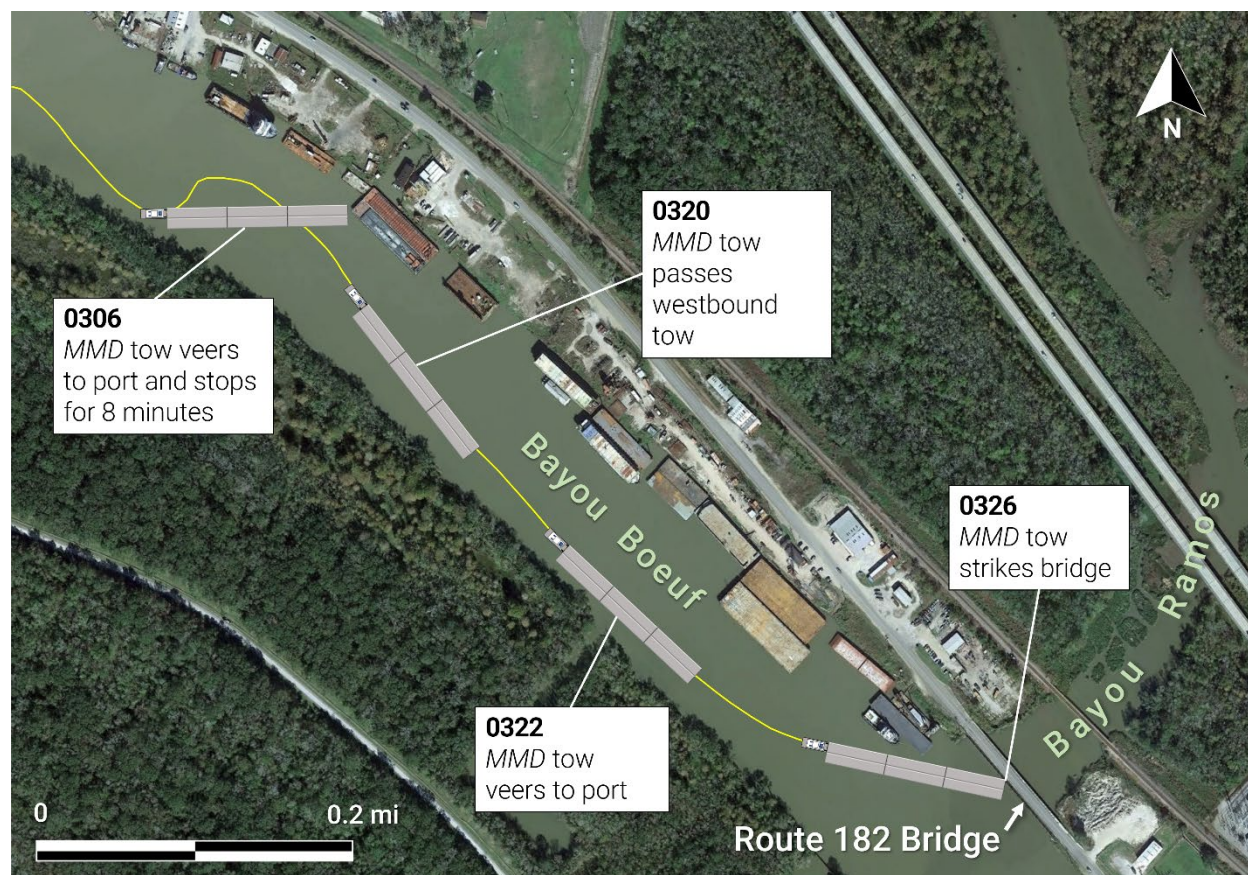
The Bayou Boeuf section of the Intracoastal Waterway is about 500 feet wide for most of its length, with a charted depth of 12 feet. There is no significant current in the waterway, and on the night of the casualty, winds were light. Just after 0300, the pilot on the *Miss Mollye D* was working the tow around a gradual bend at a speed of about 2 mph. According to data from the vessel's automatic identification system (AIS) and ECS, the tow moved to the starboard (south) side of the channel, and then, at 0303, began veering to port. It continued veering to port until the pilot stopped the tow as the head of the port lead barge, the *FJC 70B*, approached the north bank, leaving the stern of the *Miss Mollye D* near the south bank. The tow remained positioned across the width of the channel for 8 minutes. The pilot told investigators that he had heard reports over the radio of fog ahead and had stopped to consider whether to continue. He did not call the relief captain or the company to seek advice or ask for assistance. At 0314, the pilot worked to straighten the tow back in the channel, and then the tow began heading eastbound again.

Figure 4. Track of the *Miss Mollye D* (MMD), shown in yellow, as it pushed the tow before the casualty. Photo is not from the time of the casualty. Vessels shown moored along the northern bank are typical for the waterway. (Background source: Google Maps)

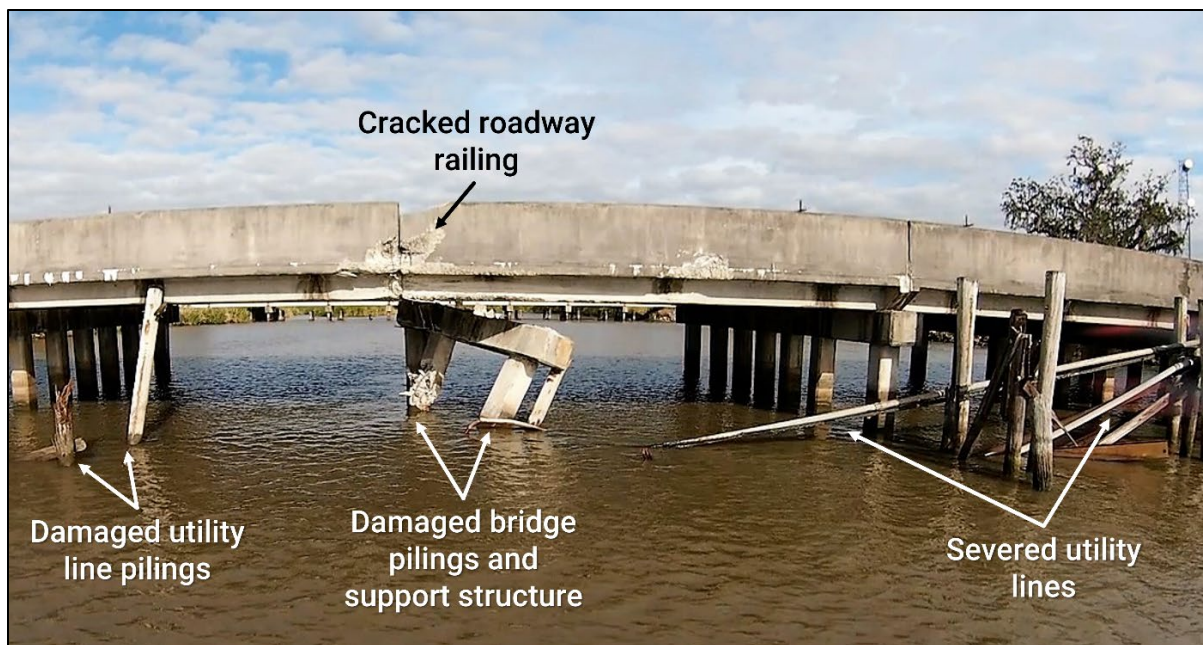
The Route 182 bridge sustained damage to several pilings, both above and below the waterline, as well as the concrete pile cap, girder, deck, bearing, and bridge railing above pilings. Water, electrical, and gas utility lines south of the bridge that were supported by separate timber pilings and cross bracing were severed when the tow made contact. The bridge was closed to traffic following the casualty; the north lane was reopened about 3 weeks later for one-way traffic alternating between east and westbound. The south lane remained closed until repairs could be made. Repairs to the bridge were estimated at \$2 million.

Figure 5. Route 182 bridge damage. (Source: Coast Guard)
