Issued February 9, 2023

MIR-23-04

Contact of *Miss Mollye D* Tow with Route 182 Bridge

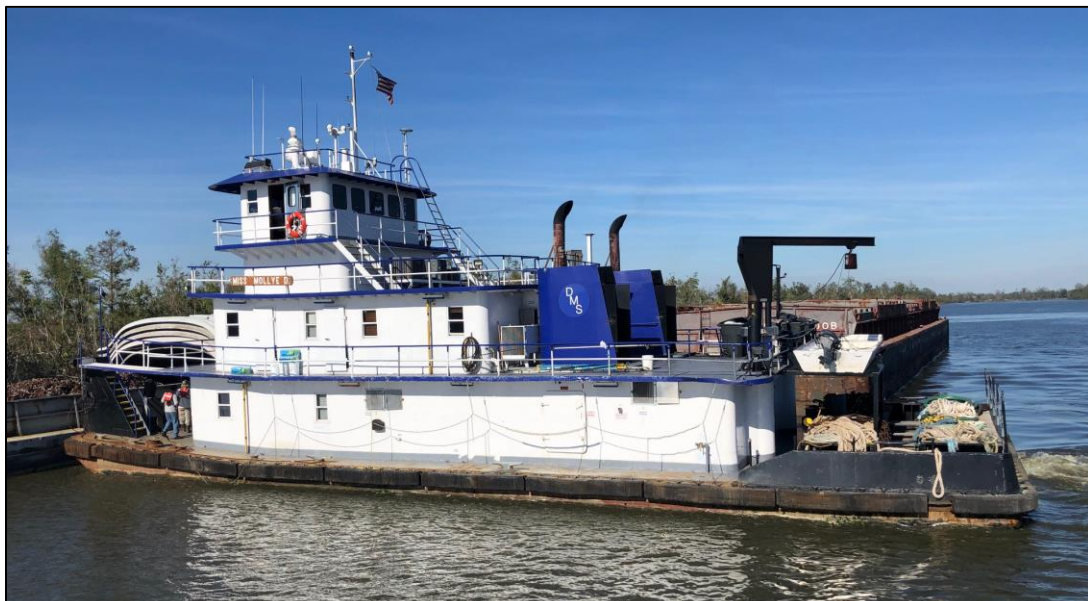
Figure 1. *Miss Mollye D* moored following the casualty. (Source: US Coast Guard)

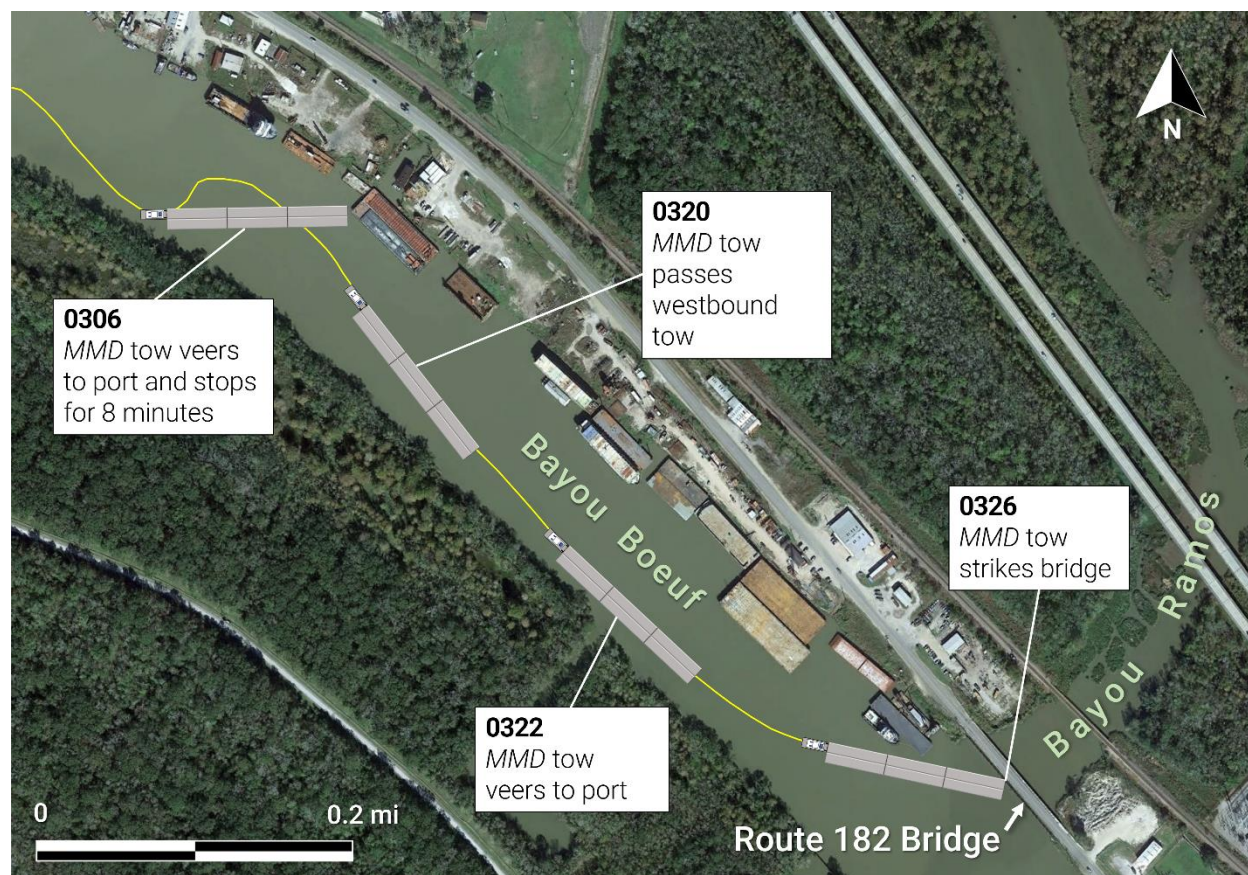
The Bayou Boeuf section of the Intracoastal Waterway is about 500 feet wide for most of its length, with a charted depth of 12 feet. There is no significant current in the waterway, and on the night of the casualty, winds were light. Just after 0300, the pilot on the *Miss Mollye D* was working the tow around a gradual bend at a speed of about 2 mph. According to data from the vessel's automatic identification system (AIS) and ECS, the tow moved to the starboard (south) side of the channel, and then, at 0303, began veering to port. It continued veering to port until the pilot stopped the tow as the head of the port lead barge, the *FJC 70B*, approached the north bank, leaving the stern of the *Miss Mollye D* near the south bank. The tow remained positioned across the width of the channel for 8 minutes. The pilot told investigators that he had heard reports over the radio of fog ahead and had stopped to consider whether to continue. He did not call the relief captain or the company to seek advice or ask for assistance. At 0314, the pilot worked to straighten the tow back in the channel, and then the tow began heading eastbound again.

Figure 4. Track of the *Miss Mollye D* (MMD), shown in yellow, as it pushed the tow before the casualty. Photo is not from the time of the casualty. Vessels shown moored along the northern bank are typical for the waterway. (Background source: Google Maps)

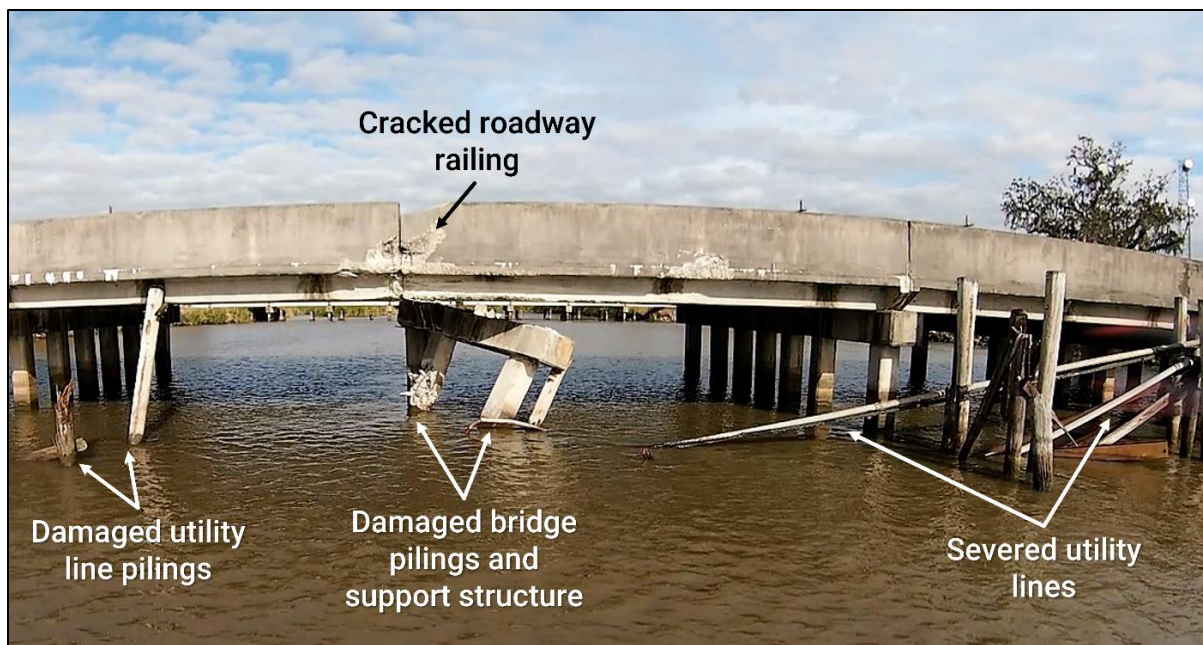
The Route 182 bridge sustained damage to several pilings, both above and below the waterline, as well as the concrete pile cap, girder, deck, bearing, and bridge railing above pilings. Water, electrical, and gas utility lines south of the bridge that were supported by separate timber pilings and cross bracing were severed when the tow made contact. The bridge was closed to traffic following the casualty; the north lane was reopened about 3 weeks later for one-way traffic alternating between east and westbound. The south lane remained closed until repairs could be made. Repairs to the bridge were estimated at \$2 million.

Figure 5. Route 182 bridge damage. (Background Source: [Coast Guard Cajun Drone Photography, Jim Pierce Jr.](#))
