Issued March 8, 2023

MIR-23-06

# Contact of *Robert Cenac* and Tow with Houma Twin Span Bridge

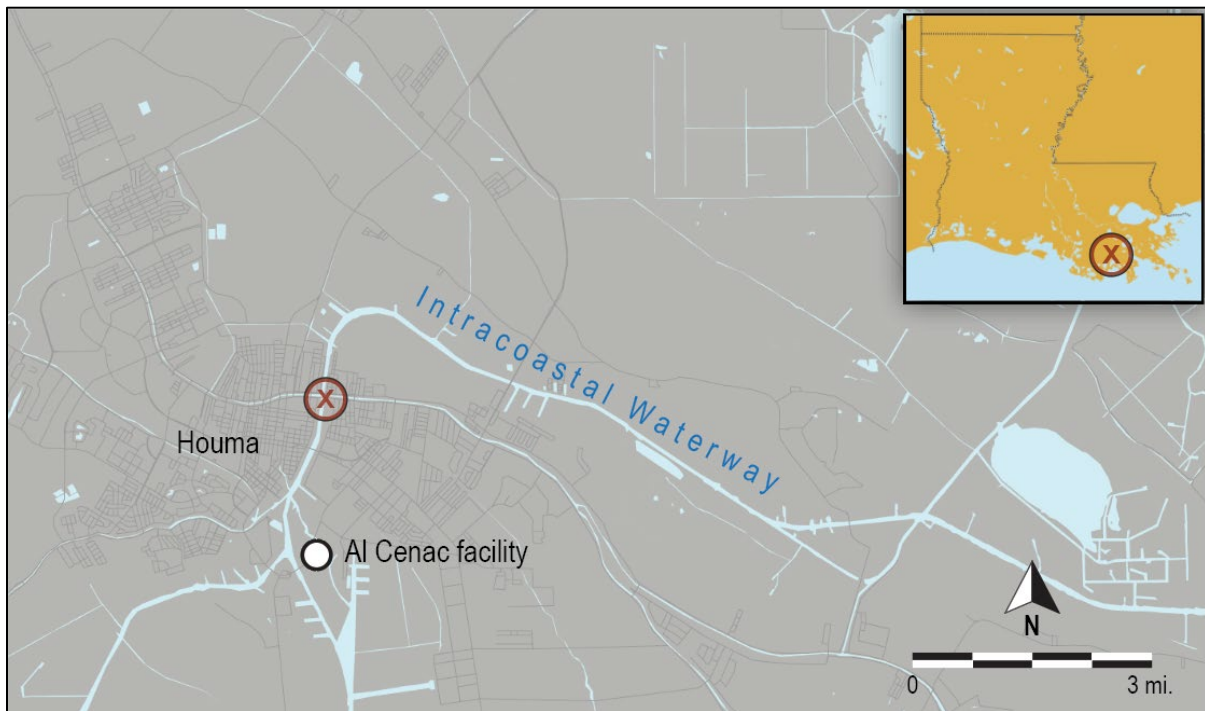
**Figure 2.** Area where the *Robert Cenac* tow contacted the Houma Twin Span Bridge, as indicated by a red X. (Background source: Google Maps)

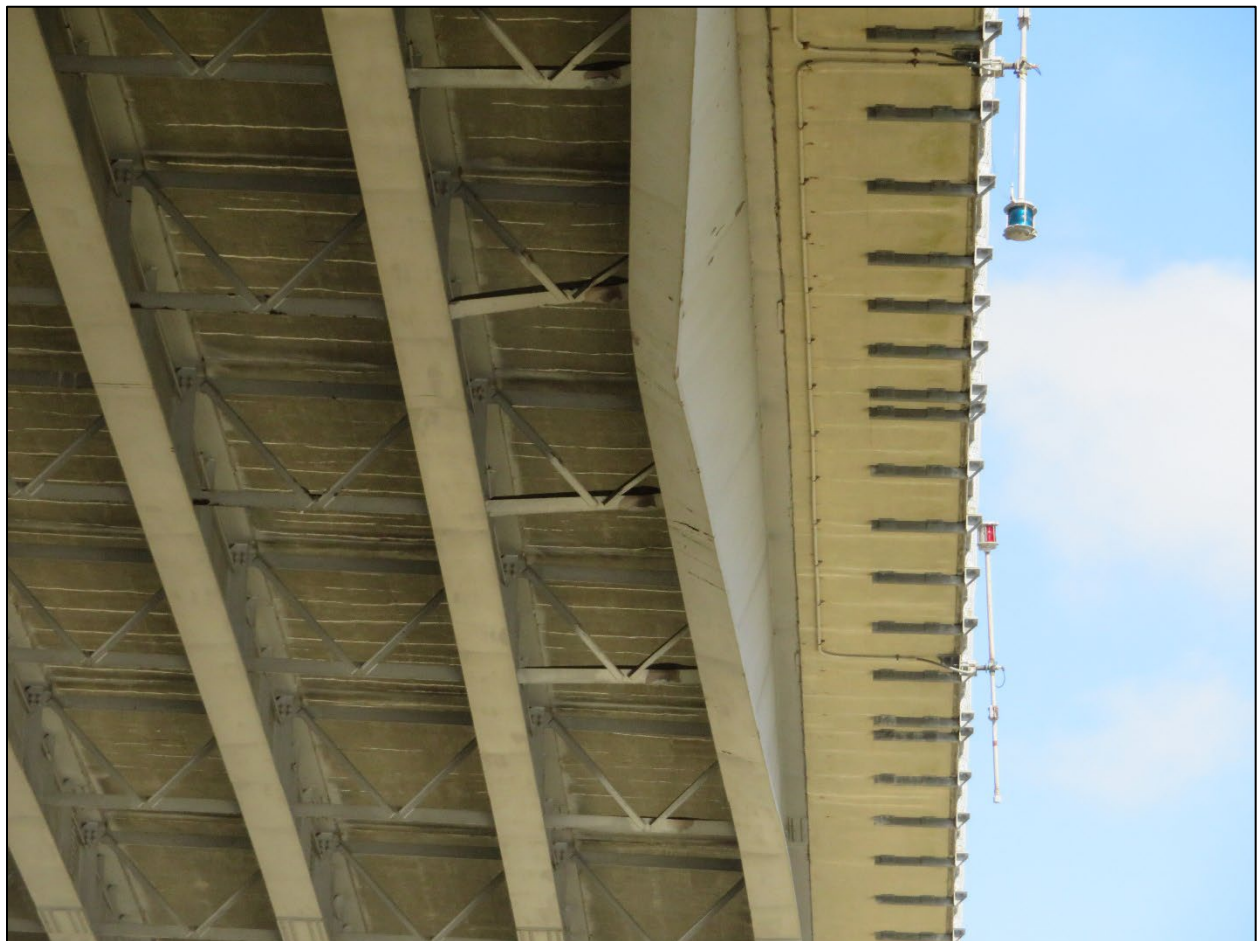
At 0038, the head of the crane boom struck the outermost stringer of the eastbound bridge. The tow was moving at a speed of 4.3 mph. When the crane made contact, the *HMT 26* broke away from the tow and had to be resecured.

The bridge sustained a bent girder, a damaged deck, and fractures to the pier caps and was completely closed to vehicular traffic until 1100, when one lane was reopened. The second lane was opened on March 16.

**Figure 5.** Eastbound span of the Houma Twin Span Bridge showing damaged stringer.

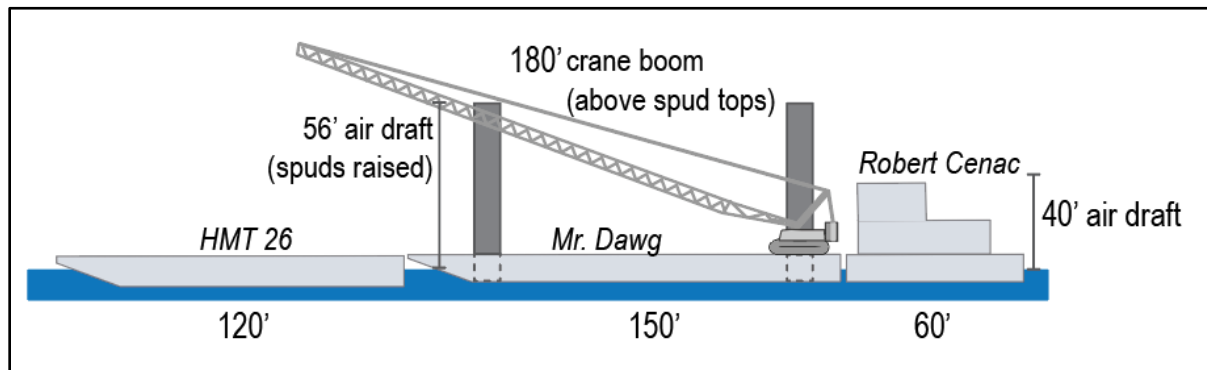
As positioned on the barge, the crane's 180-foot boom extended beyond *Mr. Dawg's* bow, and no boom rest was outfitted on the barge. By practice, according to Sealevel, crane operators would lower the boom below the spuds for transport.

**Figure 7.** Tow arrangement of *Robert Cenac* and barges at the time of the casualty. Scale approximate.
