MIR-23-10

Contact of Cruise Ship *Radiance of the Seas* with Sitka Sound Cruise Terminal Pier

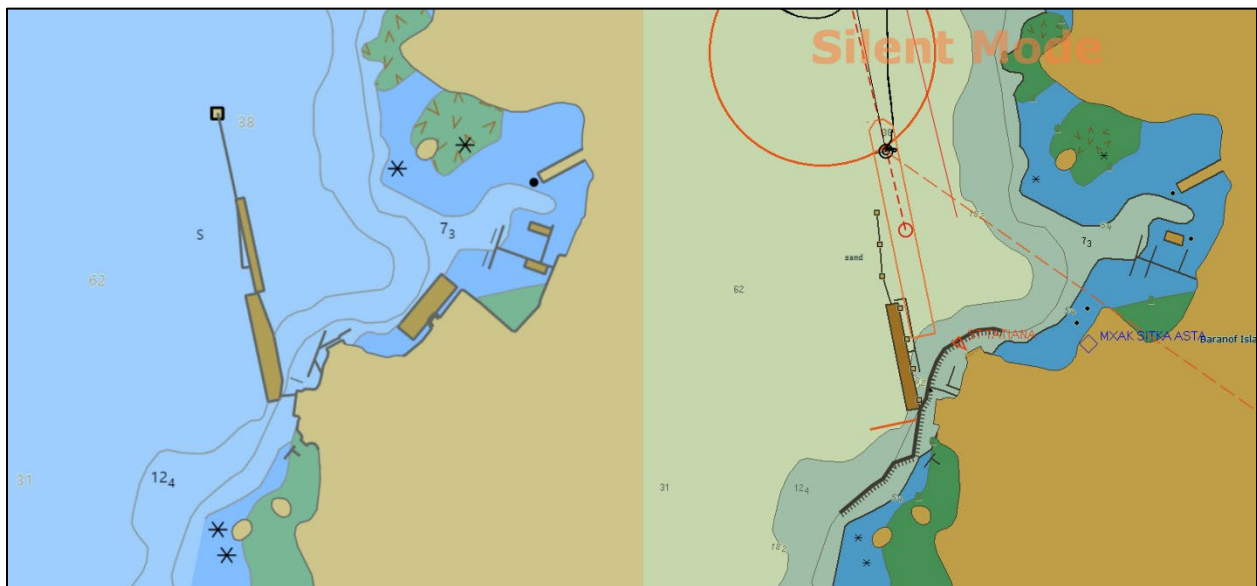
The National Ocean and Atmospheric Administration’s (NOAA) Office of Coast Survey is the hydrographic authority responsible for maintaining and issuing corrections to all US coastal nautical charts. NOAA had no record of the construction completed on the Sitka Sound Cruise Terminal pier until after the casualty, when investigators informed them of the pier’s extension. NOAA staff told investigators that they would have updated the chart if they had been informed. They also stated that it is the responsibility of facility owners to inform them when permitted construction is complete and to provide drawings of the construction as built so that corrections and updates can be made to nautical charts for that area (neither the Sitka Sound Cruise Terminal’s permit nor regulations required this). The electronic navigation chart (ENC) did not show the extended pier and added dolphins until September 8, 2022, when NOAA updated the chart.⁴

Figure 7. ENC updated postcasualty (*left*) and as seen on *Radiance of the Seas*’s ECDIS (*right*) with the ship’s outline after mooring shown in orange. (Sources: NOAA [*left*] and Royal Caribbean Cruise Lines [*right*])

Ports and terminals should immediately report significant modifications to port or terminal configurations to the appropriate hydrographic authority (for example, the National Oceanic and Atmospheric Administration) so that charts can be updated and the changes made readily available to vessel owners, operators, and crews/bridge teams.
