Issued June 7, 2023

MIR-23-11

## Fire aboard Yacht *Pegasus*

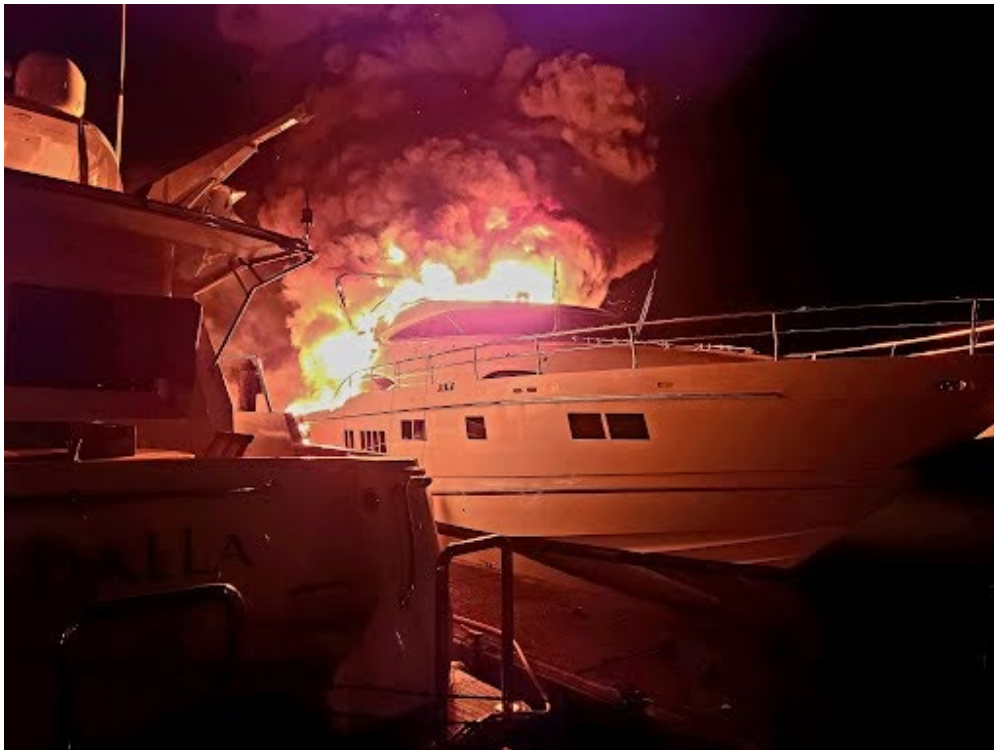
At 0204 on July 15, Peninsula Yacht Basin security cameras first captured smoke and flames emanating from the aft section of the *Pegasus*. In the video, the fire burned for about 45 minutes before intensifying and spreading forward.

At 0302, a bystander noticed the fire and called 911. Gig Harbor Police officers arrived at the marina at 0316, followed 4 minutes later by firefighting units. The police officers found the aft half of the *Pegasus* completely engulfed in flames, with the fire threatening a vessel moored nearby. Firefighters laid out fire hose from a shore plug to the end of the long pier and docks. The hose was charged, and firefighting efforts commenced at 0332 from the floating docks on the starboard side of the *Pegasus*. Nine minutes later, a firefighting boat arrived and started fighting the blaze from the opposite side of the vessel. A second fire hose was rigged from shore and charged, with water on the fire at 0342.

**Figure 4.** Yacht *Pegasus* fire at 0322 local time, just before the arrival of firefighters at the vessel's berth. (Source: Gig Harbor Police Department)
