Fire aboard Towing Vessel *Mary Dupre*

On June 26, 2022, about 0930 local time, a fire broke out in a stateroom on board the towing vessel *Mary Dupre*, which was pushing one barge of bio-diesel fuel (pyrolysis fuel oil) on the Gulf Intracoastal Waterway near Freeport, Texas.¹ Nearby Good Samaritan towing vessels retrieved the barge from the *Mary Dupre*, extinguished the fire, and evacuated the four crewmembers. There were no injuries, and no pollution was reported. The towing vessel was deemed a total constructive loss estimated at \$1 million.

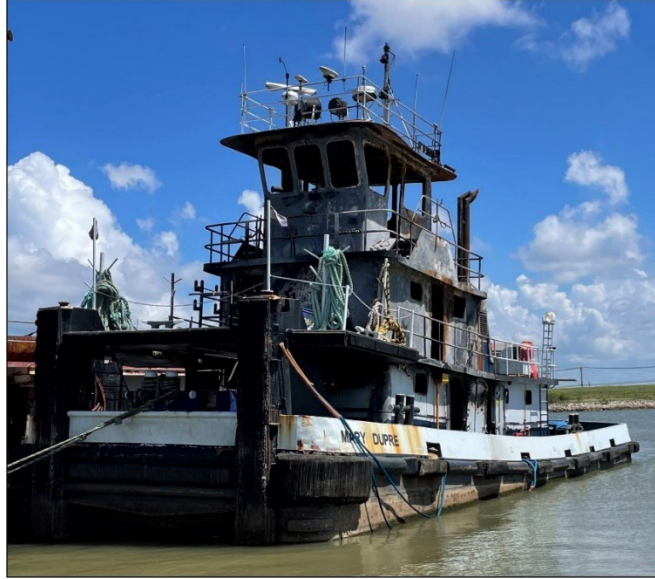
After the *Mary Dupre* was docked at the shipyard, a local fire marshal, Coast Guard investigators, and a National Transportation Safety Board (NTSB) investigator inspected the damaged vessel. Investigators observed fire and heat damage to all three decks of the superstructure. The degree of damage increased moving upward and forward on the vessel.

Figure 6. The *Mary Dupre* after the fire.

There was little to no fire and heat damage observed on the aft section of the main deck. In the engine room below the main deck, there was no damage to the main engines, generators, or other machinery. In both the wheelhouse and on the second deck, all wood framing, furniture, paneling, and joinery, as well as all paint and combustibles, were destroyed, completely consumed by fire and heat. On the main deck, combustible materials in the galley and crew quarters were partially burned. Due to the severity of the damage, the vessel was declared a constructive total loss and scrapped in October 2022.
