MIR-23-14

# Collision between US Coast Guard Cutter *Winslow Griesser* and Center-console Boat *Desakata*

Atlantic Ocean

August 8, 2022

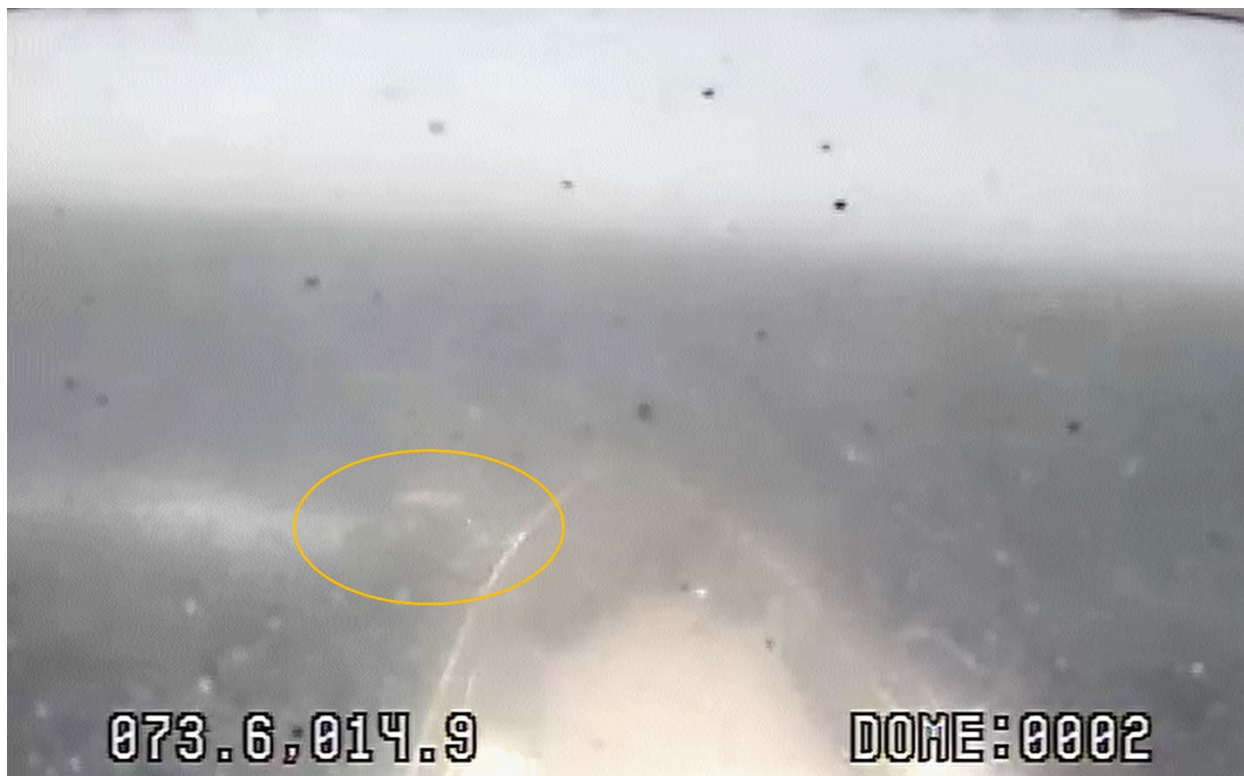
About 1417, as seen from the forward-looking camera on the mast, the cutter and the fishing boat collided (see Figure 5). Crewmembers on the cutter's mess deck, located on the main deck below the bridge, felt a shudder and heard a bang. One crewmember stated that he thought they hit a whale. Onboard cameras captured the crew's reaction to the collision on the mess deck and other crewmembers checking for damage in the engine room.

**Figure 5.** The *Desakata* as recorded from the *Winslow Griesser*'s salt-encrusted mast camera at 1417:12, immediately before the collision. (Source: Coast Guard)

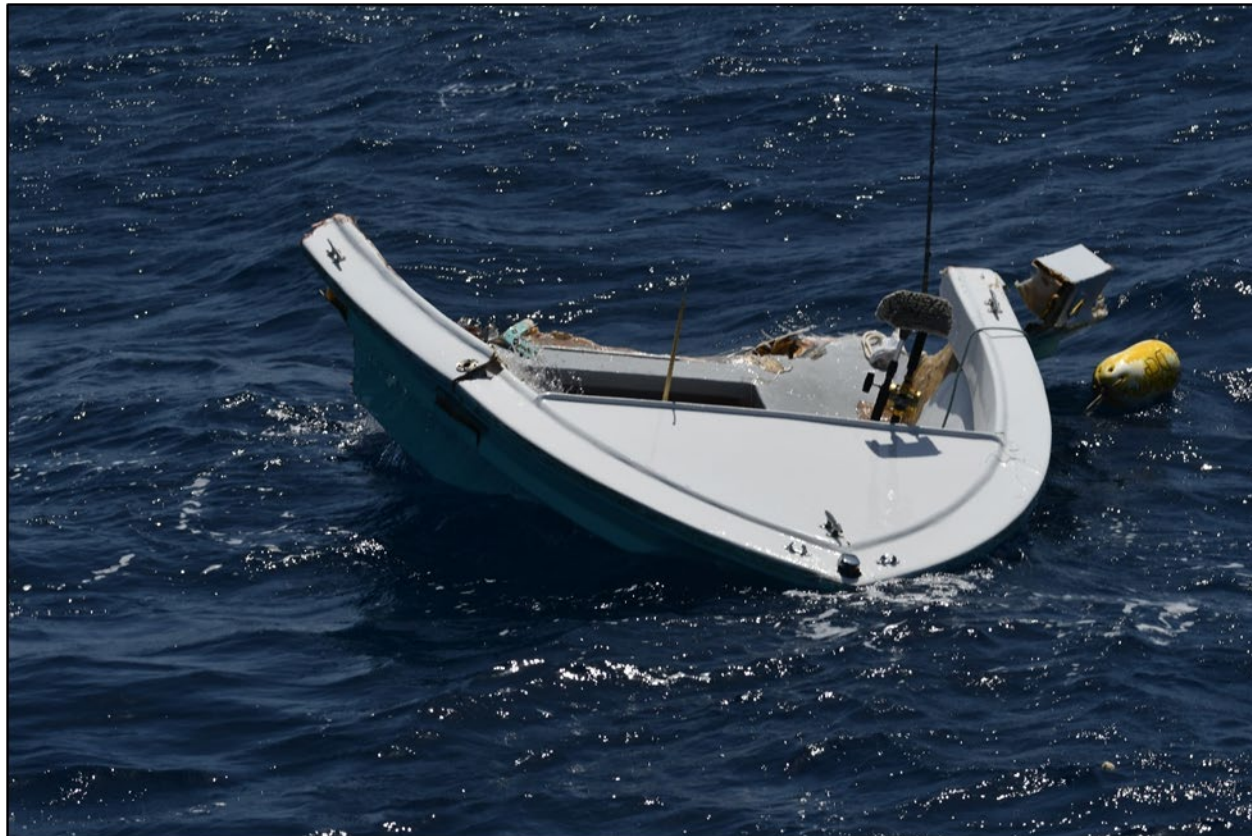
The *Desakata* was a total loss; its bow later washed ashore (see Figure 6). The vessel and fishing gear were valued at an estimated \$55,600 and \$3,200 respectively. The *Winslow Griesser* sustained cosmetic damage to its hull coatings.

**Figure 6.** The *Desakata*'s bow section adrift immediately after the collision. (Source: Coast Guard)

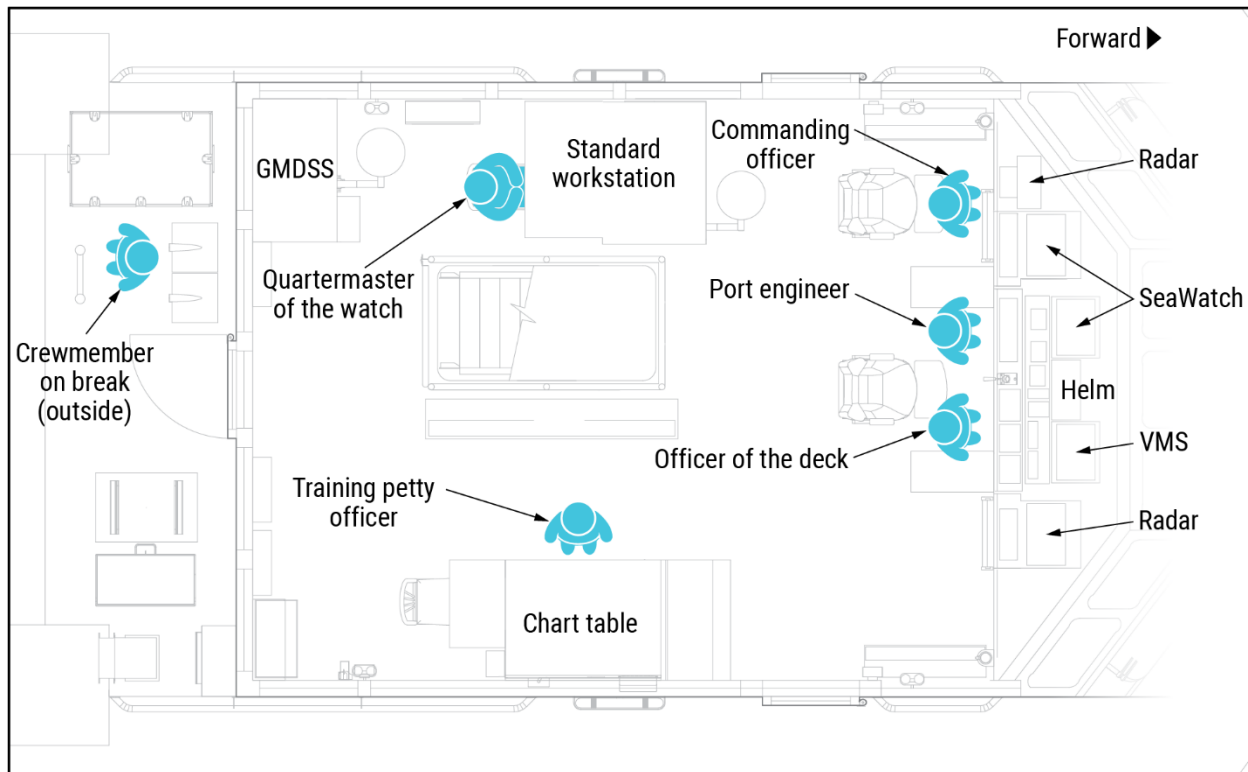
According to the port engineer and the training petty officer, the quartermaster of the watch was attending to administrative tasks in the aft part of the bridge. At one point, the port engineer and training petty officer observed the commanding officer working on the port forward console, adjusting the tracklines to Punta Cana.

**Figure 8.** *Winslow Griesser* bridge arrangement and approximate location of individuals at the time of the collision.

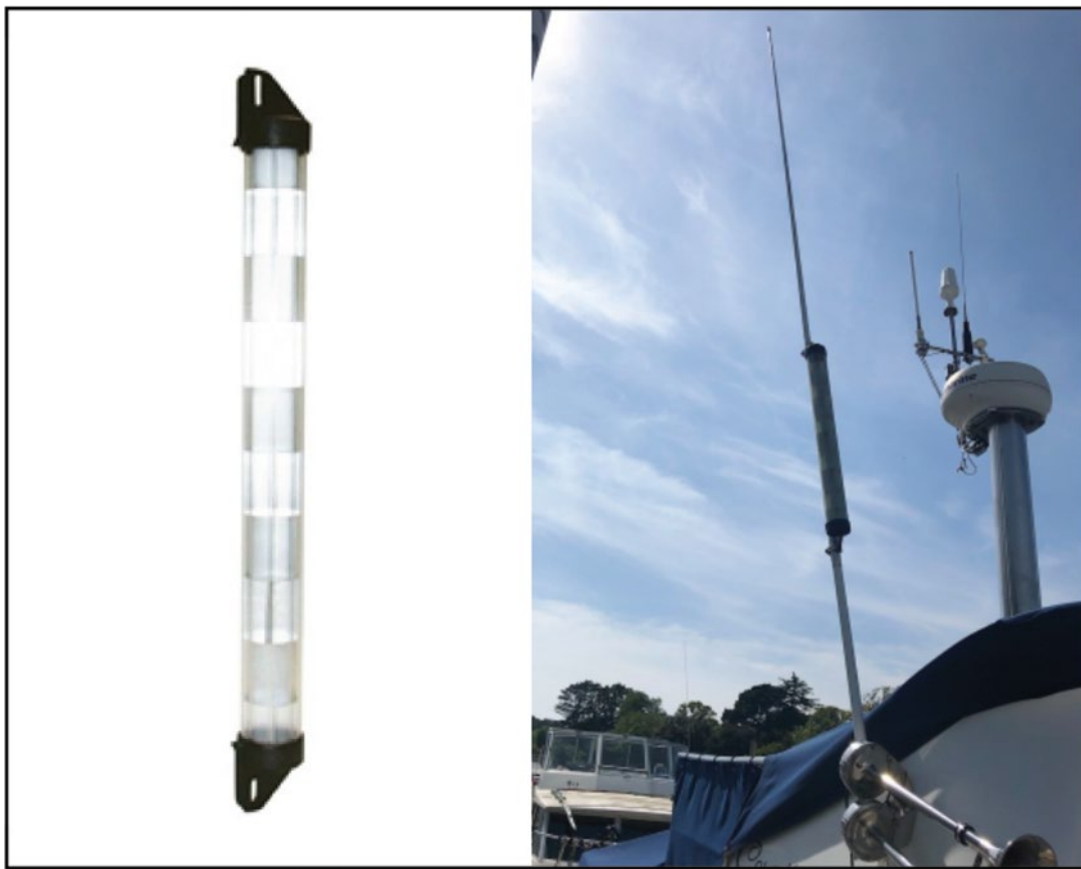
A radar reflector is a device designed to create a strong reflection of radar waves in order to make it clearly visible on vessel radar screens (see Figure 10). The reflector is mounted as high as possible on a boat, typically by hoisting the reflector from an existing or purposed mast. The Coast Guard issued a safety alert in 1997 emphasizing that

**Figure 10.** An example of a tubular style radar reflector (*left*), and a tubular radar reflector mounted on a pole aboard a recreational vessel (*right*). (Source: [ayamarnautico.com](http://ayamarnautico.com))

outfitted with a radar reflector. The Coast Guard requires radar reflectors for federally documented fishing vessels (with nonmetallic hulls) operating beyond the Boundary Line, among others, but not for vessels such as *Desakata*. The NTSB has advocated the use of radar reflectors since 1969, when we recommended that the Coast Guard find ways to encourage the use of radar reflectors. Although radar reflectors are not required for small vessels such as the *Desakata*, the use of these devices enhances safety—reducing collision risk by ensuring that the vessel is more visible to radar.
