# Grounding and Capsizing of Fishing Vessel *Challenger*

On August 7, 2022, about 0700 local time, while transiting along the northwestern shore of Kodiak Island, Alaska, the fishing vessel *Challenger* struck a submerged rock and began taking on water.<sup>1</sup> The captain and three crewmembers used onboard pumps to remove the floodwater, but the pumps were unable to keep up, and the crew abandoned the vessel. A nearby Good Samaritan fishing vessel rescued them. The *Challenger* eventually capsized. There were no injuries, and no pollution was reported. Damage to the vessel was estimated at \$600,000.

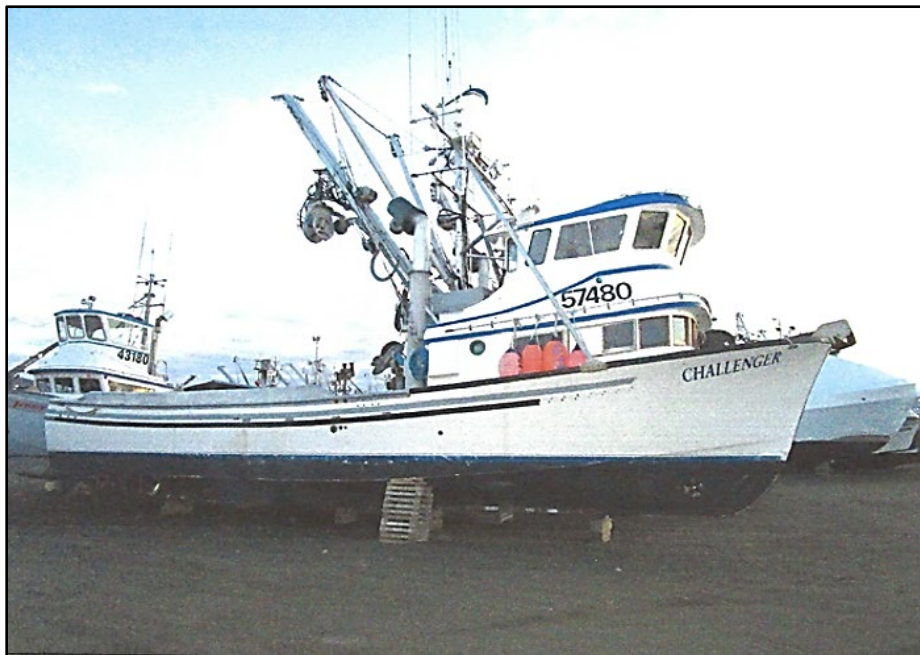
Figure 1. Fishing vessel *Challenger* on blocks before the grounding. (Source: Fleenor)

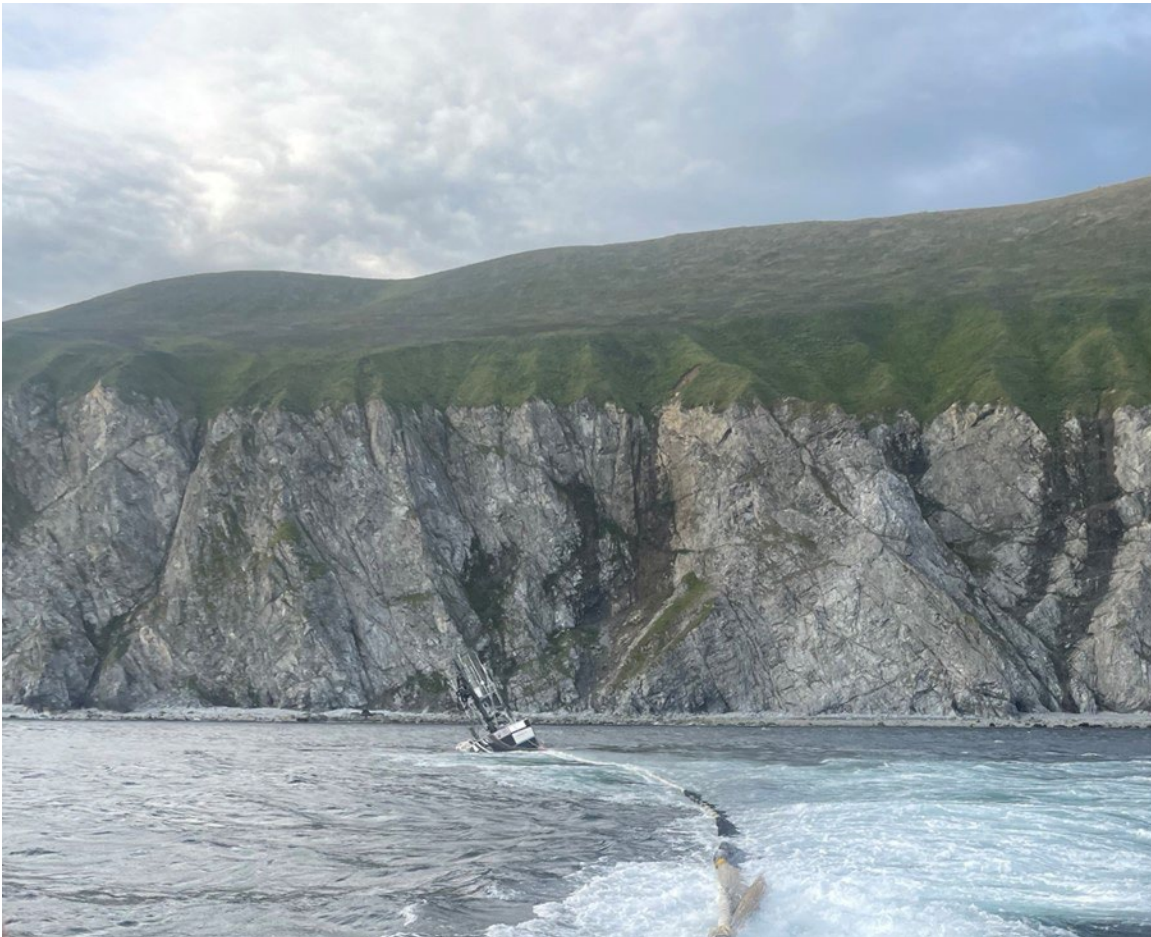
The *Challenger* capsized about 10 minutes after the crew abandoned the vessel but remained afloat.

**Figure 3.** The *Challenger's* sein net as crewmembers in the vessel's skiff removed it from the stricken vessel. (Source: Alward Fisheries)

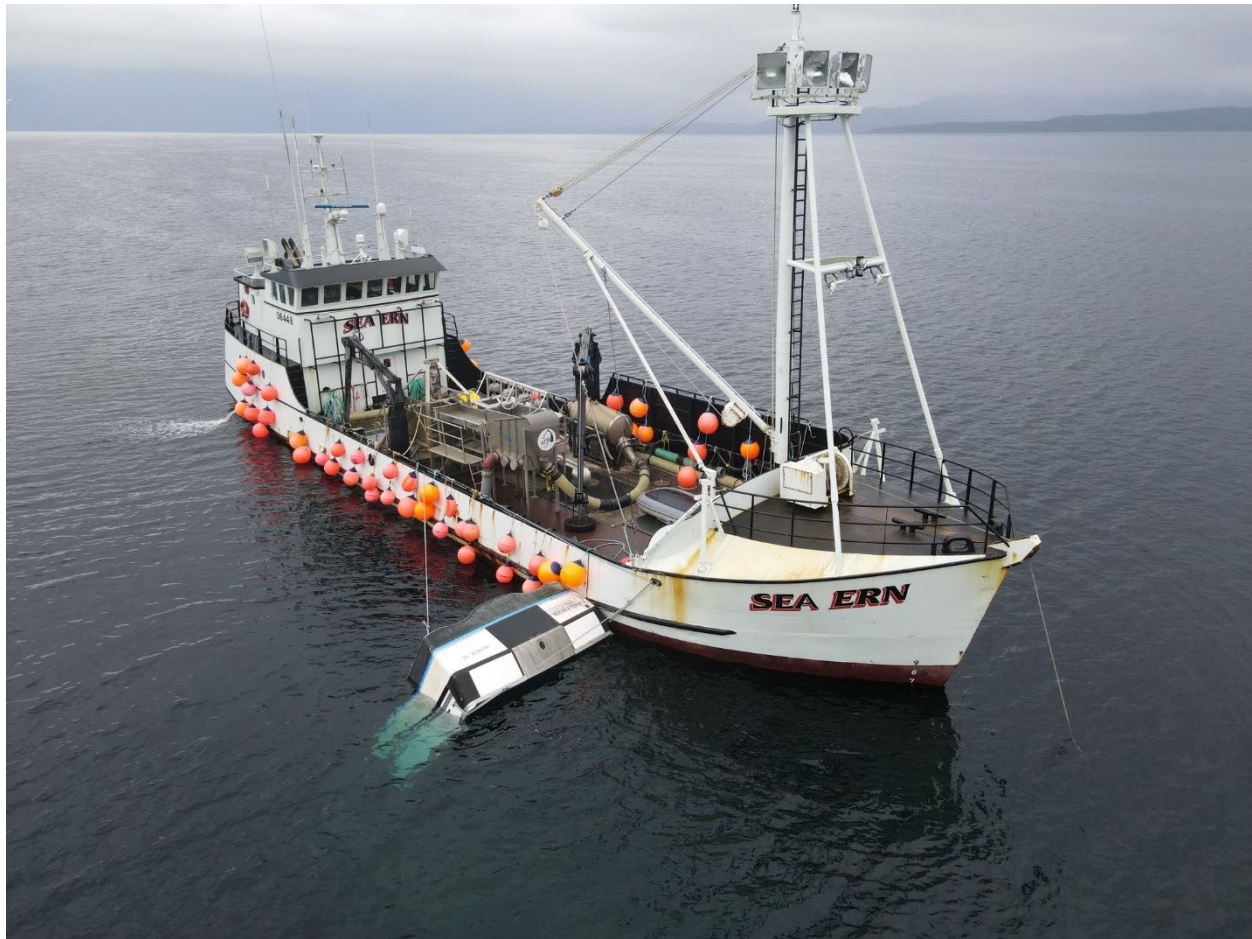
The *Sea Tsar* crew attached a tow line to the capsized *Challenger* to prevent the vessel from sinking and began towing the *Challenger* to Larsen Bay. A couple hours into the tow, the *Sea Tsar* crew transferred the tow line to the *Sea Ern*, another fishing vessel in the area. The *Sea Ern* towed the *Challenger* the remainder of the way to Larsen Bay. The vessels moored at Larsen Bay later that evening, about 14 to 16 hours after the initial flooding and capsizing.

**Figure 4.** Fishing vessel *Sea Ern* using line to prevent the *Challenger* from sinking. (Source: Alward Fisheries)

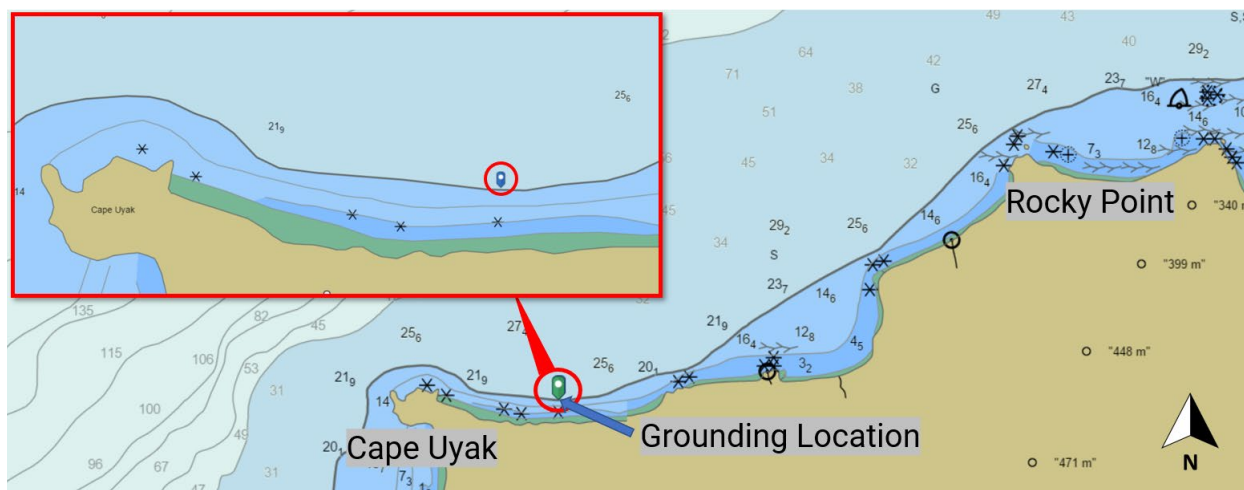
Investigators could not independently verify the exact location of the rock that the *Challenger* struck. A friend of the vessel's captain traveled to the area of the grounding several days after the casualty and supplied investigators with coordinates he said corresponded with the location of the rock. When plotted on a NOAA ENC, these coordinates corresponded to an area with a water depth of about 30 feet, located about 220 yards (660 feet) seaward of the low tide mark. The ENC showed three rocks, in about 6 feet of water, within about 150 yards (450 feet) of the coordinates supplied to investigators.

The navigation chart for the area the vessel was operating (NOAA chart 16598) indicated that a National Ocean Service hydrographic survey with partial bottom coverage was completed sometime between 1900 and 1939.

**Figure 5.** NOAA ENC for the area of the grounding. Annotations (green and blue markers) show the location of the uncharted rock as reported to investigators. (Background source: NOAA)

The captain of the *Challenger* used an electronic navigation system that incorporated updated NOAA charts for the area he was navigating. The charts, however, did not include the location of the rock. The northwestern coast of Kodiak Island, like many parts of Alaska, is remote with a complex coastline. These areas are not surveyed as frequently as would be a harbor or inland passage. Because of this, mariners should not rely solely on their navigation systems and nautical charts but also use other references, as well as their experience and knowledge of the area. The *Coast Pilot* for the area where the *Challenger* grounded indicated that vessels should give the shore a berth of at least 1 mile, much more than the 220-yard (660-foot) distance from the shore where the vessel was operating when it grounded. Additionally, the captain had knowledge of a rock in the area, having seen it before during a low minus tide. The captain could have marked the uncharted rock on his charting software the first time he observed it but did not. He assumed the risk of operating close to shore so he could be in the area where the weather conditions and fishing were more favorable, which resulted in the grounding.

In addition to marking hazards on their own charts and charting software, mariners can report issues (errors or omissions) with the National Oceanic and Atmospheric Administration's nautical charts and/or *Coast Pilot* through the Office of Coast Survey's [ASSIST](#) tool.<sup>7</sup> To report an issue such as an uncharted rock, a user can enter the rock's position manually or drop a pin on the electronic navigation chart incorporated into the ASSIST tool. Users can access ASSIST from a computer or mobile device.
